# Inspection Photos

Operator: SG INTERESTS I LTD # 77330

Location ID: 418697

Gunnison County, CO

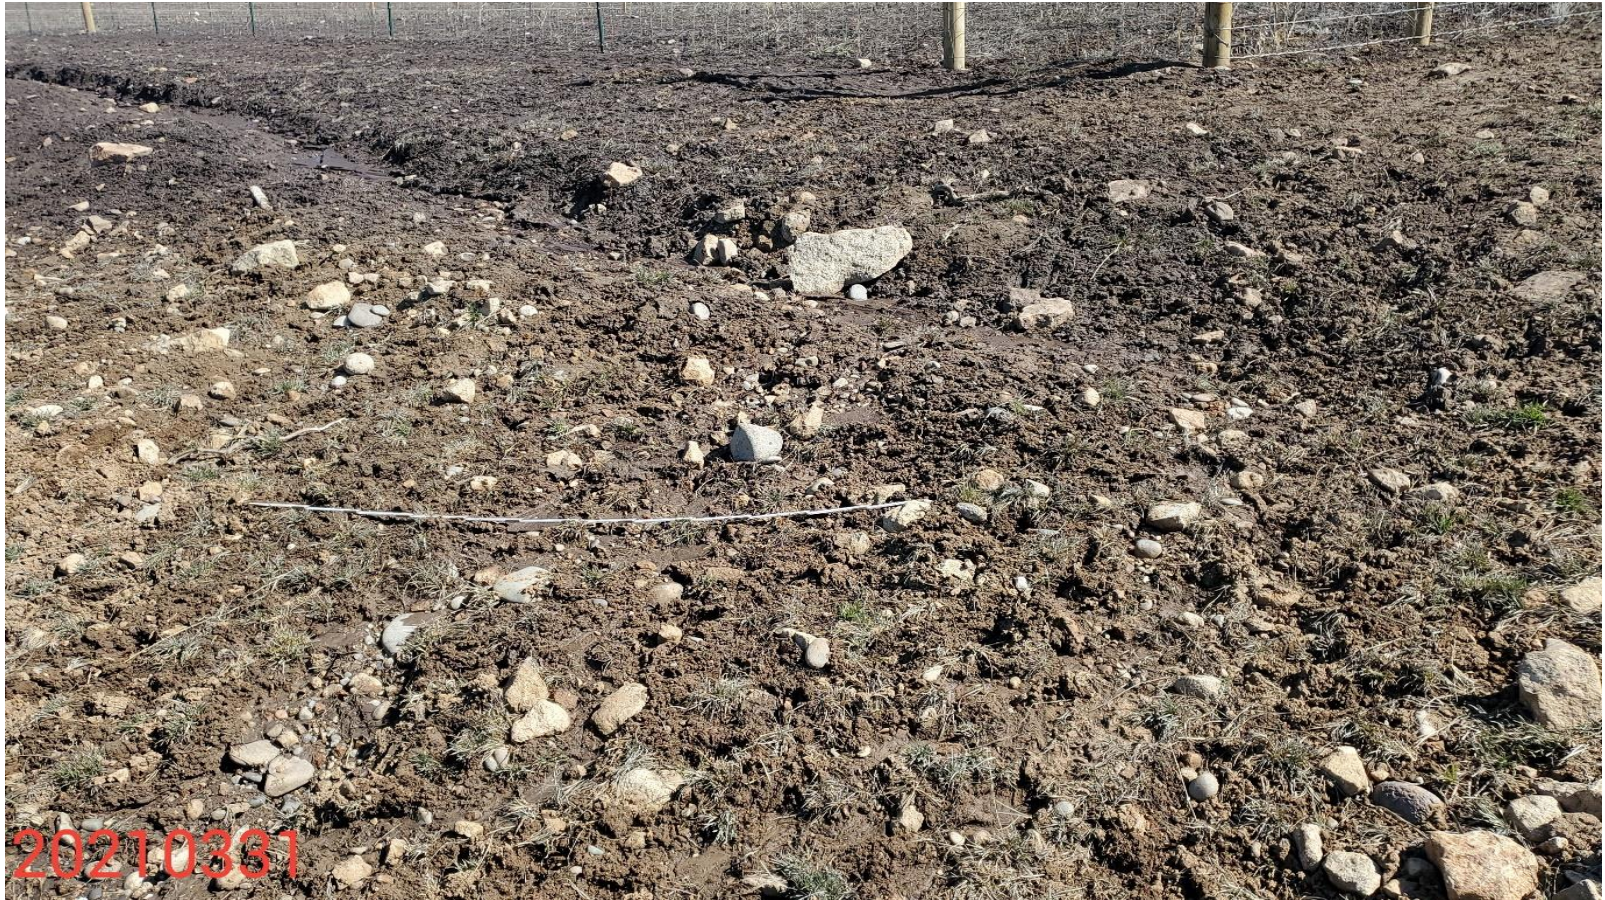
**Photo 17:** Photo taken from the stormwater ditch on the southwest corner of the pad. Photo shows stormwater ditch BMP has not been constructed in accordance with good engineering practices, including an appropriate outlet to allow for sediment laden-free stormwater discharge.

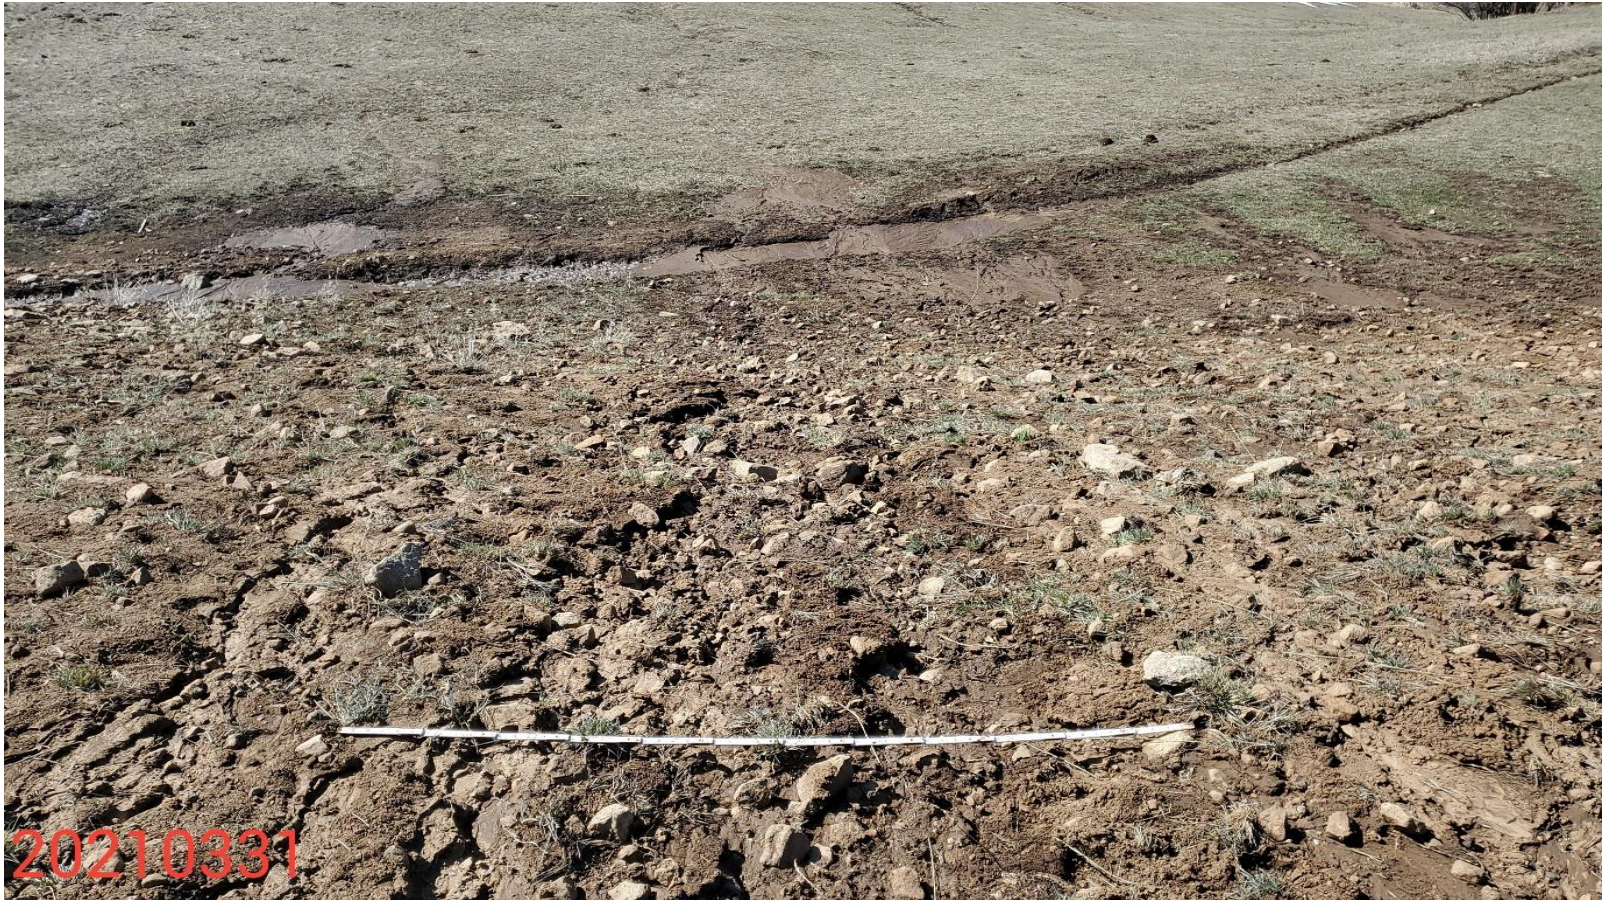
**Photo 18:** Photo taken from the slopes below the end of the ditch observed in photo 17. Photo shows an appropriate outlet to allow for sediment laden-free stormwater discharge has not been constructed at the ditch in accordance with good engineering practices. Photo also shows control measures to protect and stabilize the Location remain missing or insufficient; erosion degradation and off-site sediment transport evident.

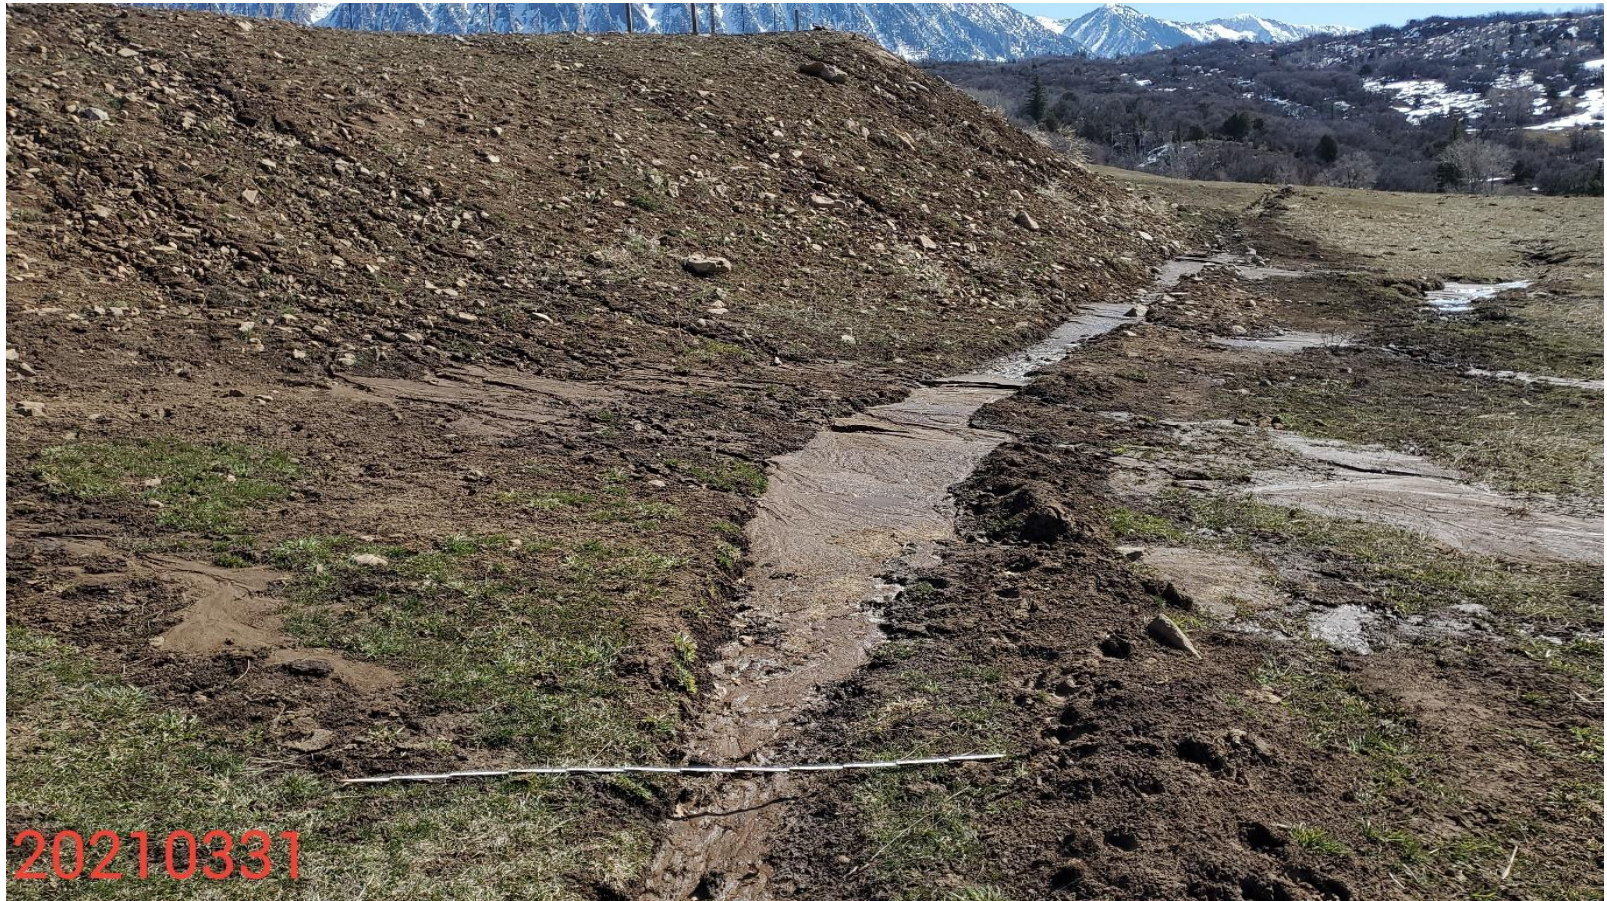
**Photo 19:** Photo taken from the irrigation ditch on the southwestern end of the Location. Photo shows control measures to protect and stabilize the Location remain missing or insufficient; photo also shows sediment has been discharged from the location, has filled the irrigation ditch and transported off-site. 6 foot measuring stick for reference.

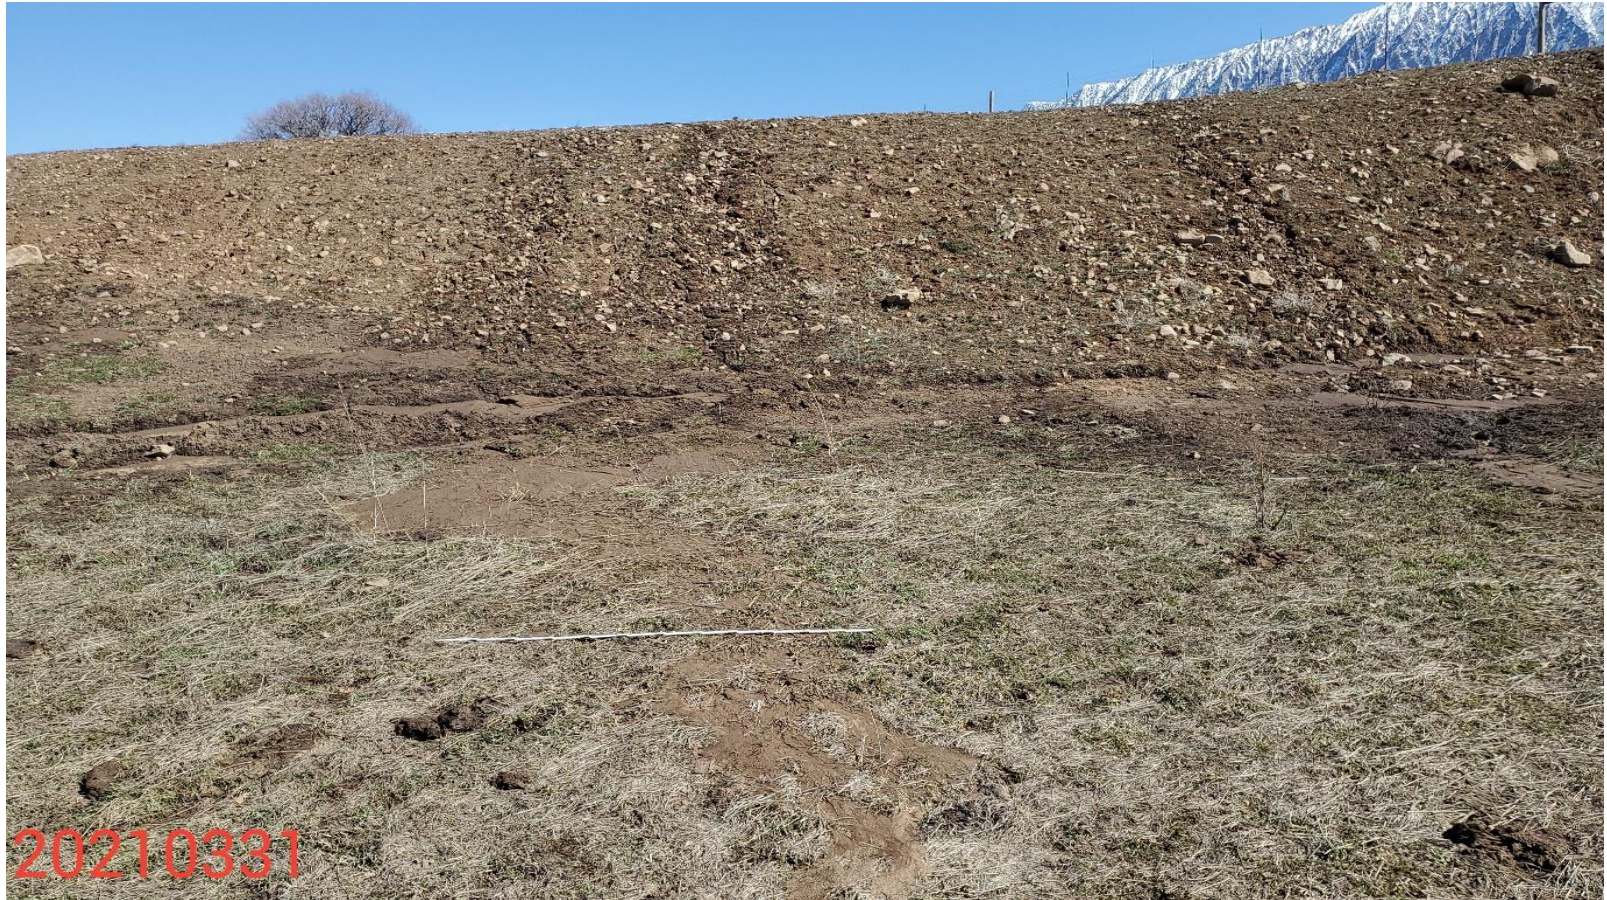
**Photo 20:** Photo taken from the southwest of the Location, facing northeast. Photo shows control measures to protect and stabilize the Location remain missing or insufficient; erosion degradation evident; photo also shows sediment has filled an irrigation ditch, and has been transported off-site. 6 foot measuring stick for reference.

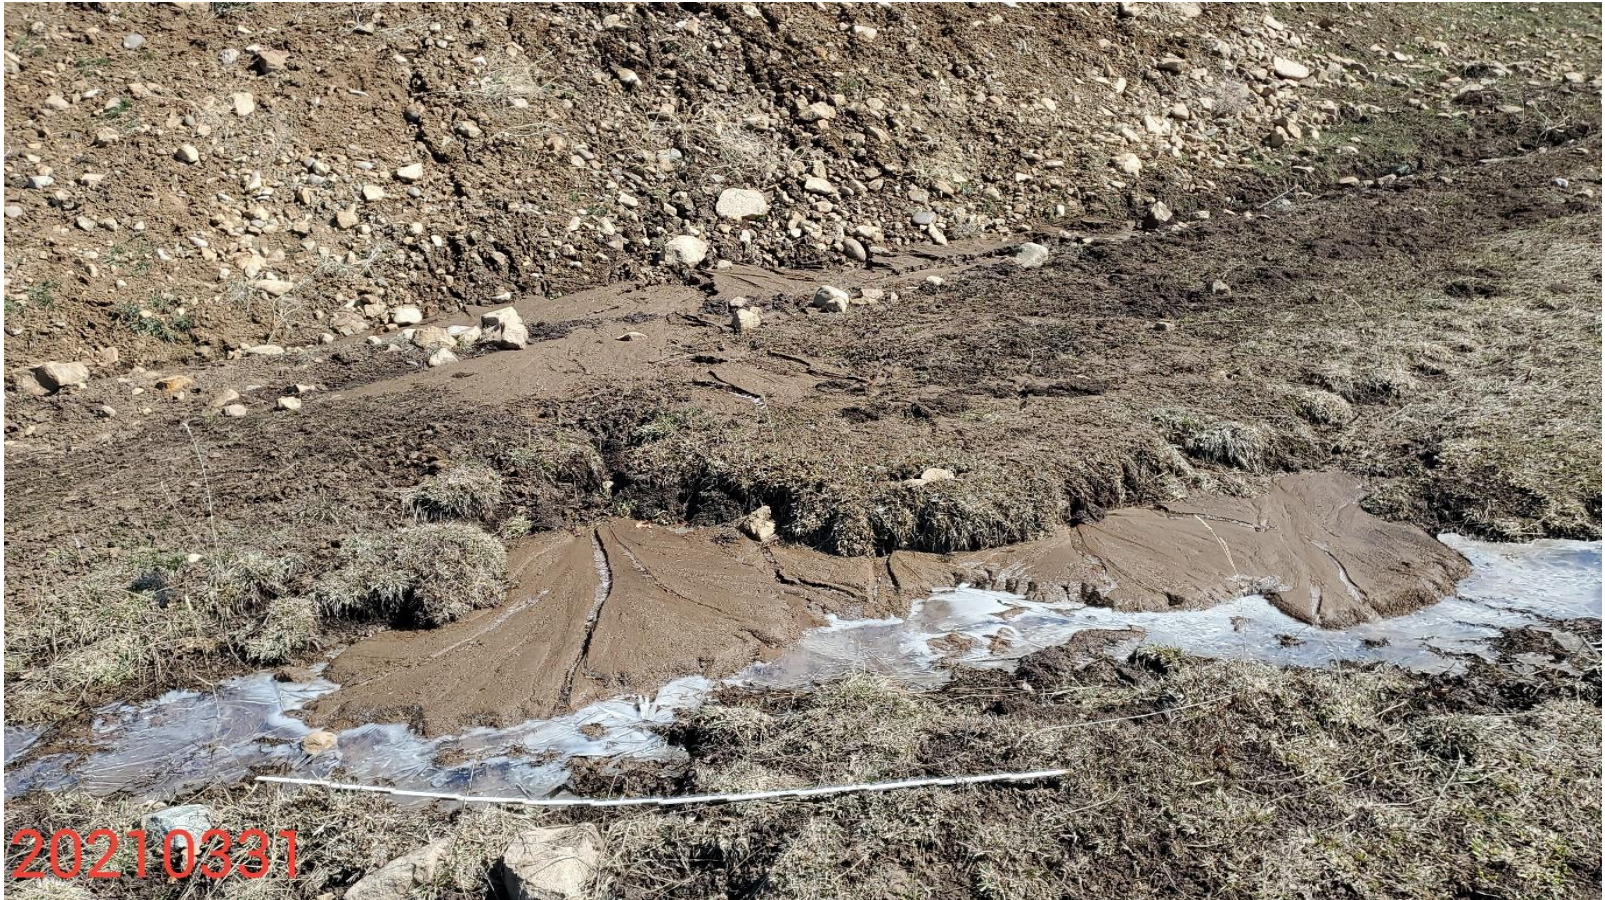
**Photo 21:** Photo shows off-site sediment discharge on the southwest end of the Location. 6 foot measuring stick for reference.

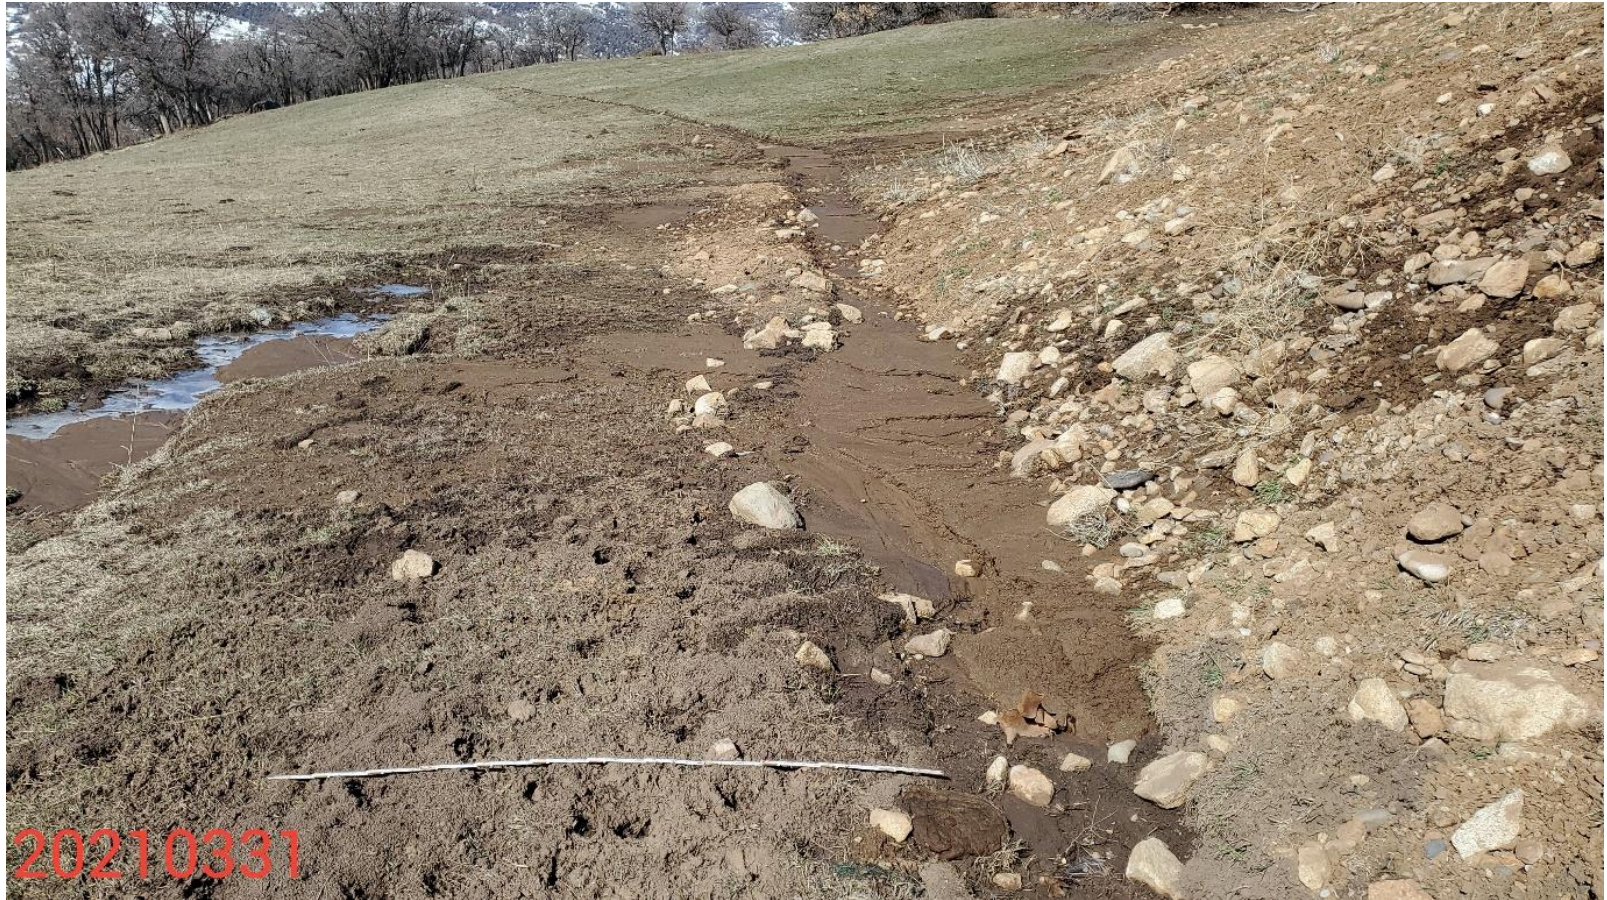
**Photo 22:** Photo shows off-site sediment discharge on the southwest end of the Location, facing west. 6 foot measuring stick for reference.

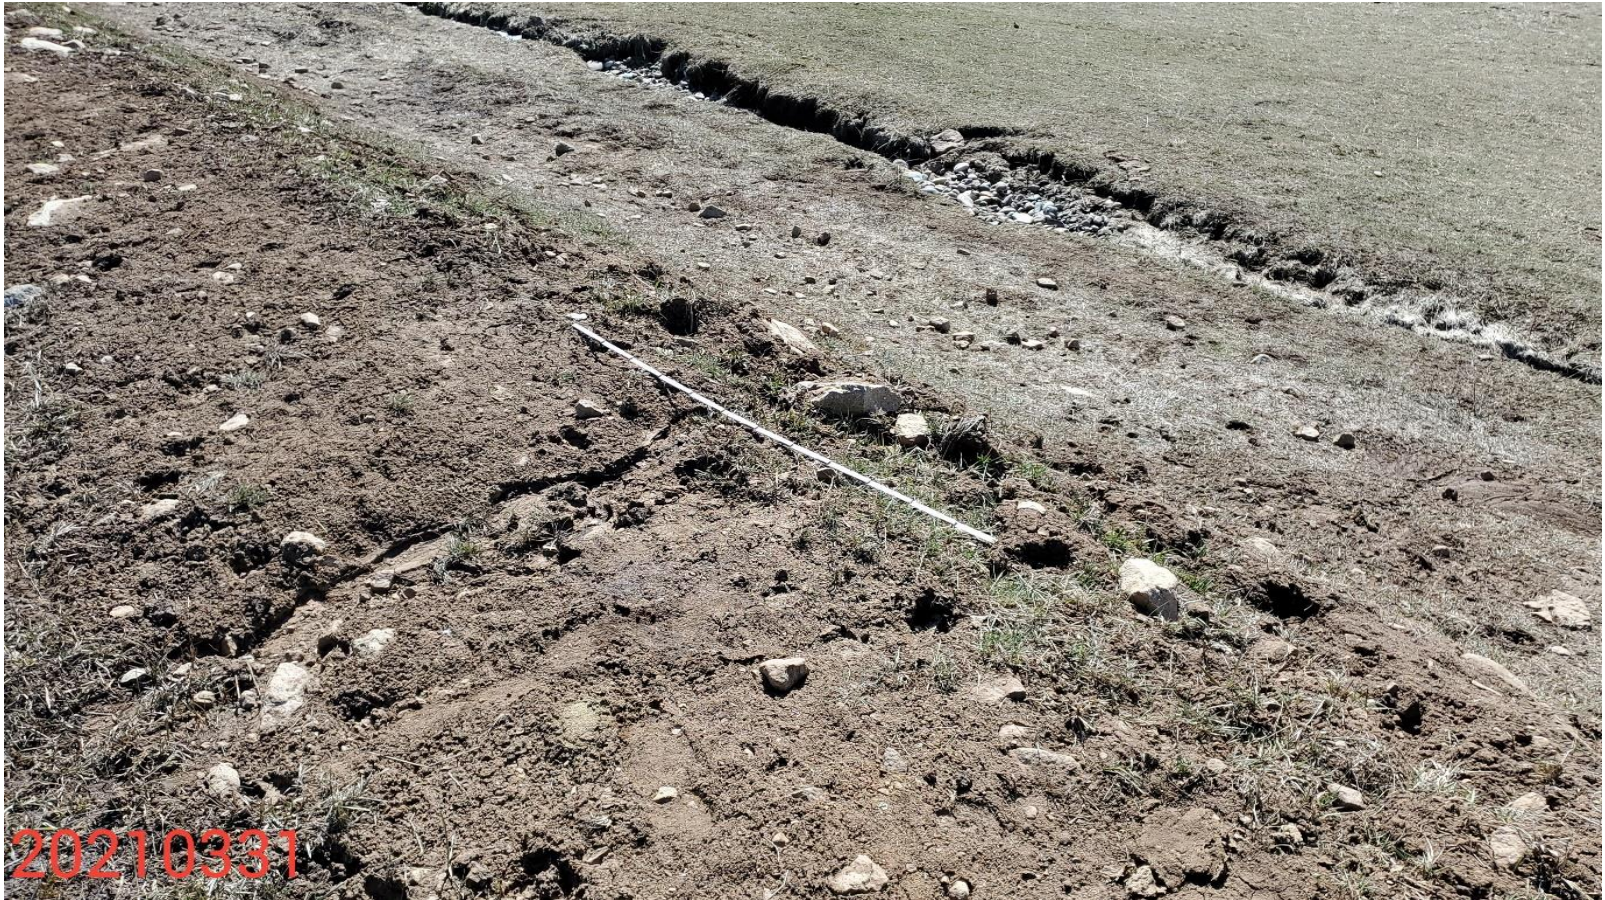
**Photo 23:** Photo taken from the south end of the Location, facing southeast. Photo shows erosion degradation due to runoff from the Location is now evident on the southern fill slopes. 6 foot measuring stick for reference.

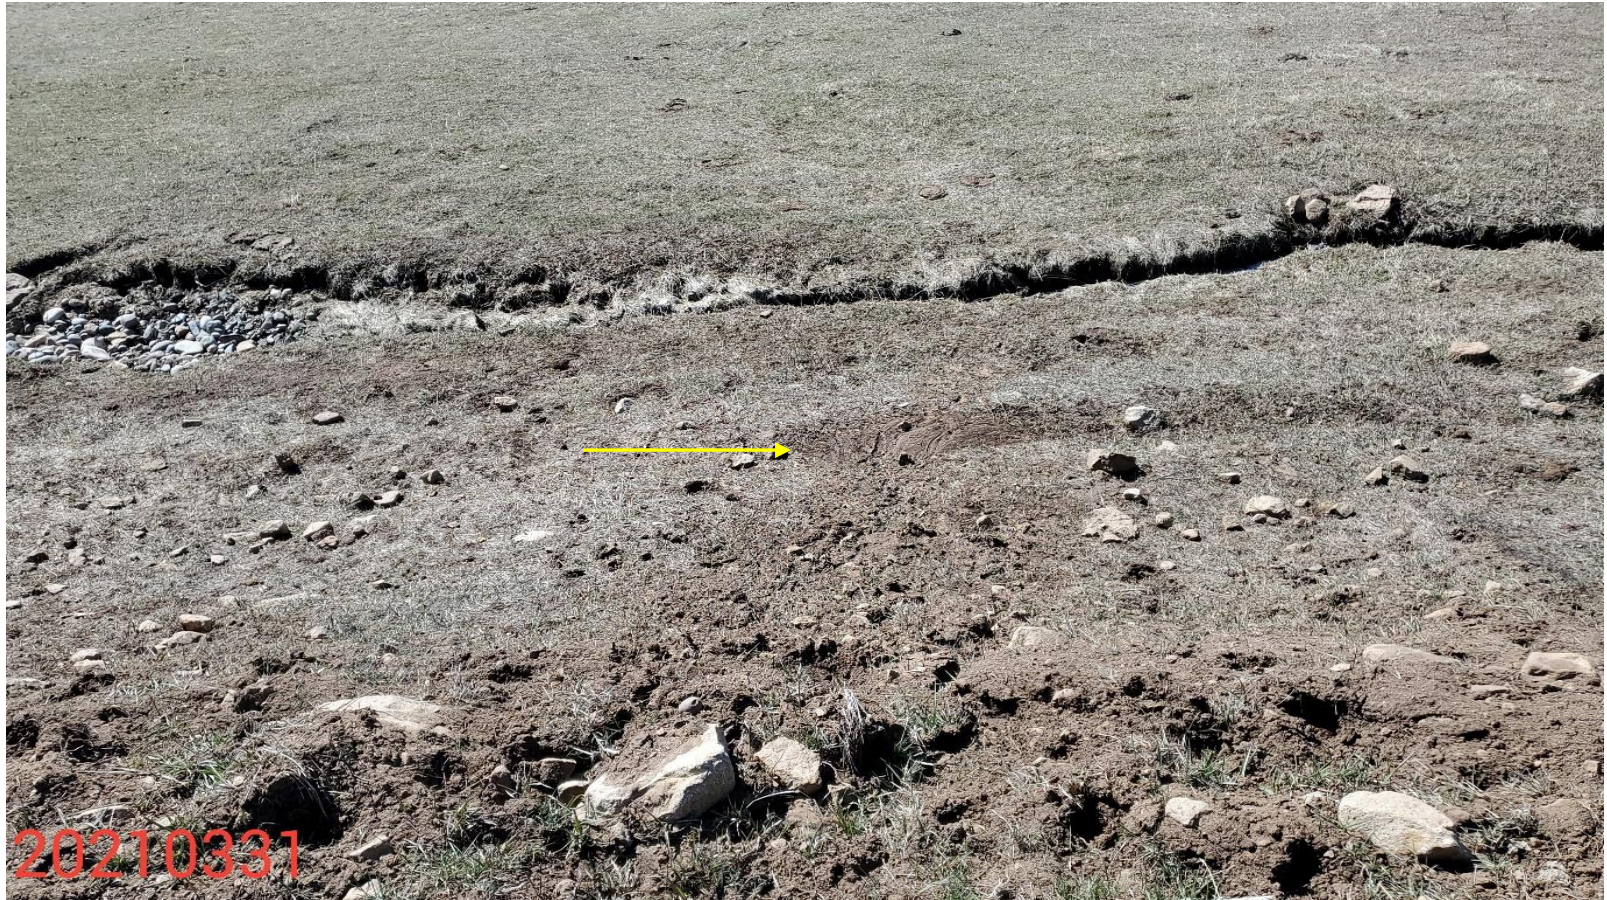
**Photo 24:** Continued from photo 23. Photo shows off-site sediment transport and deposition.
