**Inspection Photos**  
**Location Name: Robert G Berge #2**  
**Spill ID 476918 (CL)/ Remediation Project No. 15743**

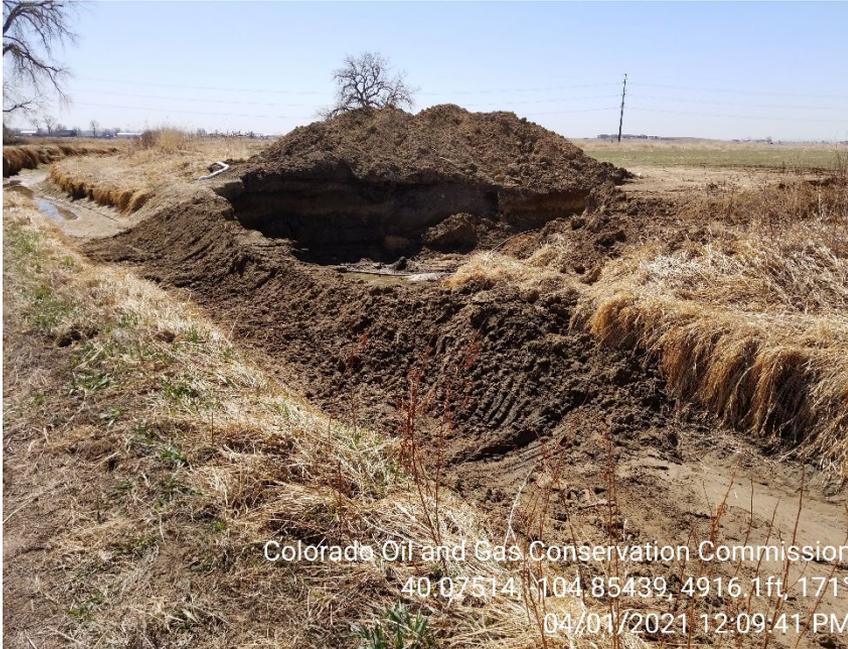
**Photo 1 – Wall of Brantner Irrigation ditch during 4/1/2021 inspection; work to reconstruct wall had begun since previous inspection. Work appear to still be in progress.**

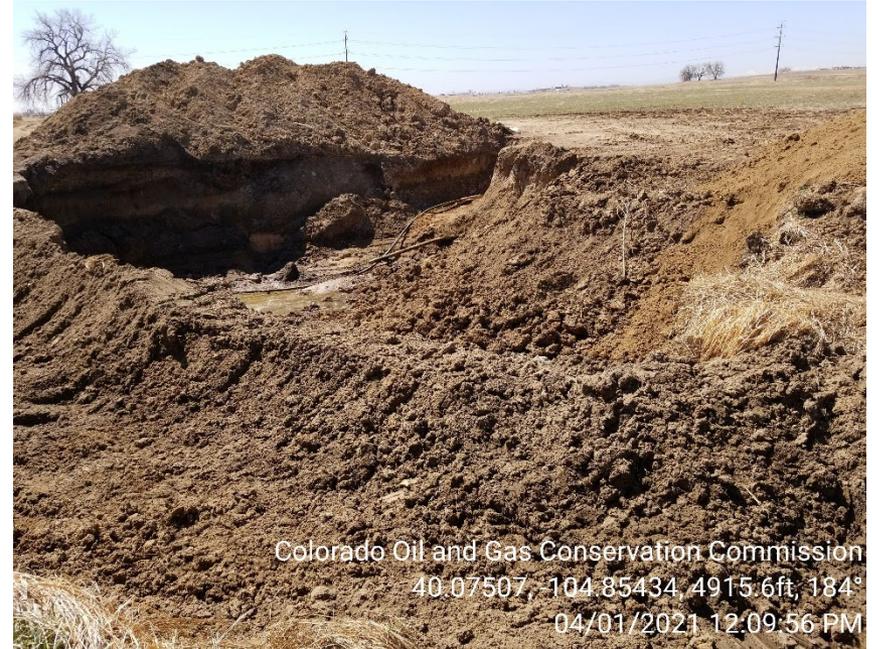
**Photo 2 – Ditch wall. Fencing around open excavation has been removed.**

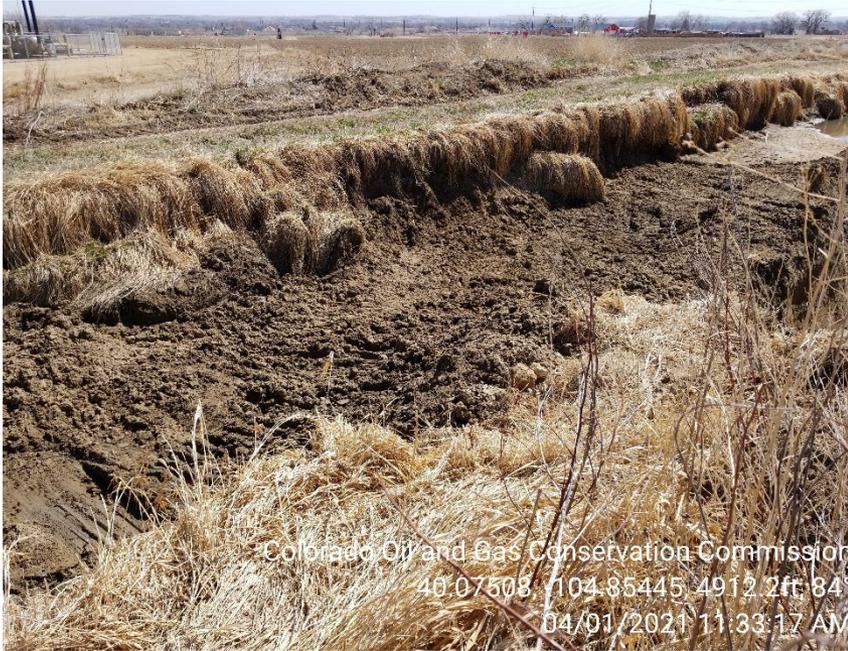
**Photo 3 – Irrigation ditch floor has been scraped by excavator since last inspection.**

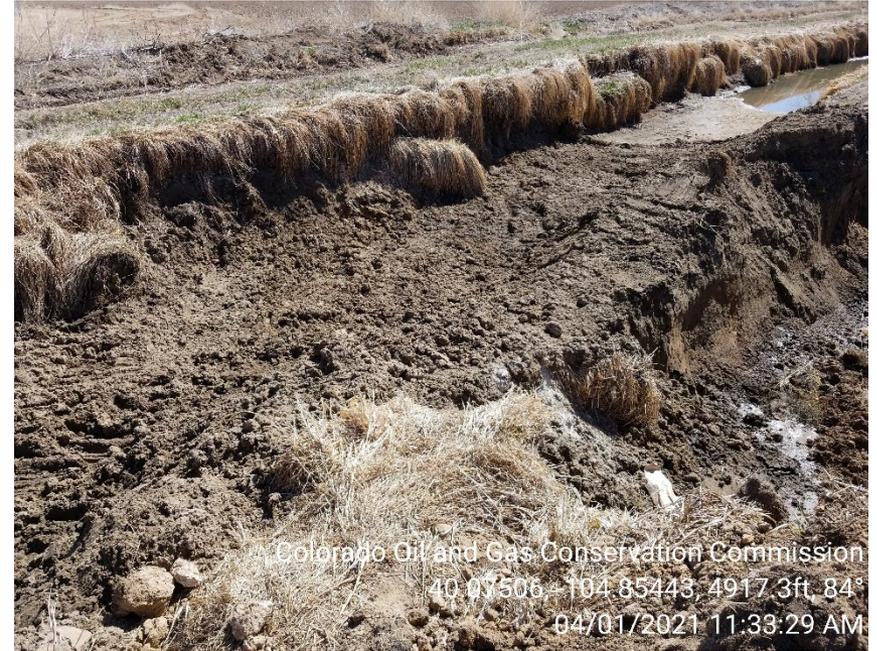
**Photo 4 – Collapsed wall of Brantner Irrigation ditch with scraped portions of ditch floor.**

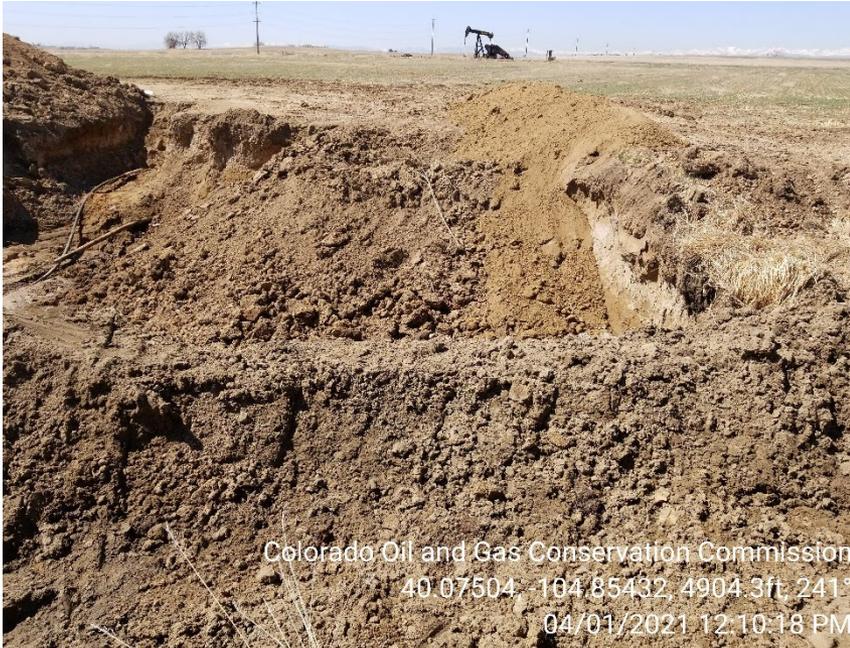
**Photo 5 – Clean fill on location. One soil stockpile appears to have been pushed back into open excavation.**

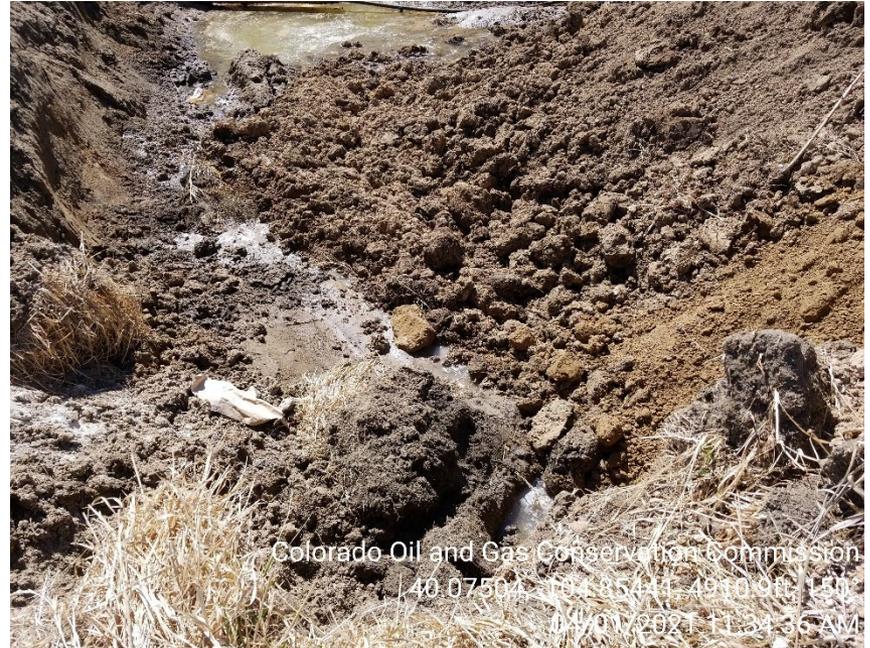
**Photo 6 – Soil stockpile pushed back into open excavation.**

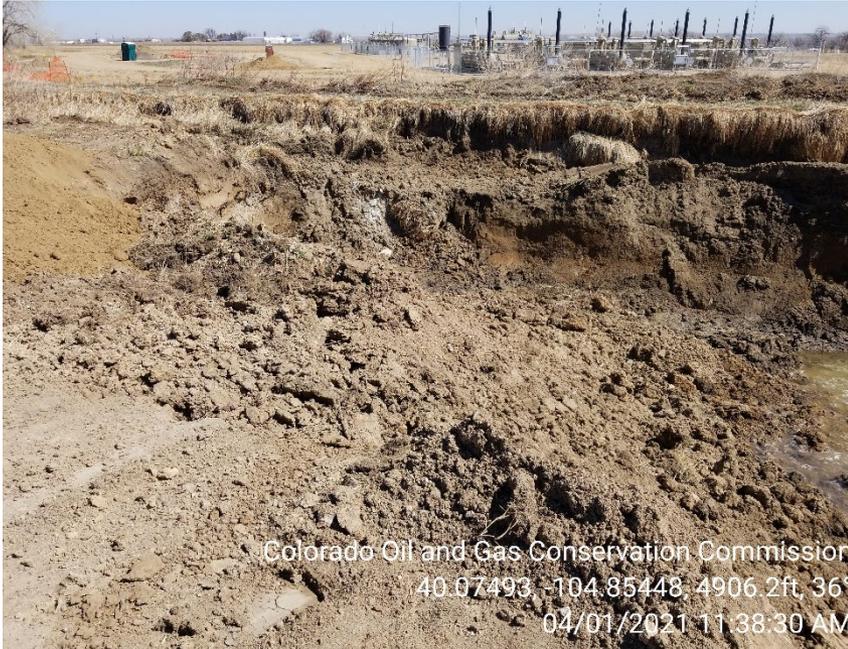
**Photo 7 – Soil stockpile pushed back into open excavation.**

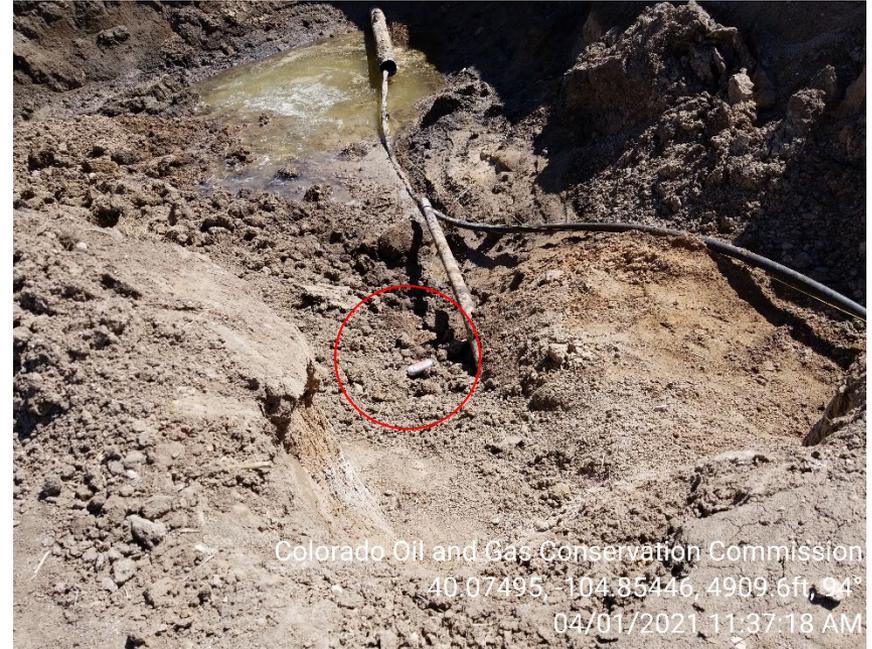
**Photo 8 – Trash visible in open excavation**

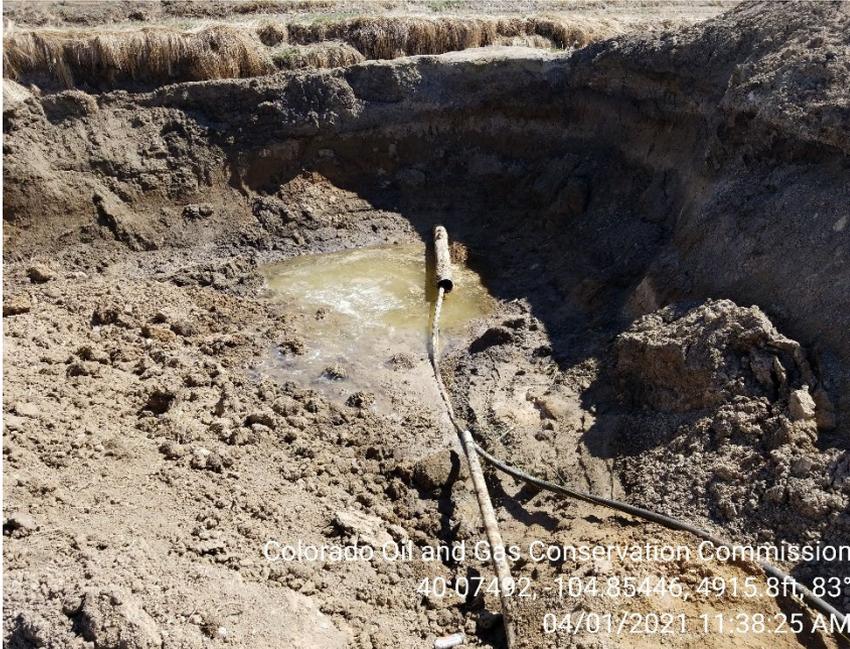
**Photo 9 – Groundwater with hydrocarbon sheen observed in open excavation.**

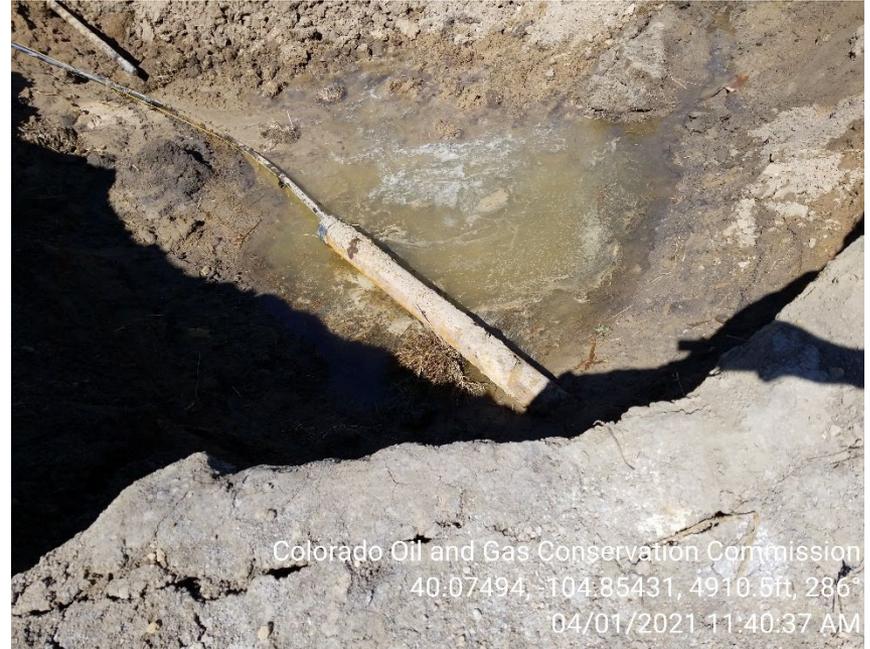
**Photo 10 – Groundwater with hydrocarbon sheen observed in open excavation.**

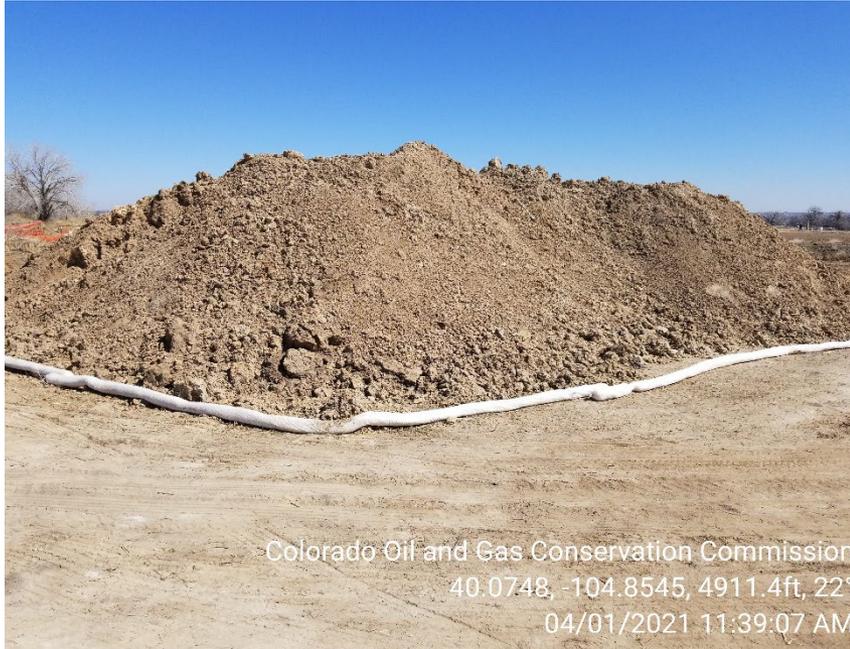
**Photo 11 – Soils stored on location; BMPs inadequate to contain runoff**

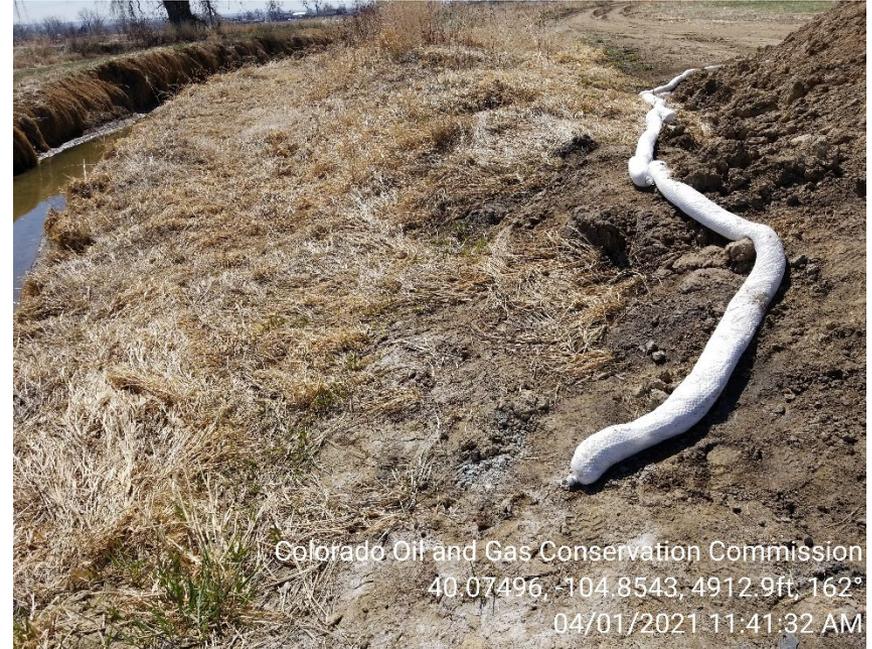
**Photo 12 – Soils stored on location; BMPs inadequate to contain runoff**

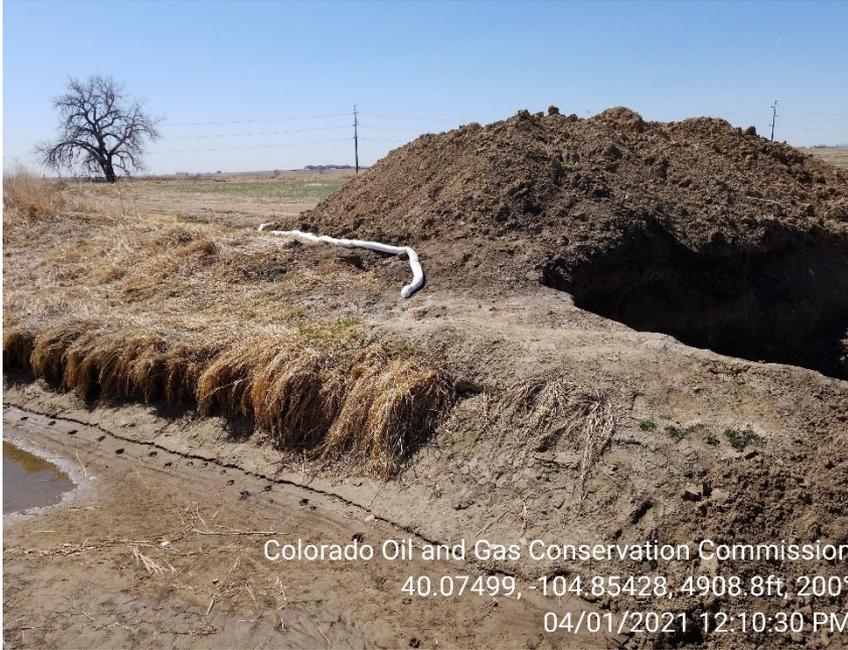
**Photo 13 –BMPs inadequate to contain runoff; any runoff from the eastern portion of the soils stockpile would go into irrigation ditch.**

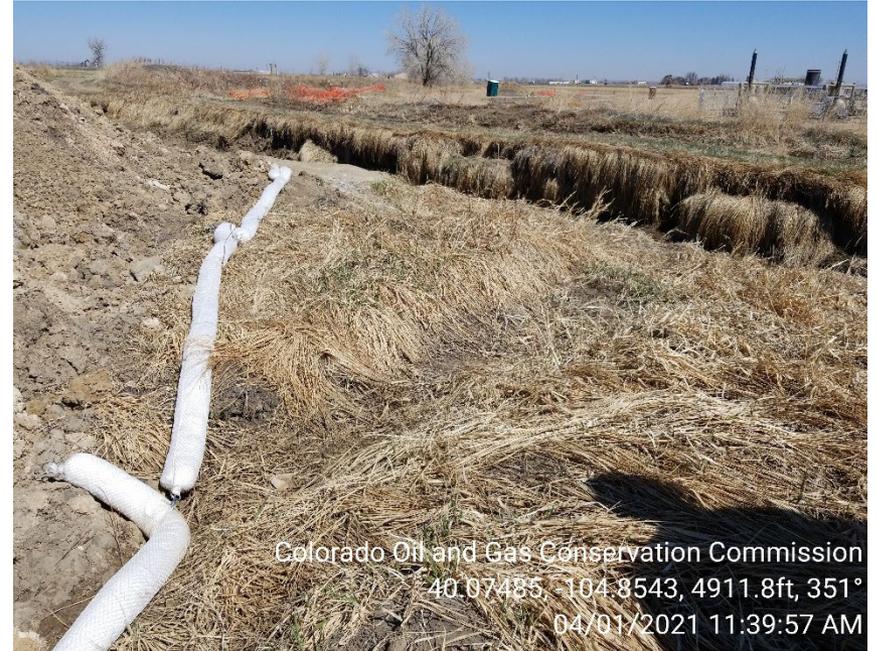
**Photo 14 – BMPs inadequate to contain runoff**

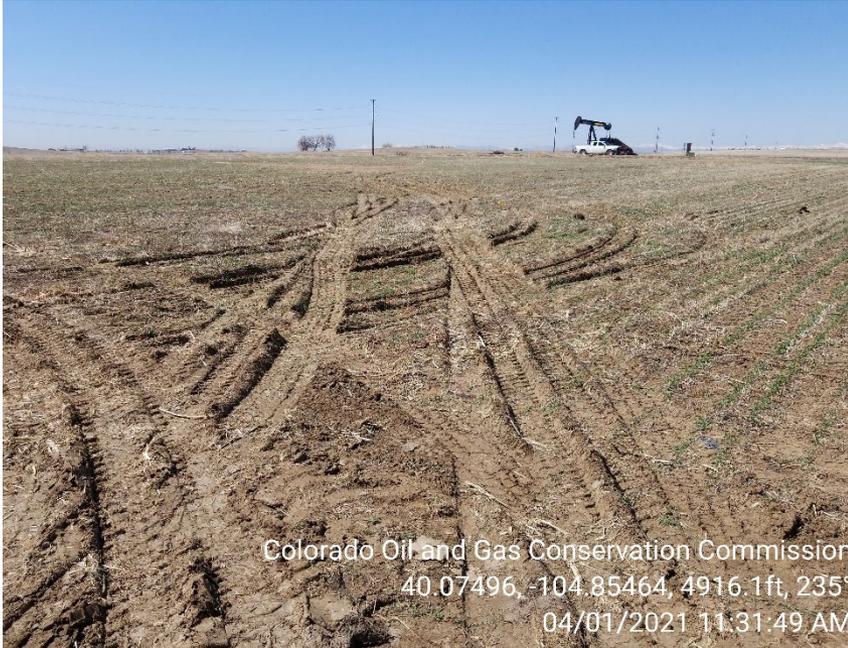
**Photo 15 – Vehicle tracking has extended an additional ~150’ west of the excavation, making ruts in field**

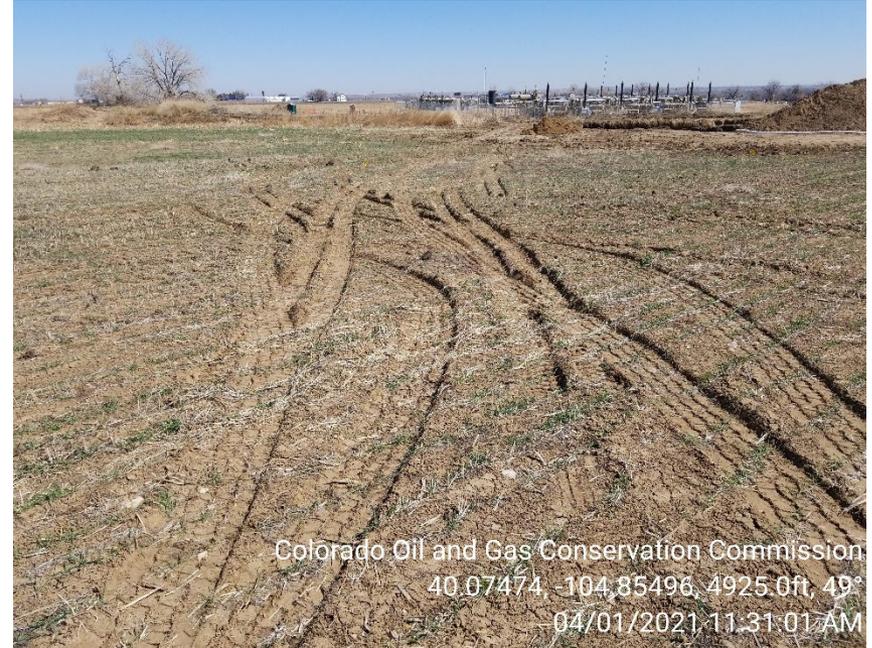
**Photo 16 – Vehicle tracking has extended an additional ~150’ west of the excavation, making ruts in field**
