**Inspection Photos**  
**Paul Heinze #1 Flowline**  
**Spill ID 479232 (AC)**

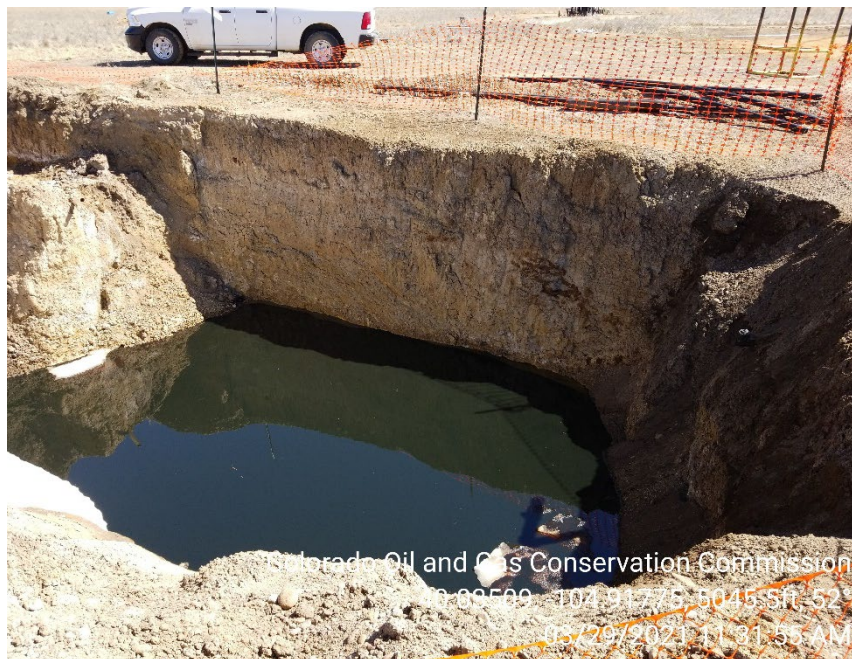
**Photo 1 – Free product observed on groundwater in open excavation.**

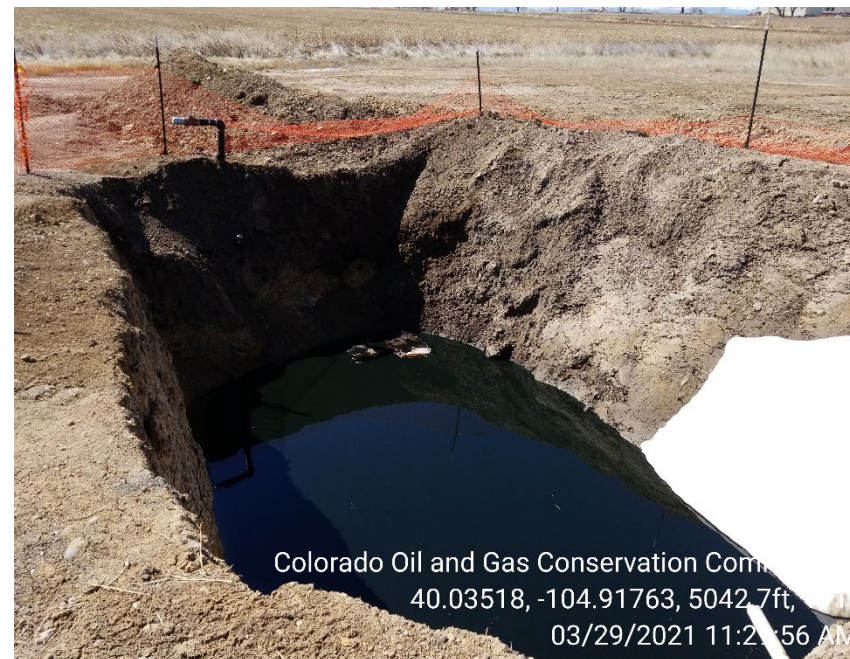
**Photo 2 – Free product observed on groundwater in open excavation. Fencing down around open excavation.**

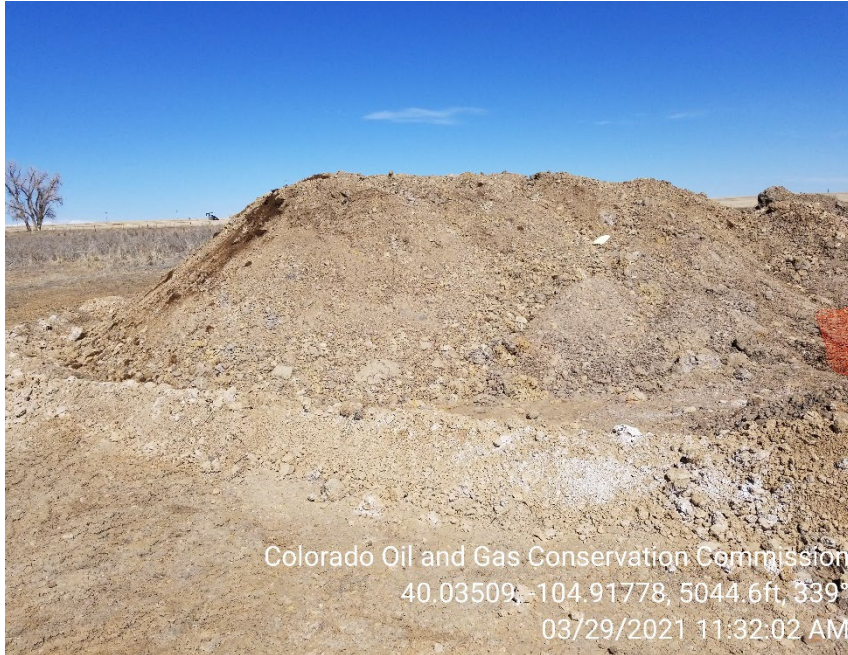
**Photo 3 – Soils stored on site with inadequate BMPs**

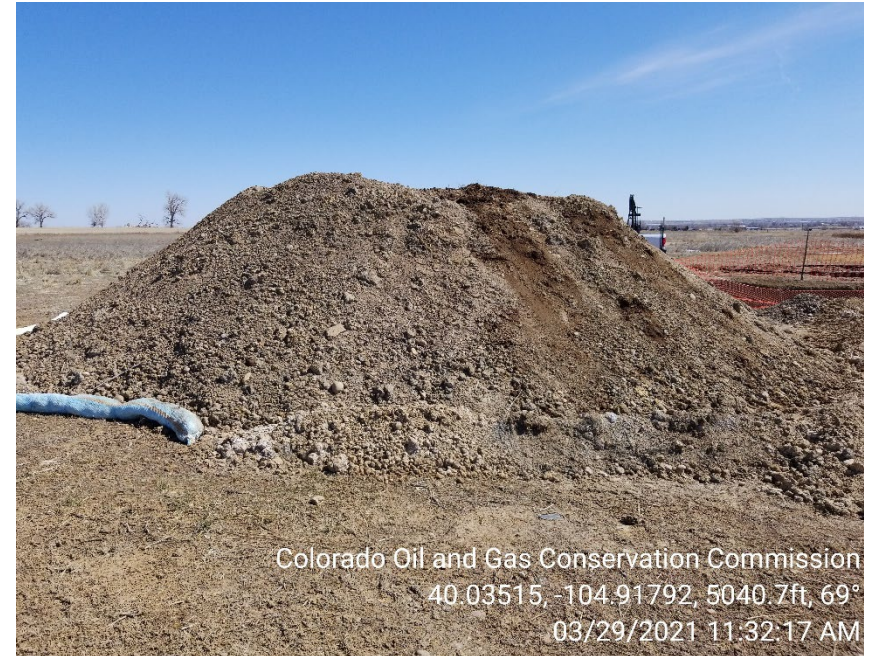
**Photo 4 – Soils stored on site with inadequate BMPs**

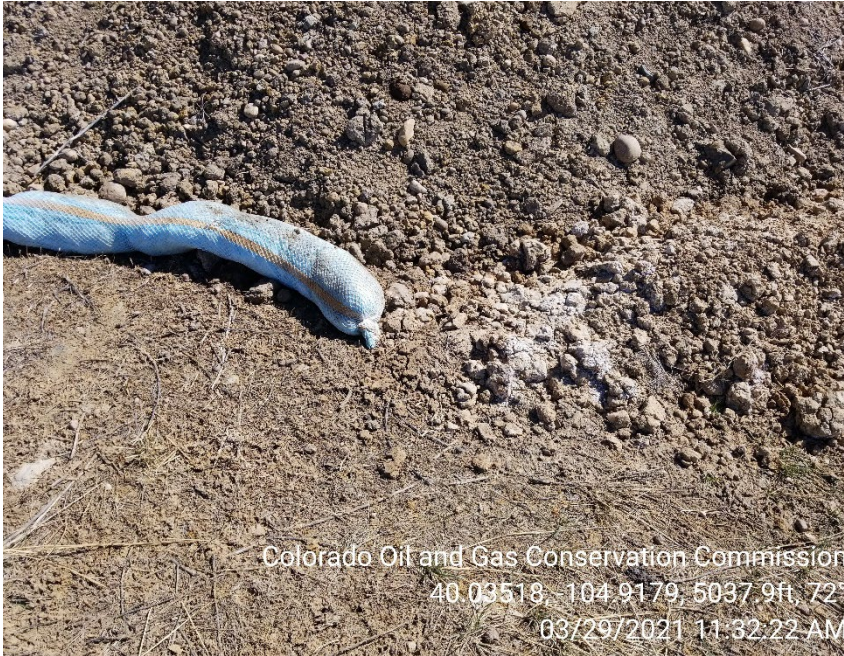
**Photo 5 –Inadequate BMPs**

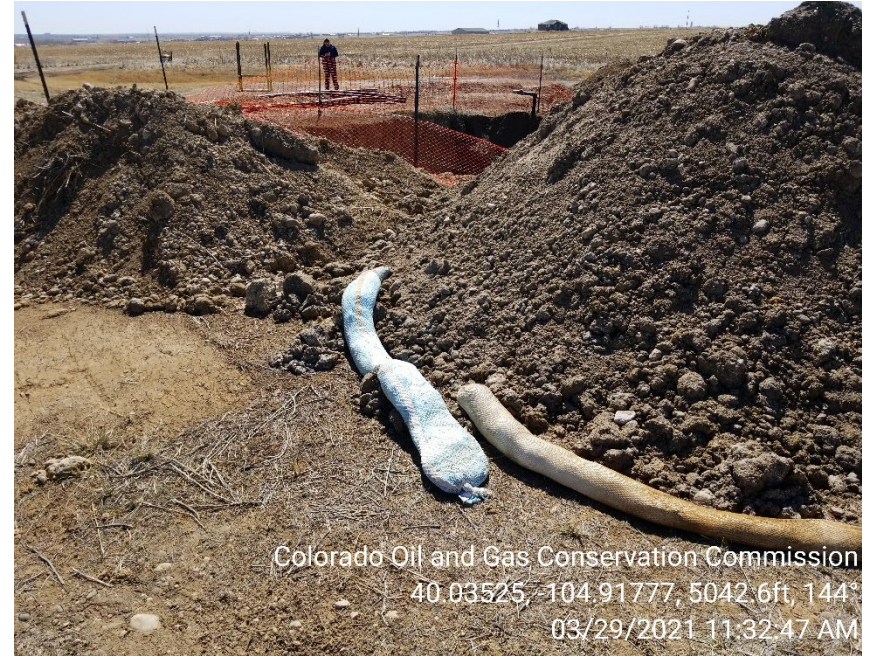
**Photo 6 – Soils stored on site with inadequate BMPs**

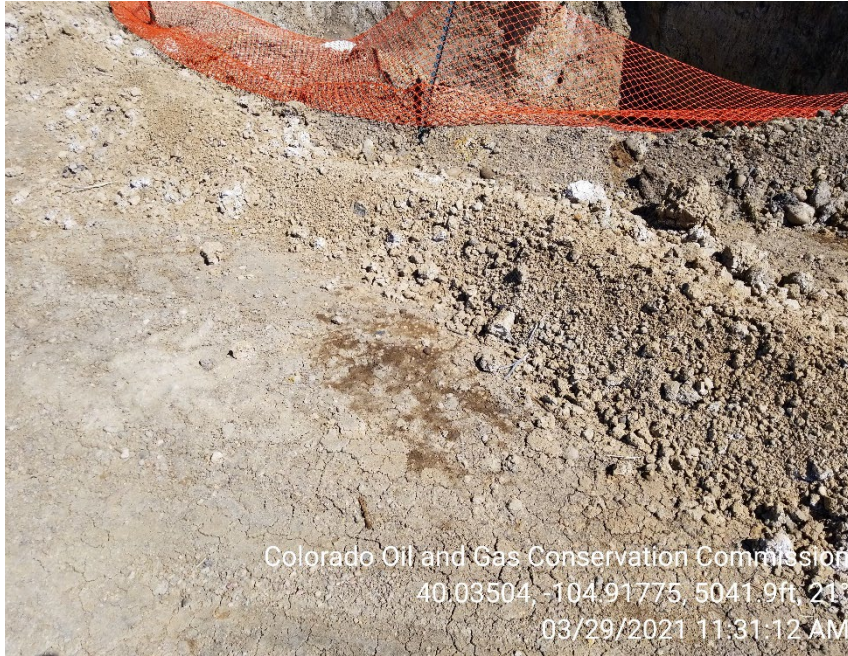
**Photo 7 – Stained soils visible on surface.**

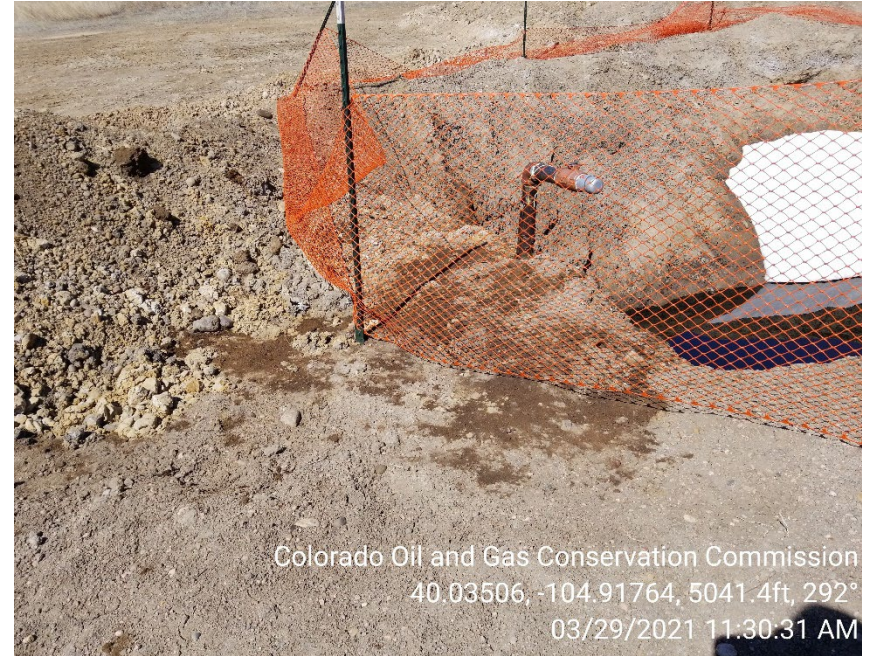
**Photo 8 – Stained soils visible on surface.**
