Inspection Photos
Operator: Simcoe
Facility: 067-07296
Date: 4/1/2021

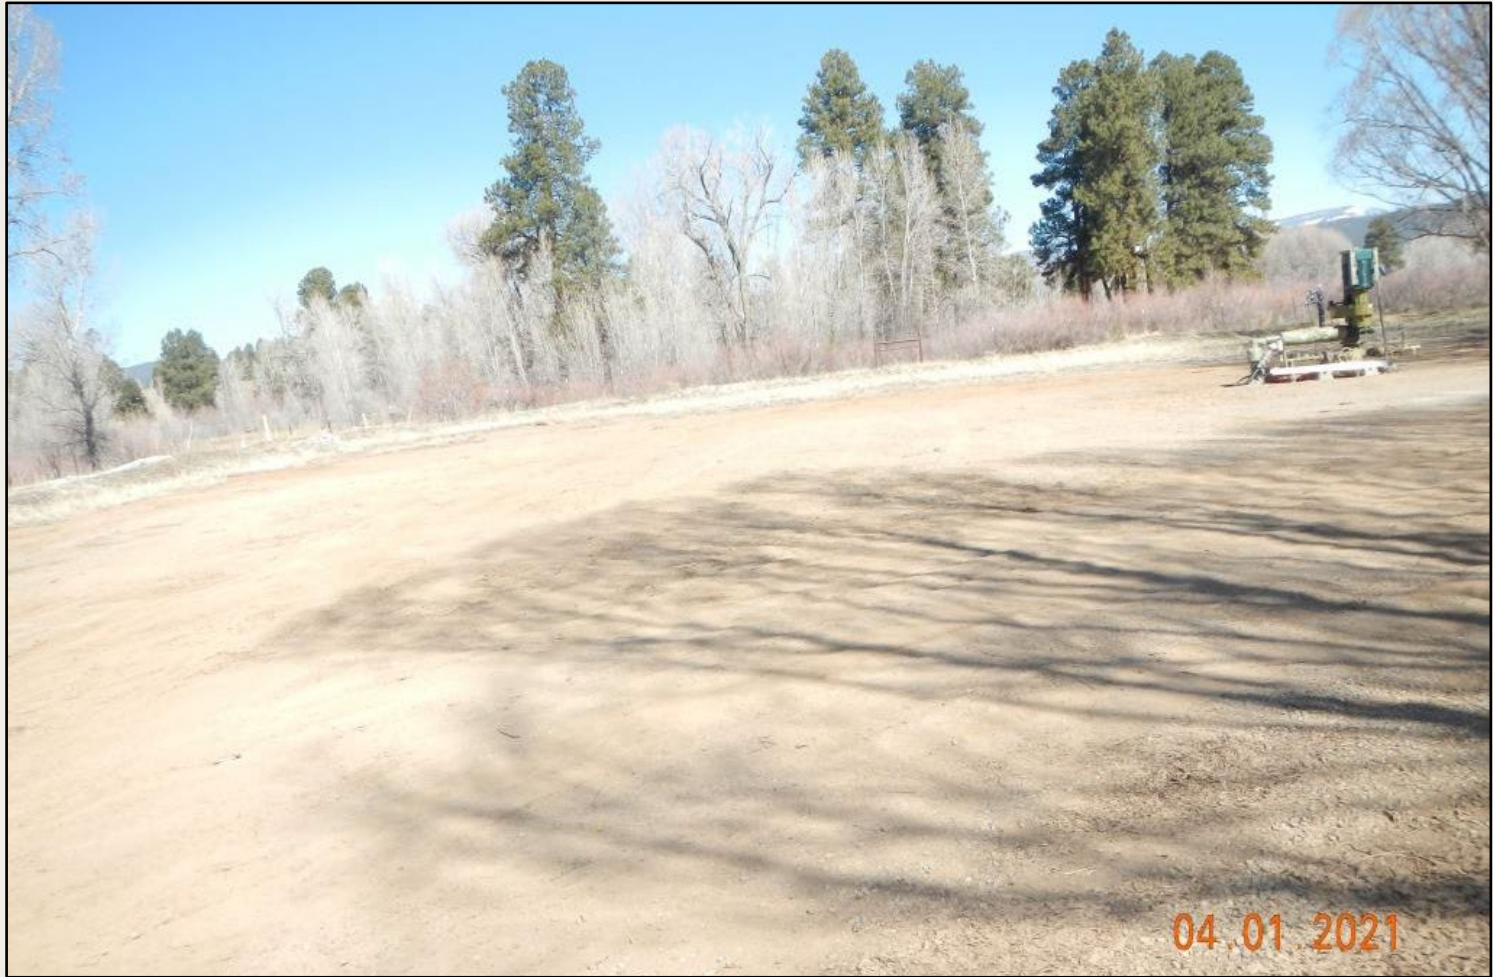
Photo 1. View of the project area from the well pad entrance facing center.

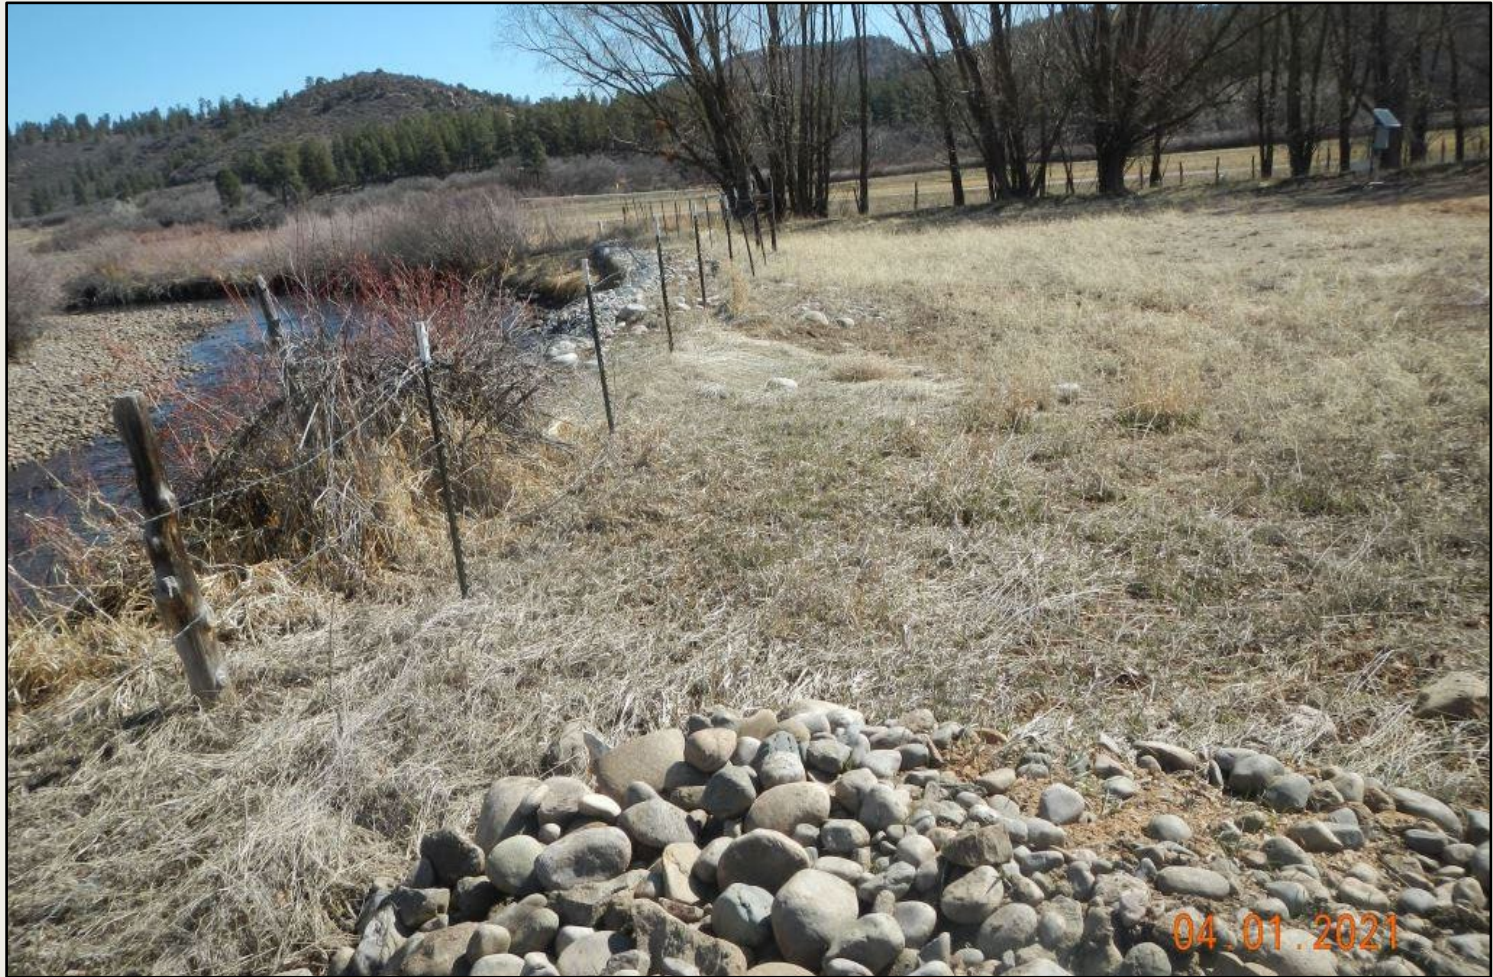
Photo 2. View of the northern project area from the northwestern corner facing eastward. Revegetation is progressing, largely with smooth brome and sand dropseed.

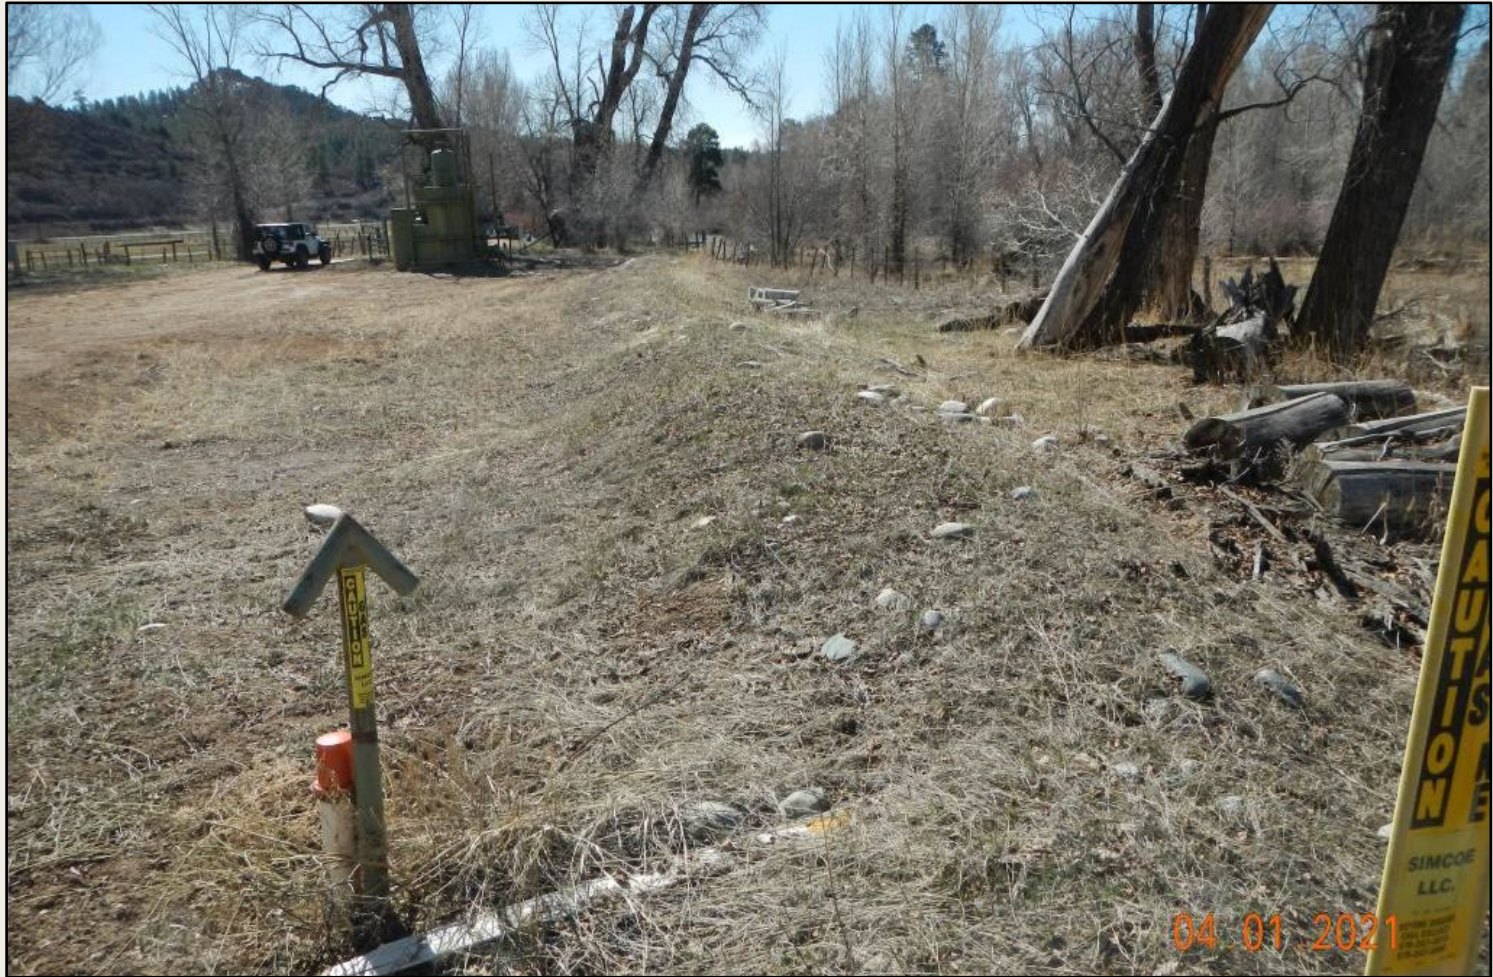
Photo 3. View of the western project area from the northwestern corner facing southward.

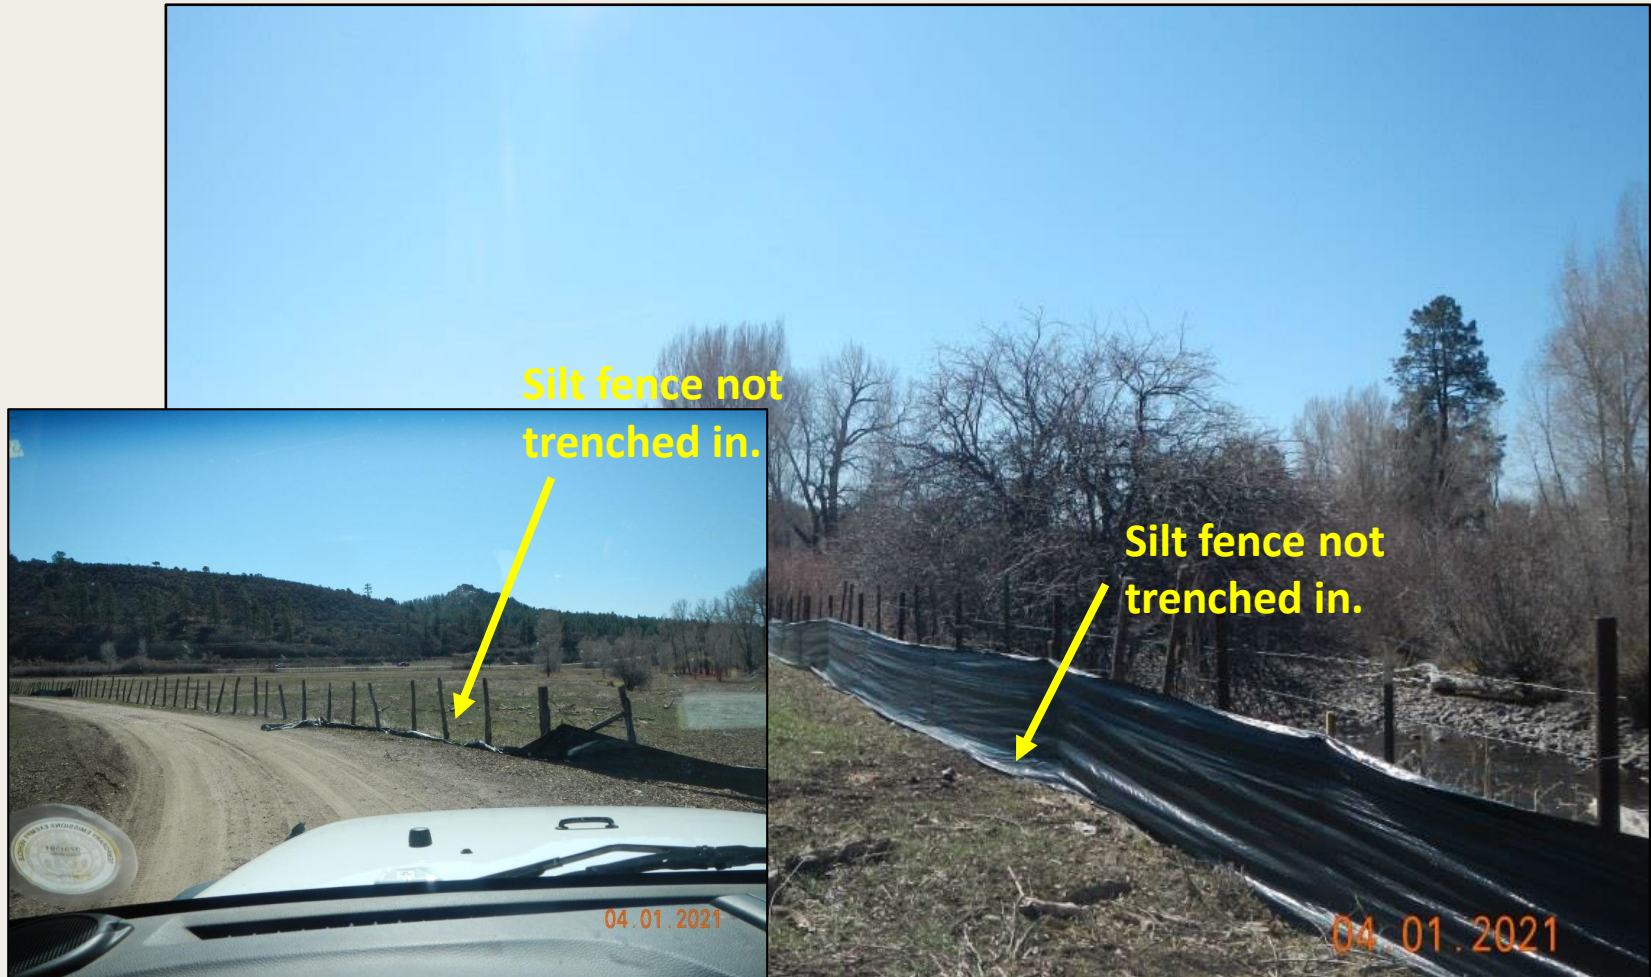
Photo 4. View of silt fence downslope from pipeline disturbance. Silt fence is not functioning because it is not trenched in and is blown down in portions (see inset).

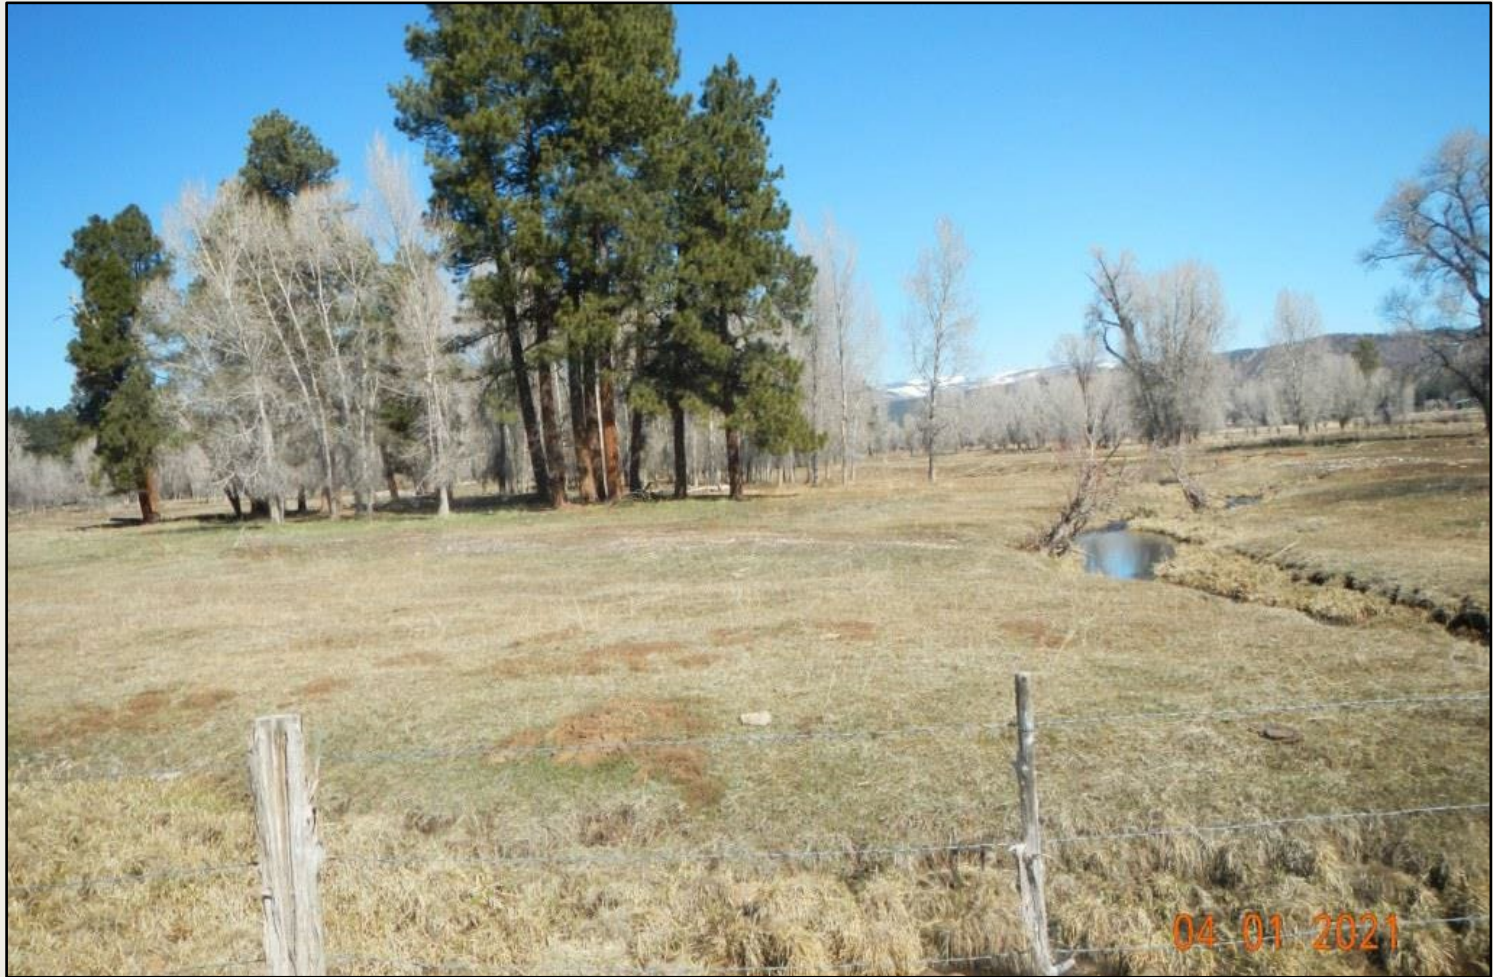
Photo 5. View of the reference area comprised of irrigated grass field, cottonwood trees, and ponderosa pines.
