Inspection Photos
Operator: Simcoe
Facility: 067-08355
Date: 4/1/2021

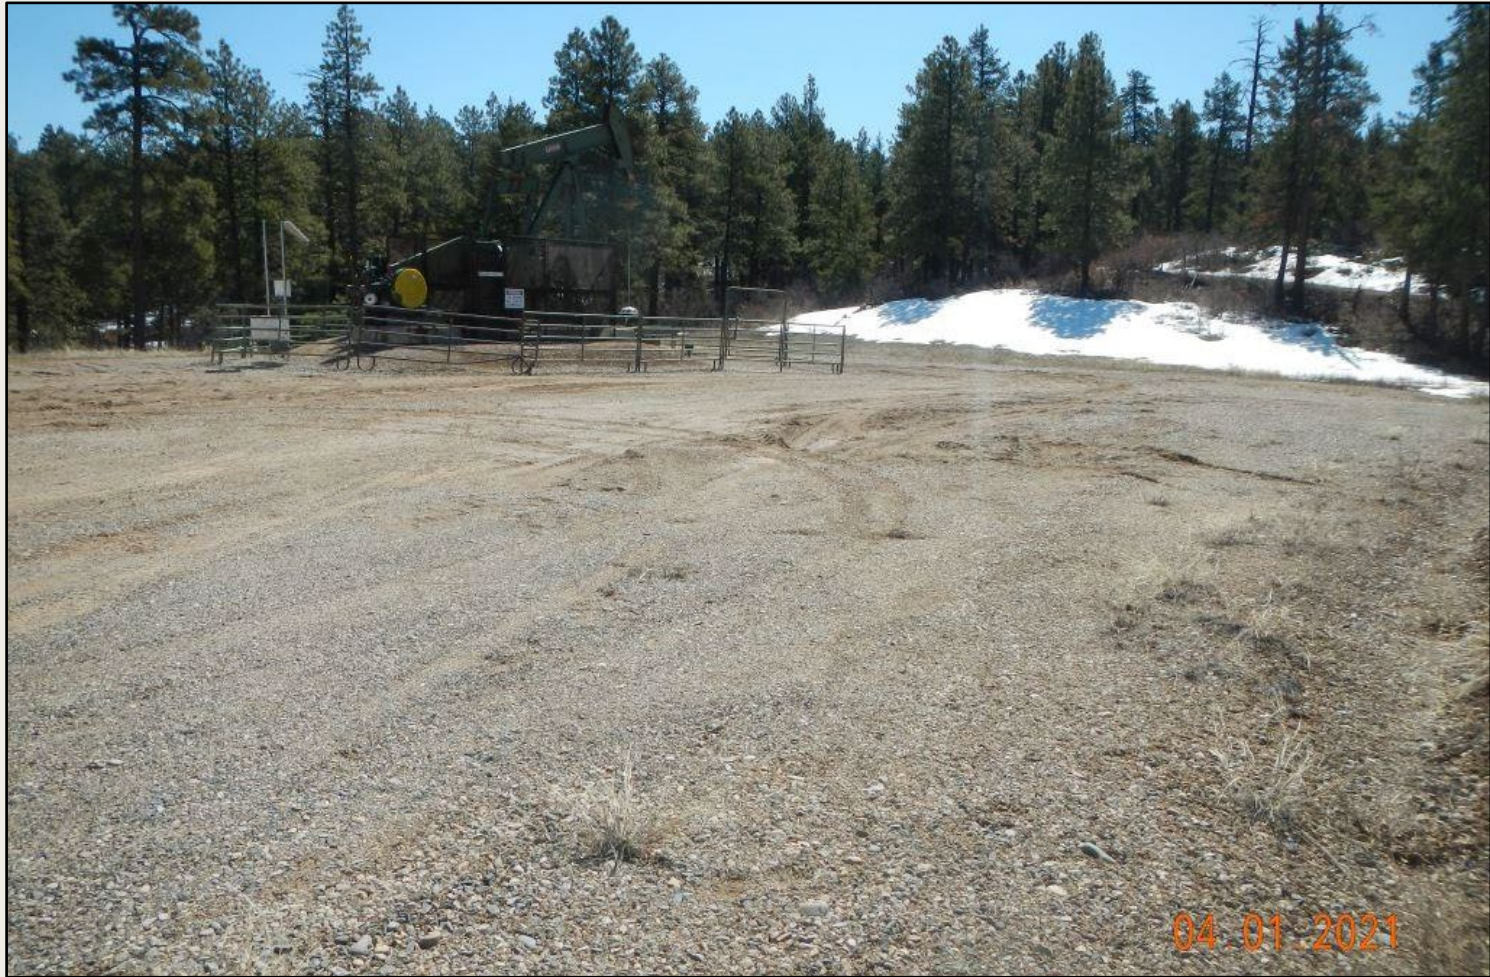
Photo 1. View of the project area from the well pad entrance facing center.

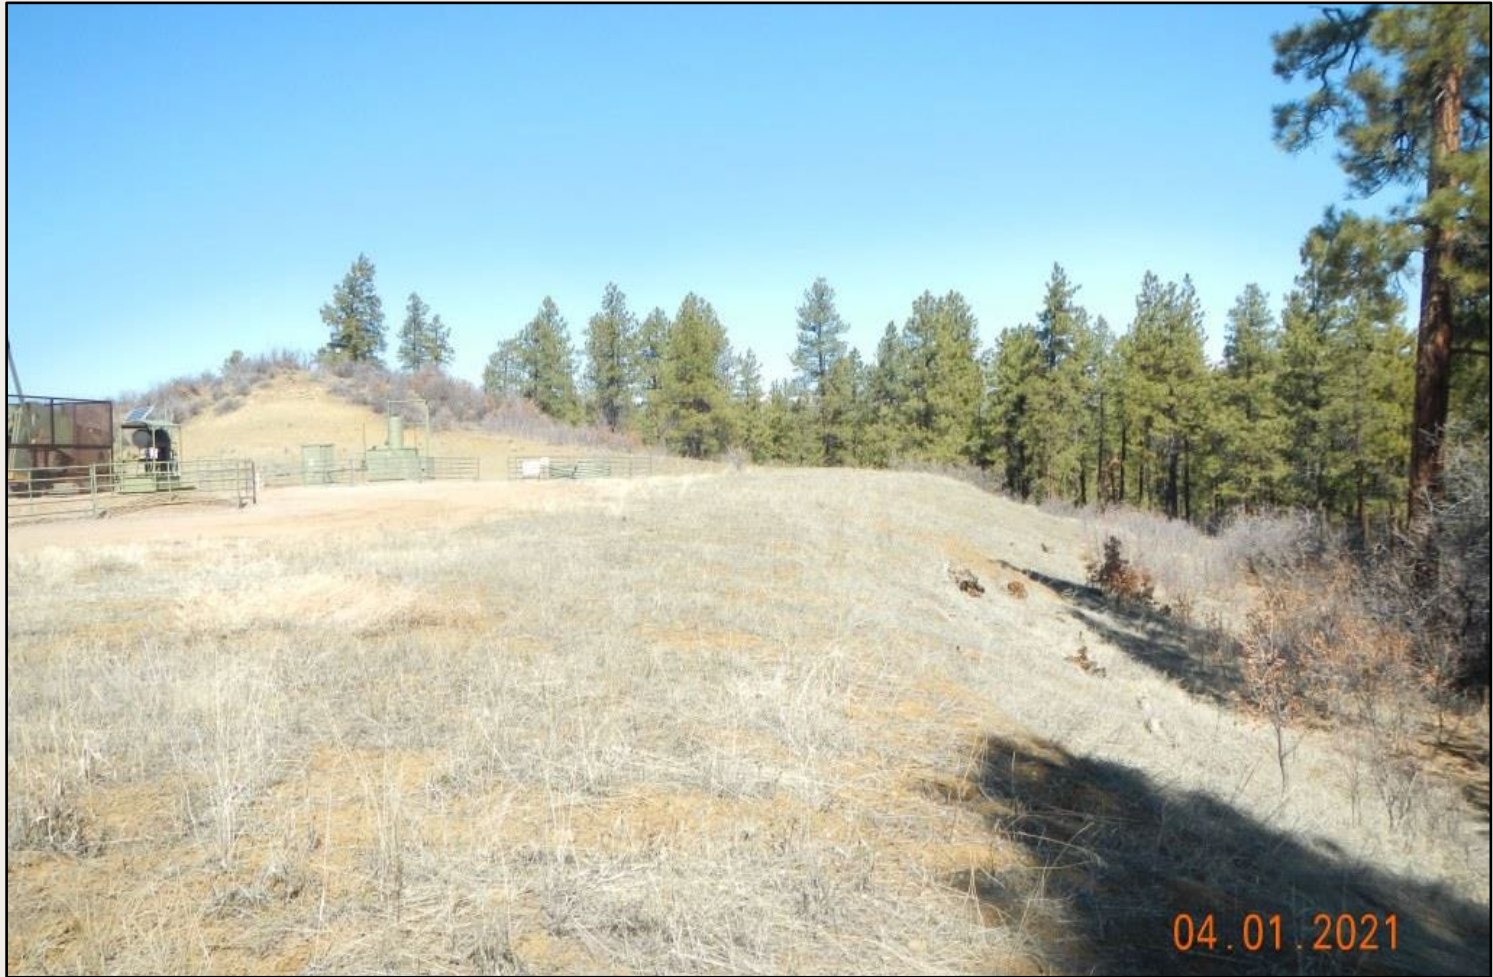
Photo 2. View of the eastern fill slope from the southeastern corner facing northward. Revegetation is progressing with smooth brome, sand dropseed, and western wheatgrass.

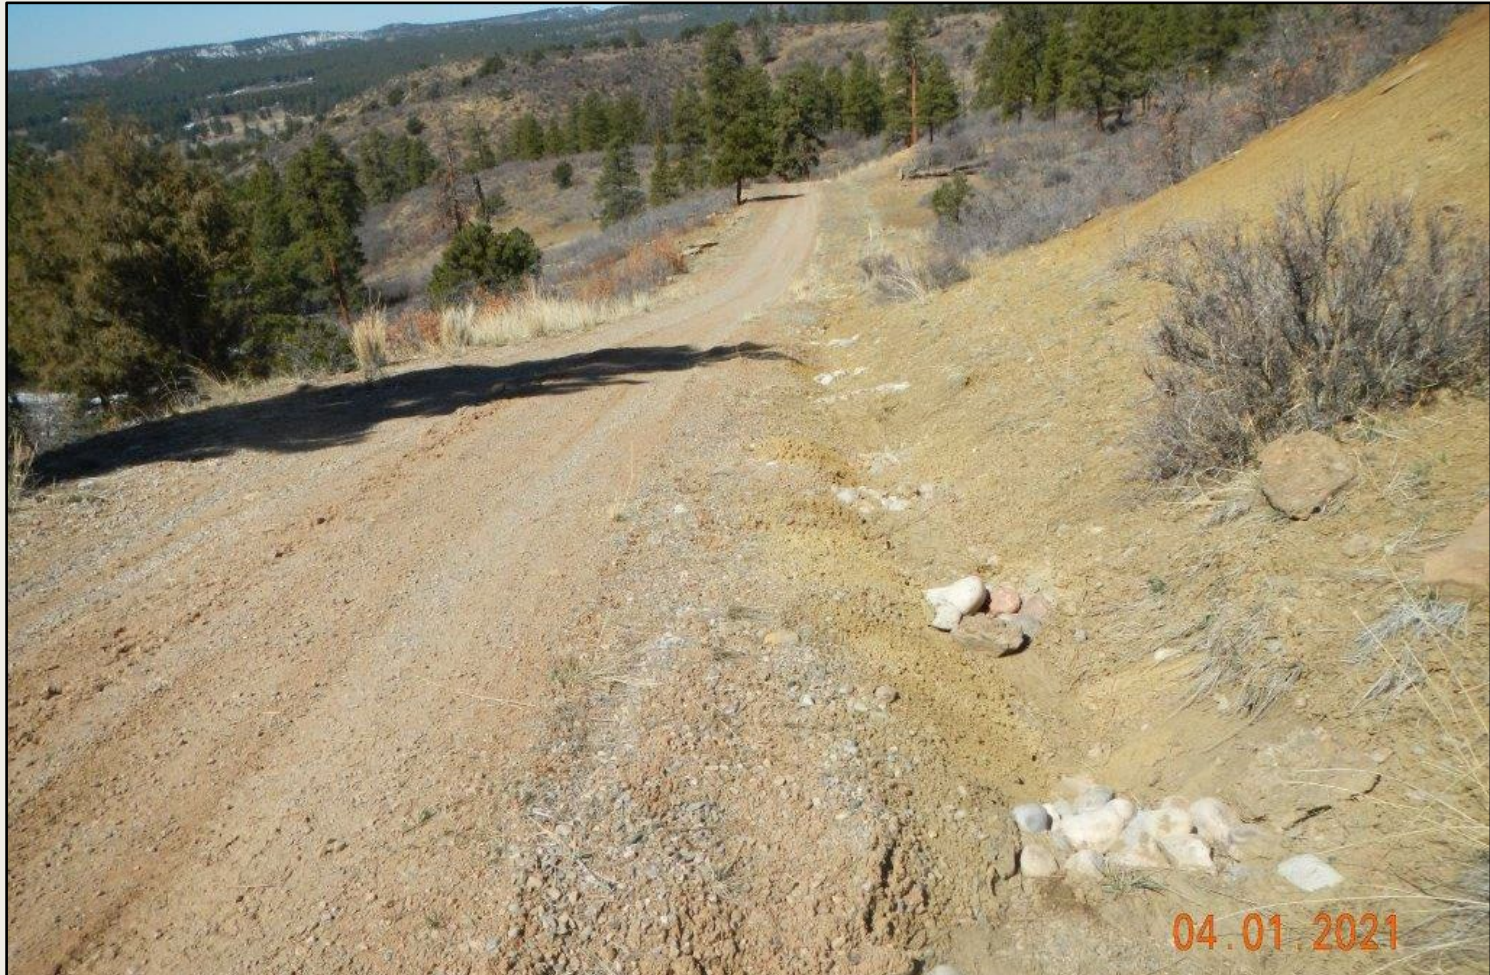
Photo 3. View of velocity checks placed along the access road. These checks are not properly sized/installed as stormwater flows around the checks resulting in continued erosion along the roadside.

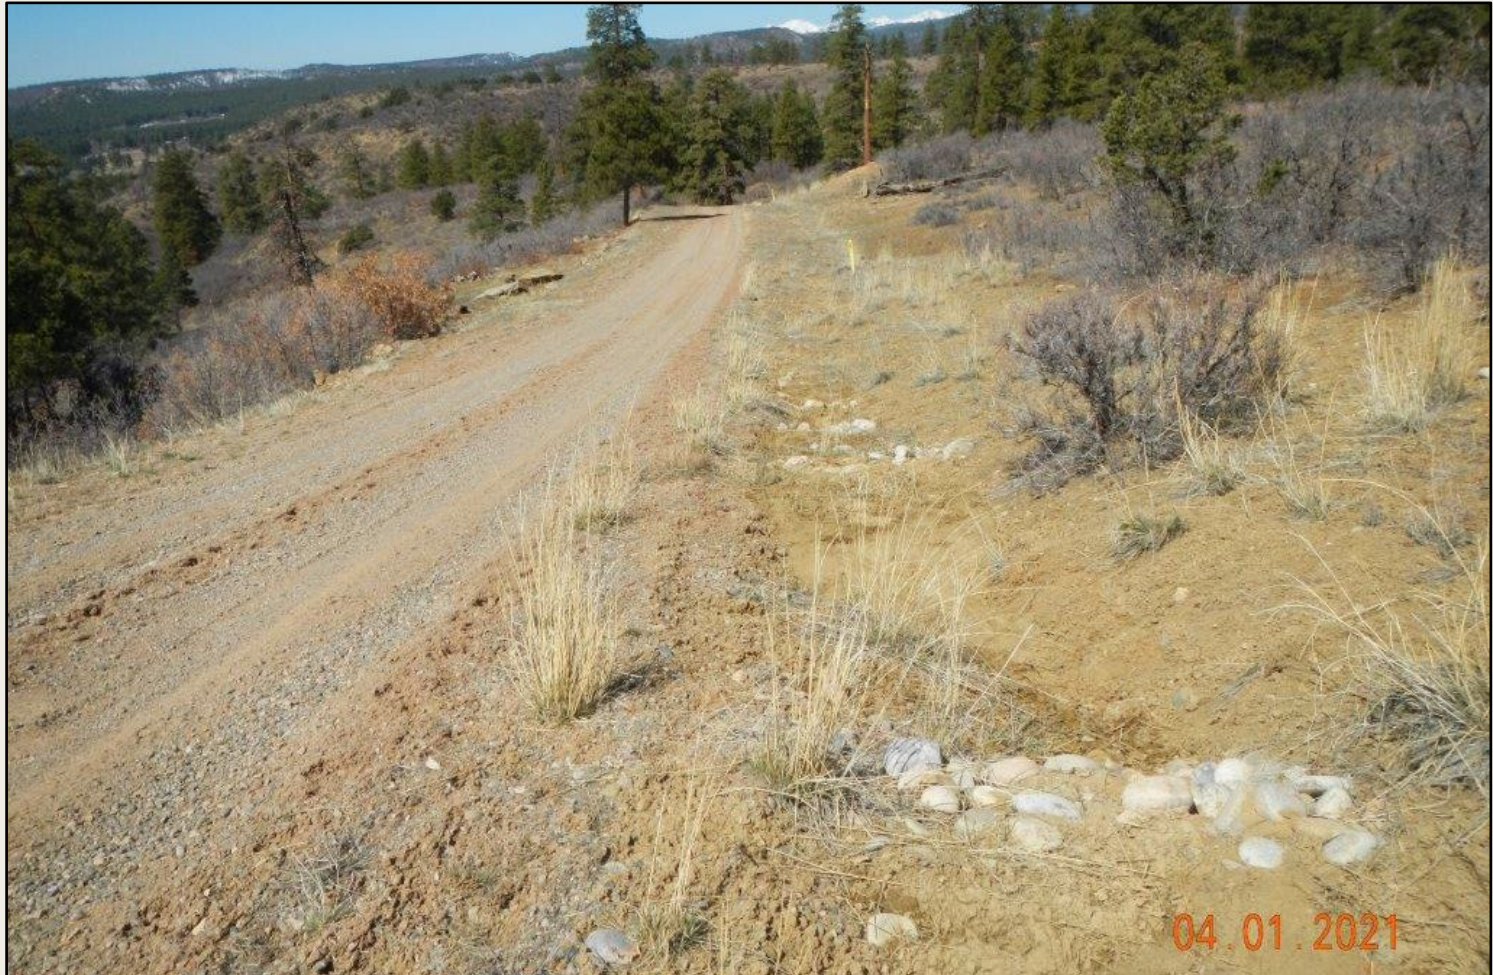
Photo 4. View of velocity checks at the bottom of the slope that are full of sediment and overflowing. These need maintenance.

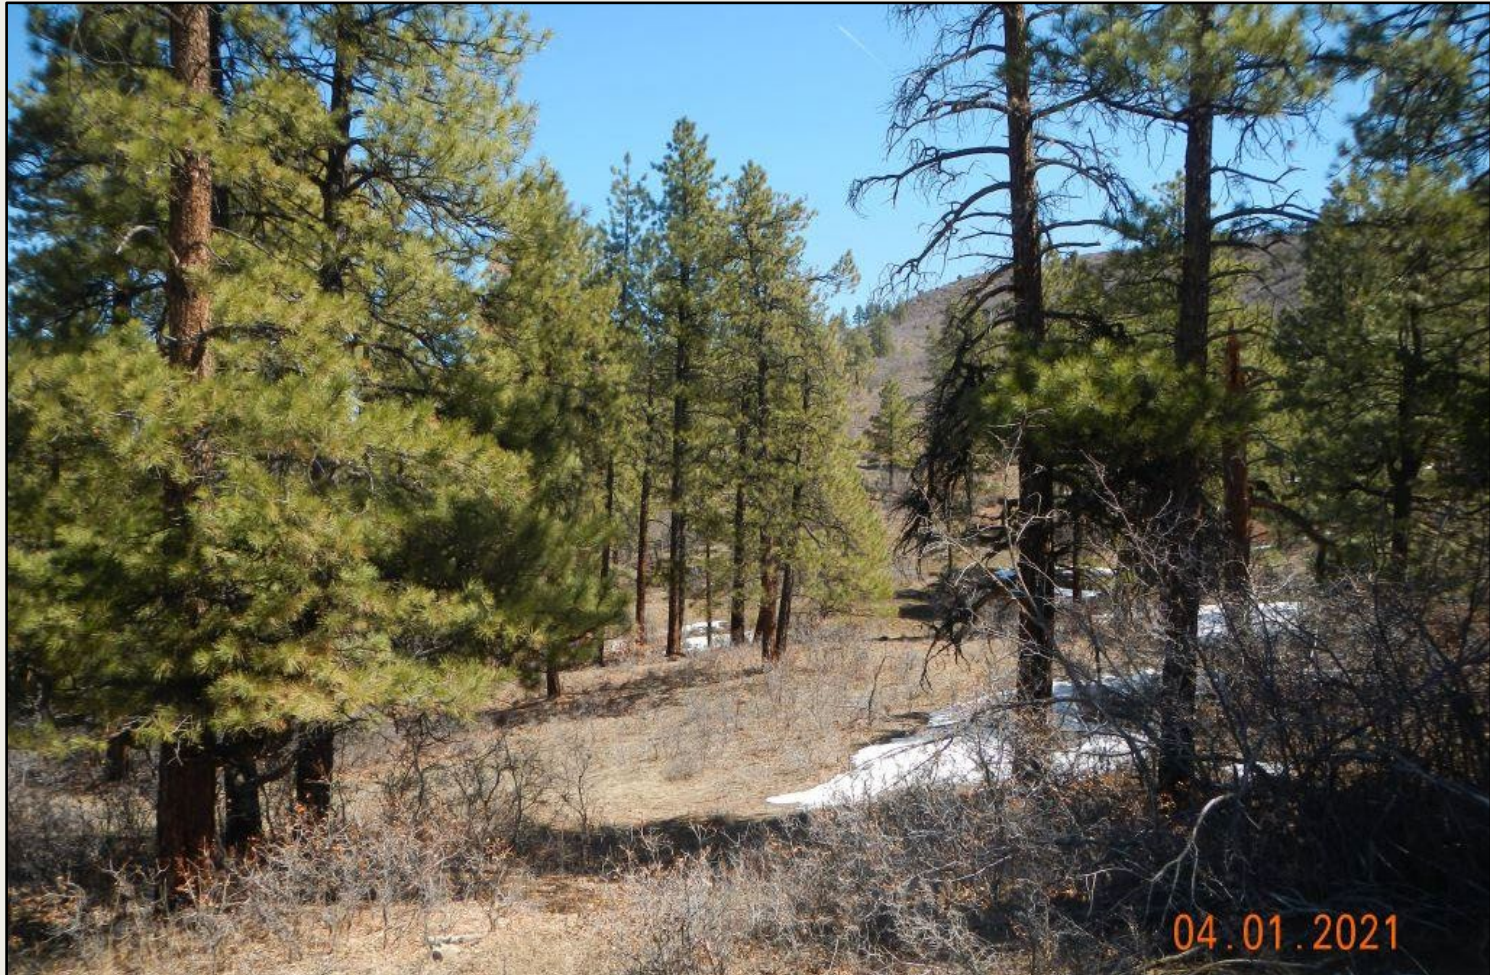
Photo 5. View of the reference area comprised of ponderosa pine woodland with understory of gambel oak and grasses such as western wheatgrass, muttongrass, and forbs such as Oregon grape and white sagebrush.
