Interim Reclamation and Stormwater Inspection

Operator: PDC ENERGY INC - 69175

Location ID: 442103

Inspection Photos
Location Name: Collins /4N64W18T
Location ID: 442103

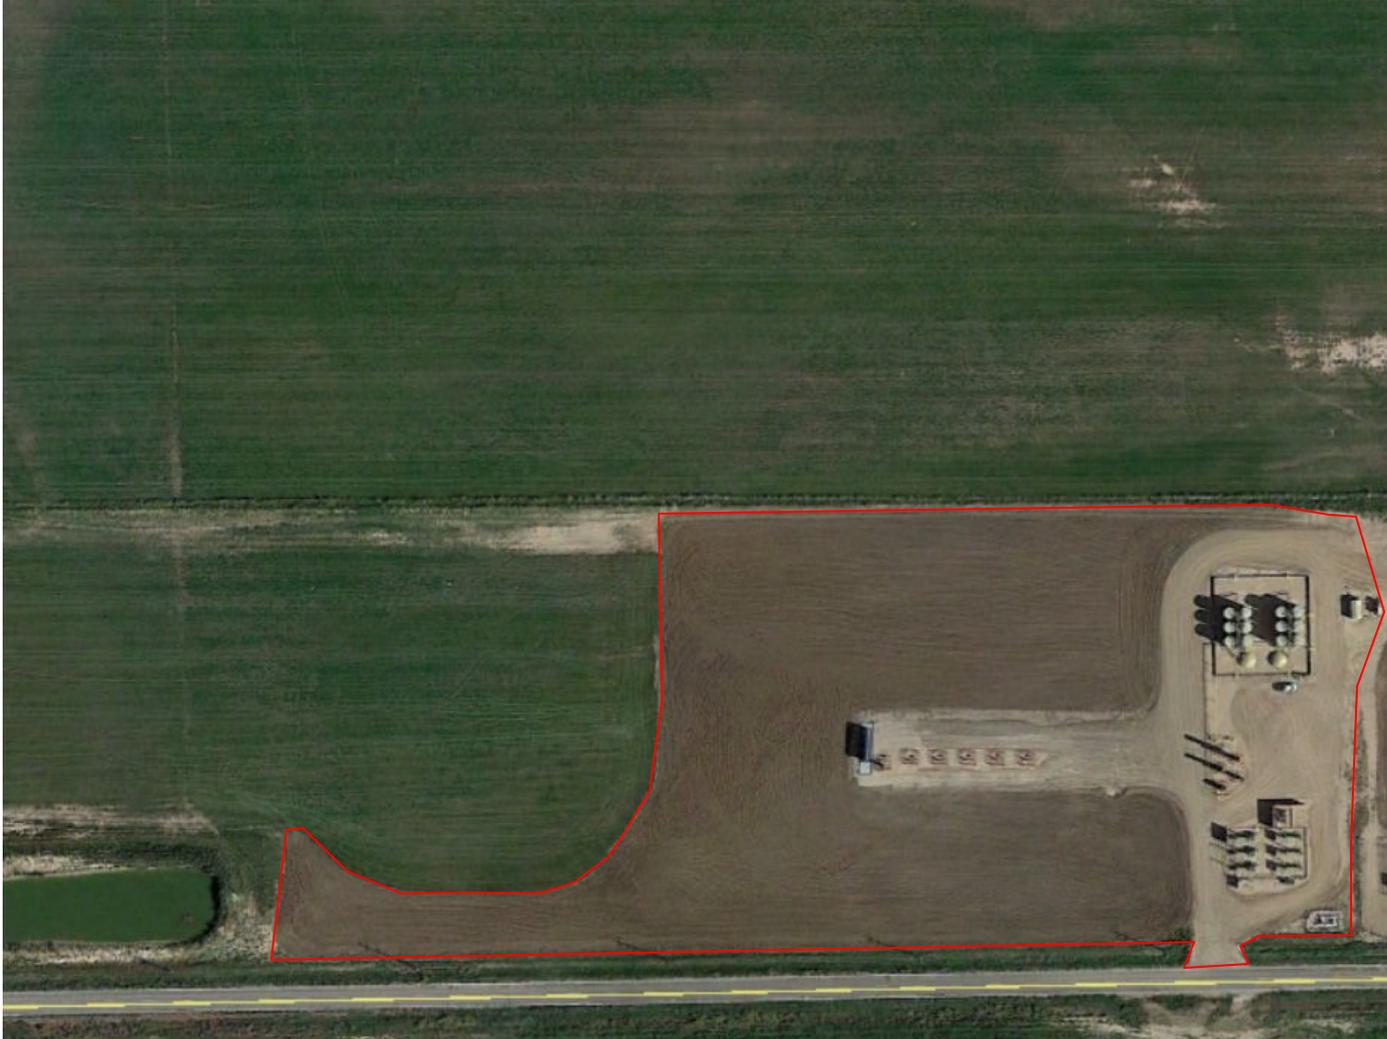
Photo 1. Google Earth aerial imagery from 9/7/2016 illustrates a disturbance area of approximately 8.5 acres (red polygon). This illustrates that interim reclamation appeared to be completed and was initiated around 3/2016.

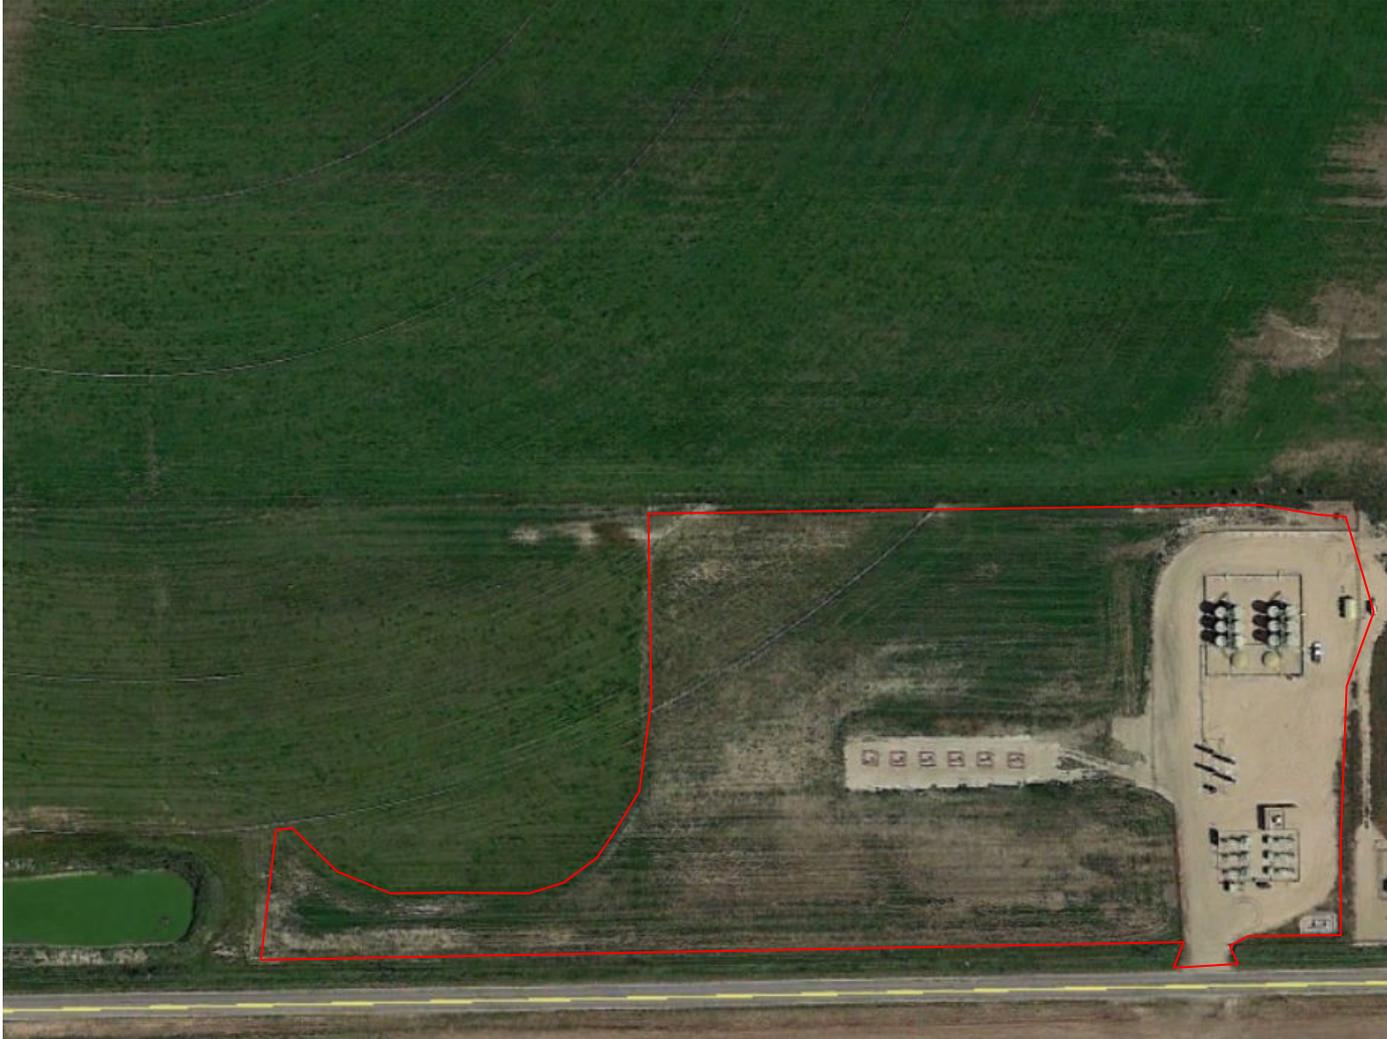
Photo 2. Google Earth aerial imagery from 7/17/2019 during the active growing season illustrates that interim reclamation areas do not appear reflective of reference areas.

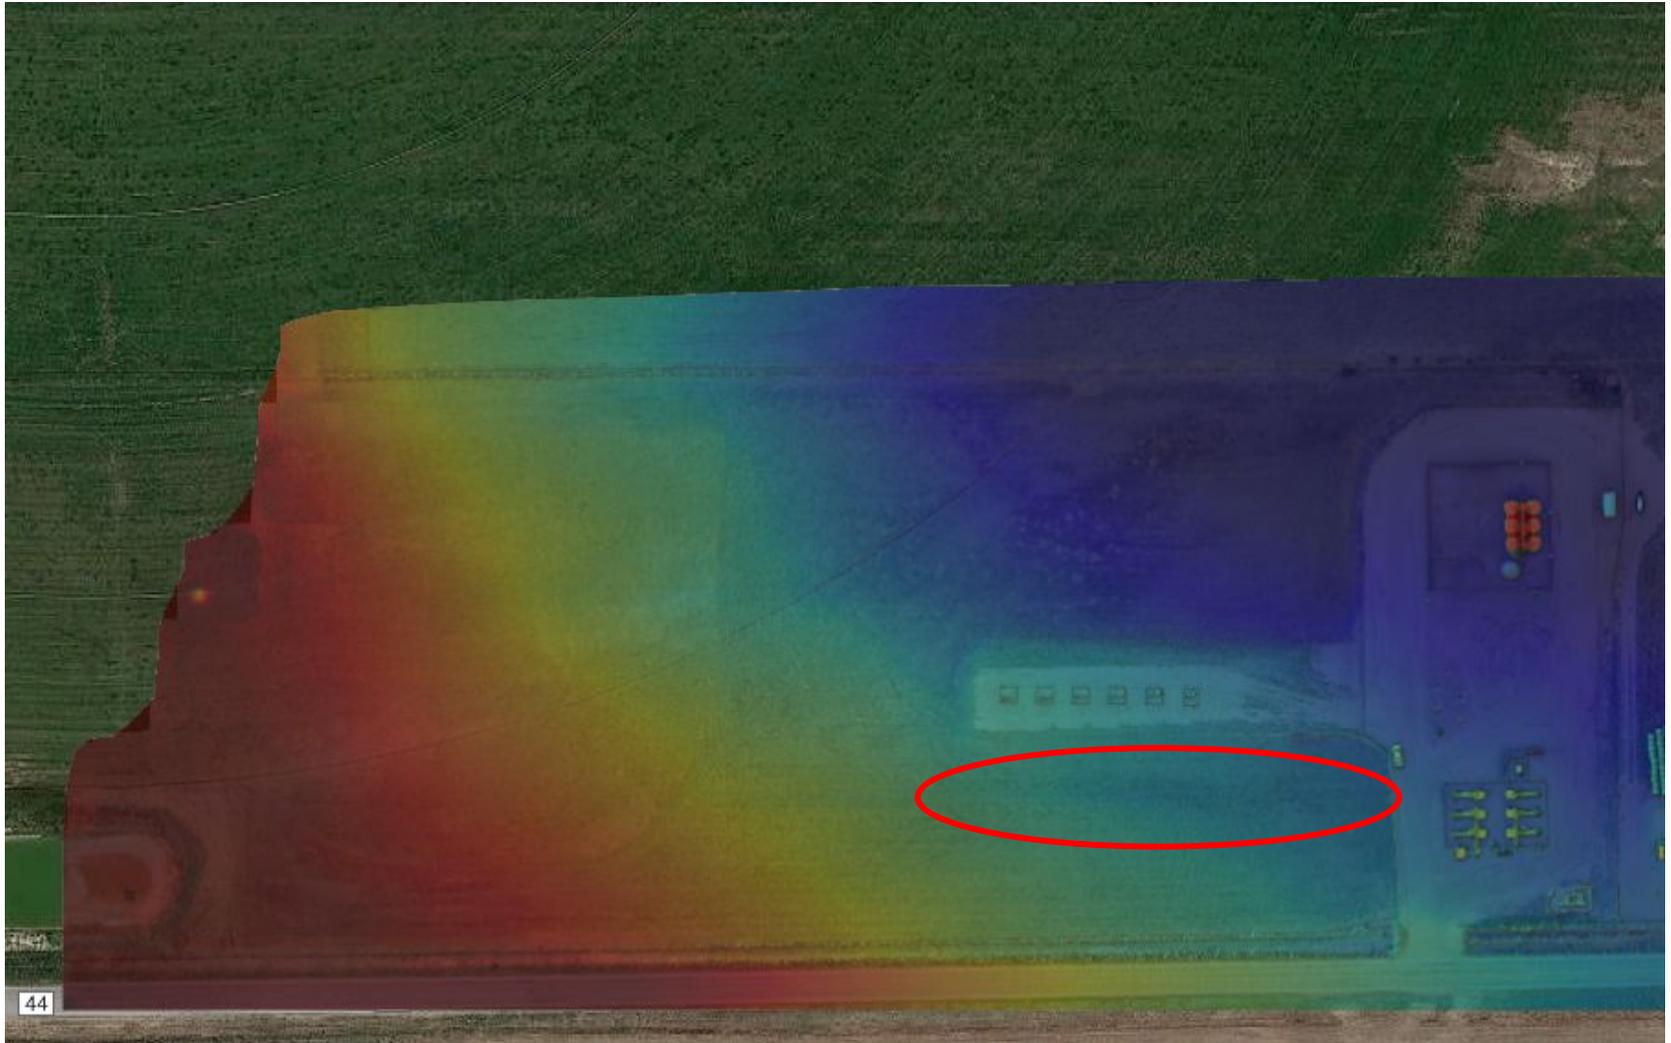
Photo 3. Drone aerial imagery from 3/30/2021 illustrates that interim reclamation areas do not appear to be properly contoured to allow for successful flood irrigation for the southeastern property. There appears to be a low spot south of the wells (red circle).

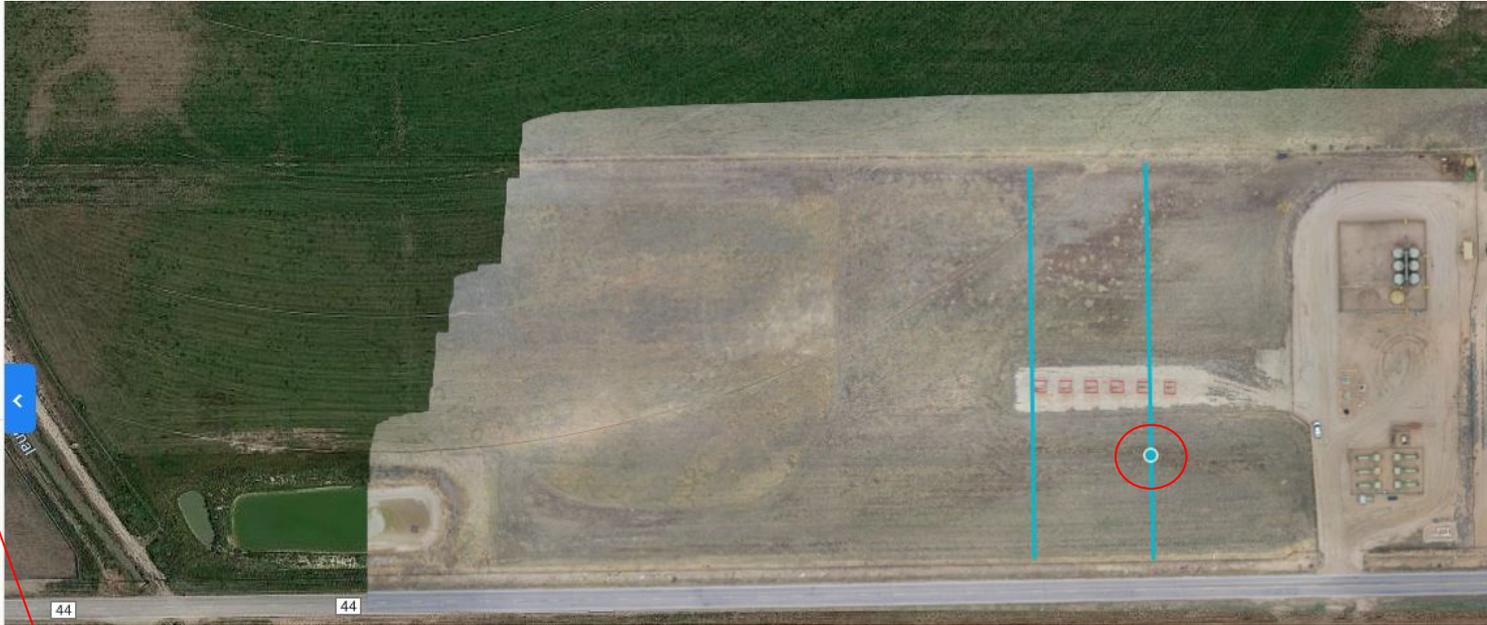
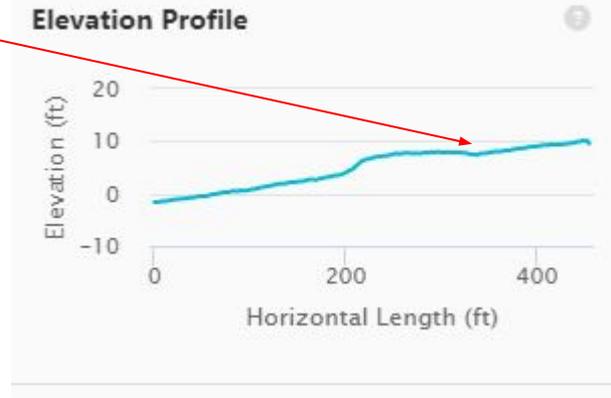
Horizontal Length 455.02 ft
Surface Length 454.98 ft
Slope 1.41°, 2.46%
Vertical Height 11.18 ft

Photo 4. Drone aerial imagery further illustrates the low spot south of the wells (red circle and red arrow) with the elevation profile.

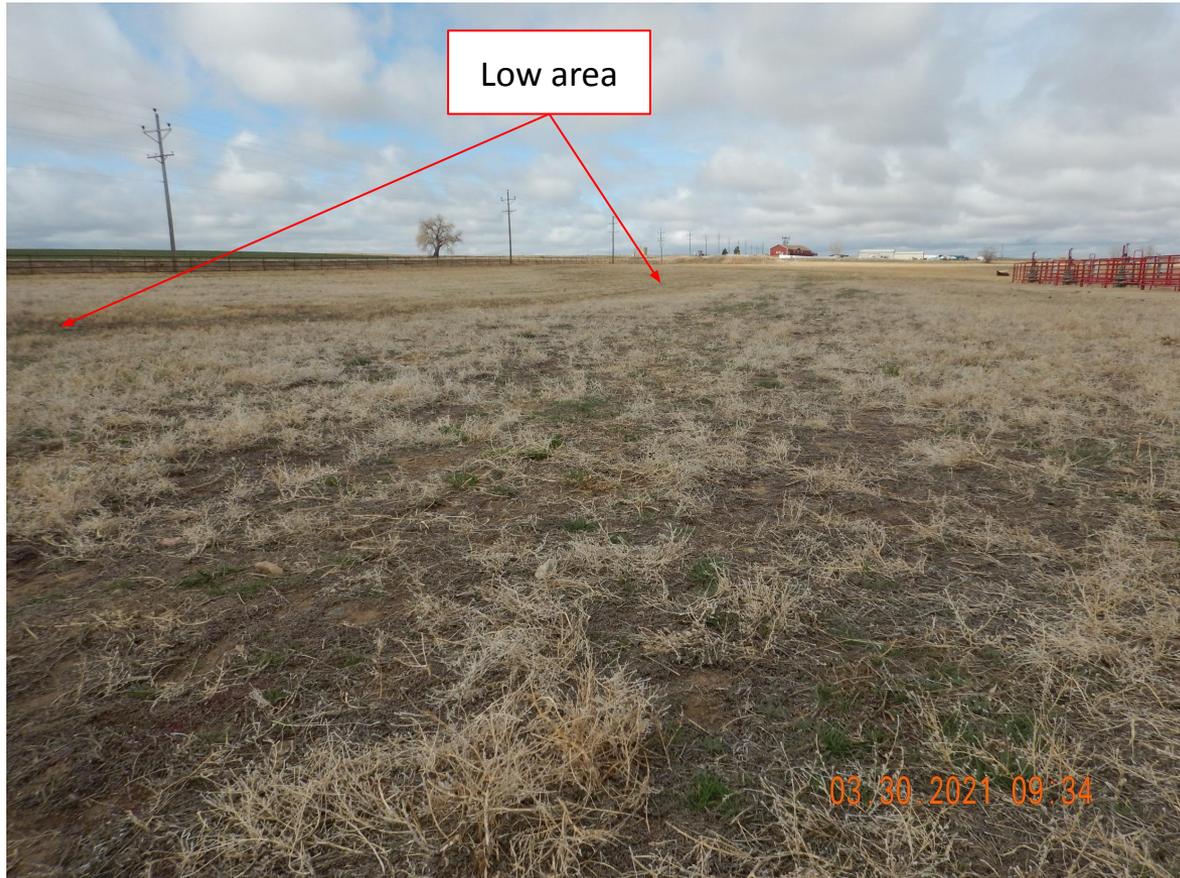
Photo 5. Photo taken from the eastern interim reclamation area, facing West. Photo illustrates a low area that would not appear to allow for successful flood irrigation.

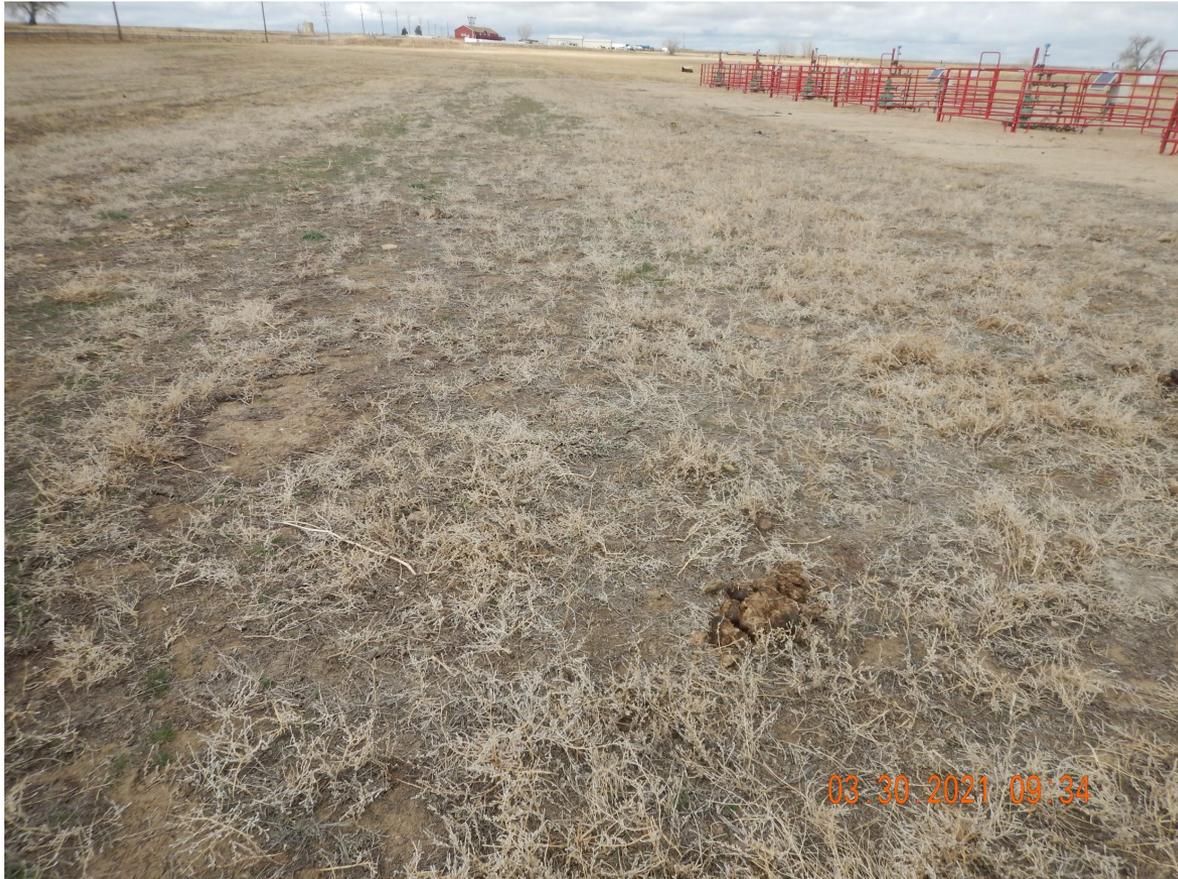
Photo 6. Photo taken from the southeastern interim reclamation area, facing West. Photo illustrates mostly annual weedy vegetation establishment, which is not reflective of reference areas.

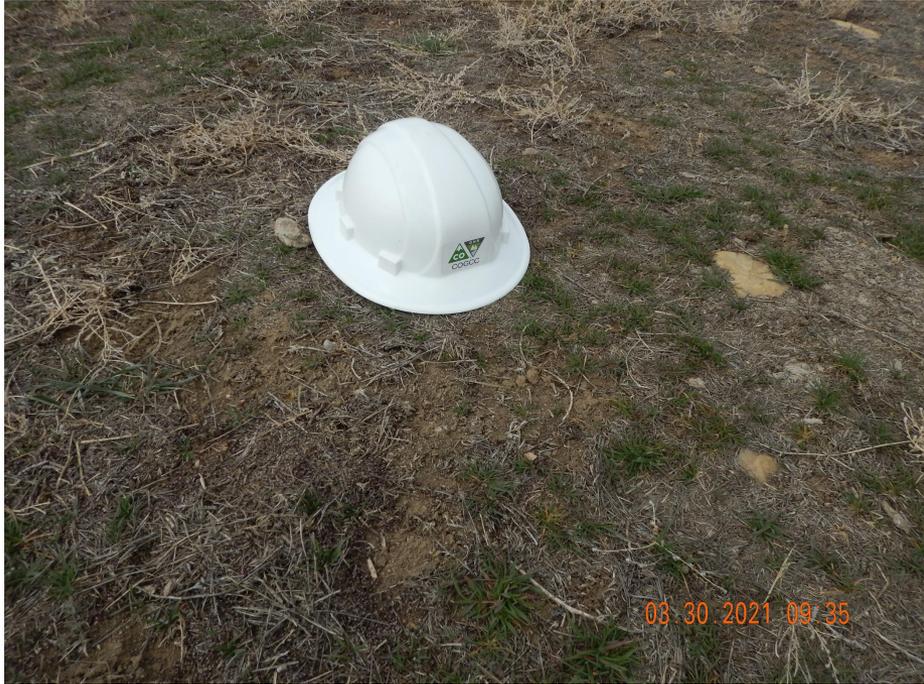
Photo 7. Close up photo taken from the southeastern interim reclamation area. Photo illustrates mostly annual weedy vegetation establishment (Kochia and cheatgrass), which is not reflective of reference areas.

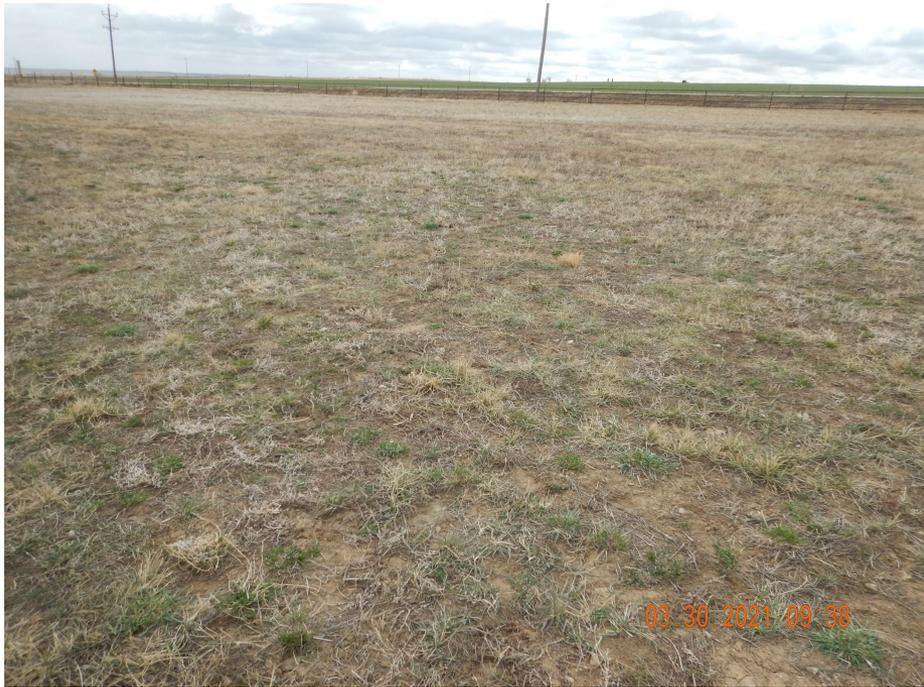
Photo 9. Photo taken from the western interim reclamation area, facing South. Photo illustrates the establishment of some desirable perennial vegetation but it is still not reflective of reference areas.
