Inspection Photos
Location Name: RMF CO 15-09
Location ID: 330987

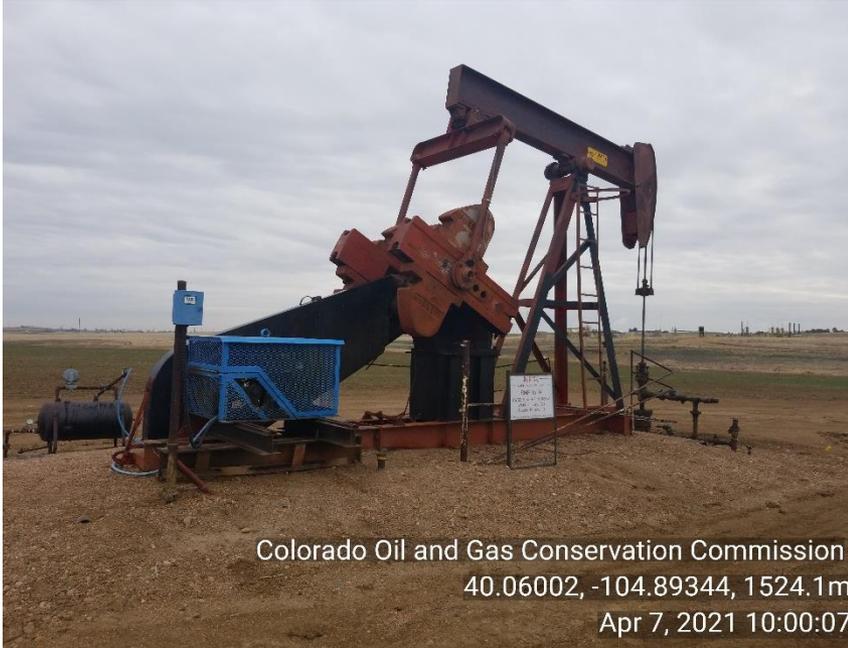
Photo 1 WH

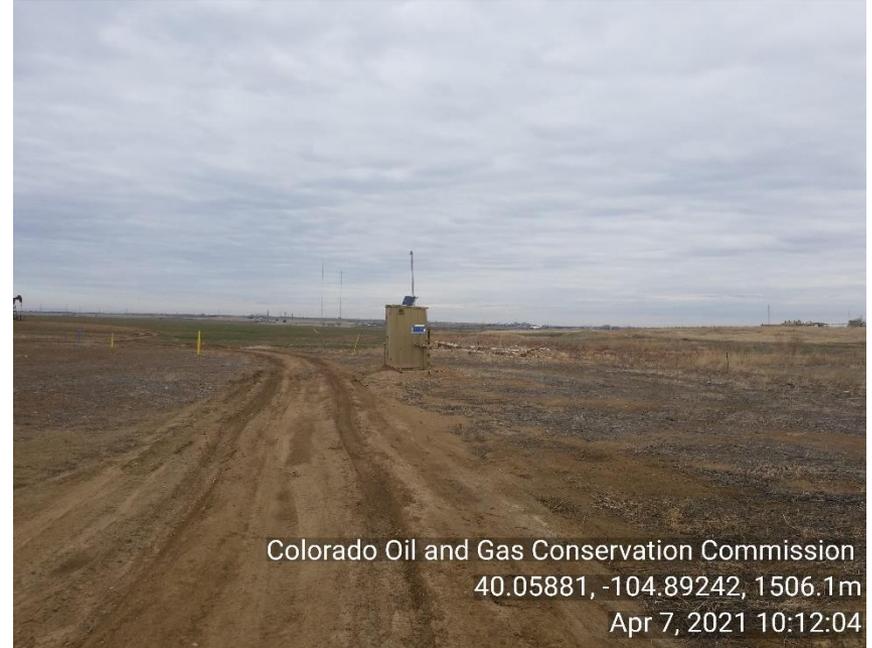
Photo 2 Meter house

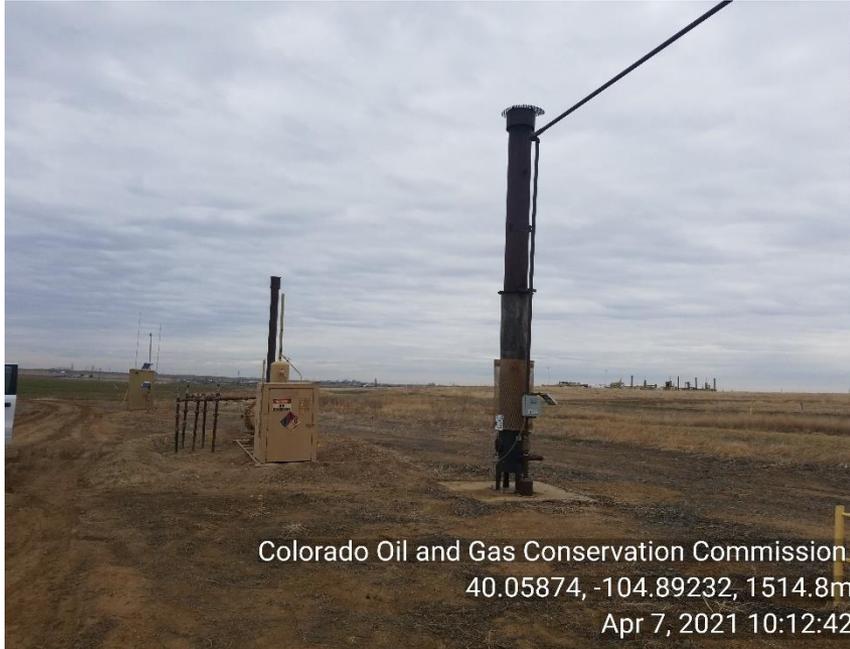
Photo 3 production equipment

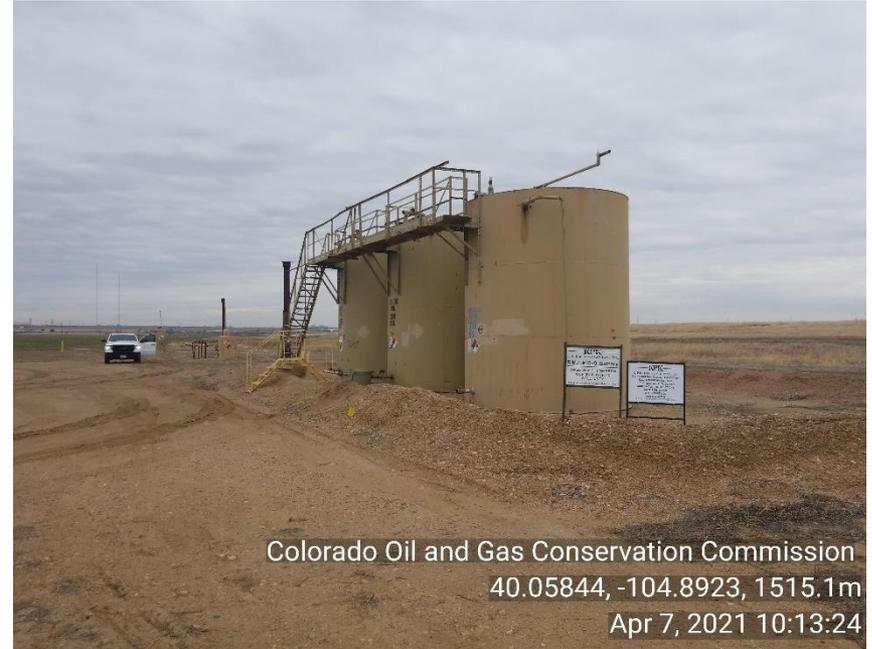
Photo 4 TNK BTRY

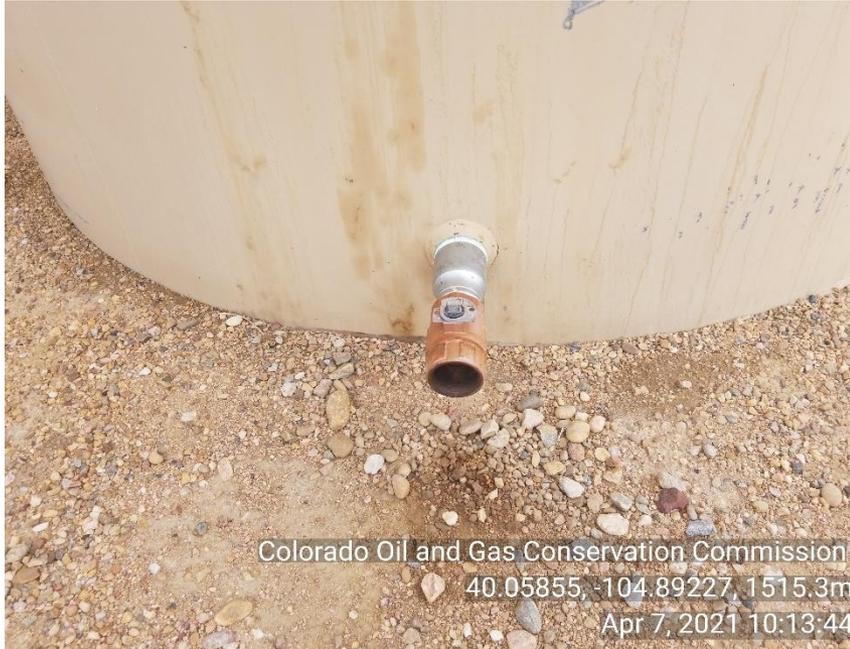
Photo 5 mechanical issue no bull plug and stained soil under unsecured valve on produced water tank

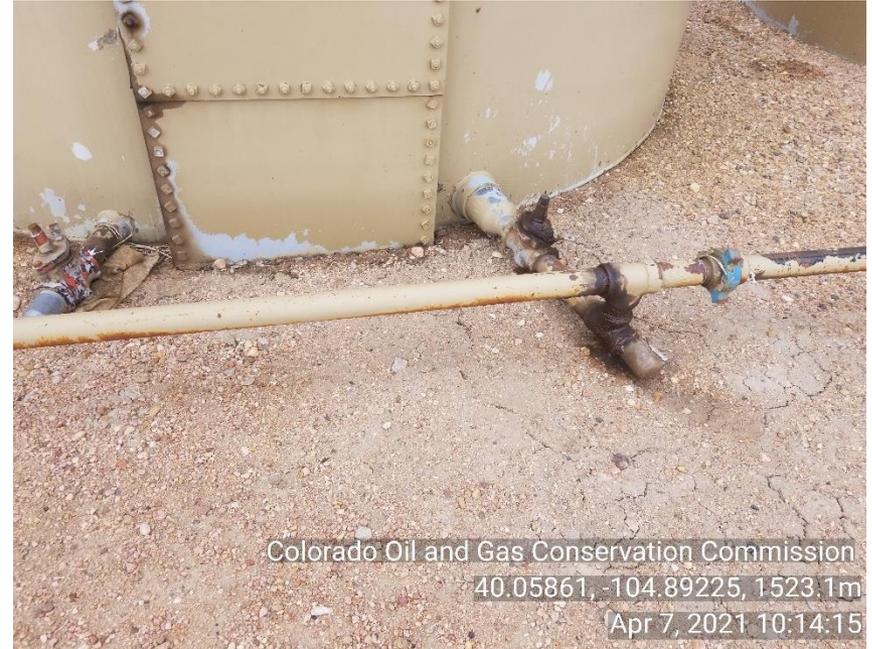
Photo 6 mechanical issue fittings and valves leaking on load out lines on crude oil tanks

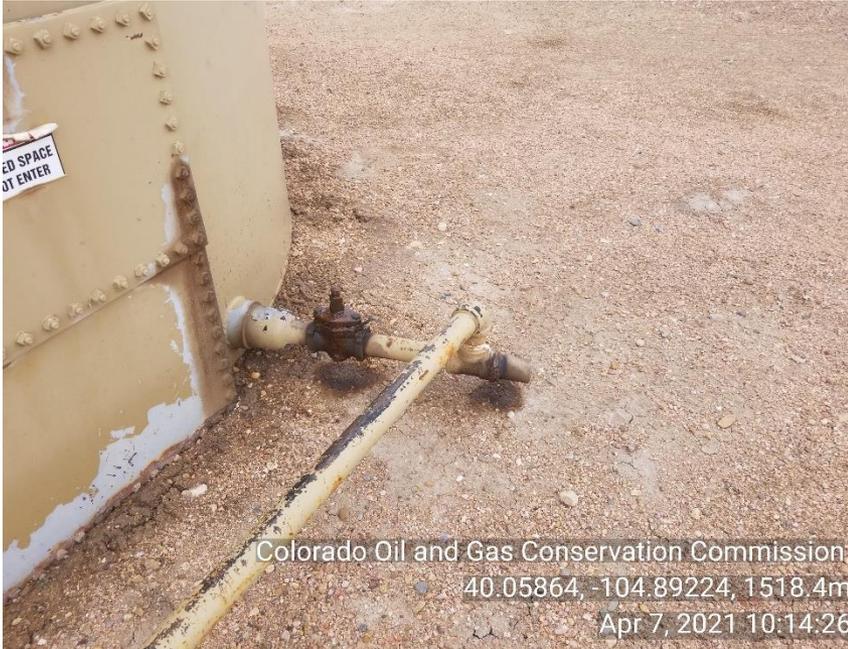
Photo 7 Mechanical issue and stained soil on load out lines on crude oil tanks.

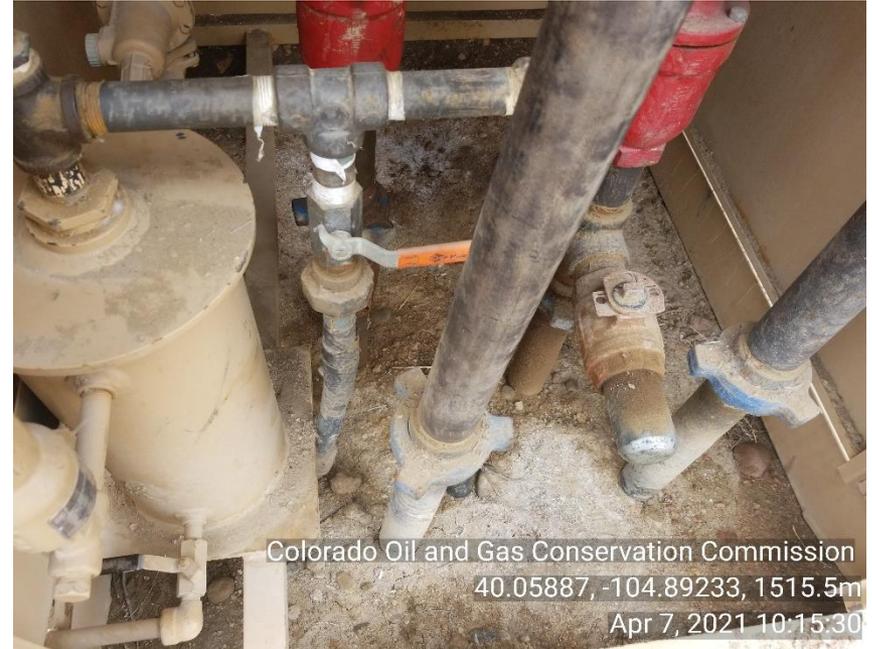
Photo 8 Mechanical issue and stained soil on piping inside HOZ Sep.

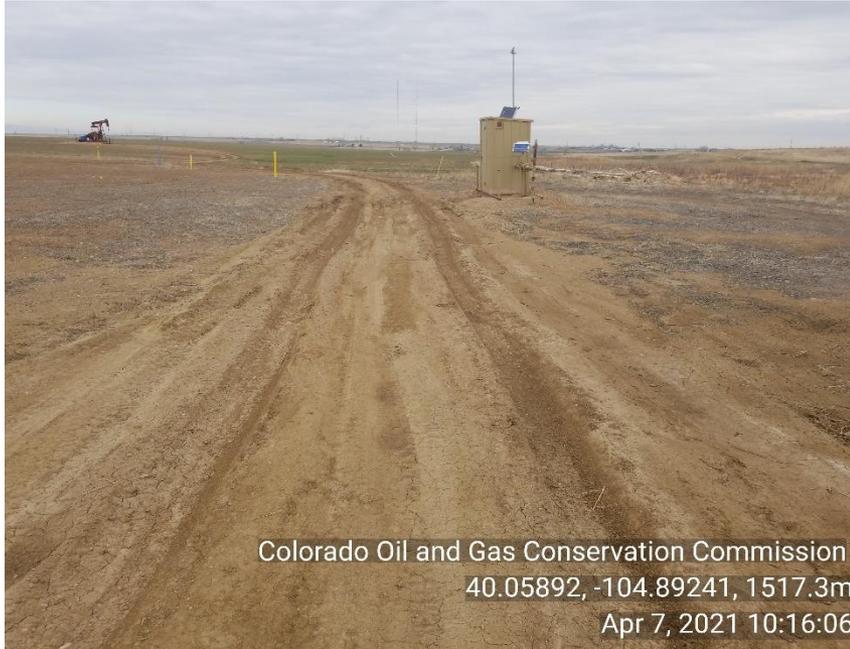
Photo 9 Deep ruts on access road, road in need of proper BMP's

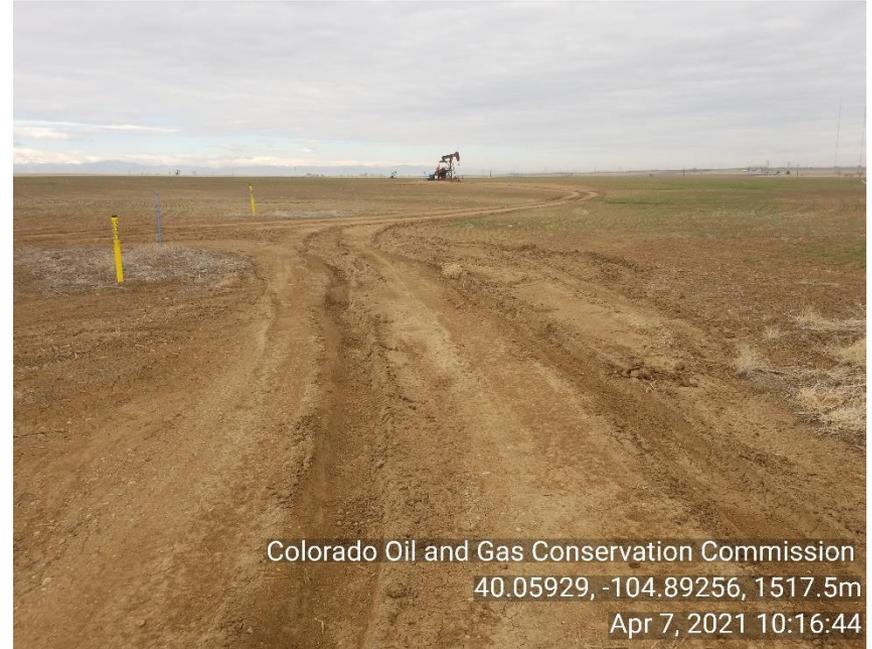
Photo 10 Deep ruts on access road, road in need of proper BMP's
