COLORADO
Oil & Gas Conservation
Commission
Department of Natural Resources

Ant Hill Unit Wyatt 31-12 API: 05-103-10291
Inspection: 701500216

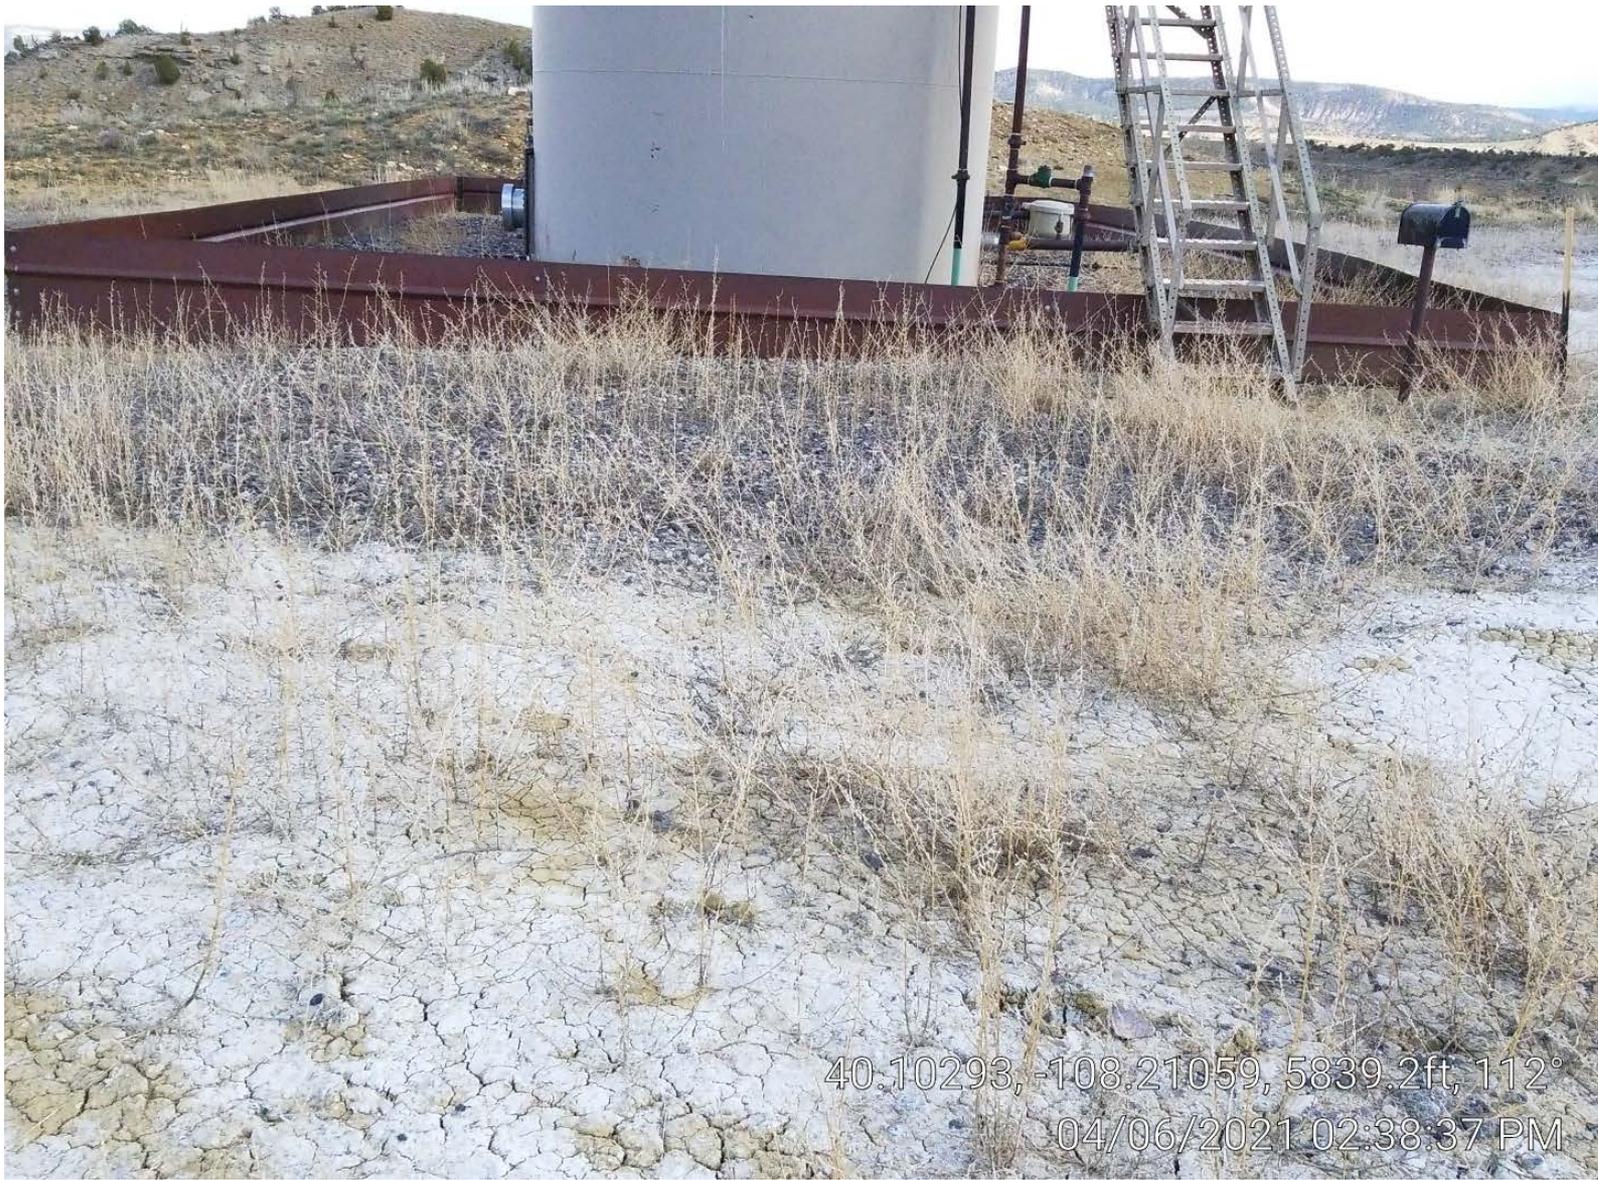
Photo 6. Debris.

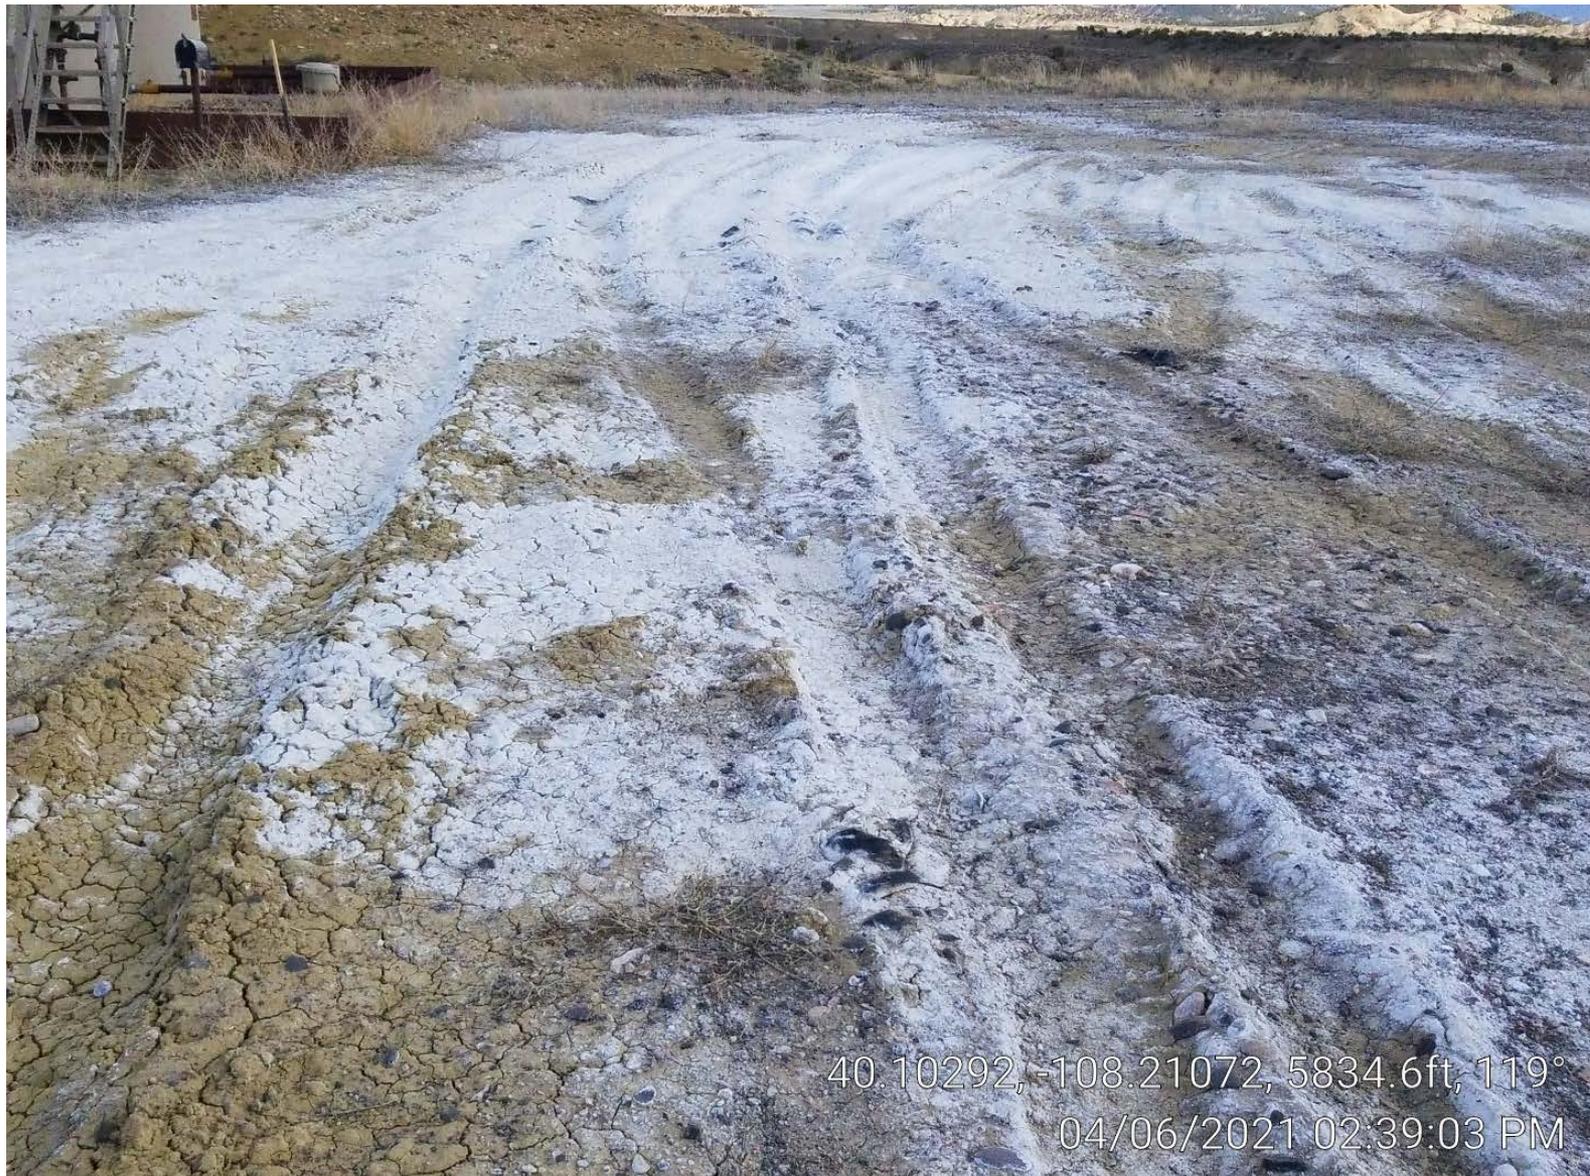
Photo 8. Ruts in sediment that flowed unto location.

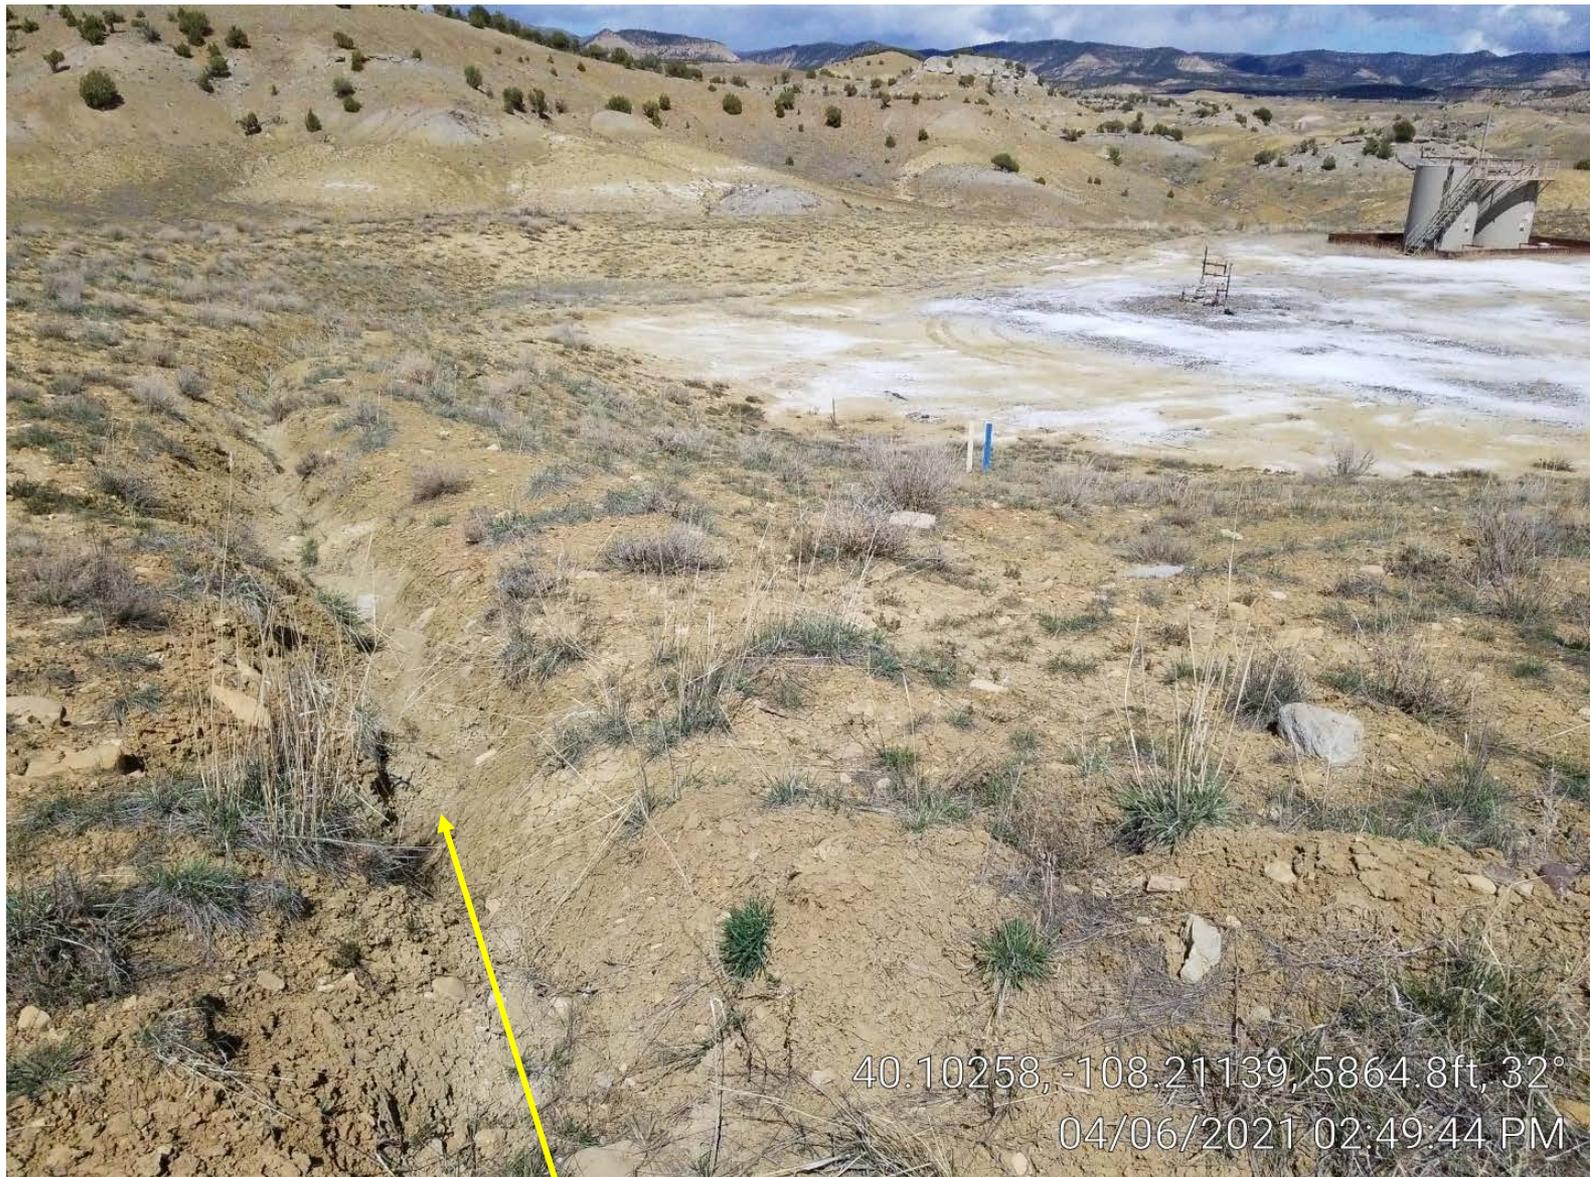
Photo 9. Start of storm water ditch around location.

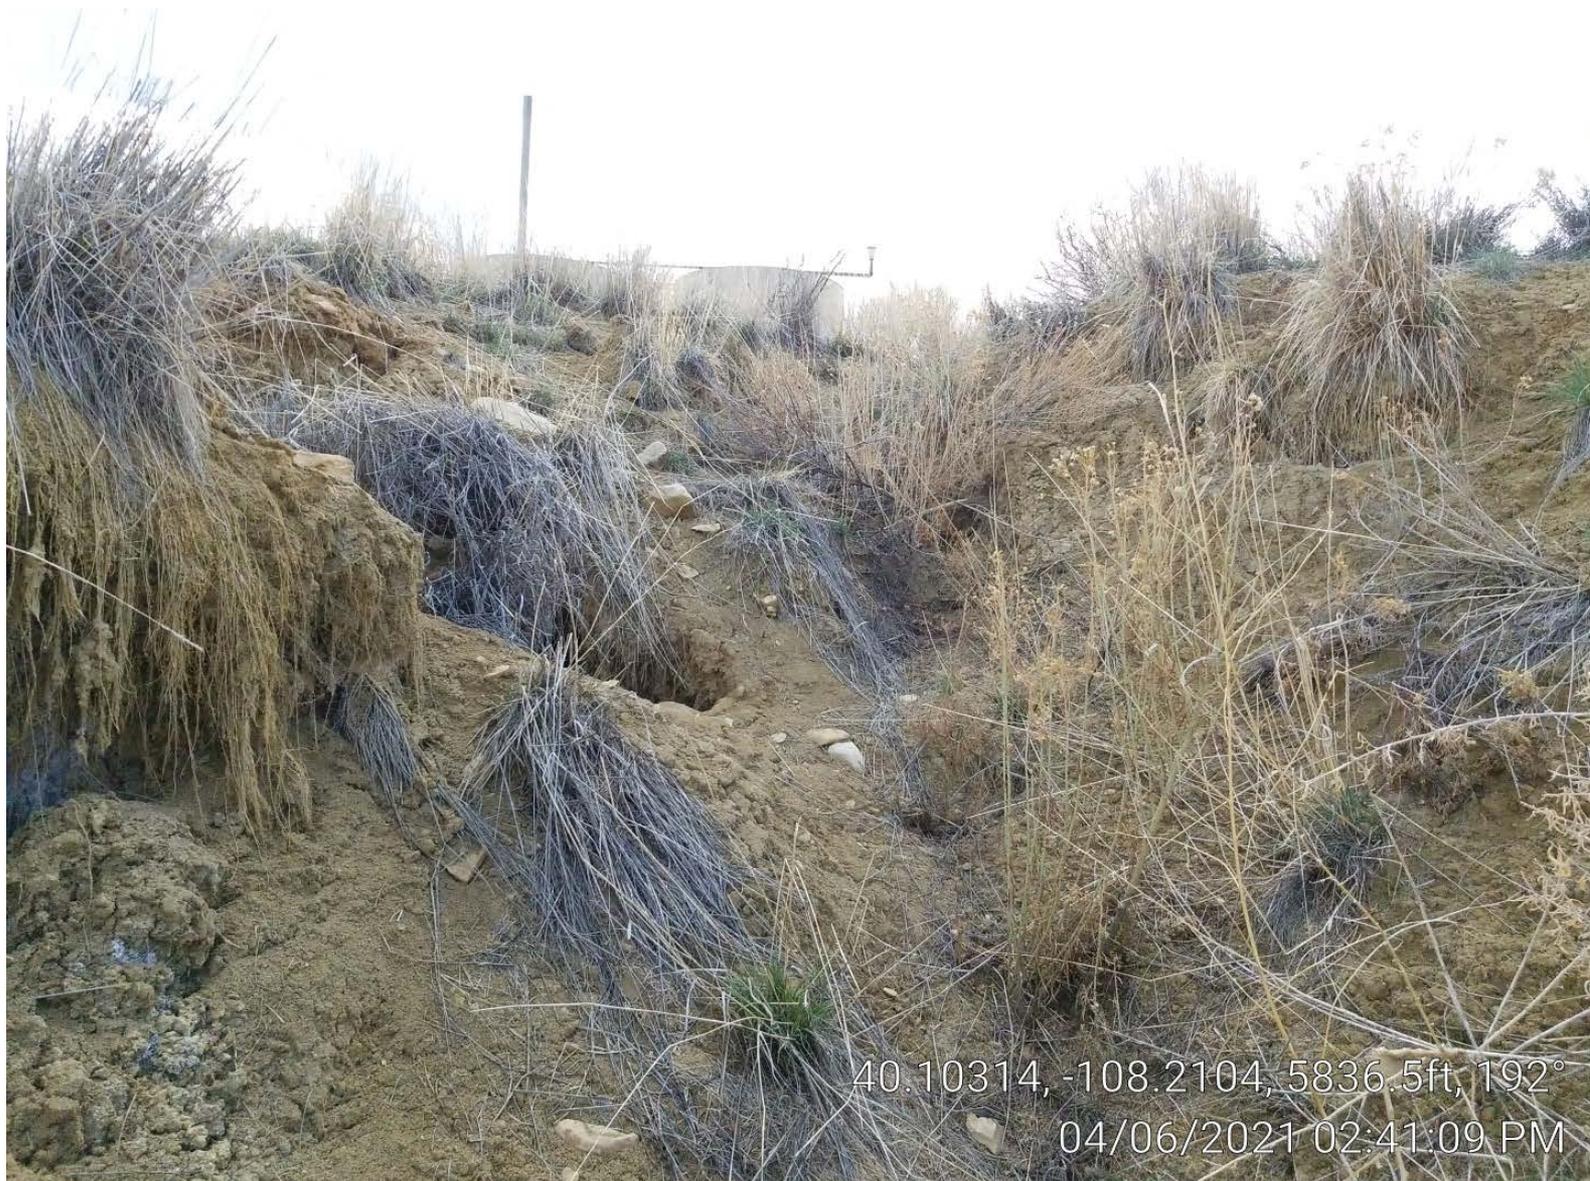
**Photo 11. Storm water channel below tanks
from ditch.**

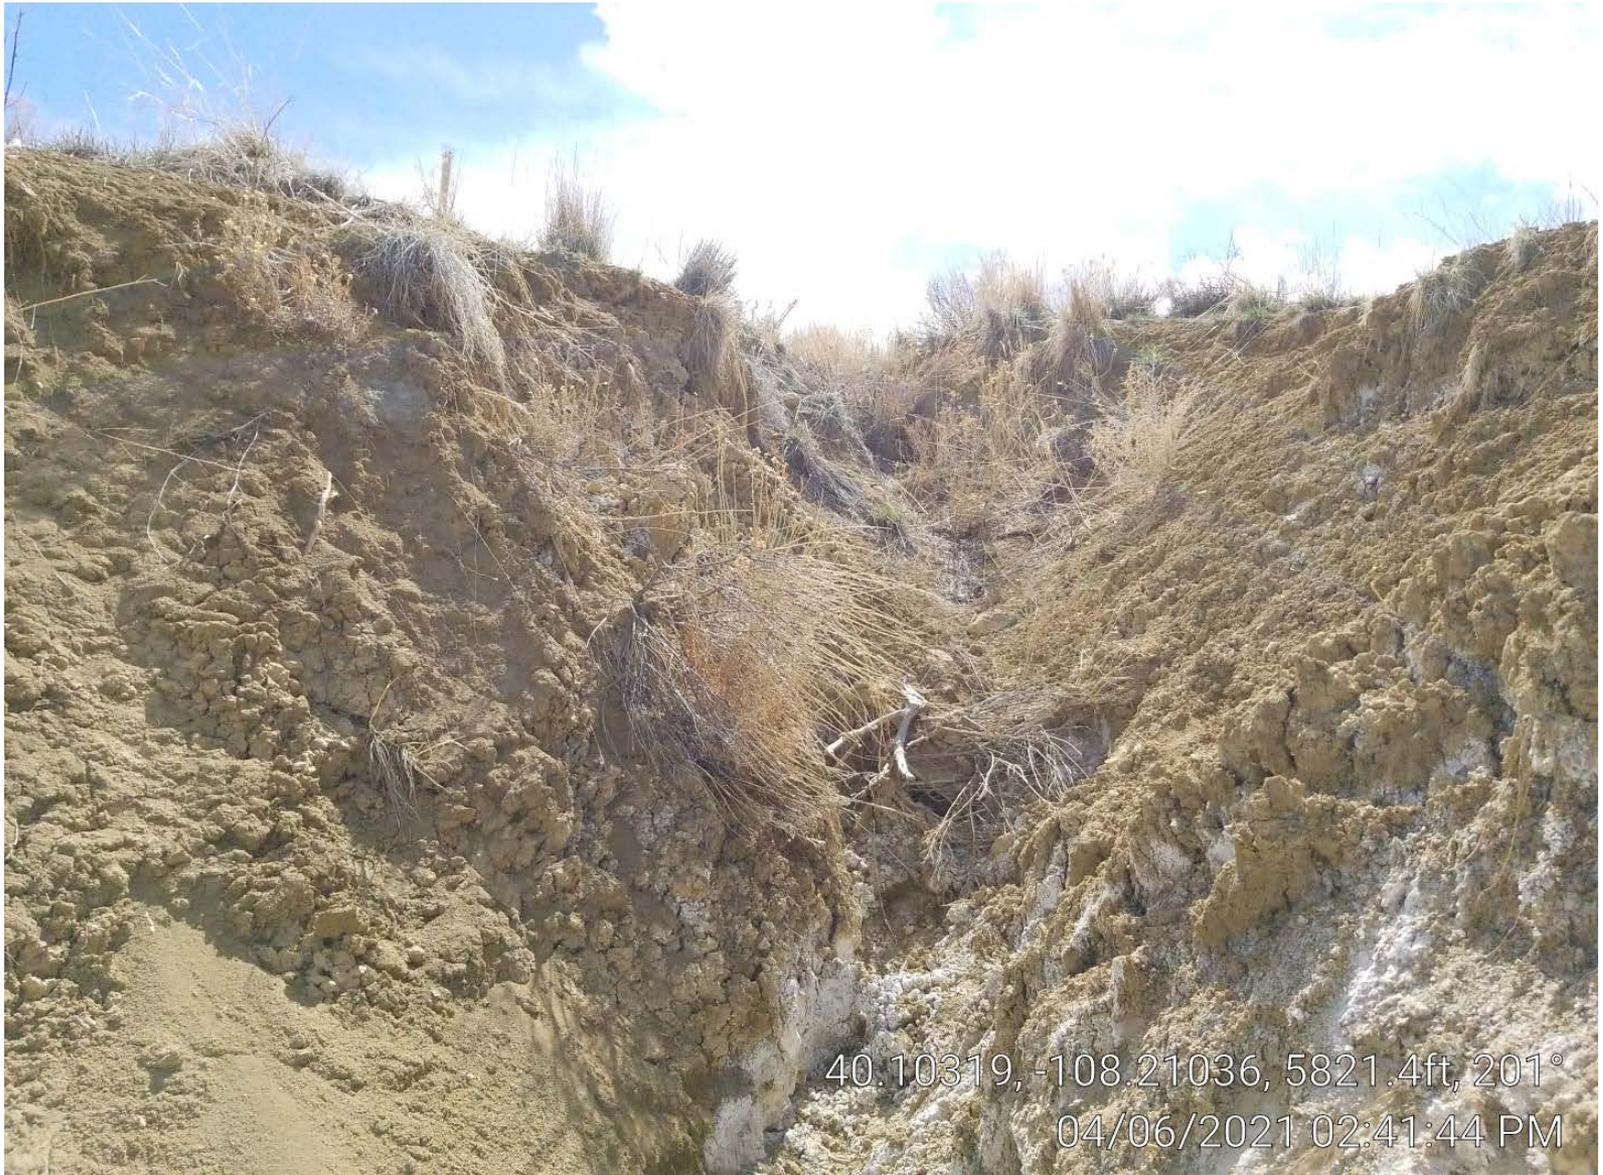
**Photo 12. 8 ft deep storm water channel from
location ditch.**
