Inspection Photos

4/6/2021

Operator: LARAMIE ENERGY LLC

Location ID: 312452

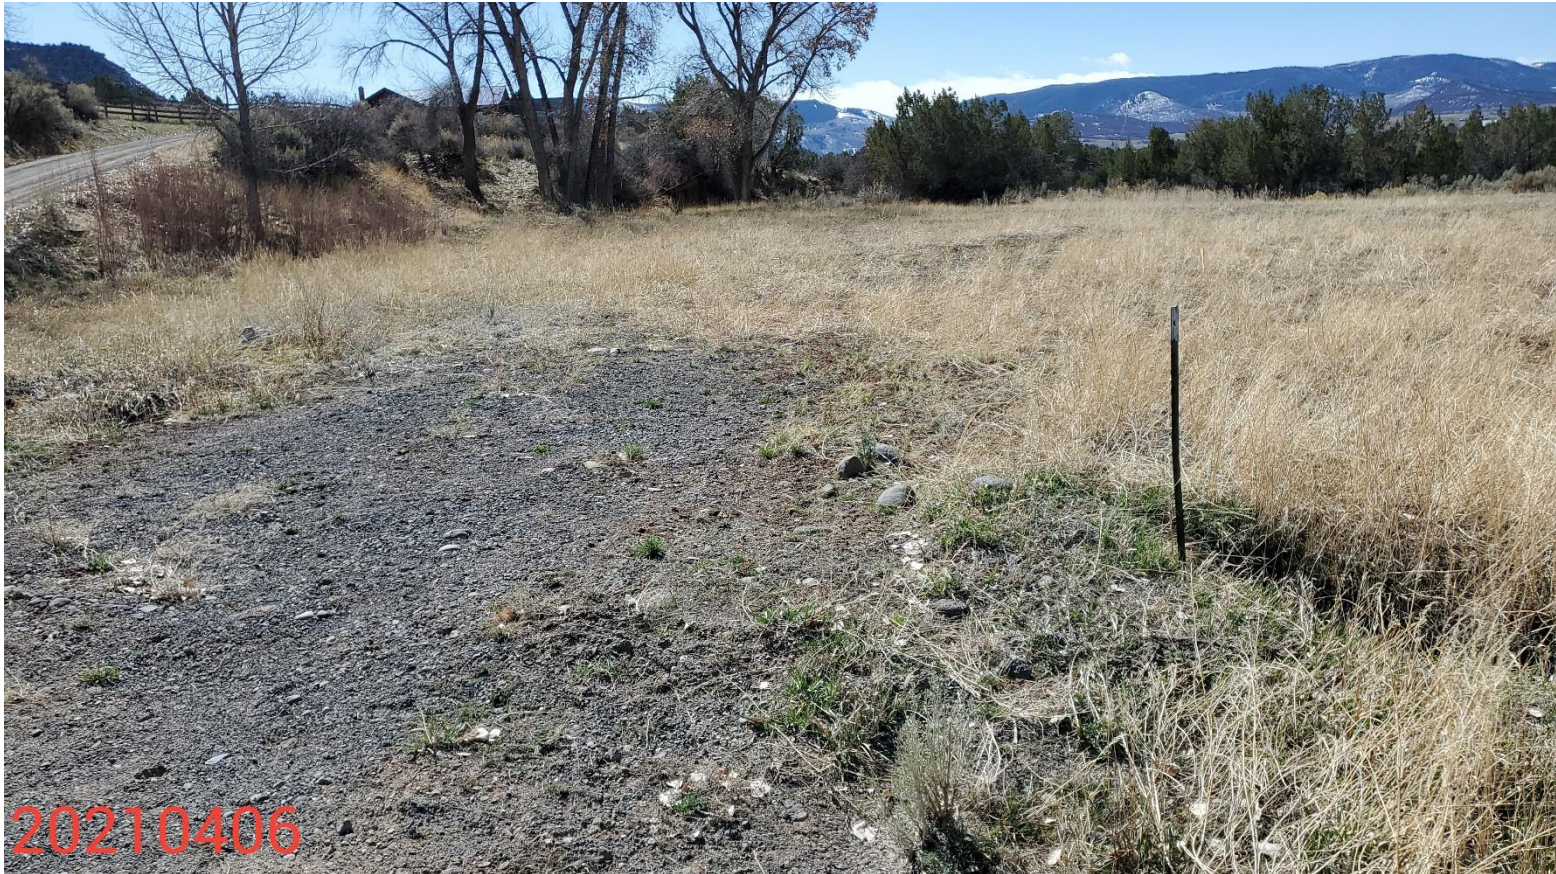
Photo 1: Photo taken from the Location entrance, facing south. Photo shows reclamation has not been conducted in accordance with COGCC 1004 Rules; culvert has not been removed and entrance reclaimed; gravel remaining on the Locaiton.

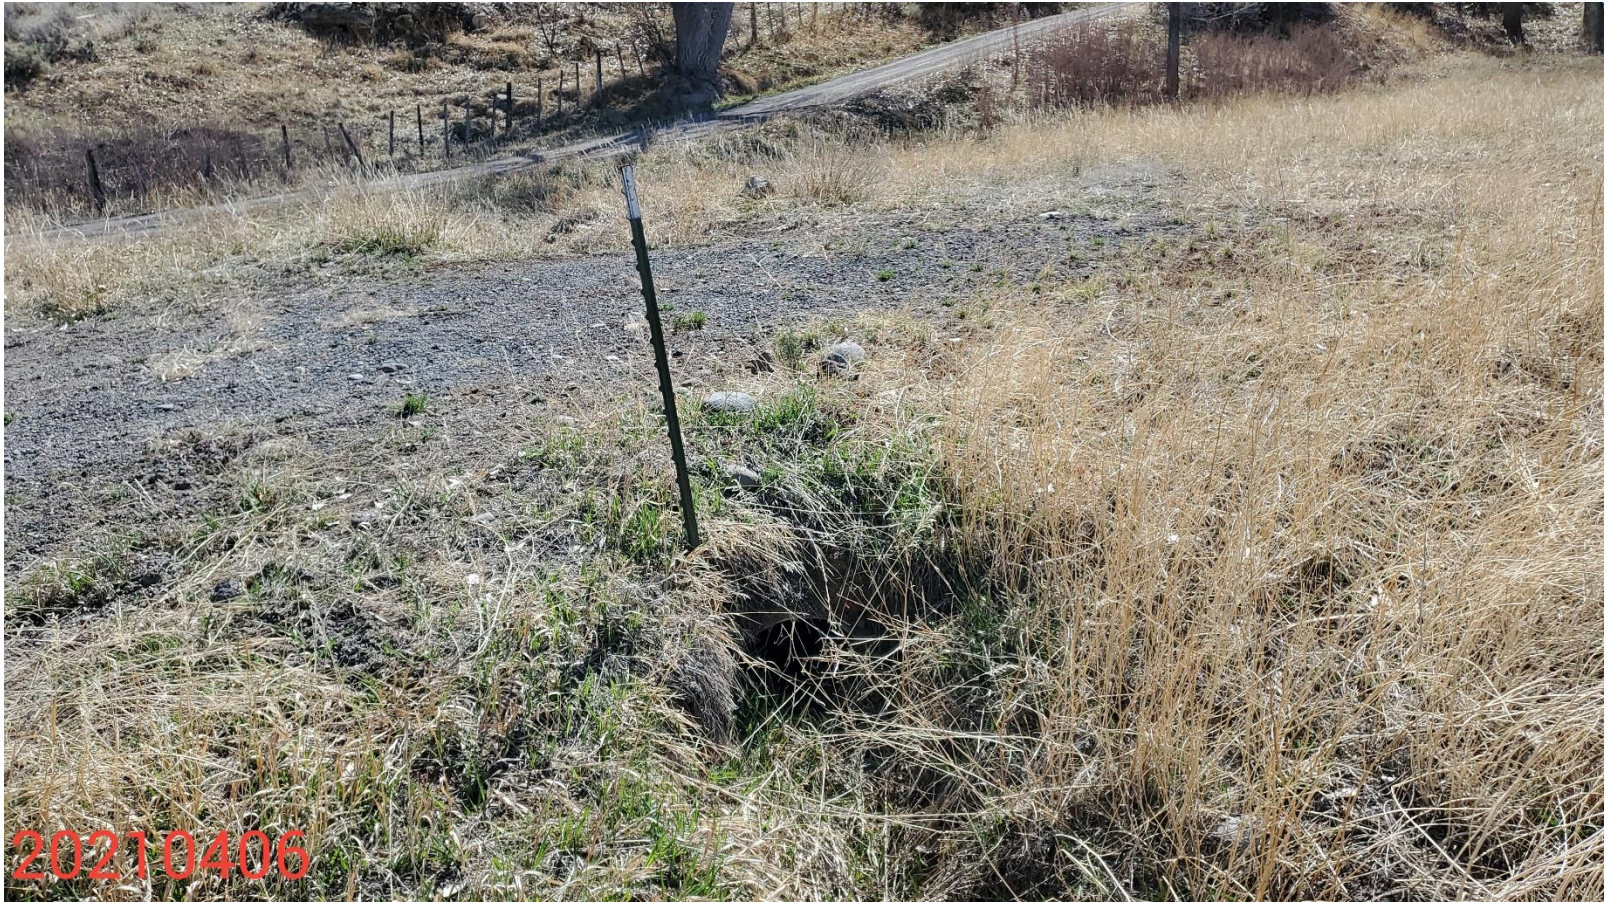
Photo 2: See comments under photo 1.

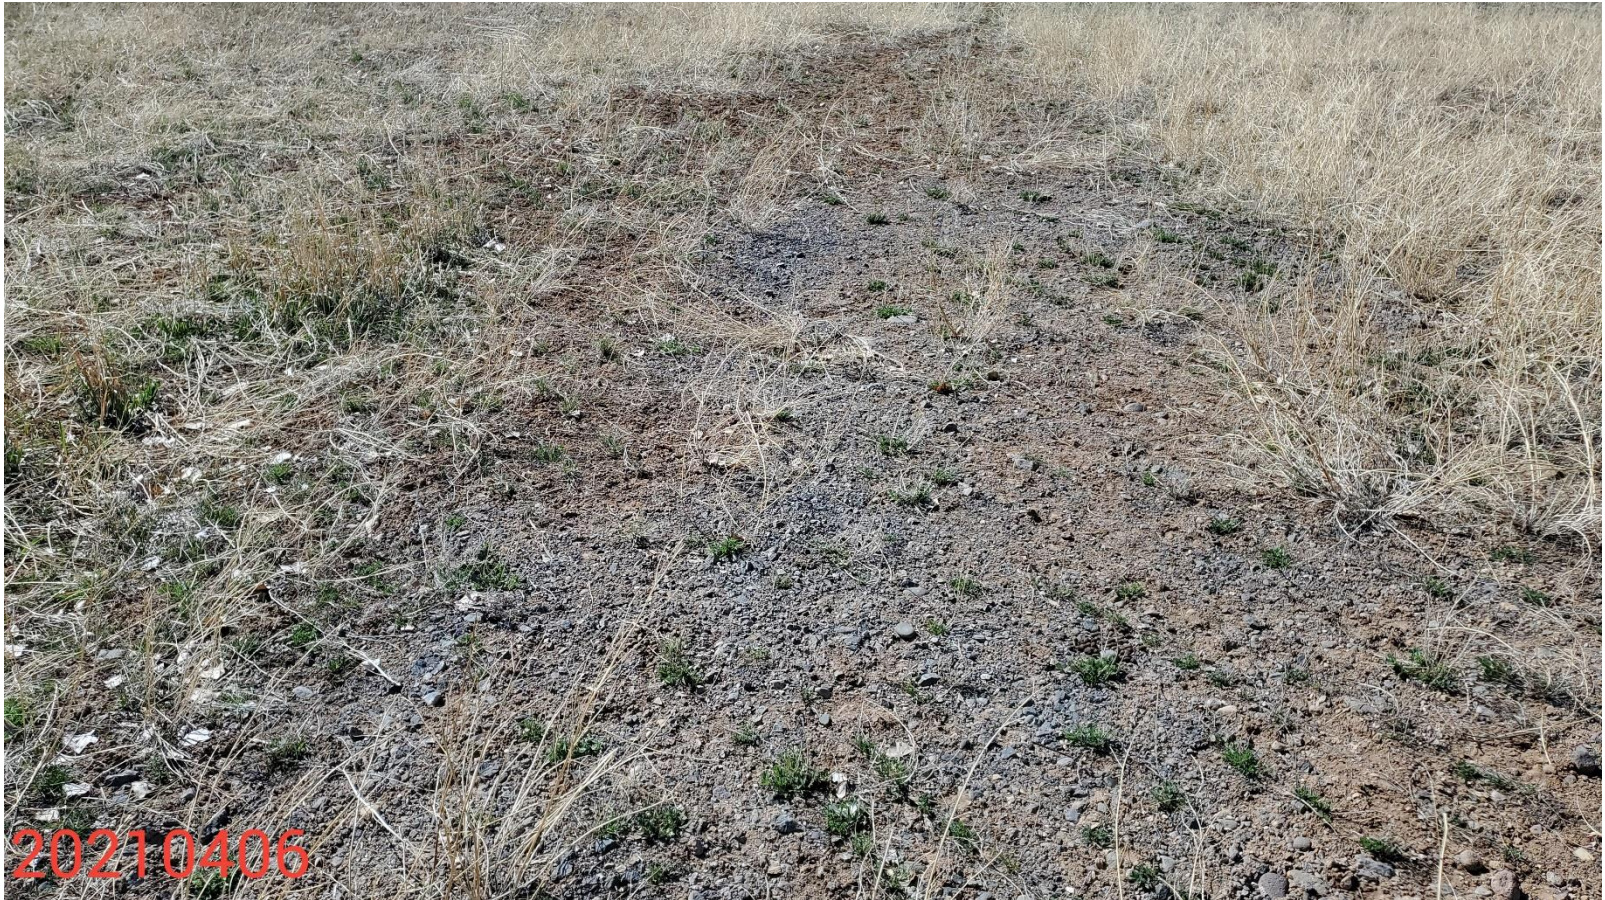
Photo 3: See comments under photo 1.

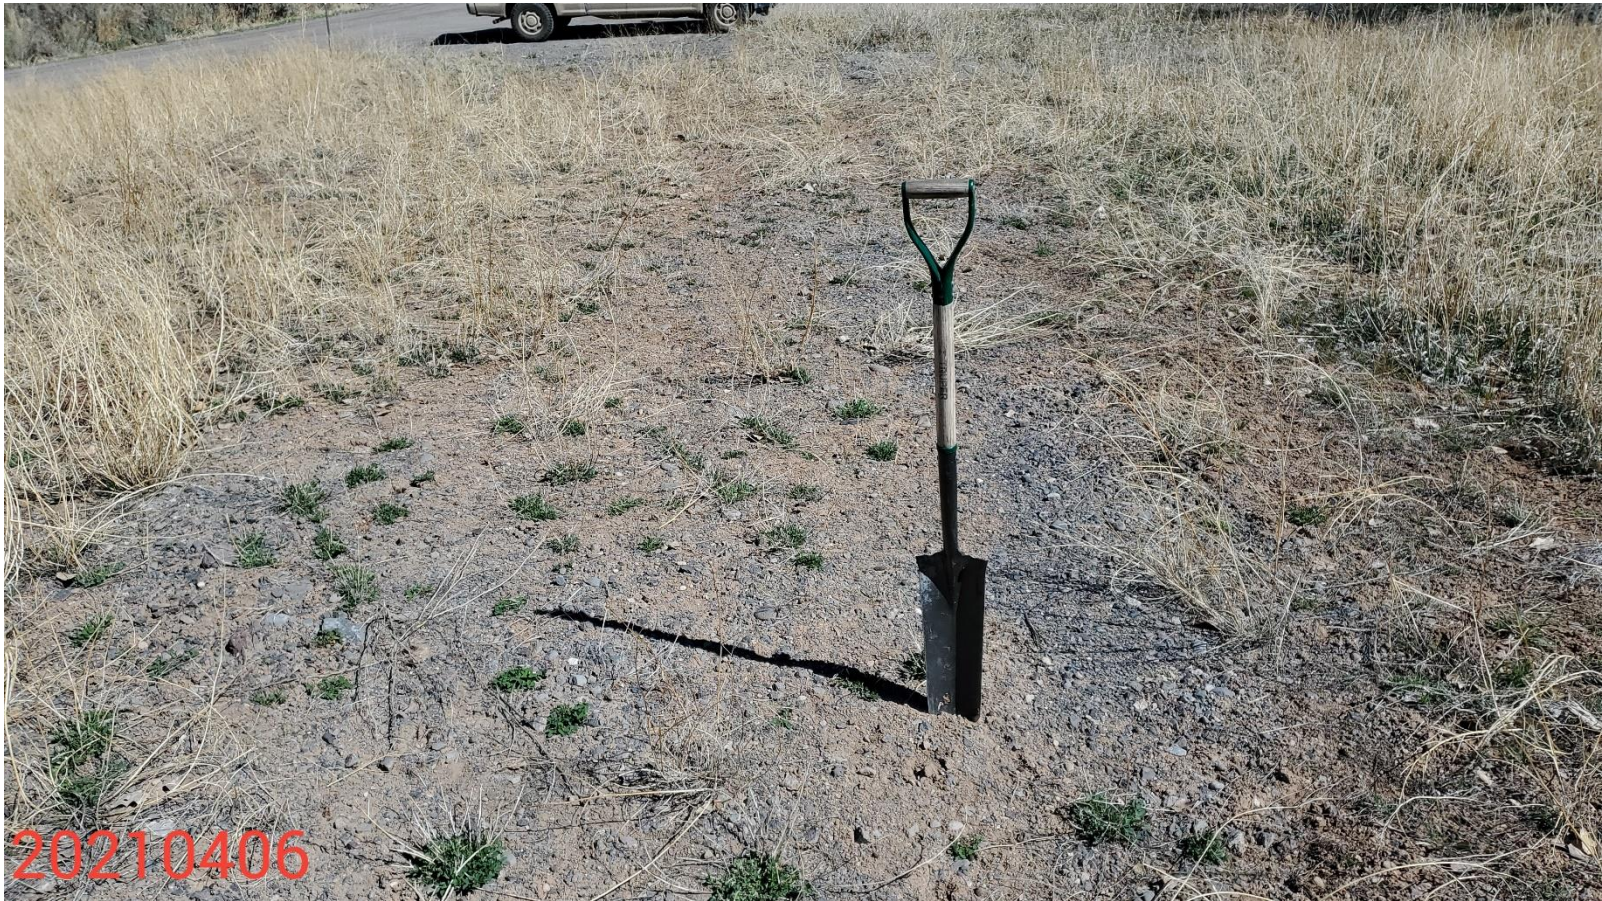
Photo 4: See comments under photo 1. Reclamation Specialist conducted test pits throughout the Location; gravel remaining and compaction remains evident; photo shows example of areas where compaction was evident at the surface; Reclamation Specialist unable to easily penetrate soil surface.

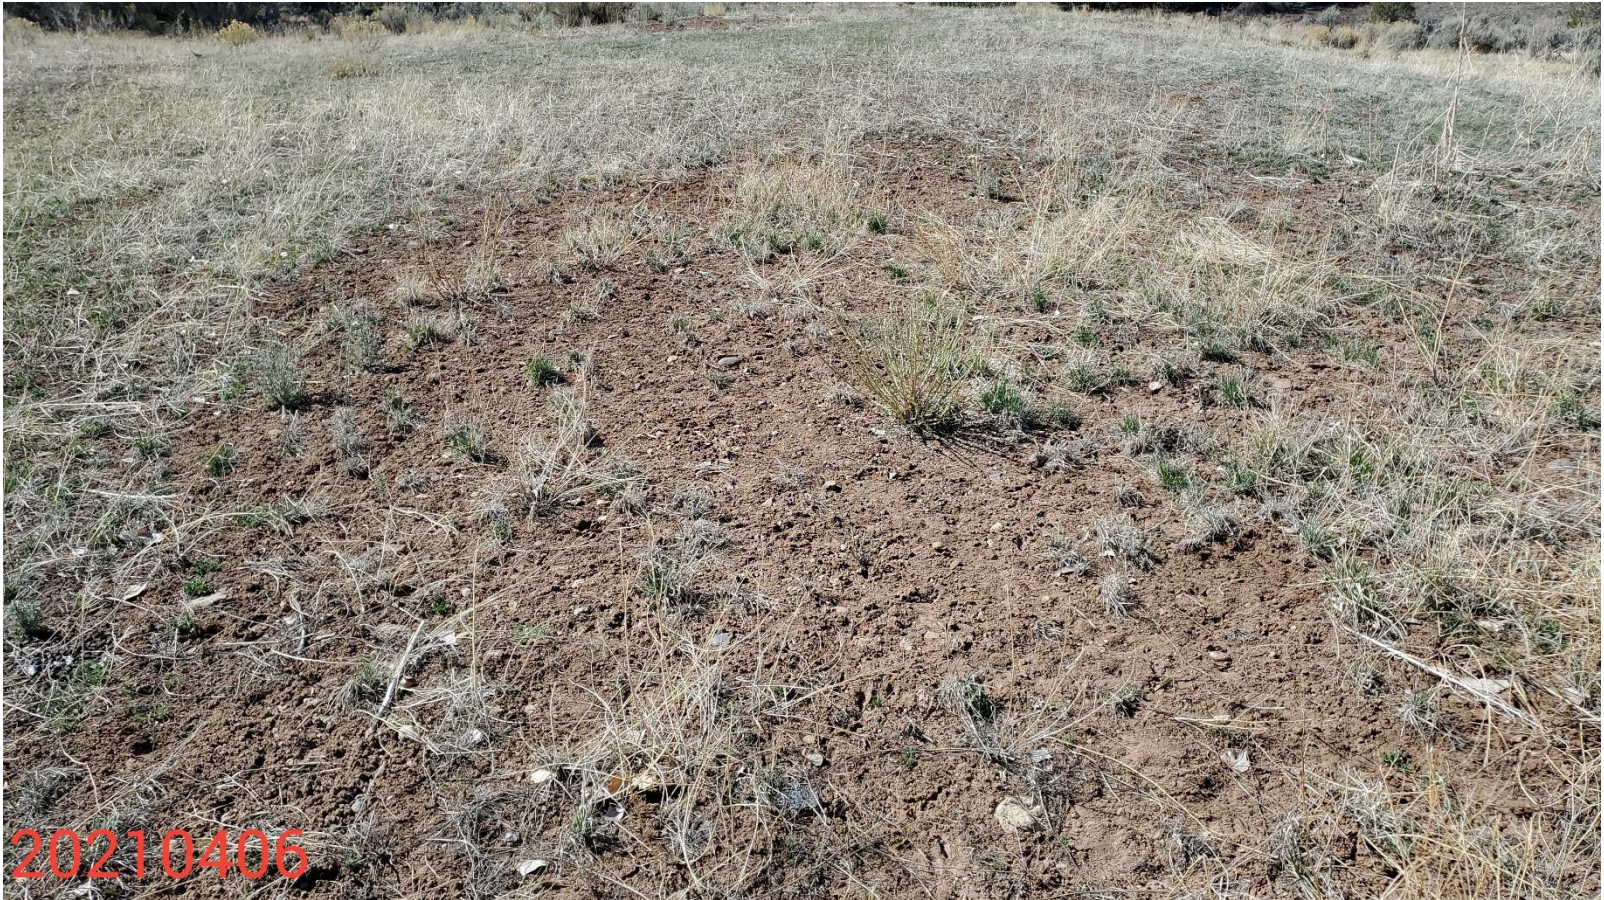
Photo 5: Photo shows example of areas where production equipment was Located on the site; compaction concerns evident.

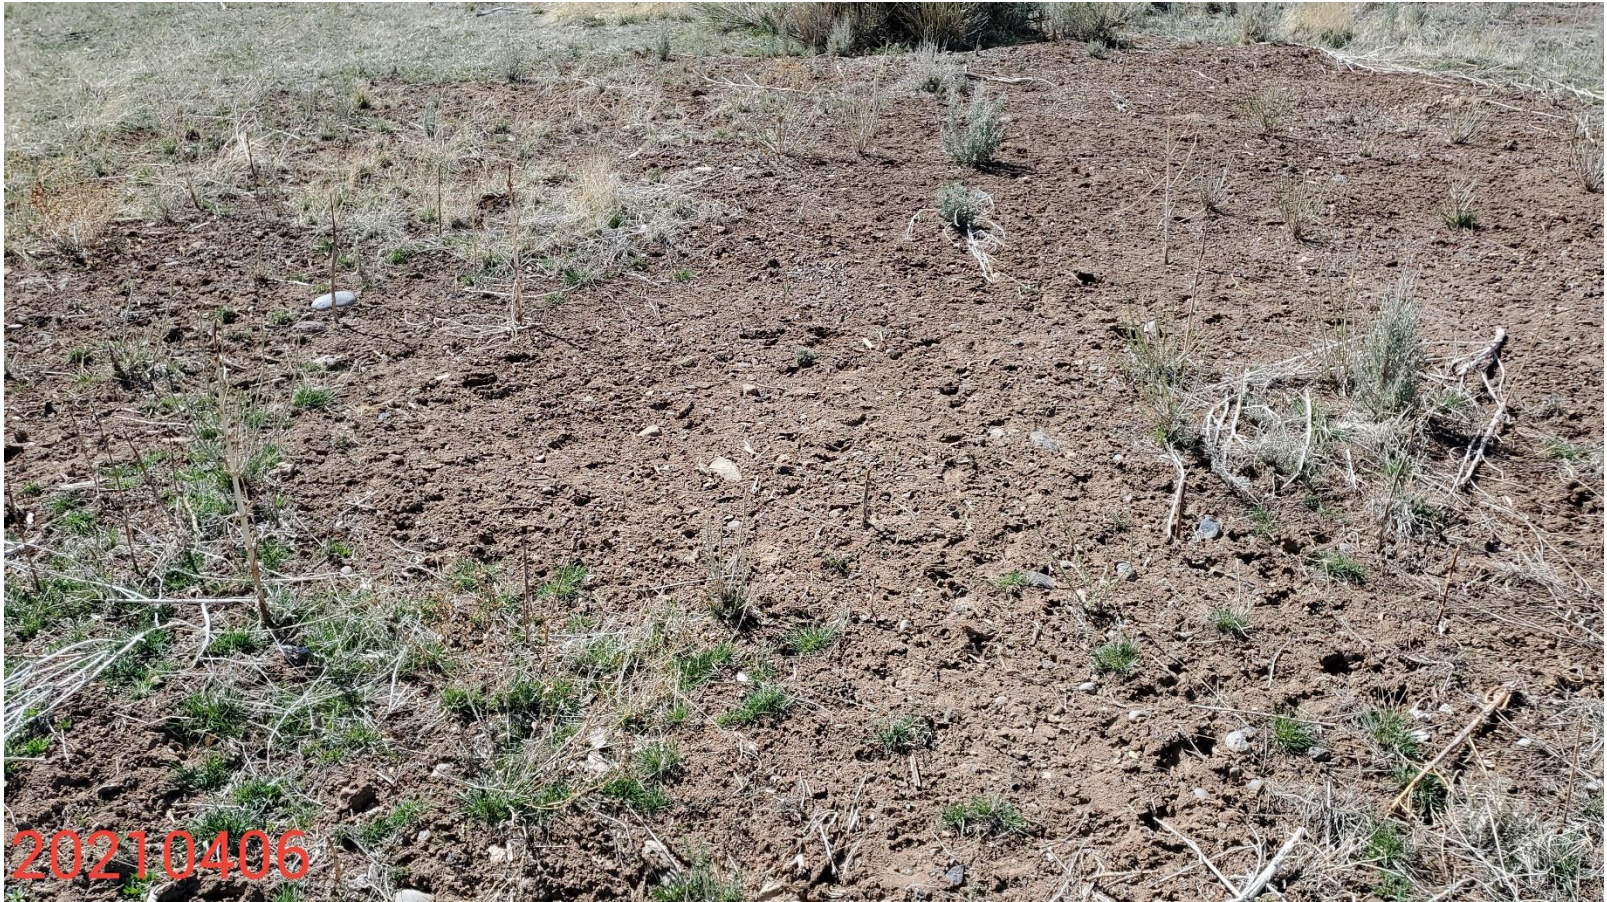
Photo 6: Photo shows example of areas where production equipment was Located on the site; compaction concerns evident.

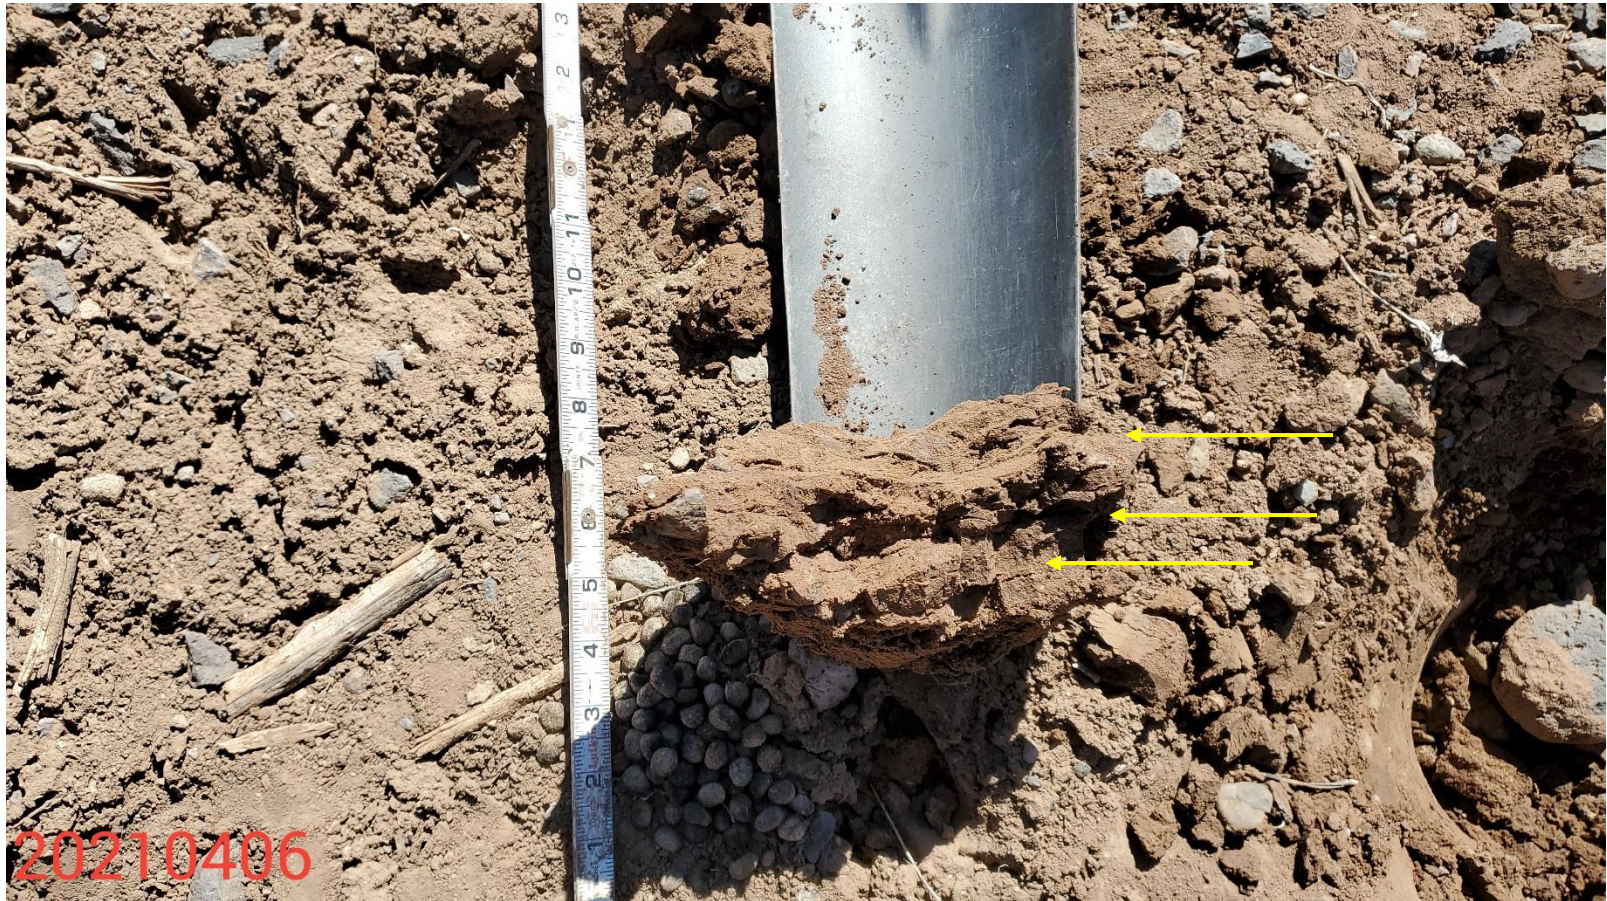
Photo 7: Photo shows example of a compaction test pit performed on the Location. Photo shows “platy” soil structures observed within the first 4-6 inches of the soil. These structures are thin, flat plates of soil that lie horizontally and are usually found in compacted soils; unable to find evidence that sufficient compaction alleviation was performed on the Location in accordance with 1004 Rules

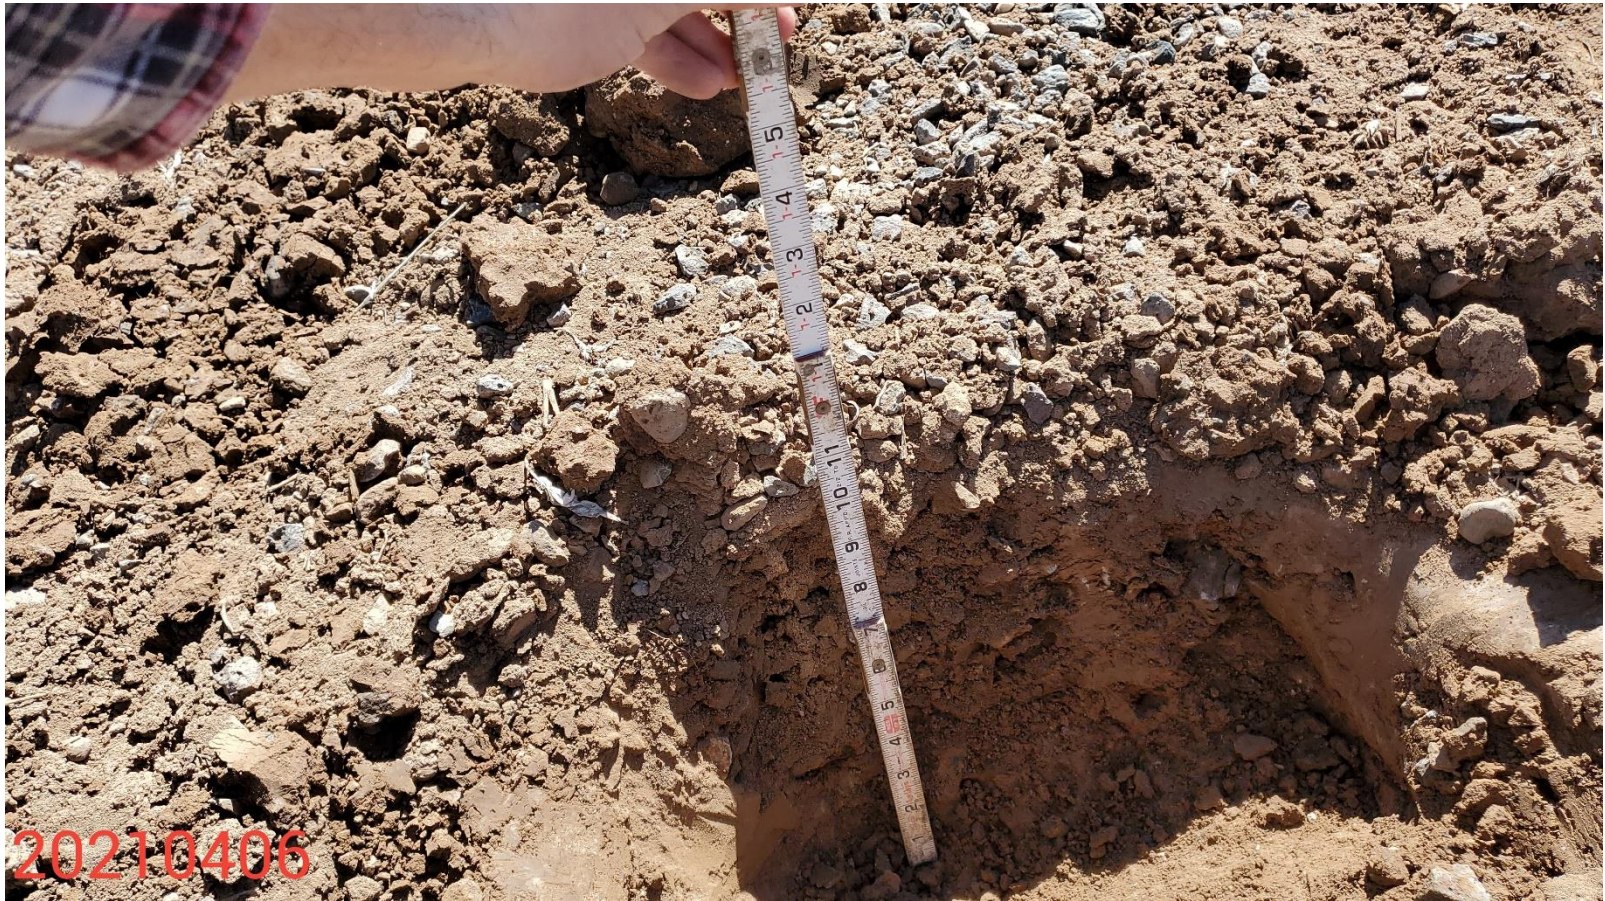
Photo 8: Photo shows example of a compaction test pit performed on the Location. Zones of compaction observed within the first few inches below soil surface. Gravel also observed to not have been removed.

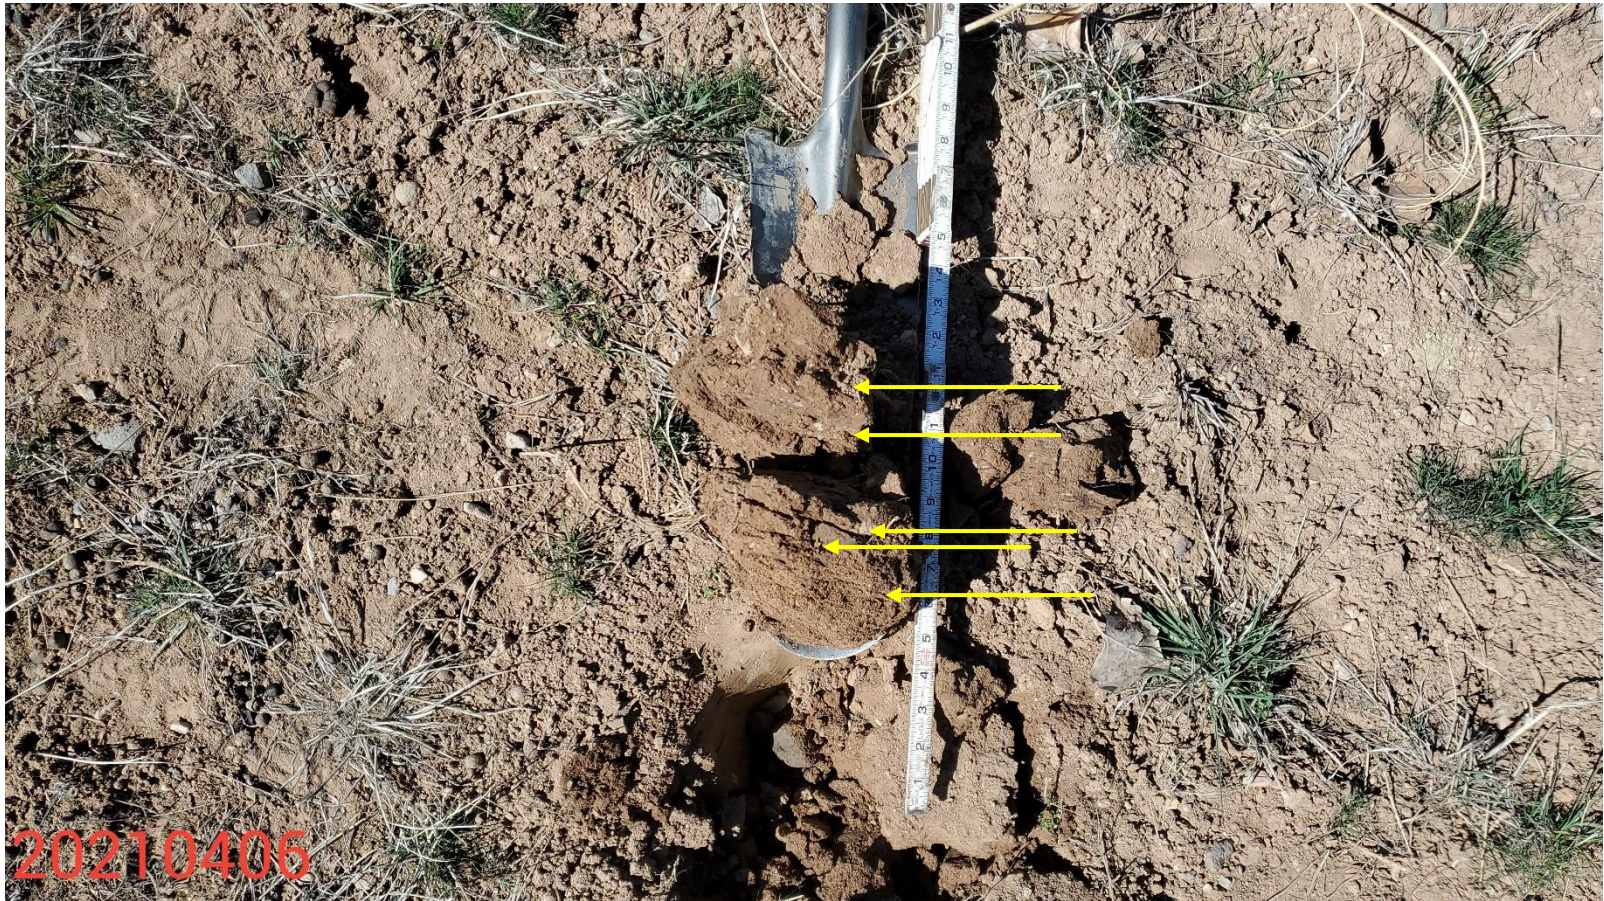
Photo 9: Photo shows another example of a compaction test pit performed on the Location. Photo shows “platy” soil structures observed within the first 4-6 inches of the soil. These structures are thin, flat plates of soil that lie horizontally and are usually found in compacted soils; unable to find evidence that sufficient compaction alleviation was performed on the Location in accordance with 1004 Rules
