Construction and Stormwater Inspection

April 7, 2021

Operator: GMT EXPLORATION COMPANY LLC- #10243

Location ID: 478811

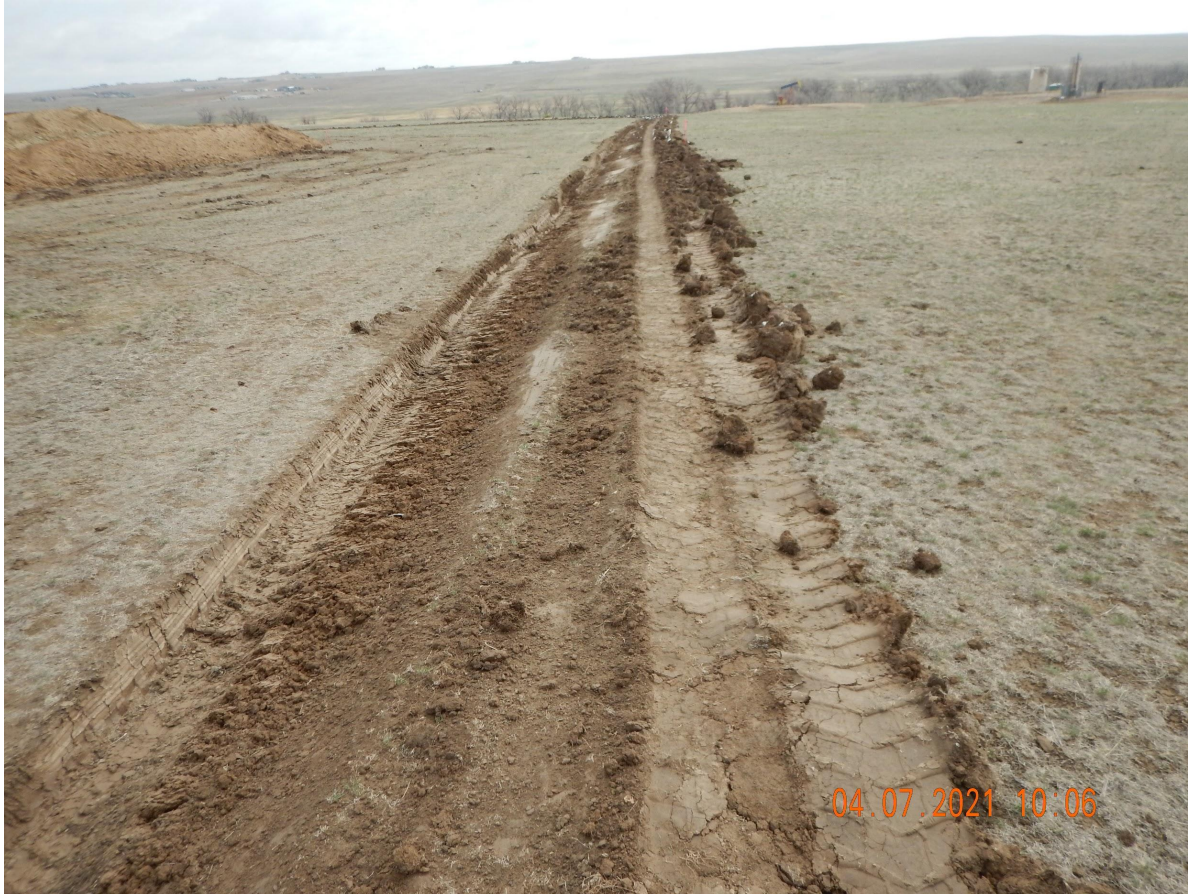
Photo 1. Photo taken from the southern location, facing East. Photo illustrates the Operator has installed a ditch and berm BMP during construction operations. However, the BMP is not in proper functioning condition.

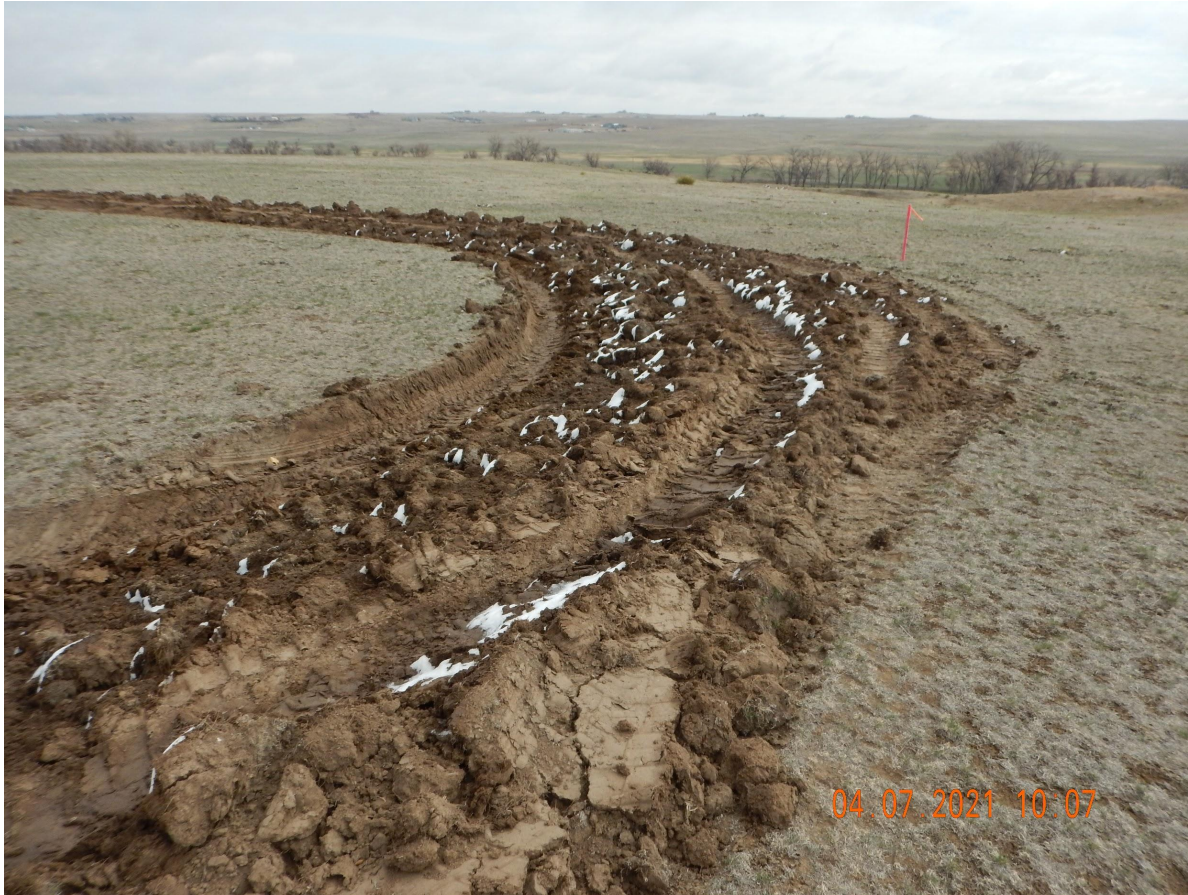
Photo 2. Photo taken from the southeastern location, facing East. See comments under Photo 1.

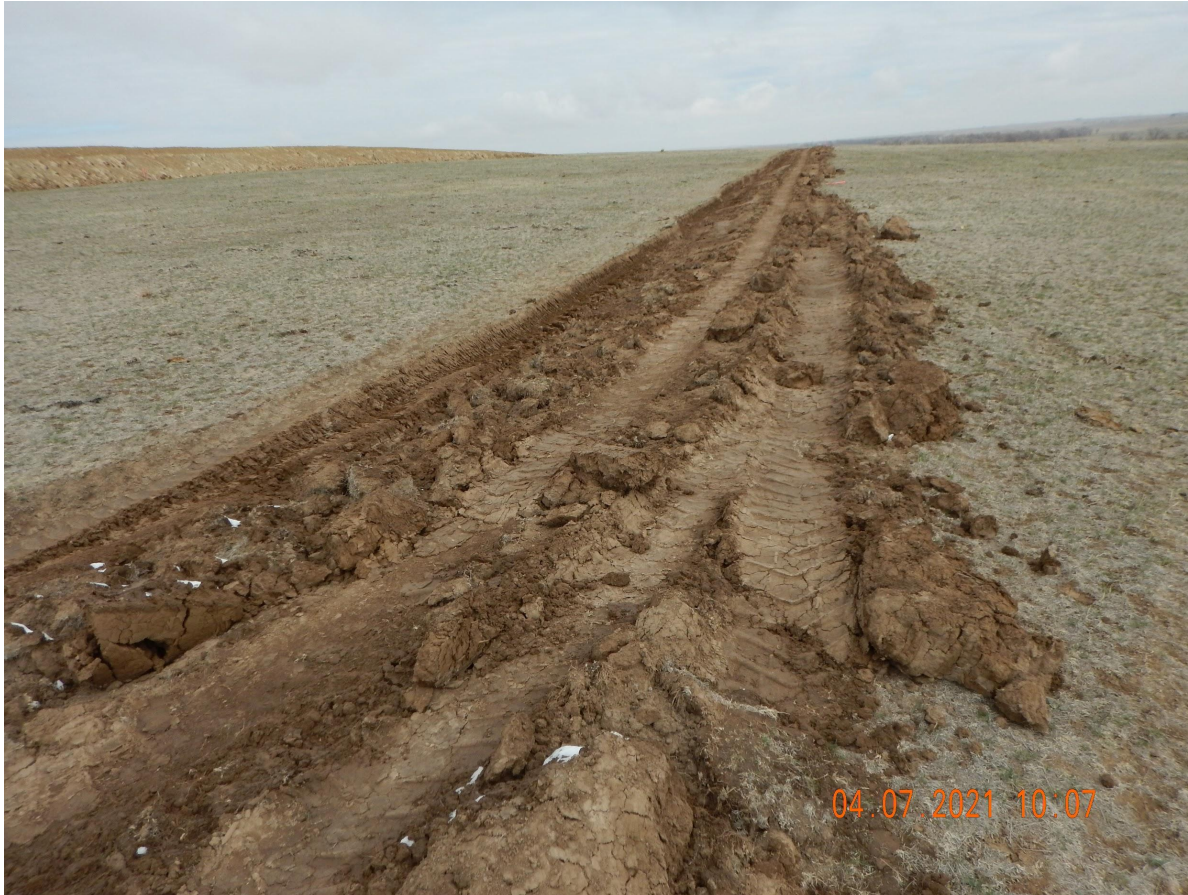
Photo 3. Photo taken from the southeastern location, facing North. See comments under Photo 1.

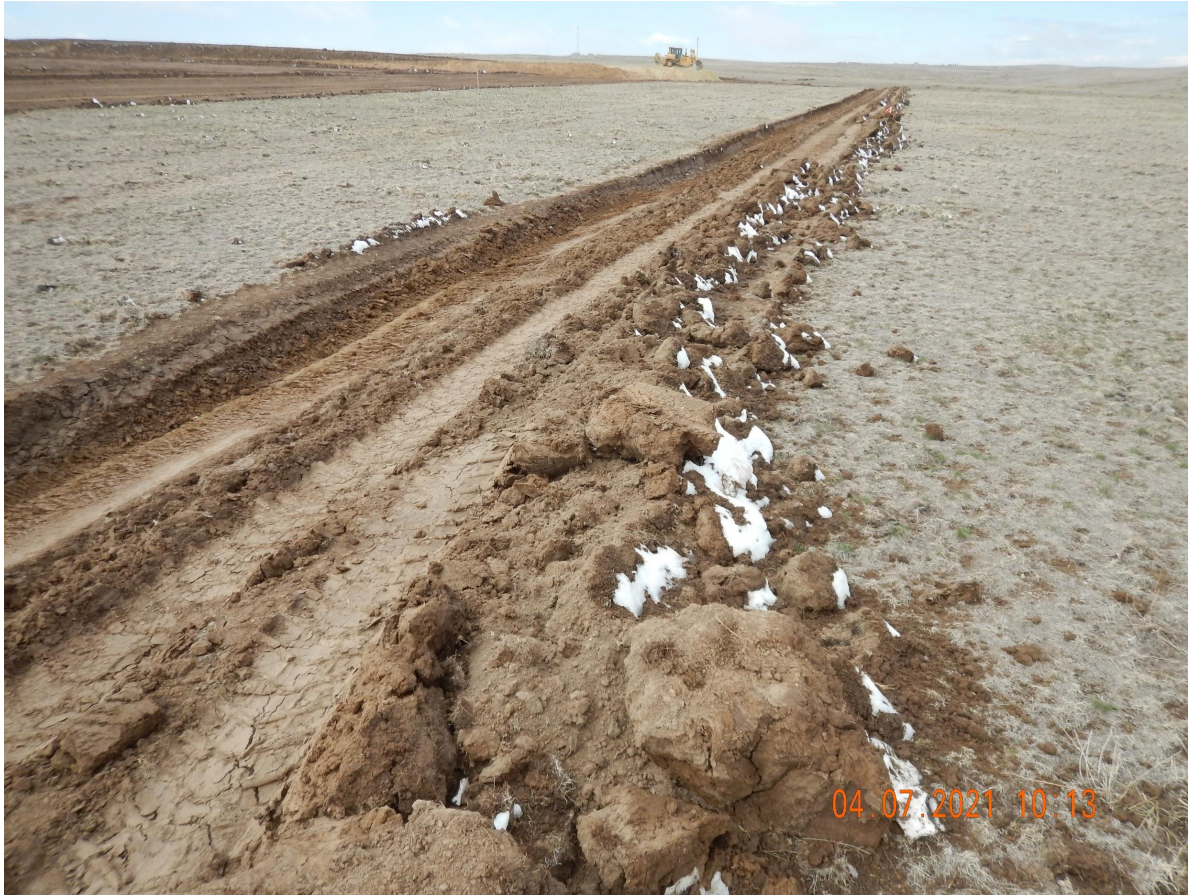
Photo 4. Photo taken from the northern location, facing West. See comments under Photo 1.

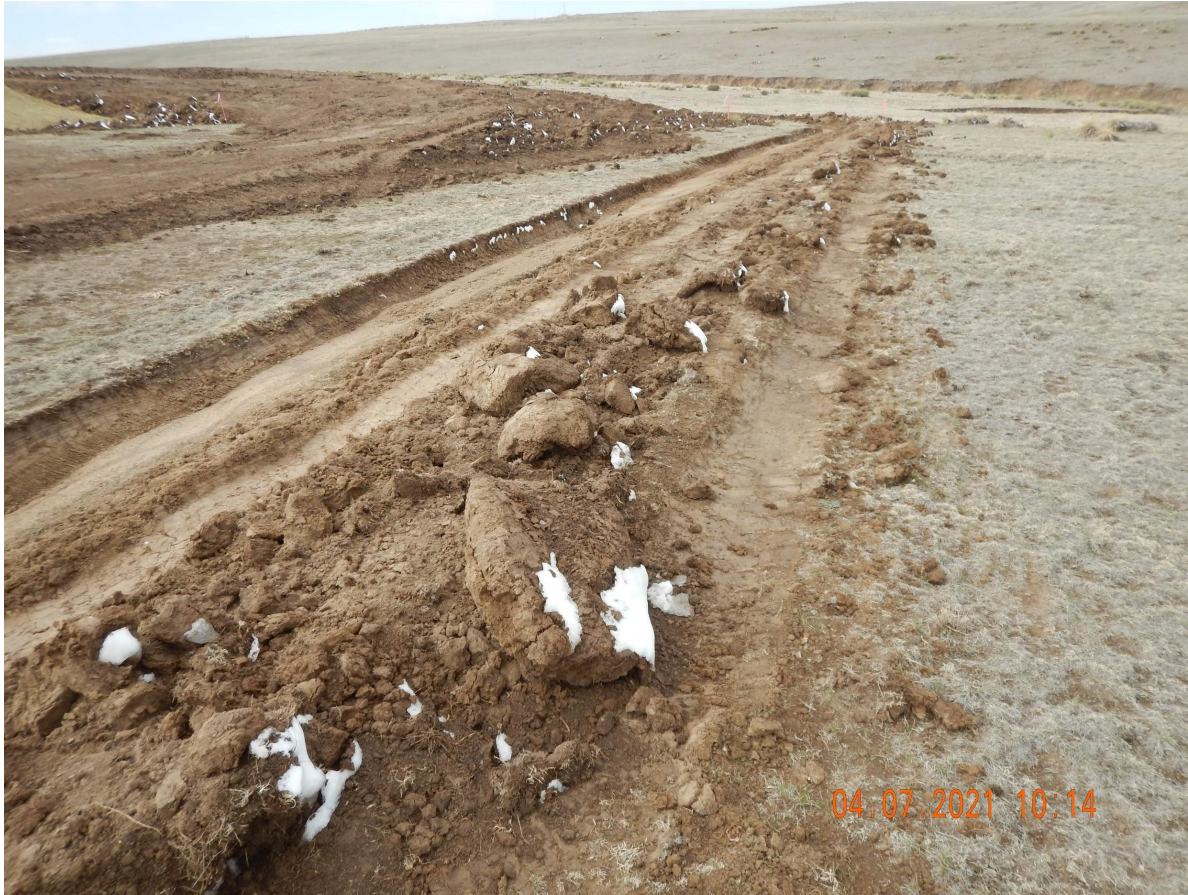
Photo 5. Photo taken from the northwestern location, facing West. See comments under Photo 1.

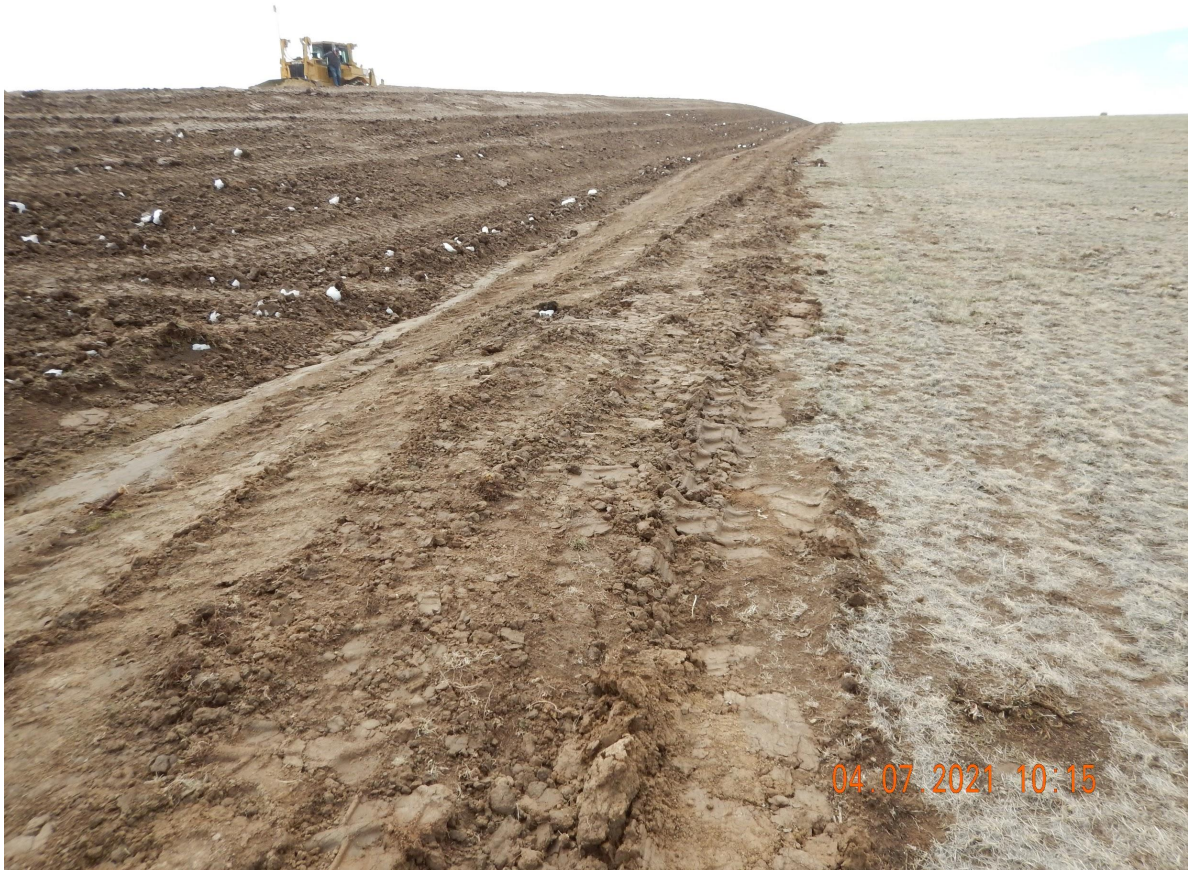
Photo 6. Photo taken from the western location, facing South. Photo illustrates the Operator has sufficiently stabilized the berm BMP.

Note- topsoil has been salvaged and stored along the western perimeter of location.

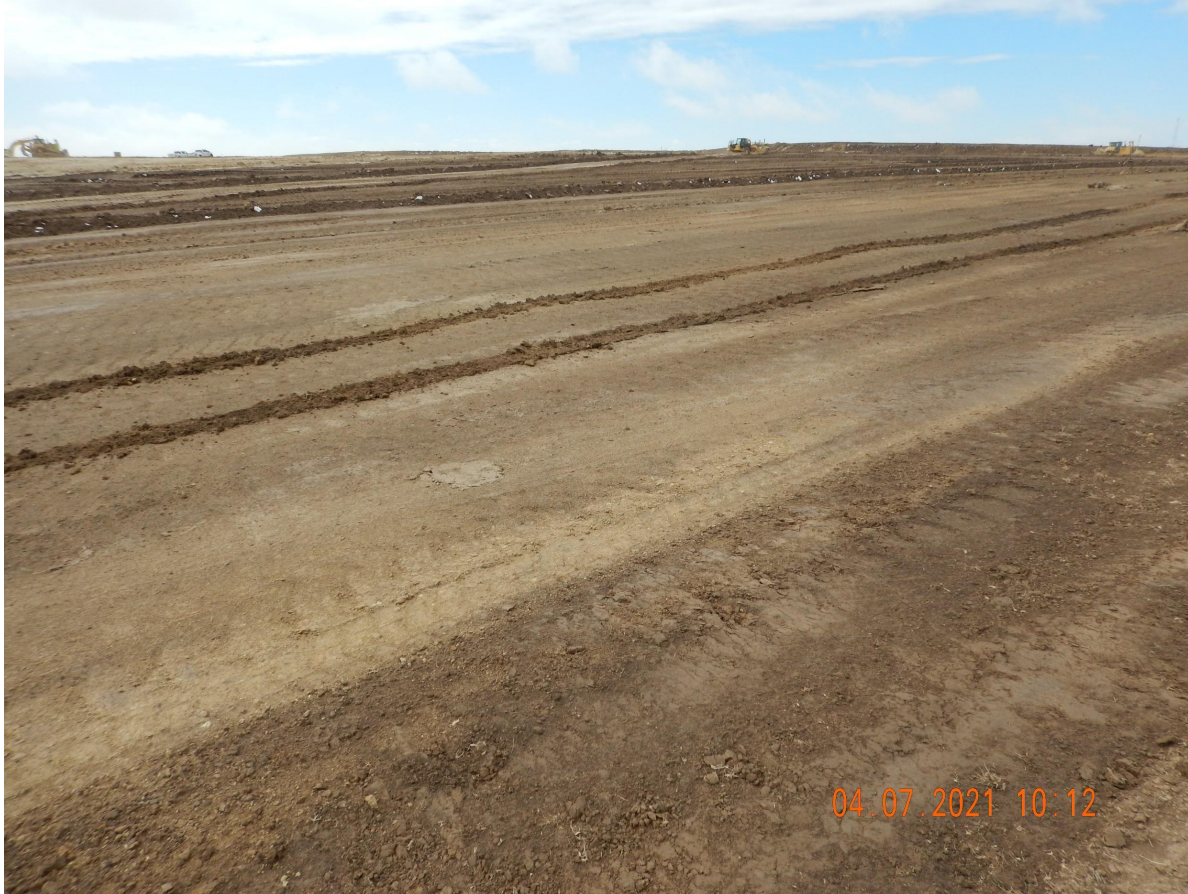
Photo 7. Photo taken from the northern location, facing Southwest. Photo illustrates the Operator appears to have salvaged topsoil in compliance with Rule 1002.b. There was an observed color change from topsoil to subsoil.
