Inspection Photos
Location Name: Nielson #3
API: 05-007-06116

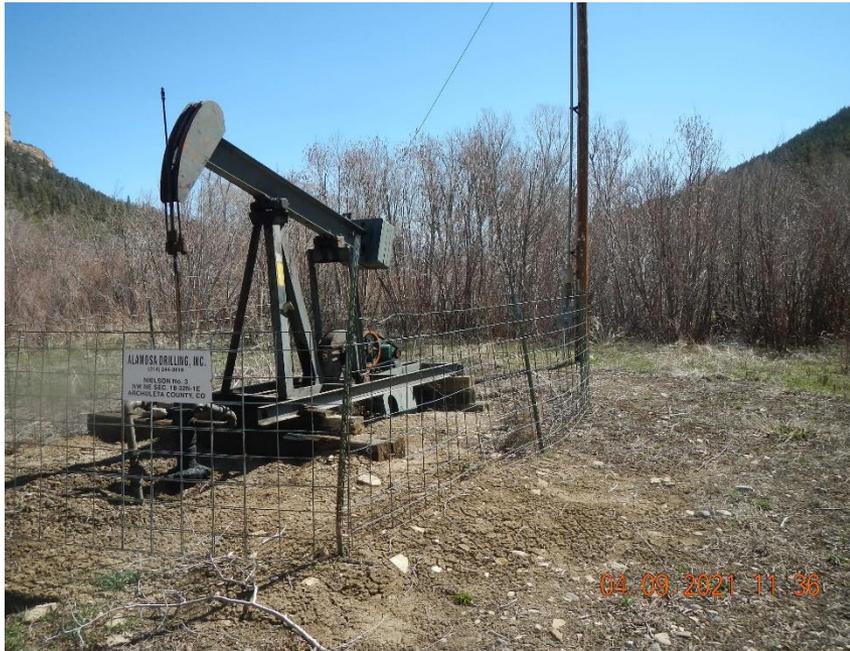
Nielson #3 well head and pump jack.

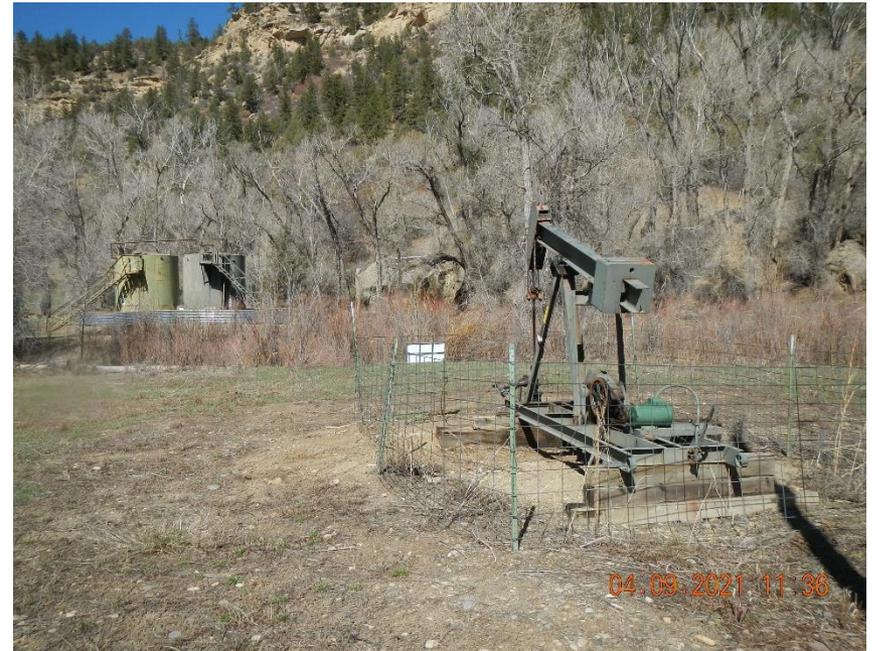
Nielson #3 location photo with tank battery in the background.

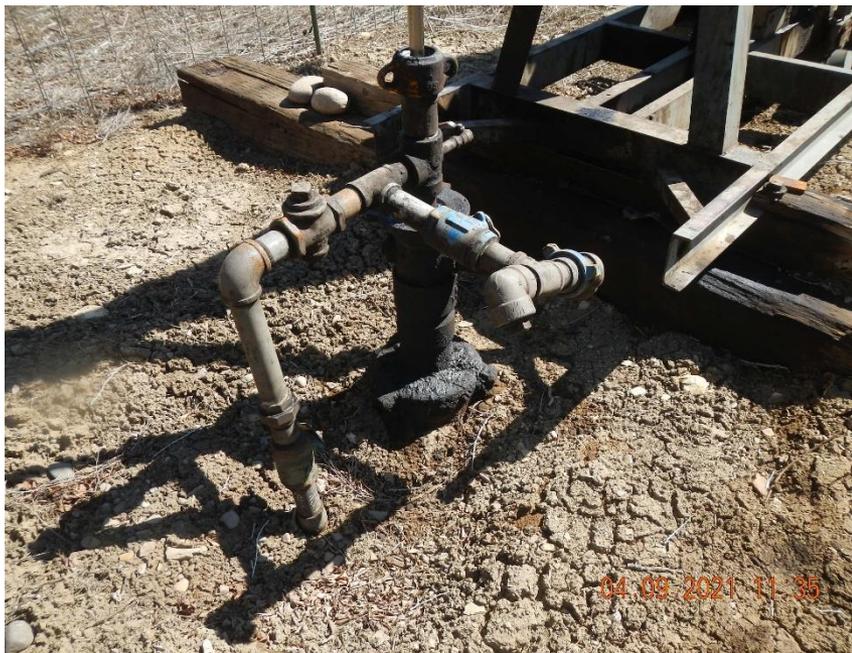
Oil stained well head.

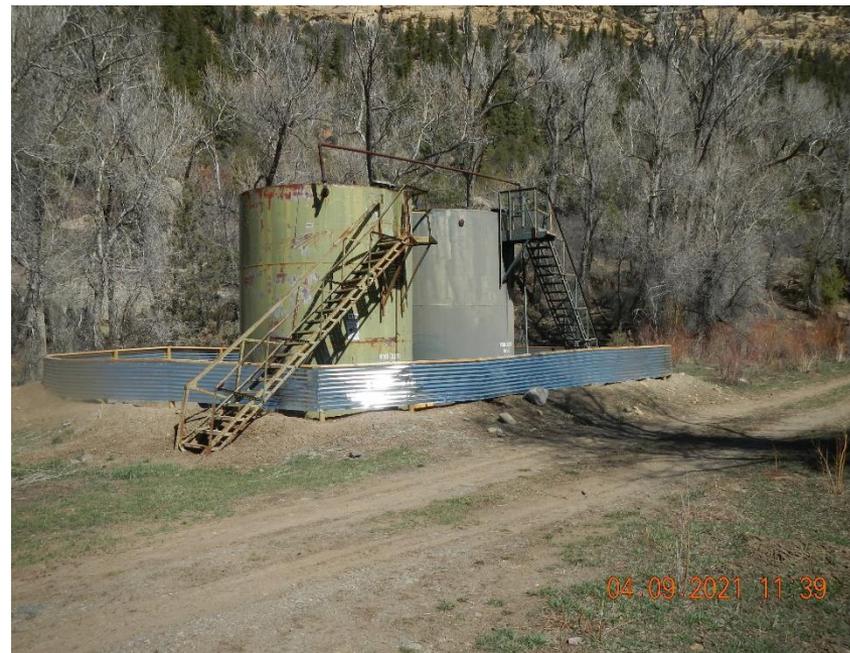
Nielson #3 tank battery.

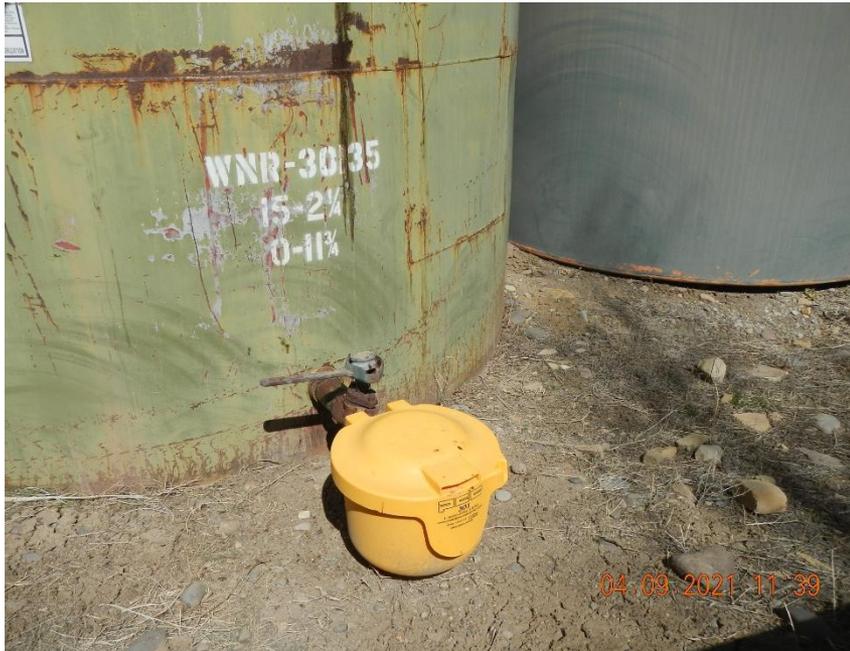
Drip pot of south AST.

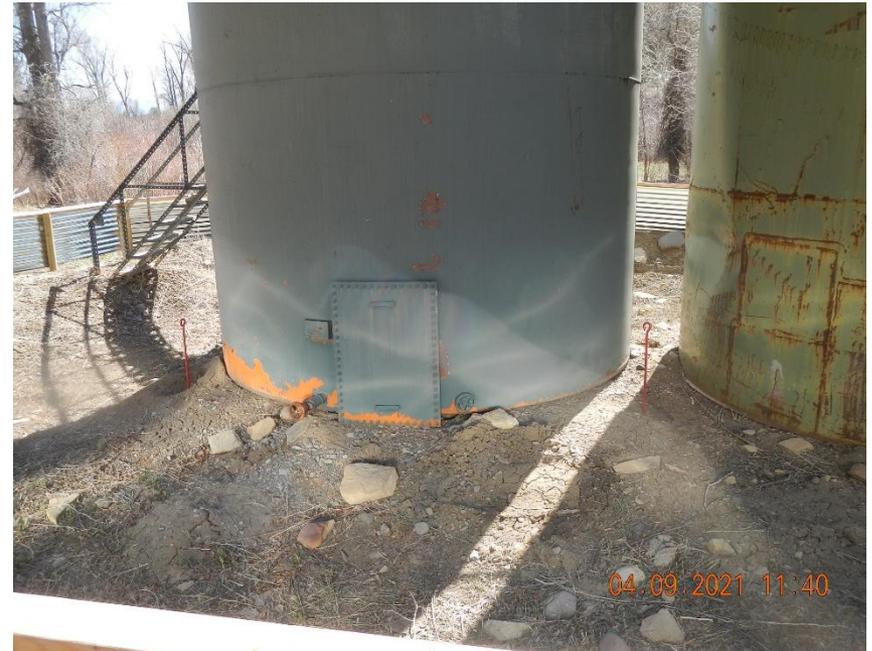
Anchors have been installed, but are not connected to the tanks.

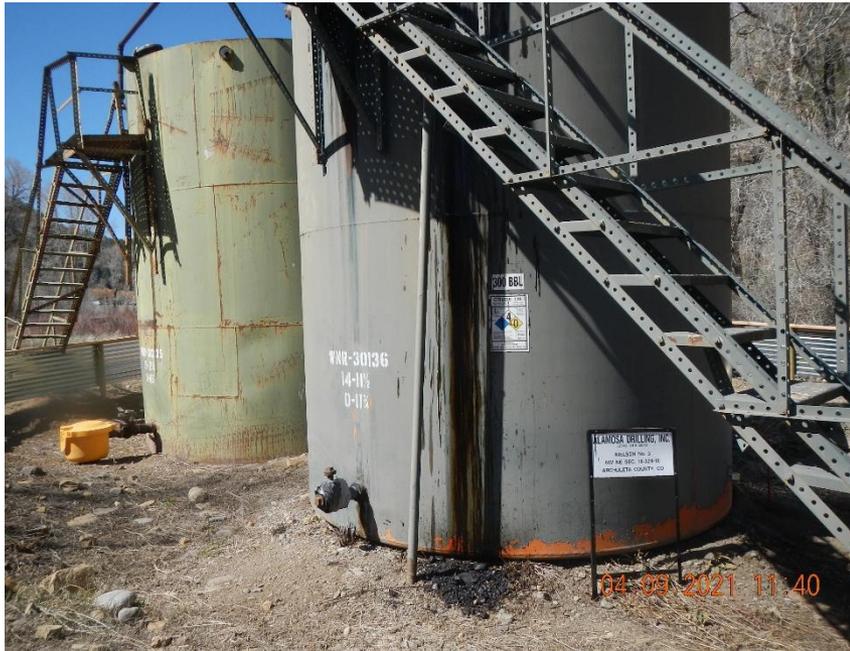
Northern AST has oil staining the side.

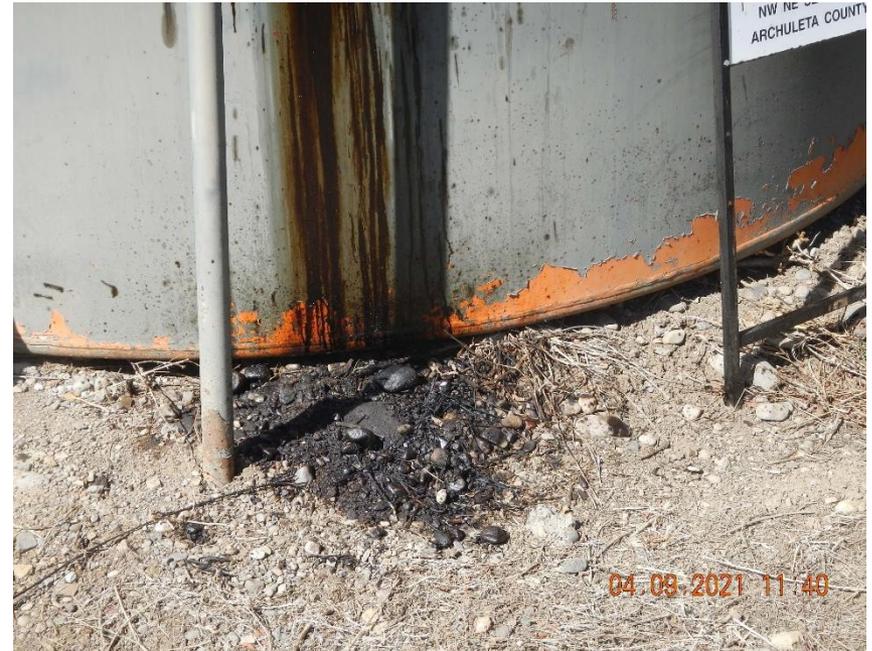
Oil stained soil at the base of the northern AST.
