# Inspection Photos

API: 071-06814

Operator: WAPITI OPERATING LLC

Inspection Date: 4/12/2021

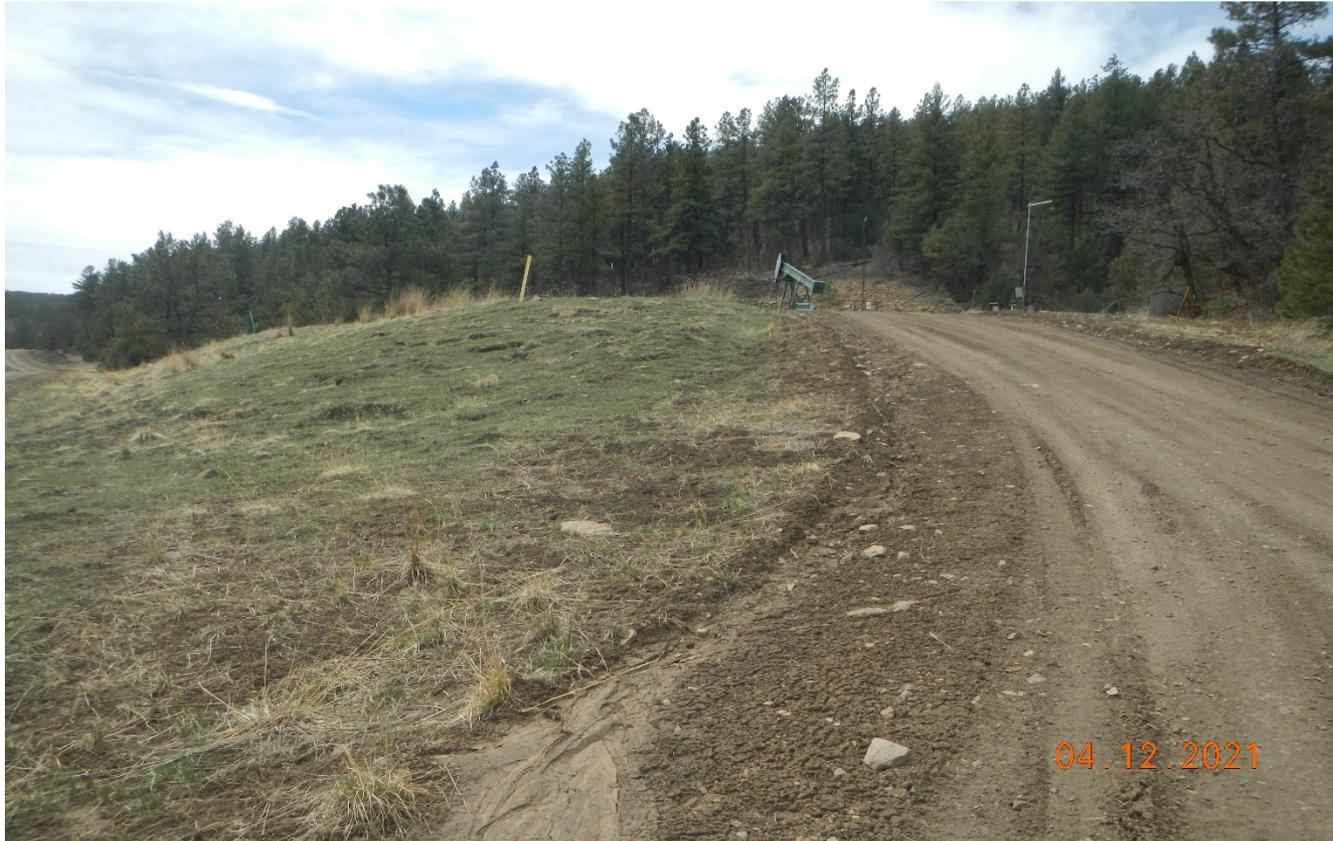
**Photo 1.** Facing toward the access road and location which appears to be stabilized.

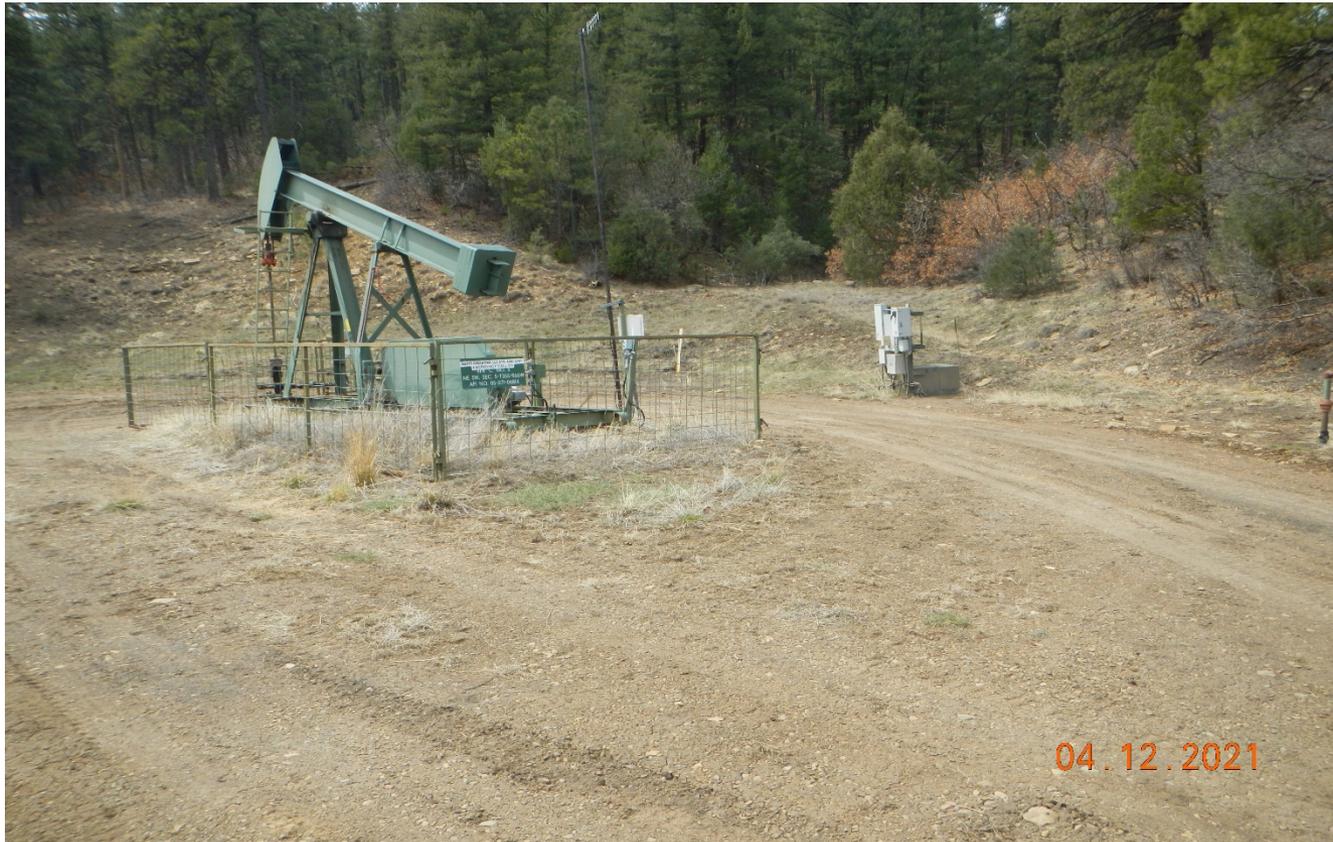
**Photo 2.** Facing toward the location.

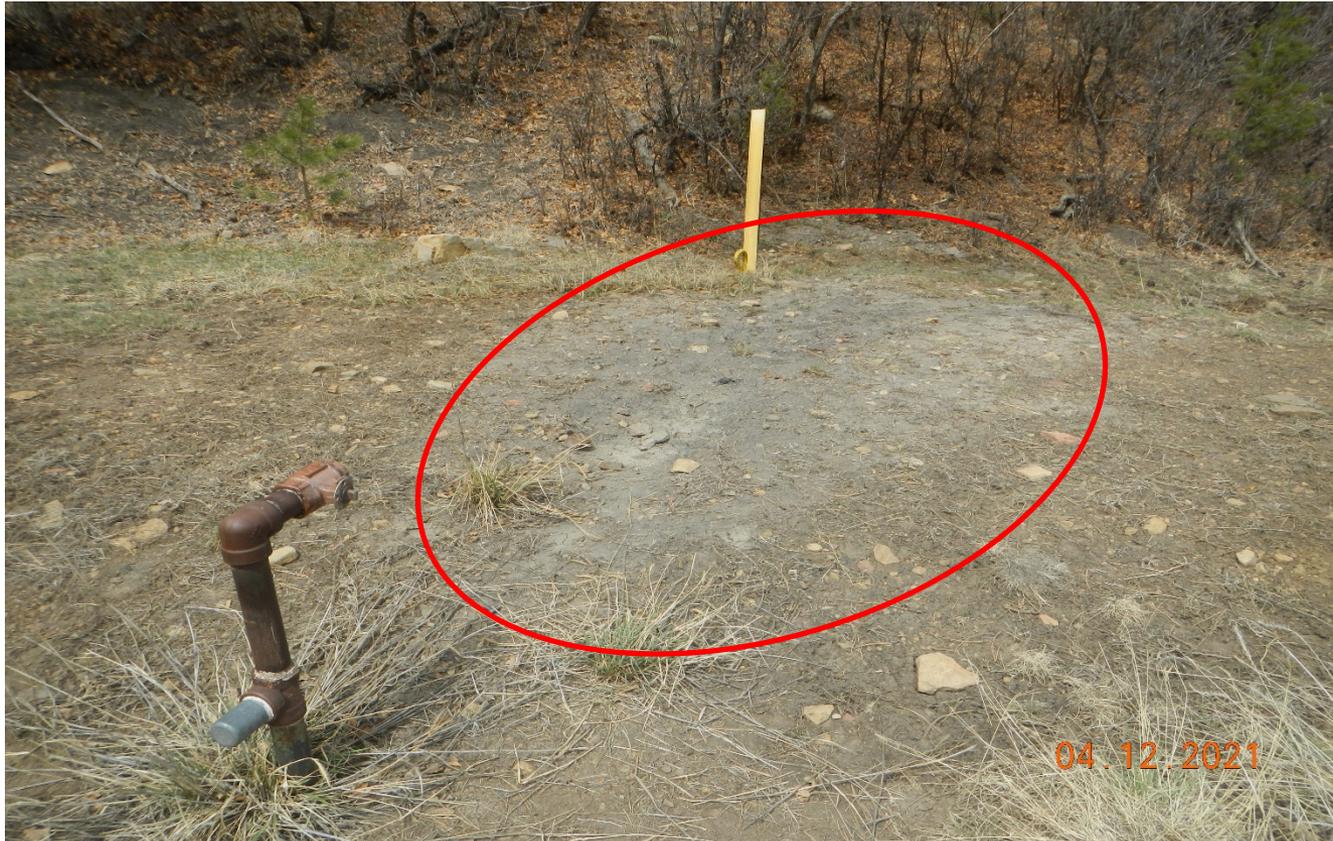
**Photo 3.** There is signs of produced water discharge from this pipe. There is a grey/brown in area circled.

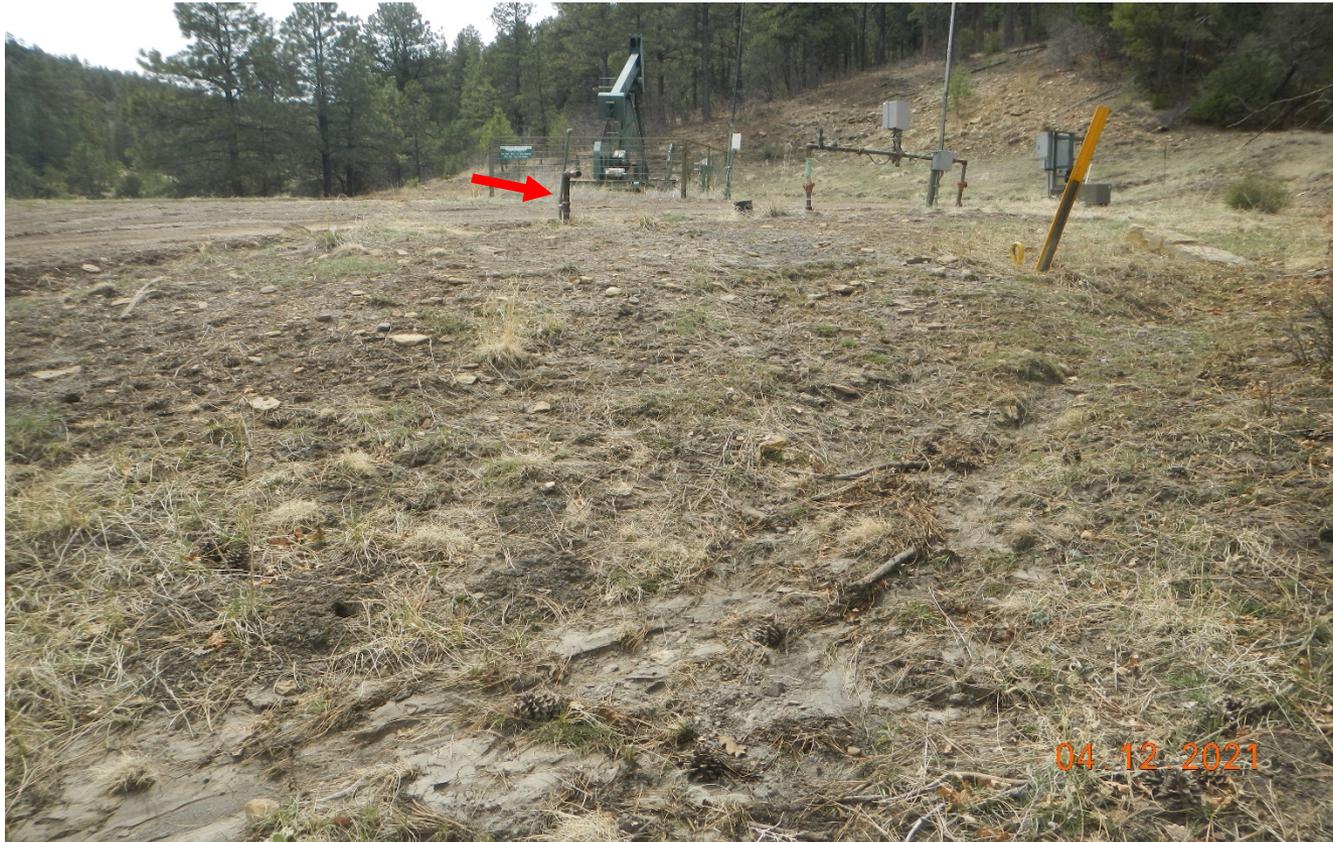
**Photo 4.** There is signs of discharged which flowed down hill from the pipe outlet (red arrow).
