Inspection Photos
Location Name: F.S. Duncan B 3
Location ID: 312843

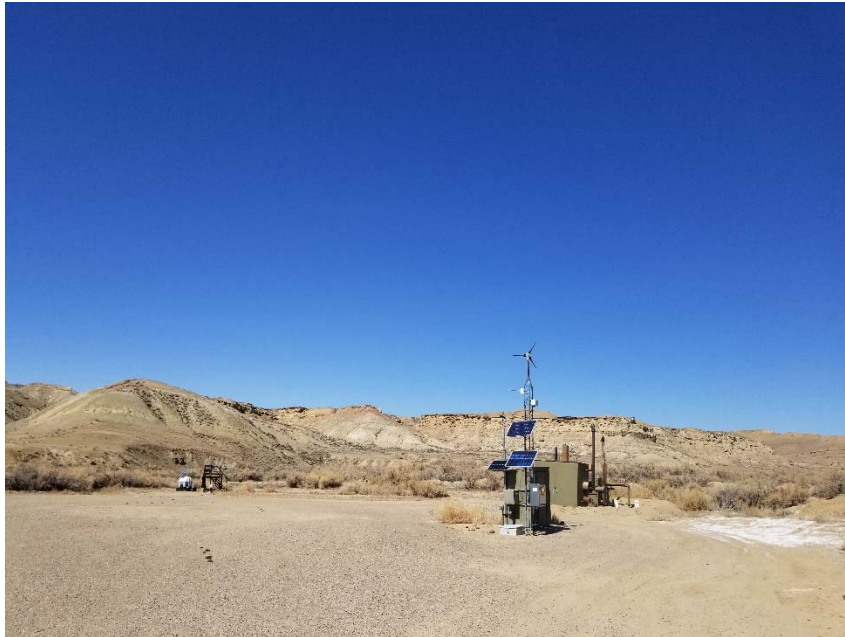
Photo 1. Overview of location taken facing northwest.

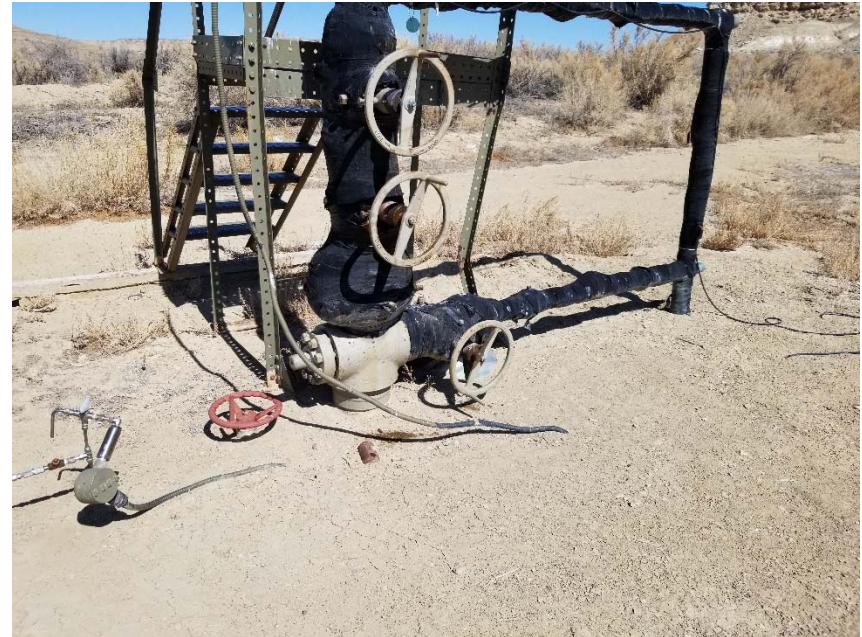
Photo 2. No bradenhead access apparent.

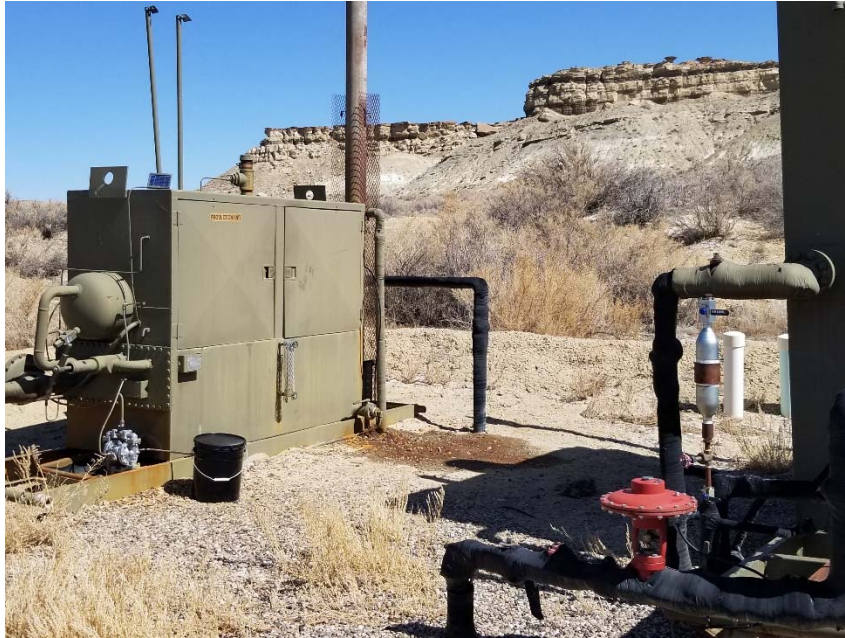
Photo 3. Stained soil at separator.

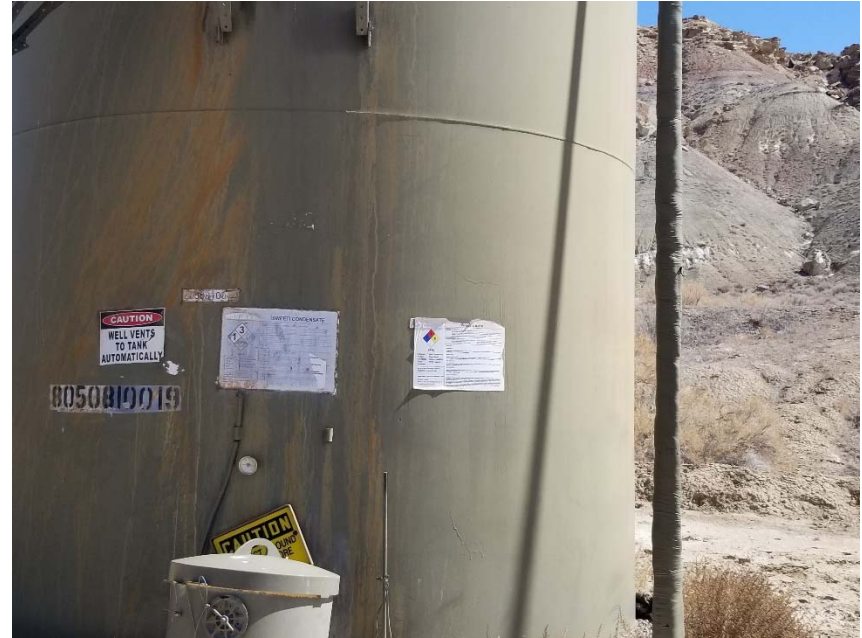
Photo 4. Incomplete tank labels.

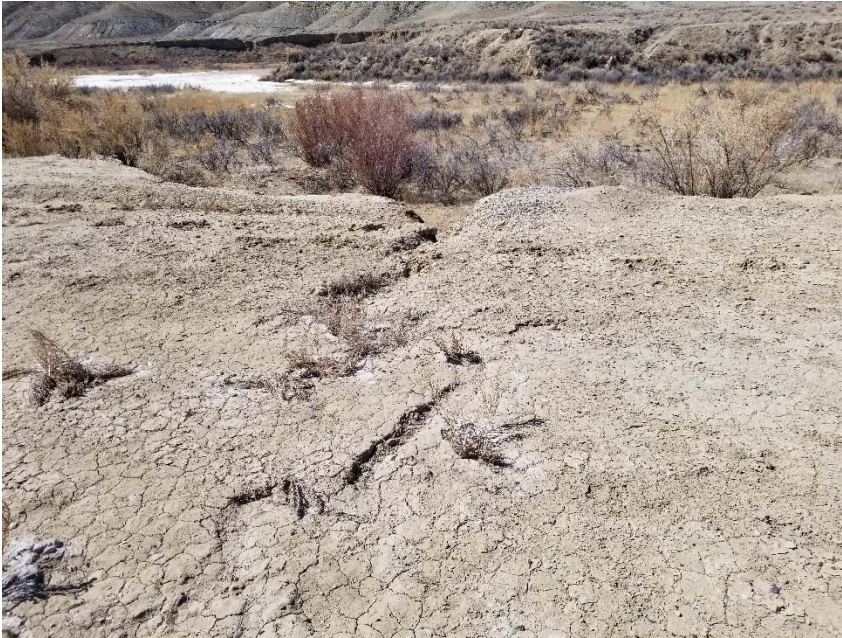
Photo 5. Erosion rills transporting sediment off location.

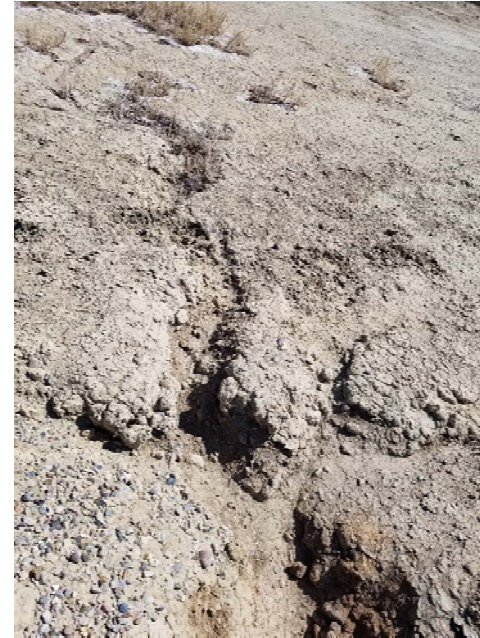
Photo 6. Erosion rills transporting sediment off location.

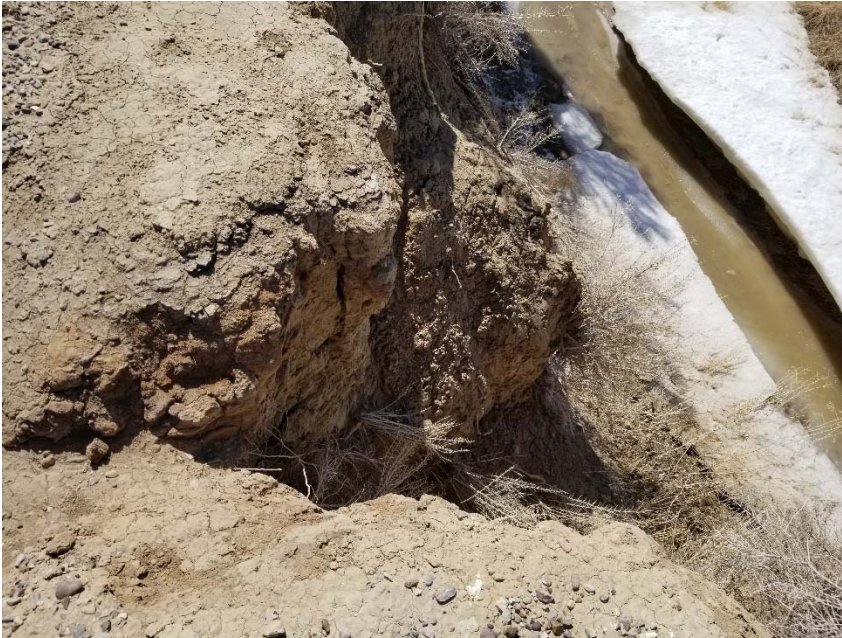
Photo 7. Erosion rills transporting sediment off location.

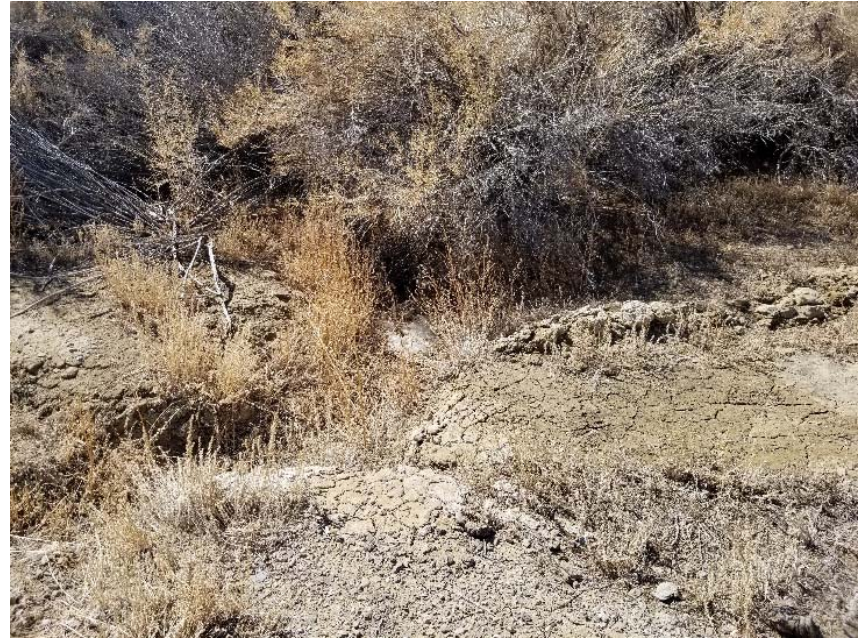
Photo 8. Erosion rills transporting sediment off location.
