Inspection Photos

API: 071-06141

Operator: OGRIS OPERATING LLC

Inspection Date: 4/14/2021

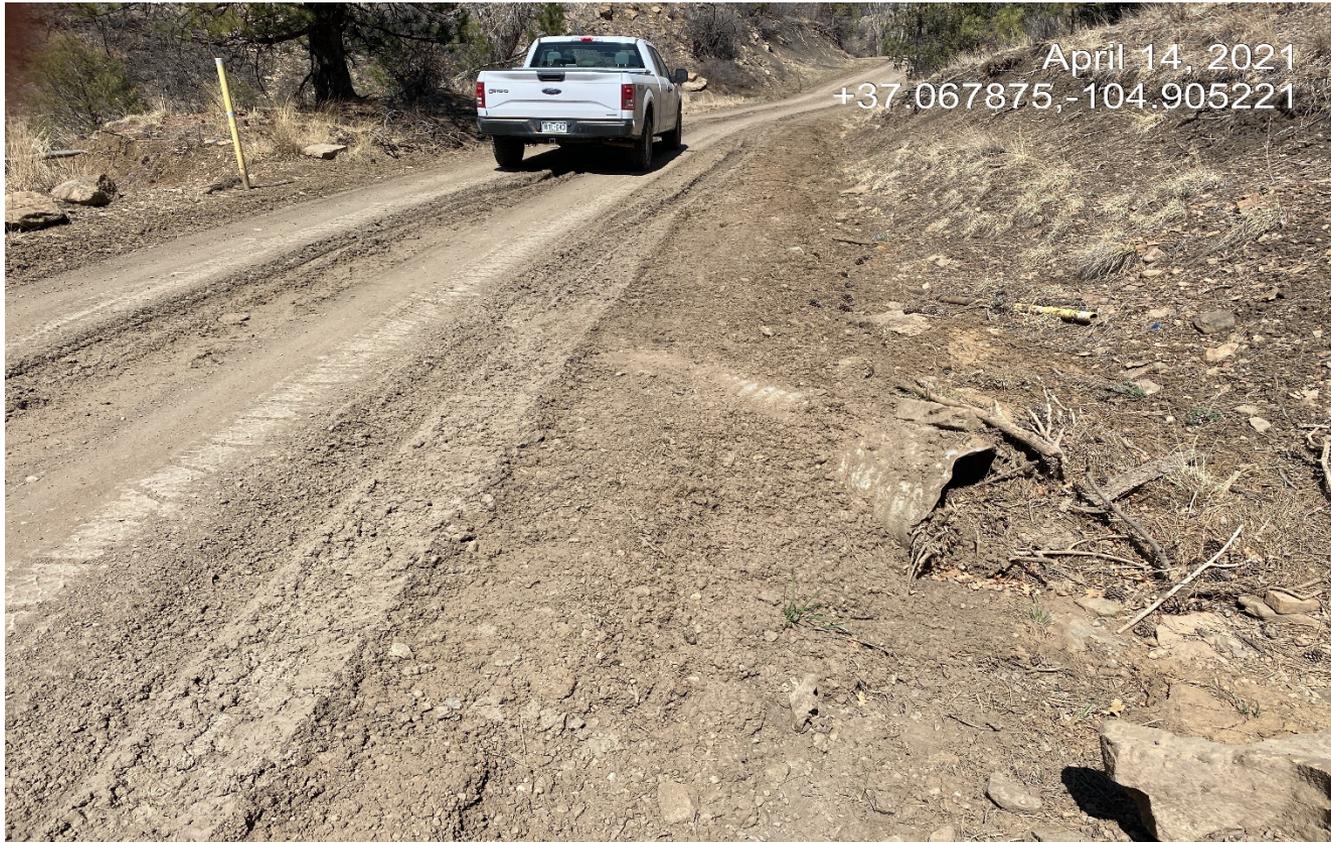
Photo 1. The culvert in the main canyon is filled in with debris.

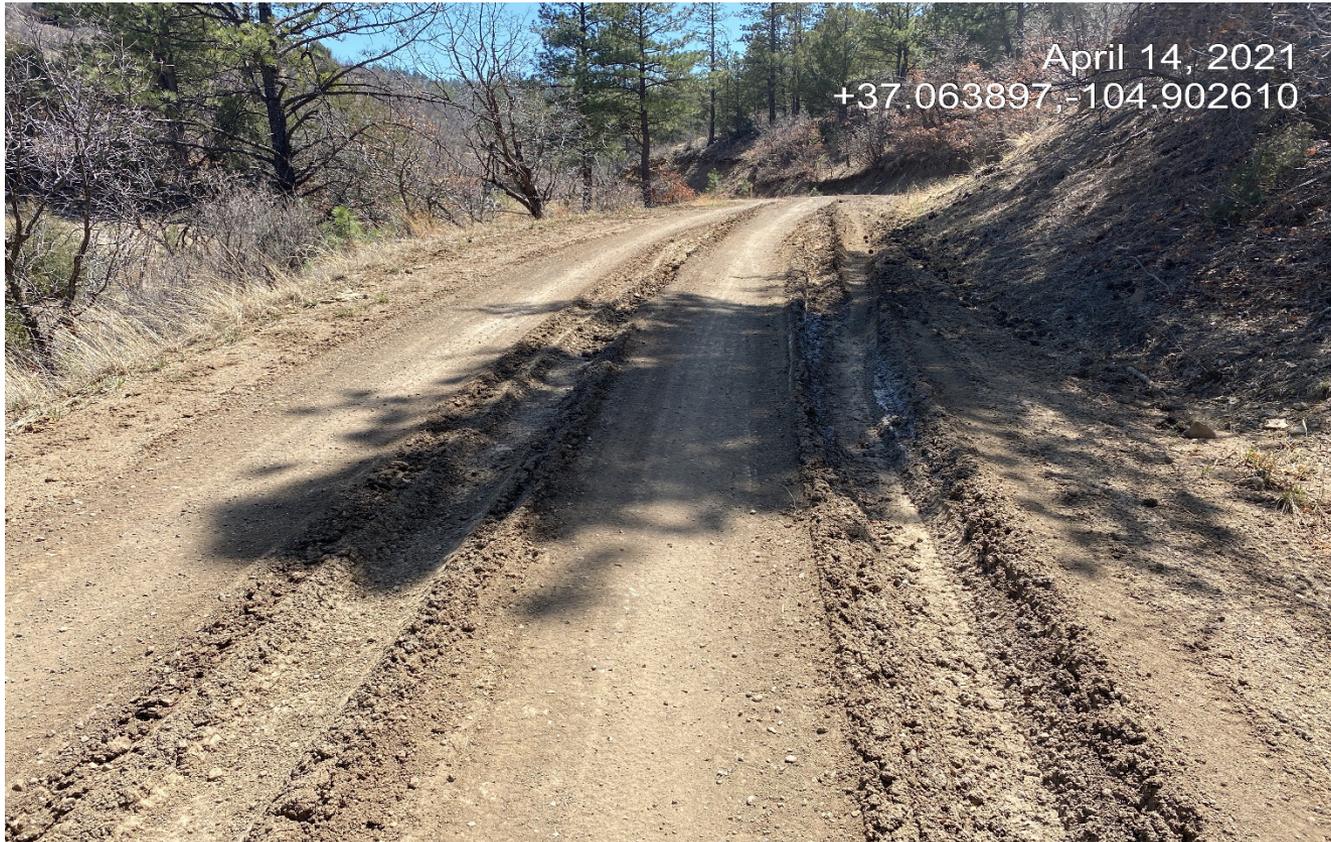
Photo 2. There are vehicle ruts along areas of th road which need to be repaired and stabilized.

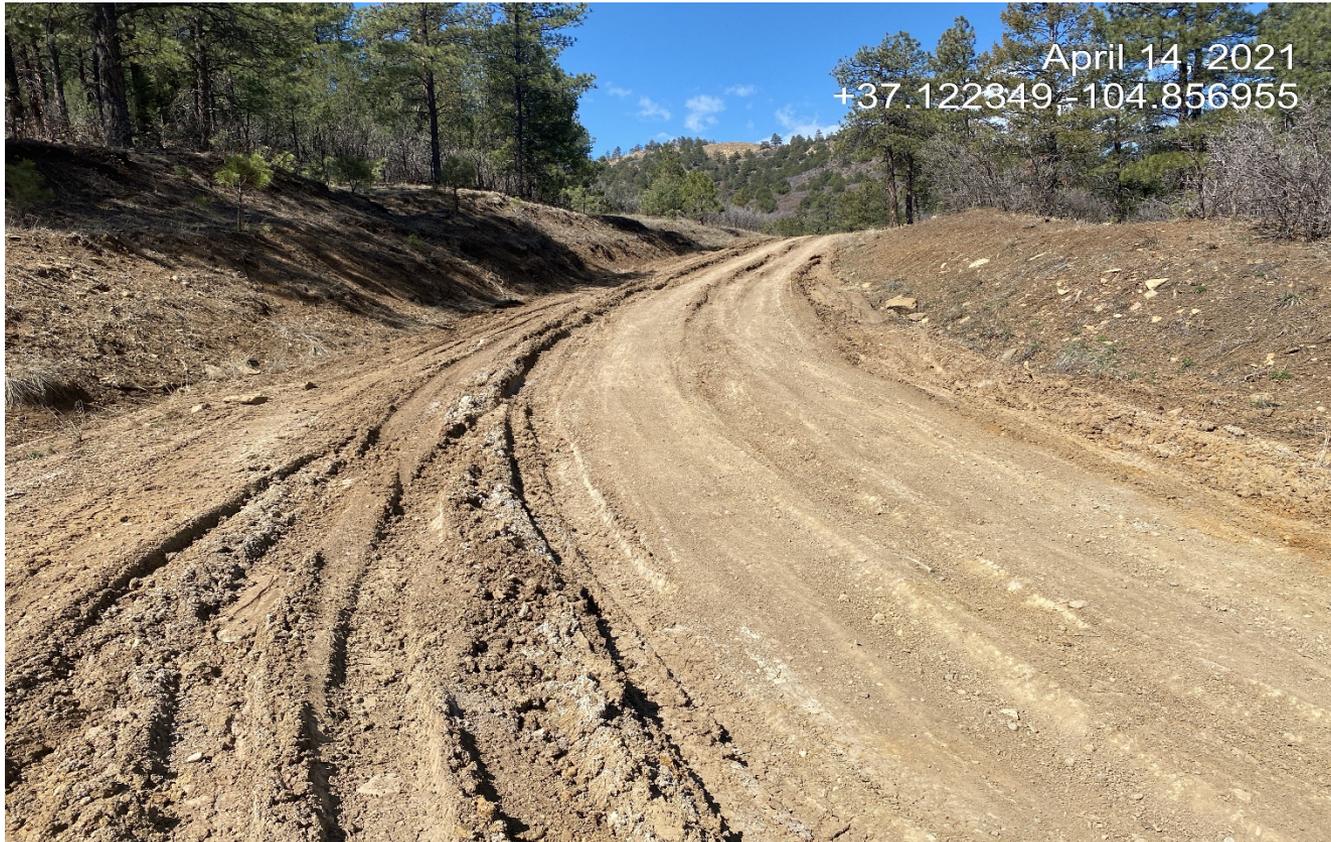
Photo 3. There is vehicle rutting along the first switch back in the road. It appears vehicles are spinning out in this area.

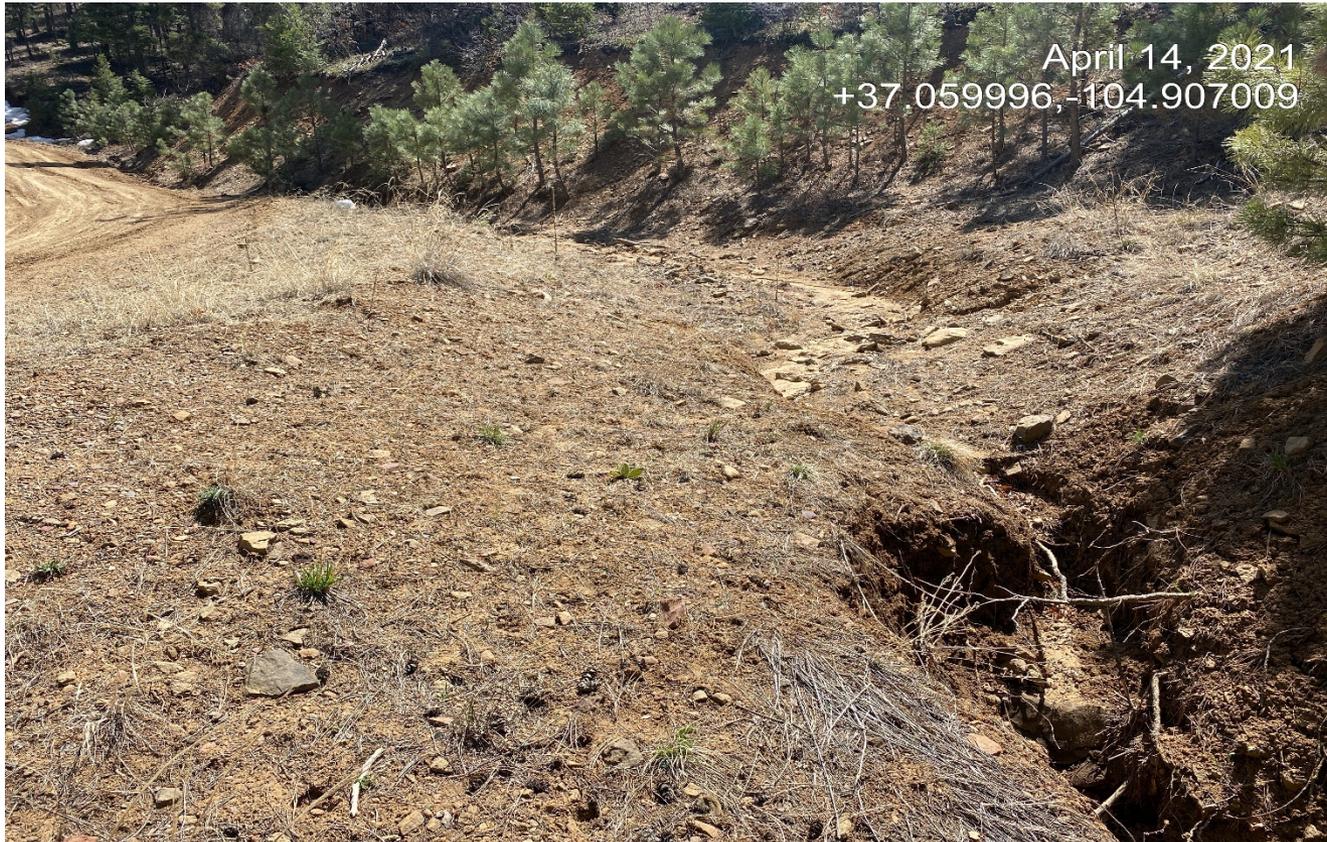
Photo 4. At the second switch back in the road, stormwater diverted off the road has caused erosion in bottom right of photo. This area needs to be stabilized with BMP's
