TEP ROCKY MOUNTAIN LLC
UNOCAL-67S96W 2NWNE
Location # 323884

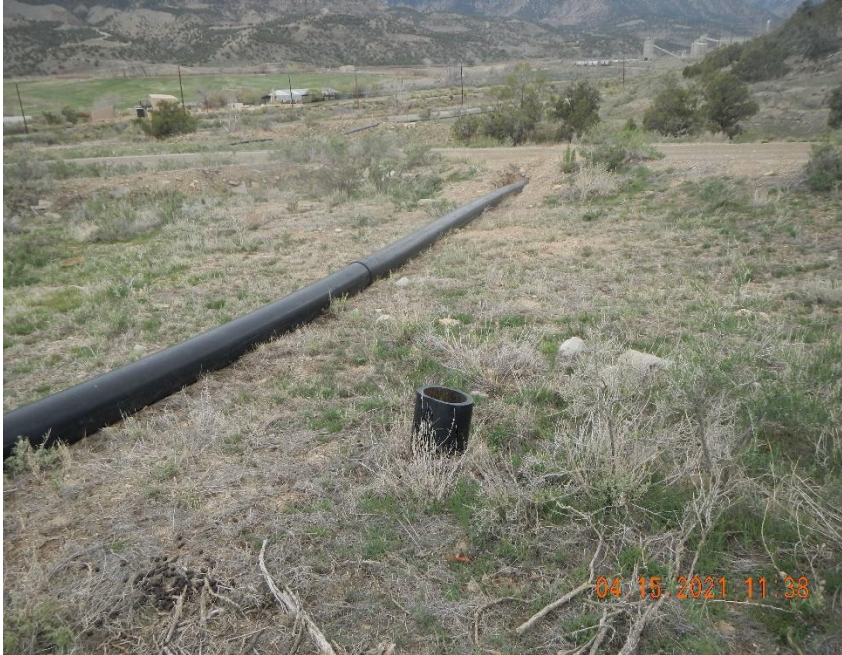
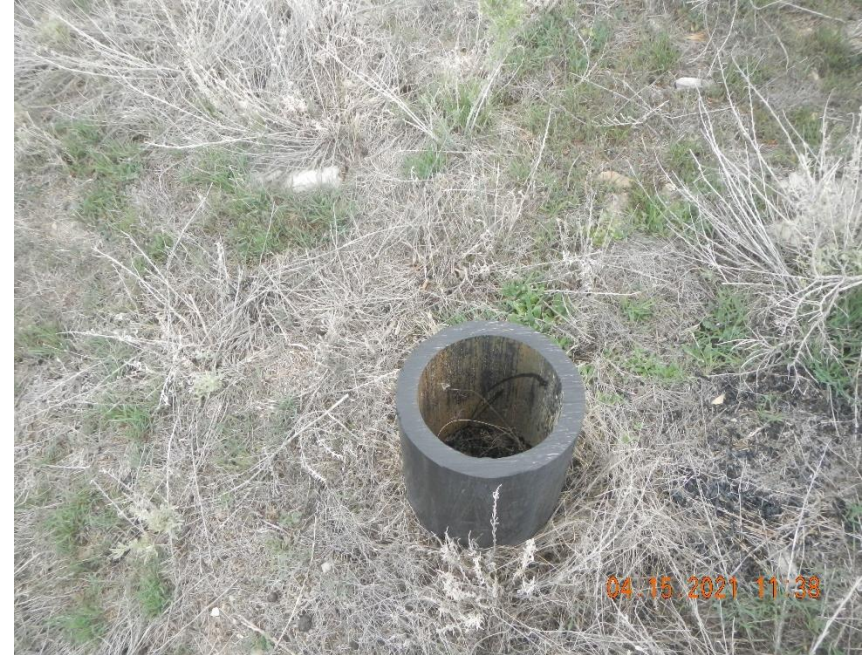
Unused piece of poly pipe along poly water moving pipe.

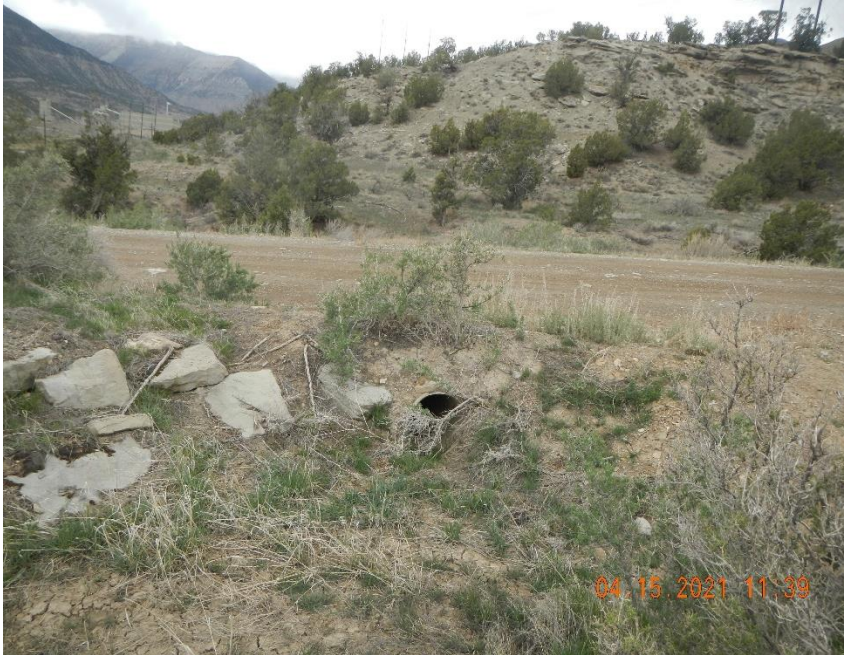
Inlet basin of culvert needs cleaned out.

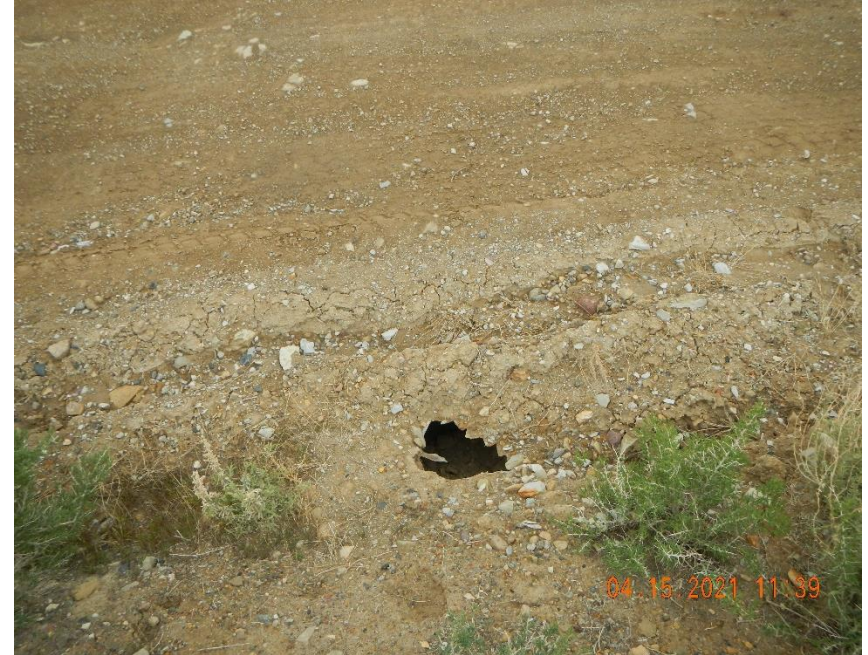
Culvert is damaged in road side ditch.

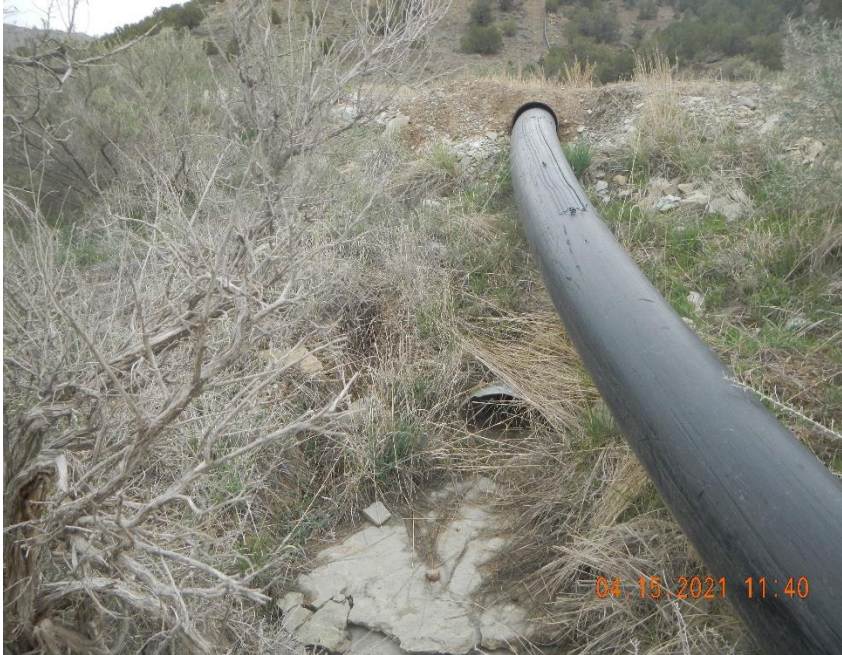
Culvert outlet needs cleaned.

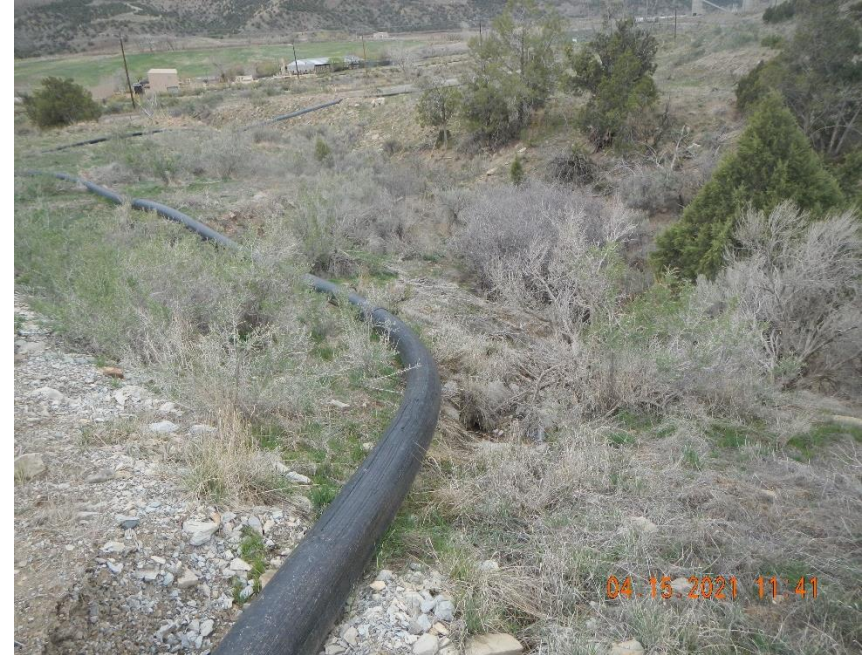
Storm water washing bank at culvert outlet.

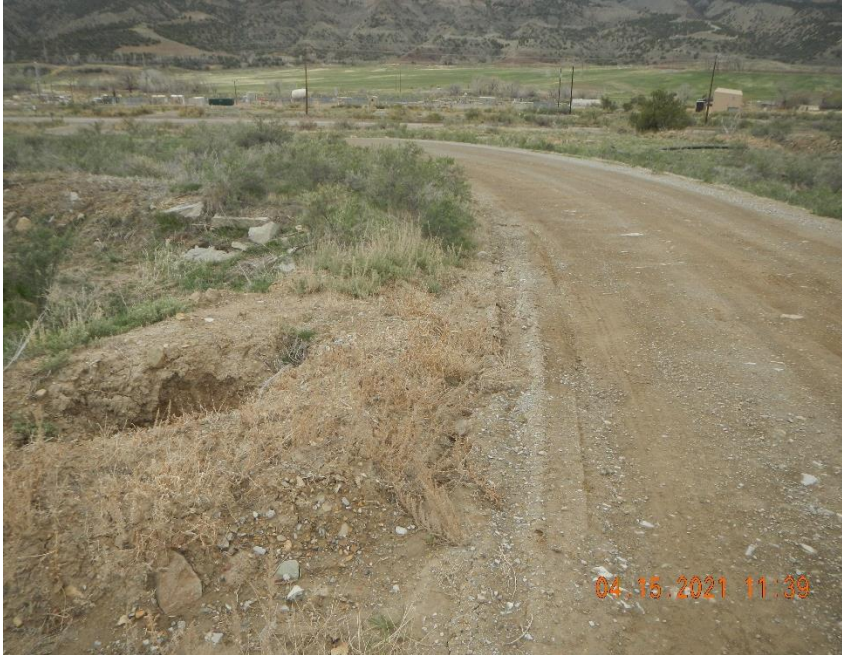
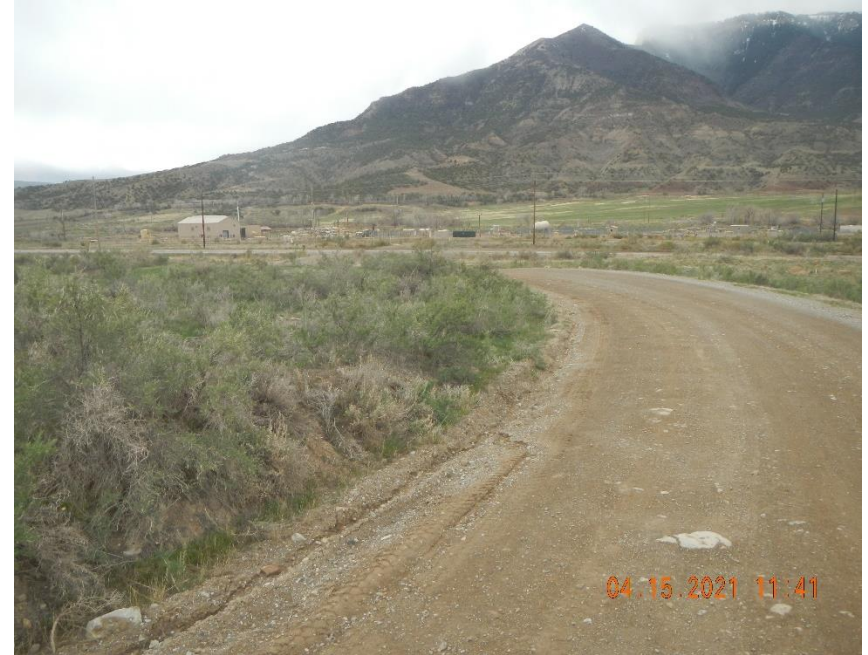
Road ditch needs maintained.

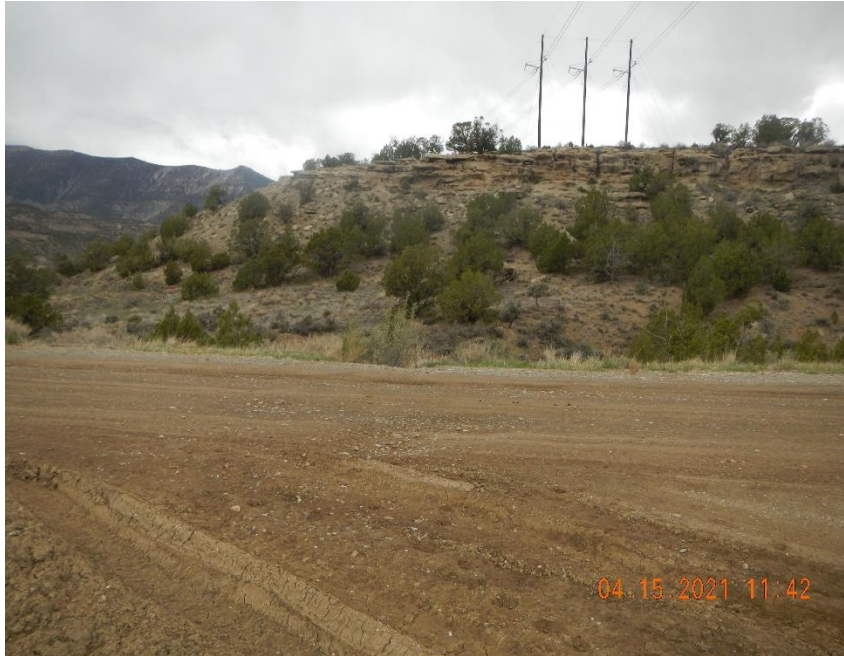
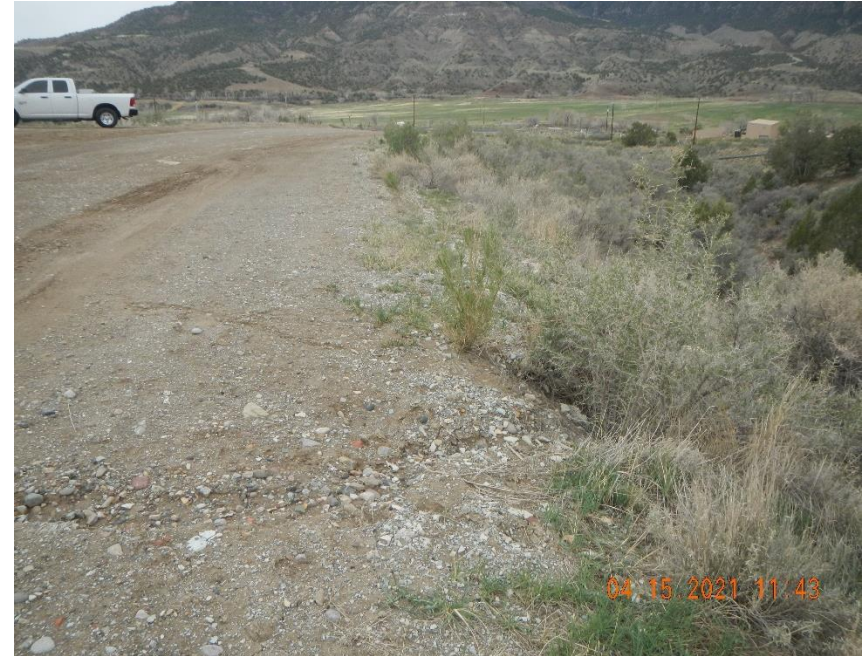
Water crossing roadway and over bank of road.

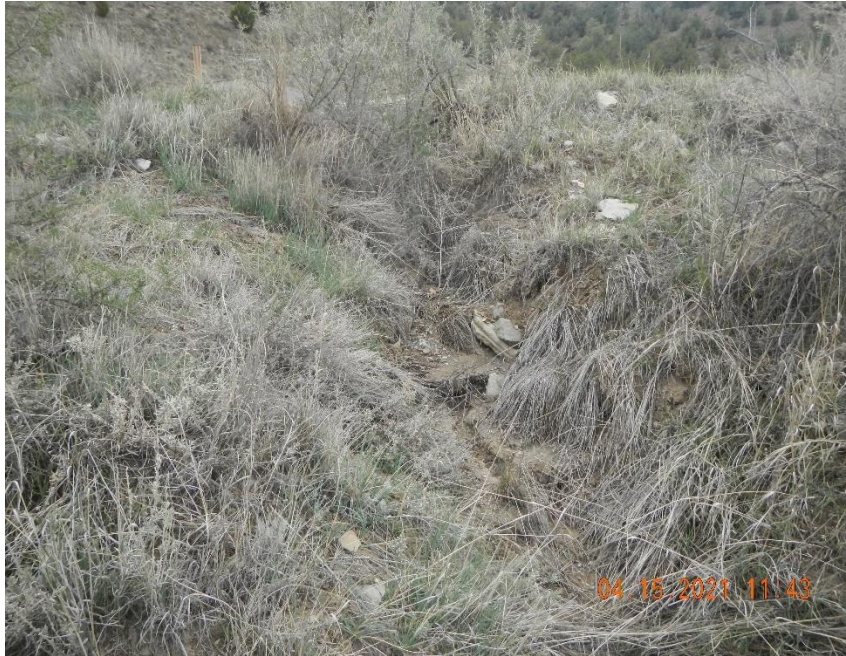
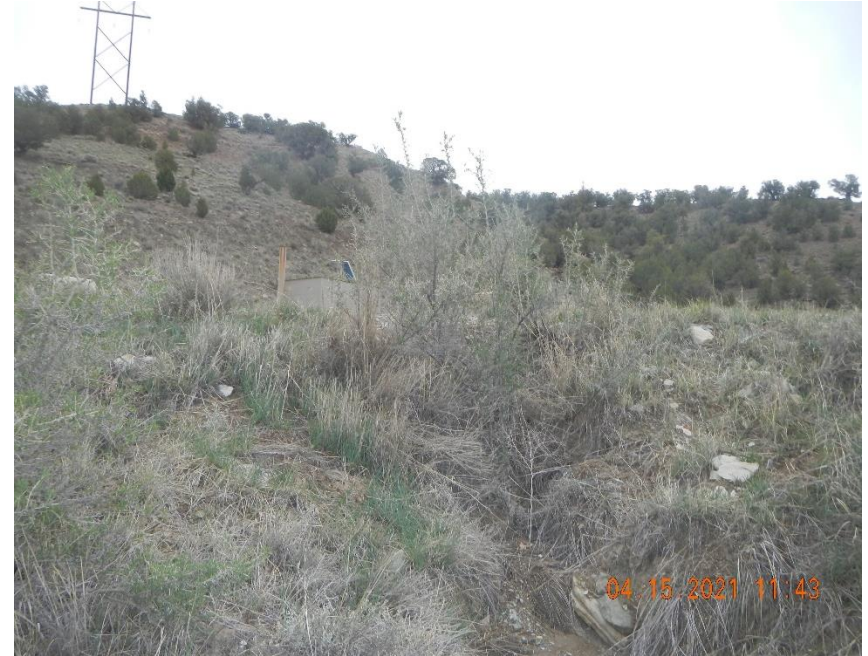
**Storm washing and damaging roadside bank from
storm water crossing roadway.**

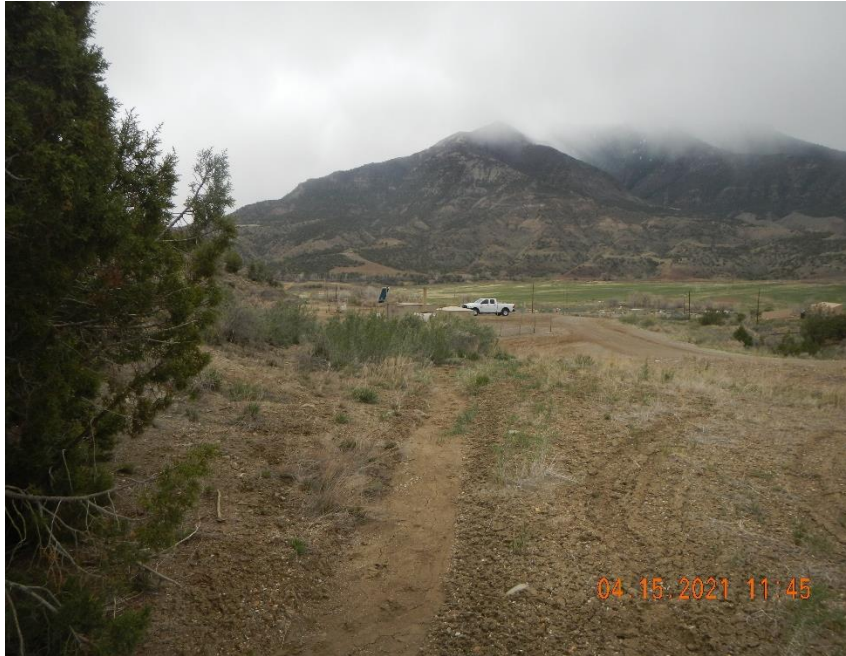
Storm water ditch running towards location.

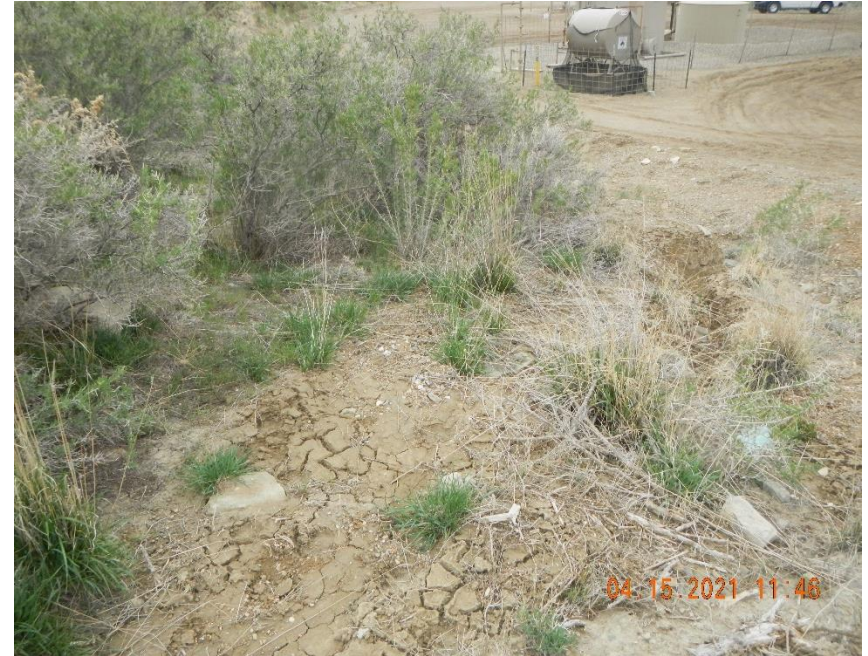
Sediment build up over vegetation.

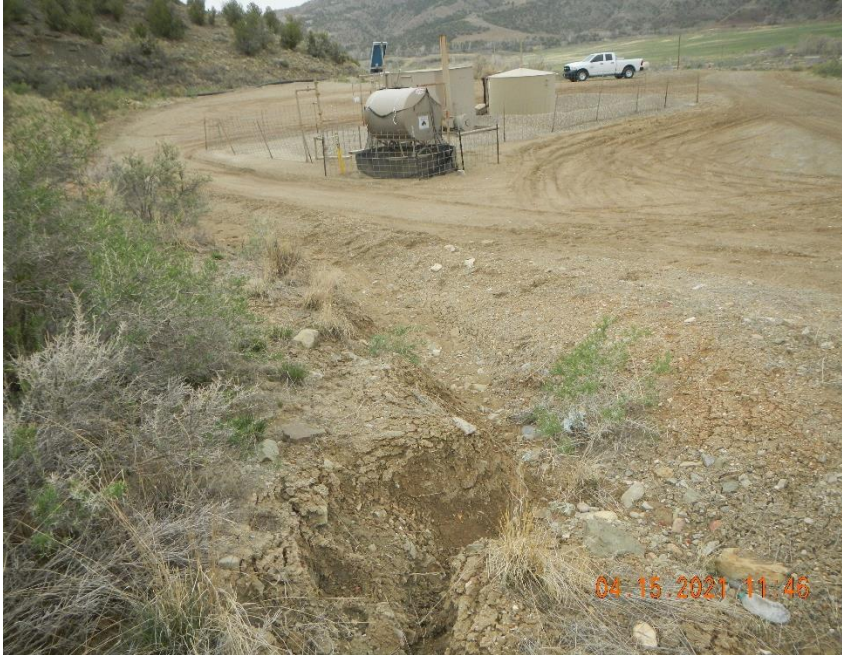
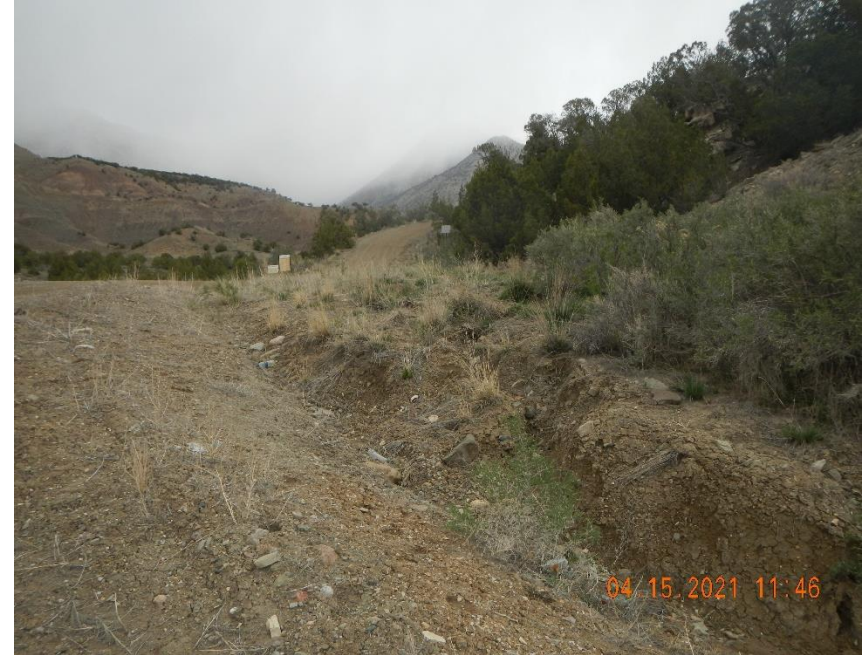
Storm water damage on perimeter ditch around location.
