Inspection Photos
Operator: Hilcorp
API: 067-09426
Date: 4/15/2021

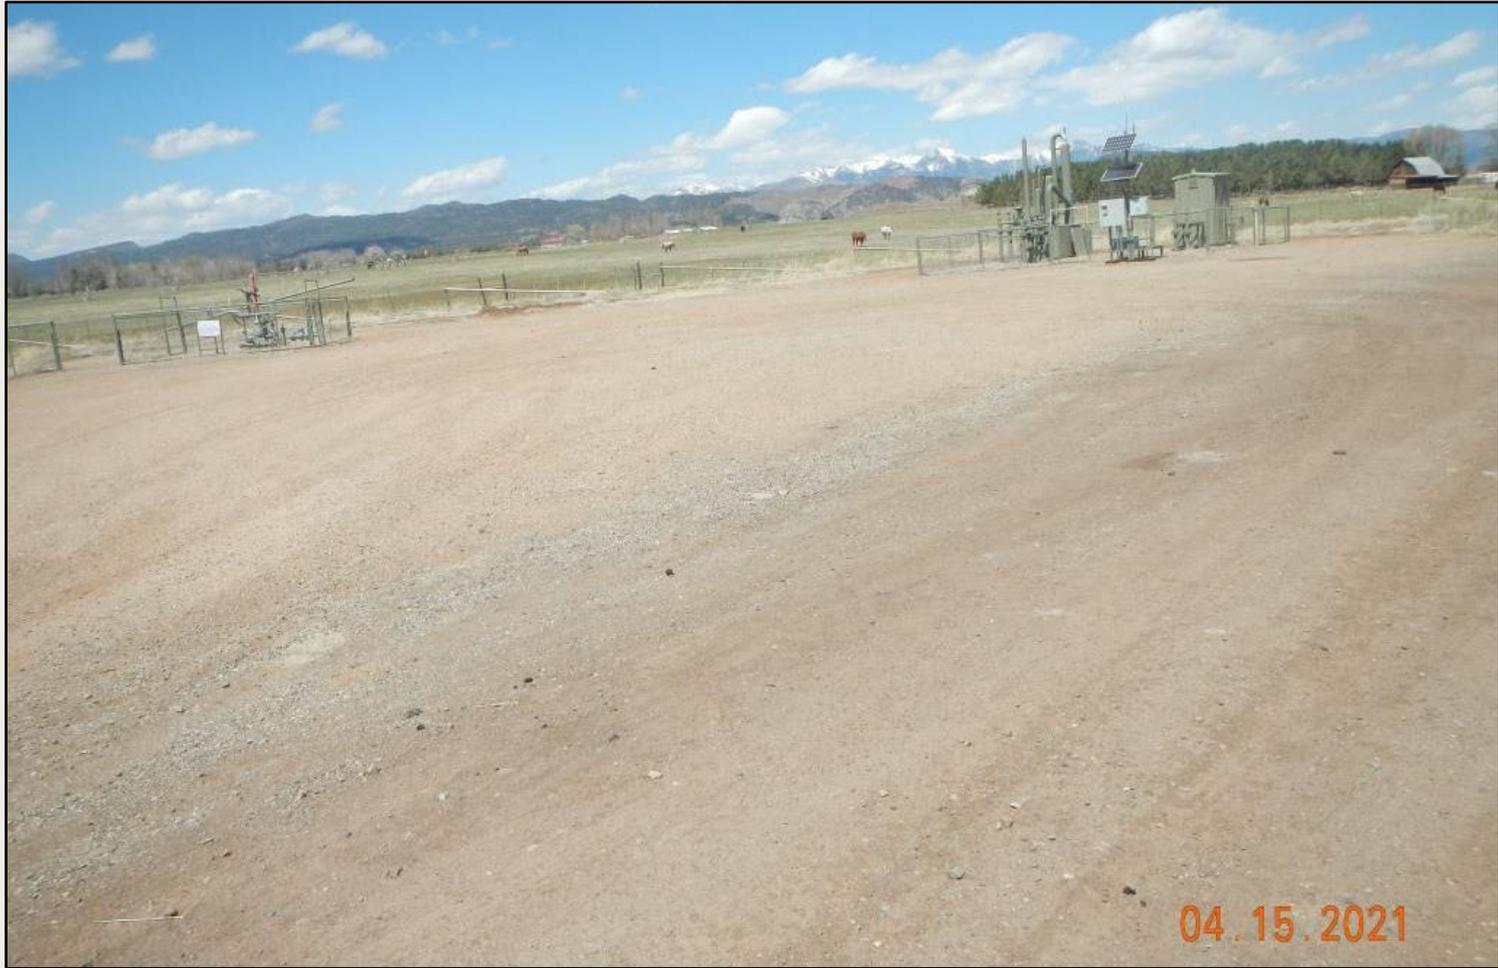
Photo 1. View of the project area from the well pad entrance facing center.

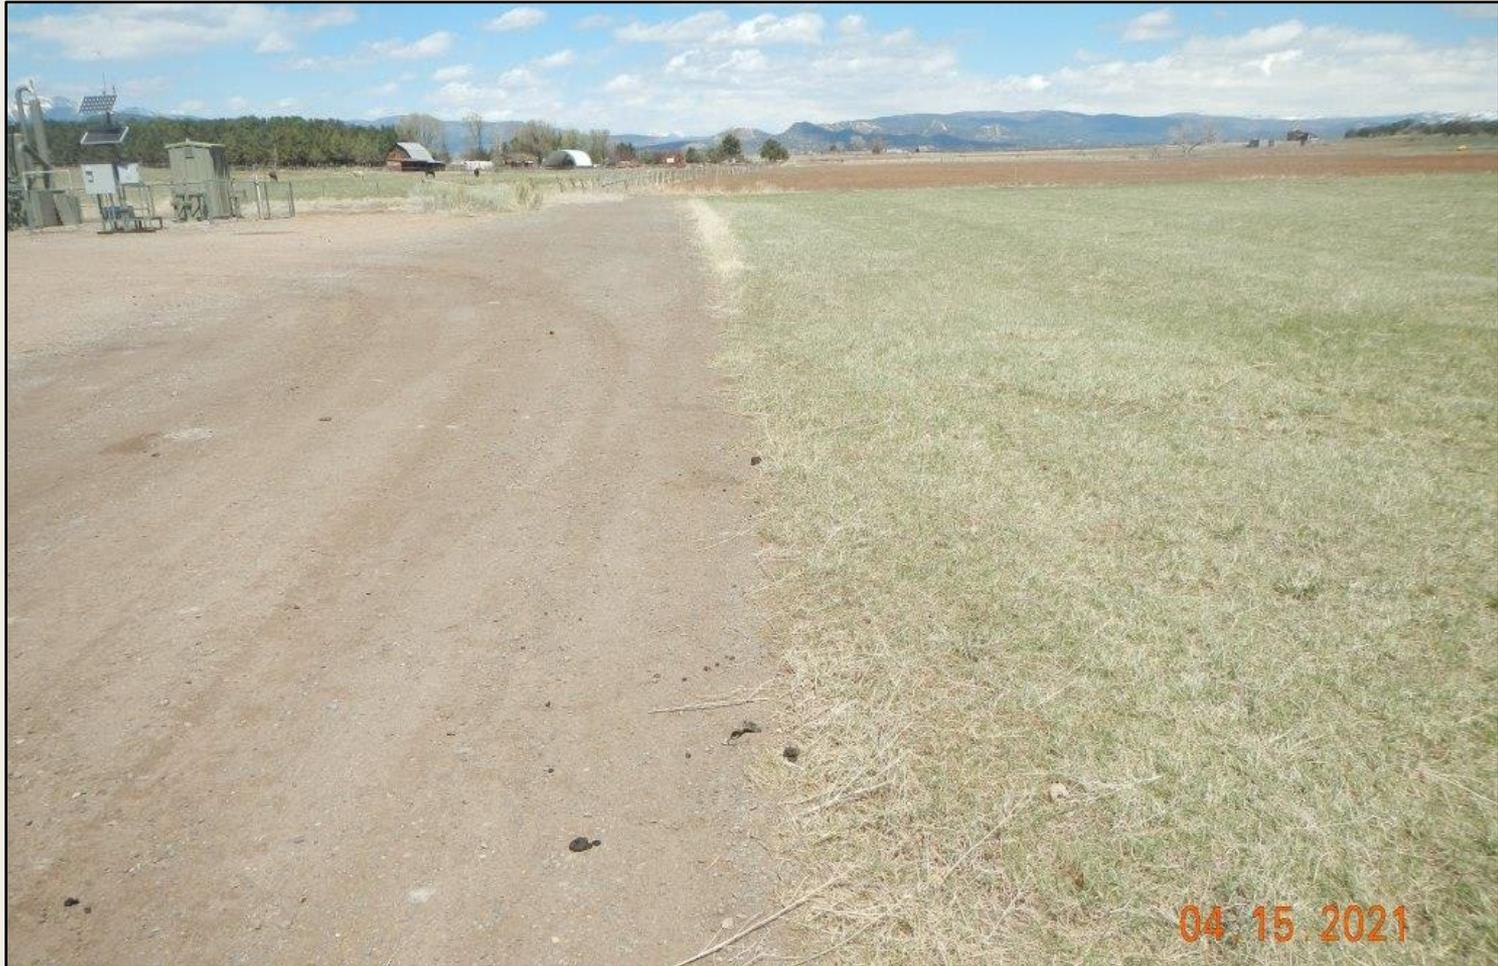
Photo 2. View of the eastern project area from the southwestern corner facing northward. Revegetation is established here and largely continuous with surrounding grass crop field.

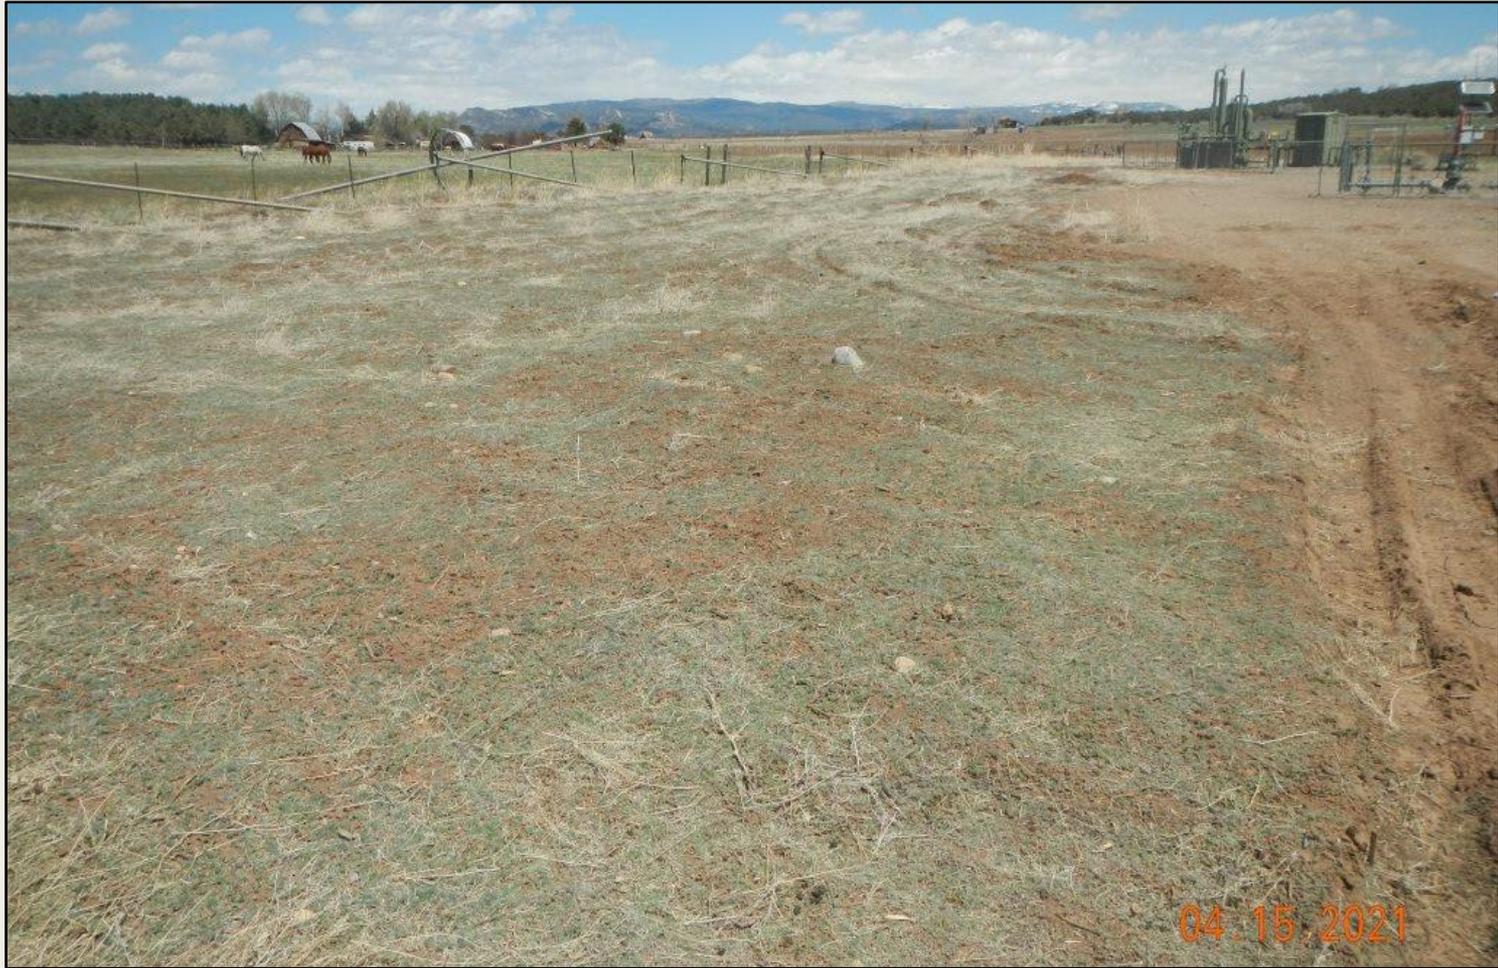
Photo 3. View of the western project area from the southwestern corner facing northward. This area is comprised of dense kochia and is not in cultivation. Revegetation needs to be conducted here.

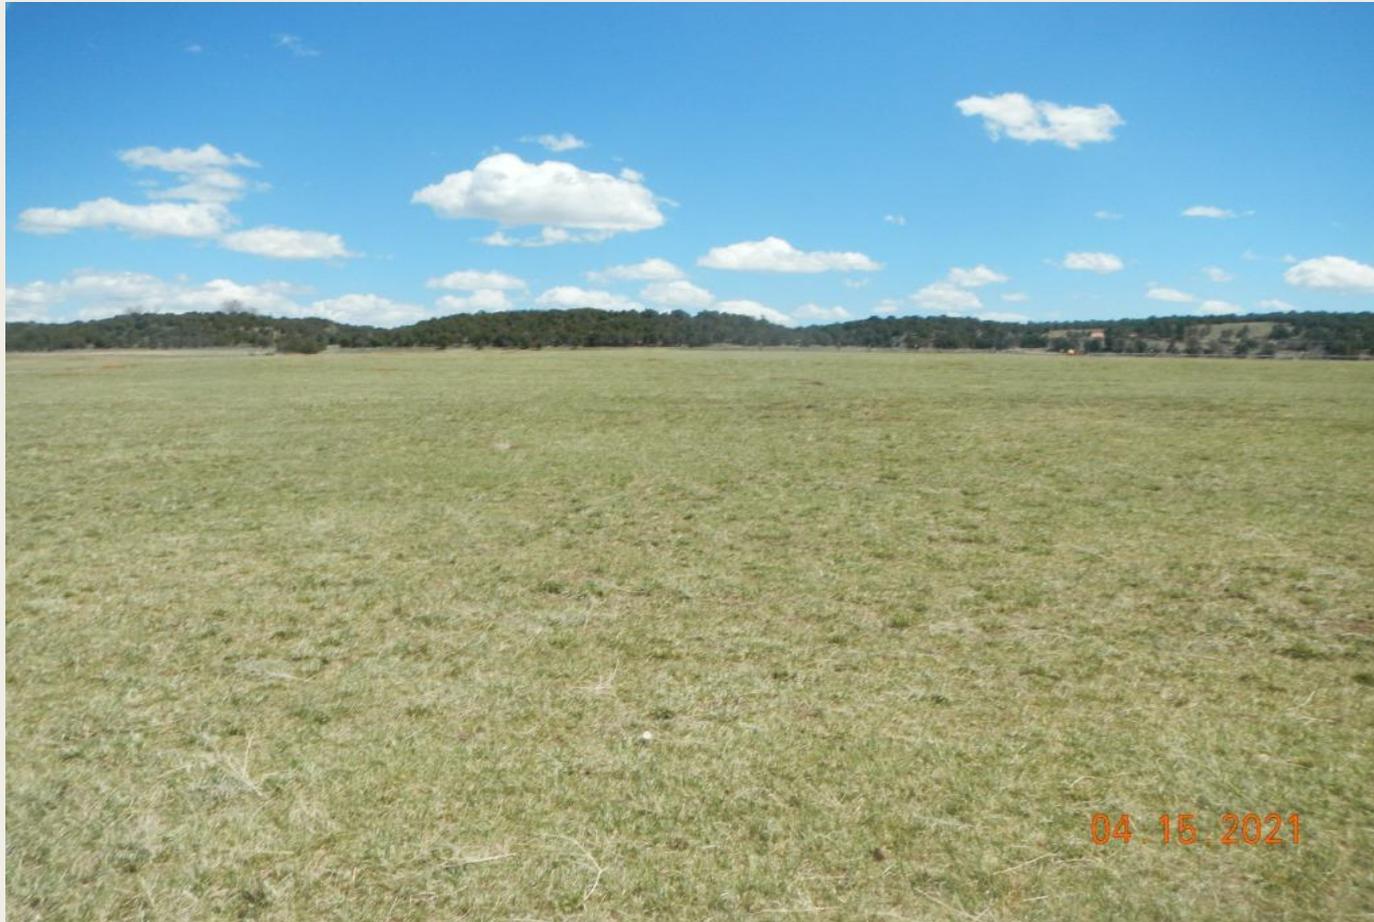
Photo 4. View of the reference area east of the well pad, facing westward. Vegetation is comprised of irrigated grass field.

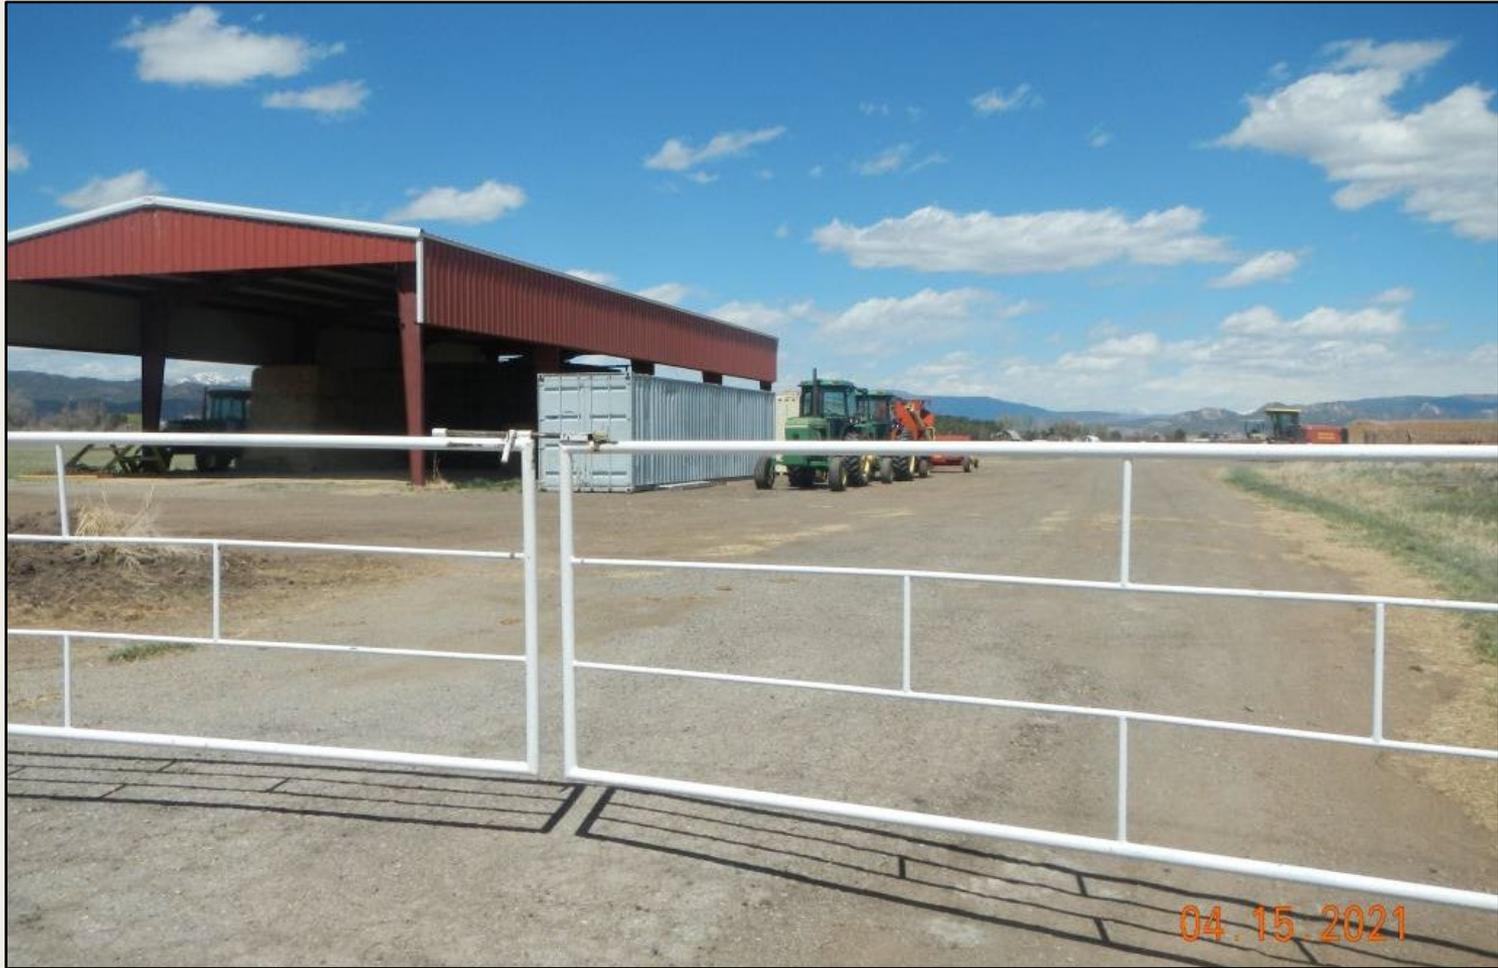
Photo 5. View of closed gate after leaving location.
