## Inspection Photos

Location Name: CAERUS PICEANCE LLC FEDERAL-68S95W /7NWNW

Location ID: 311684

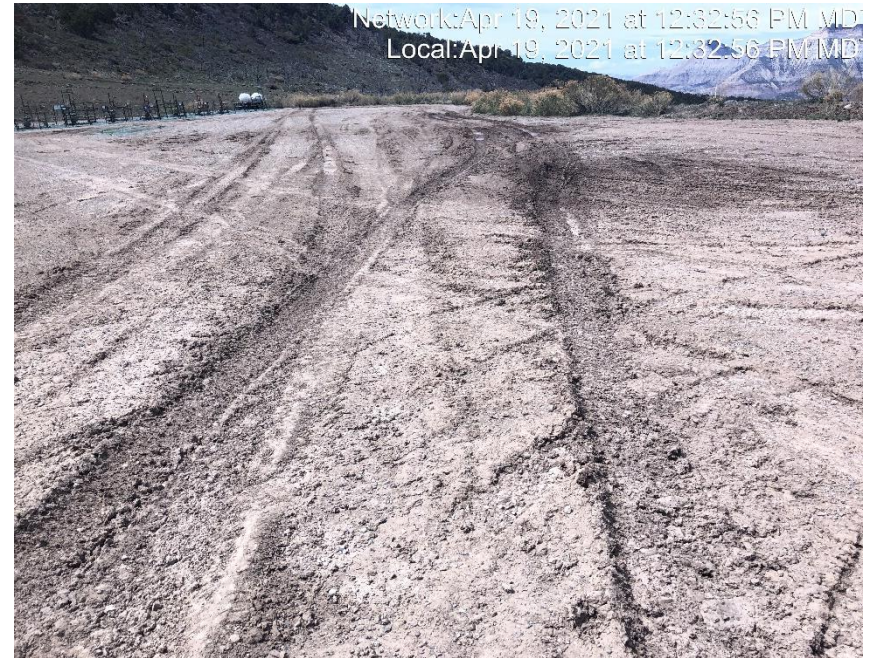
**Photo #3534 Location lacks stabilization.**

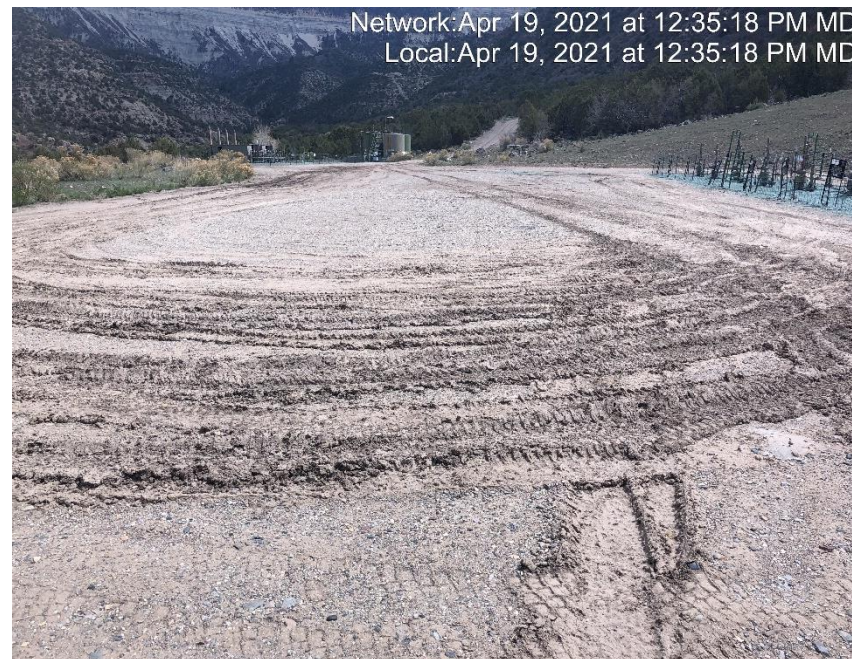
**Photo #3535 Location lacks stabilization.**

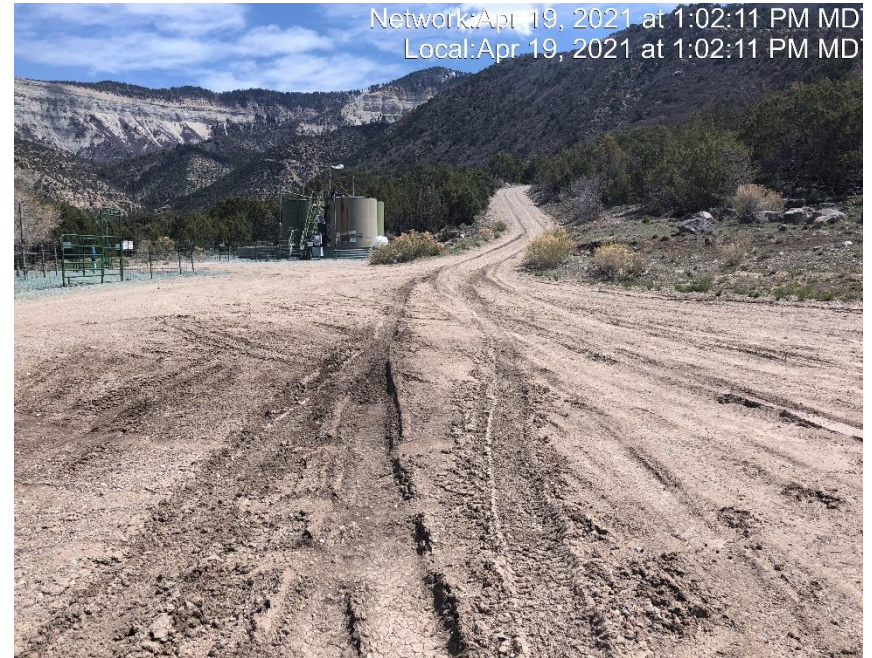
Photo #3538 No form of tracking control at entrance to location.

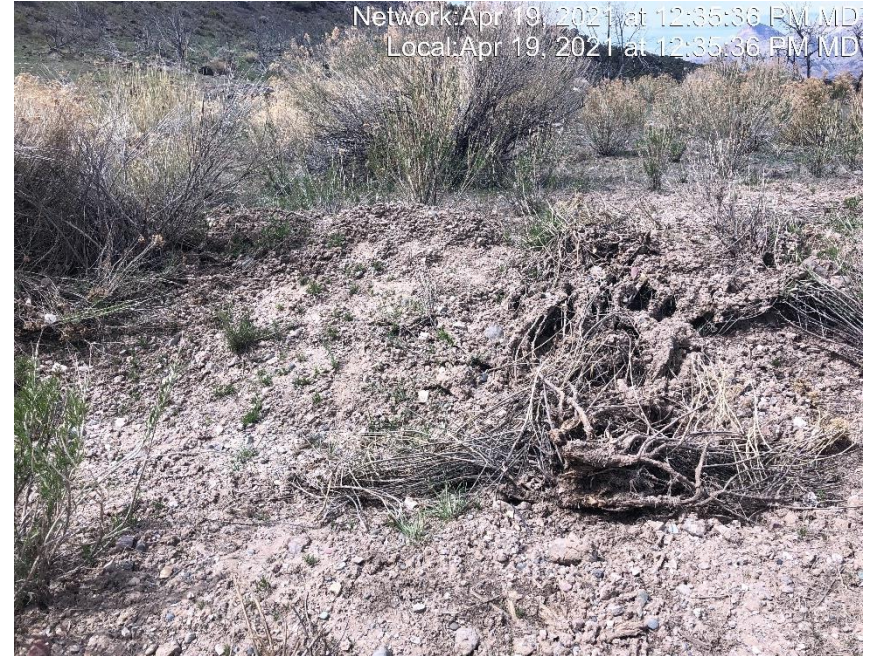
Photo #3536 Sediment has been transported off of NE end of location.

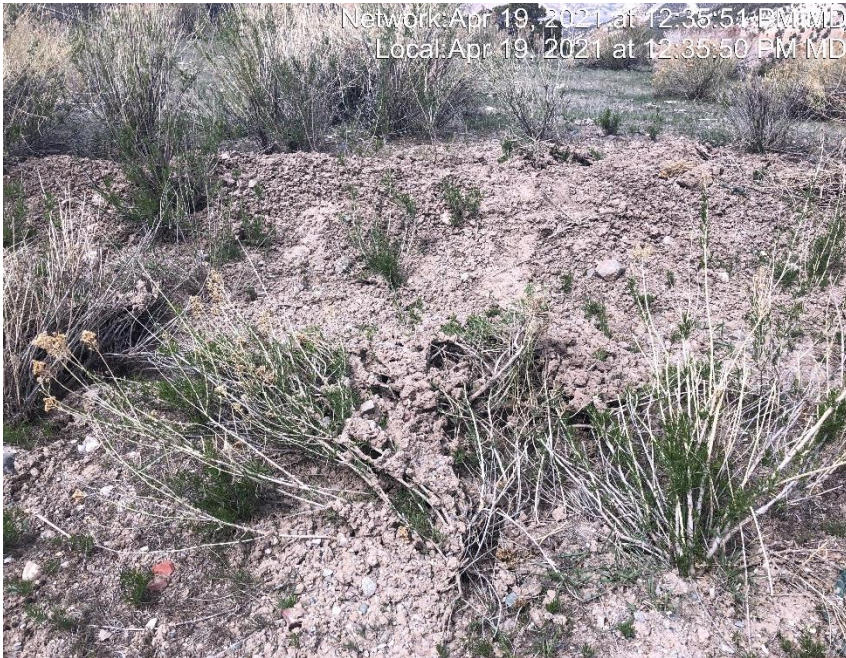
**Photo #3537 Sediment is choking off vegetation.**
