Inspection Photos
Location Name: Grizzly Hebron 12 0881
Location ID: 448834

COLORADO
Oil & Gas Conservation
Commission
Department of Natural Resources

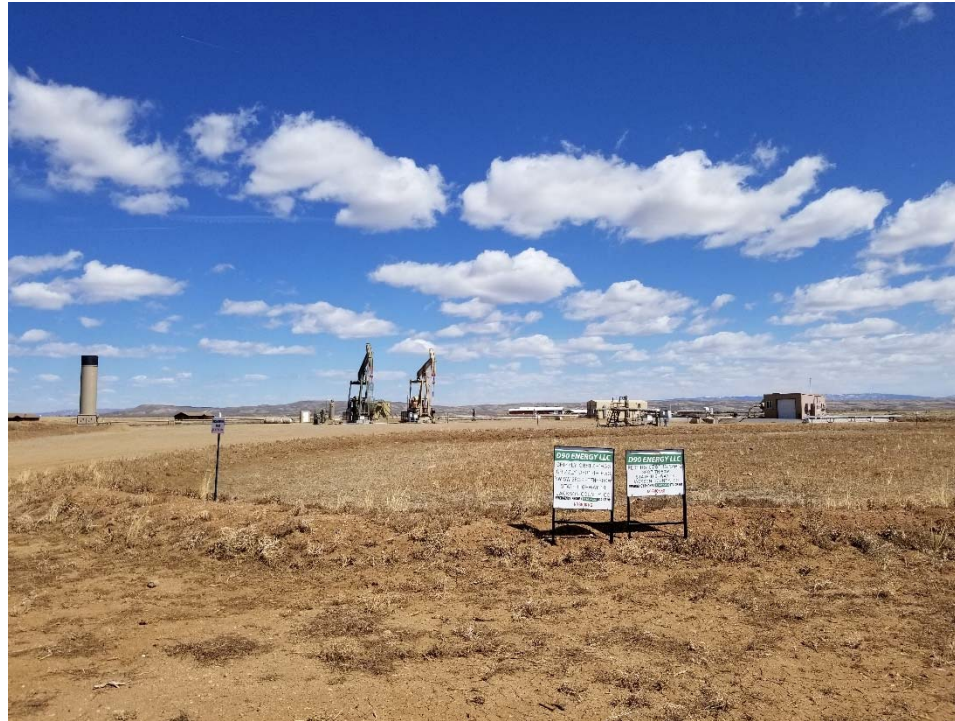
Photo 1. Overview of location taken facing northeast.

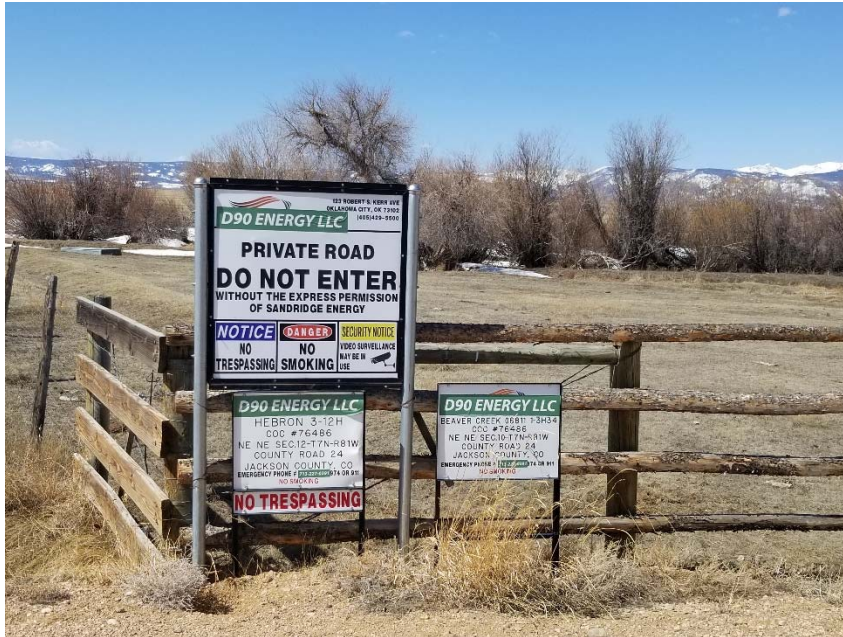
Photo 2. Incomplete sign at location entrance.

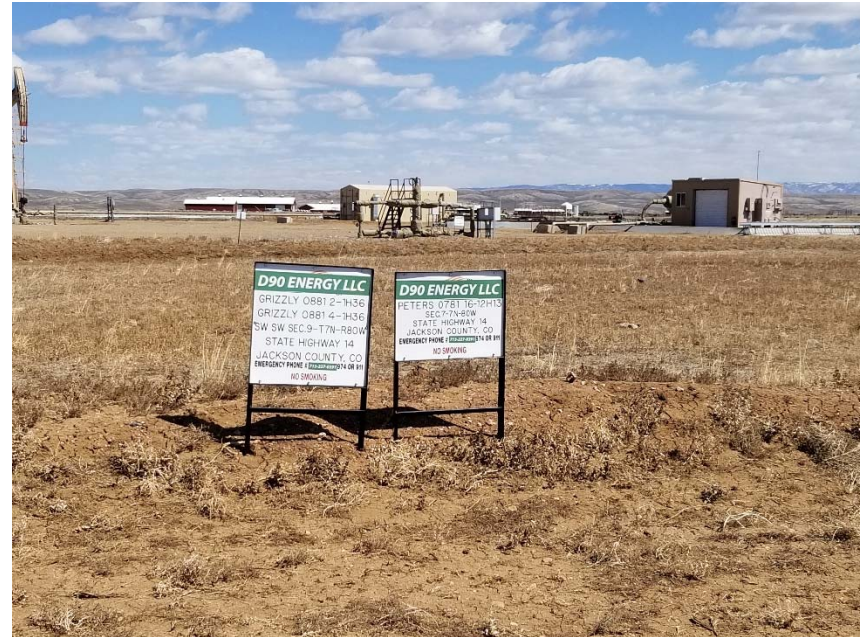
Photo 3. Signs at entrance incomplete.

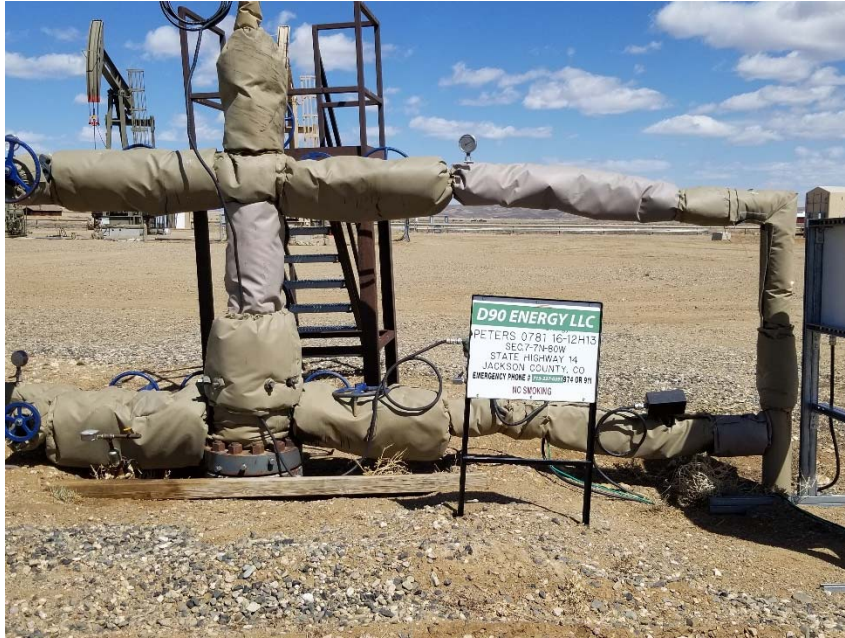
Photo 4. Incomplete wellhead sign.

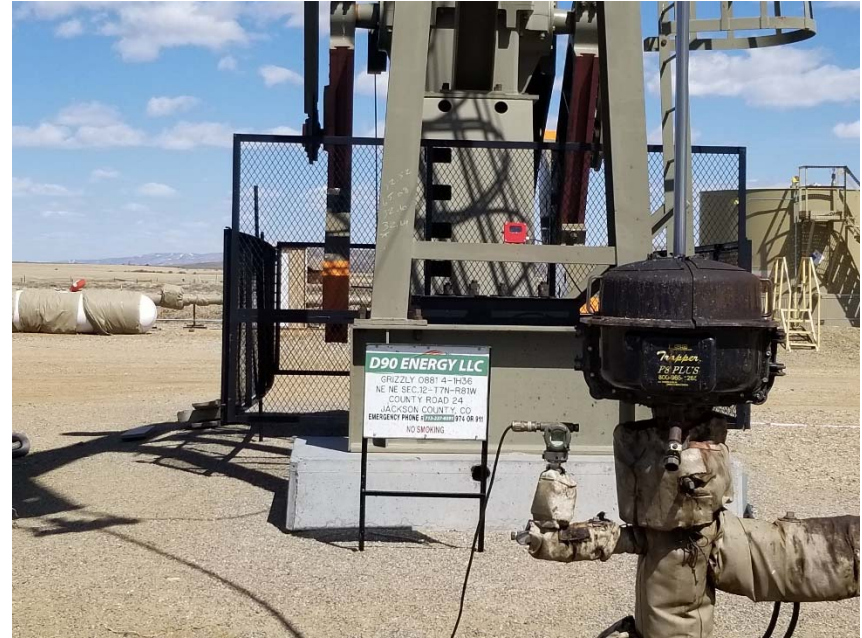
Photo 5. Incomplete wellhead sign.

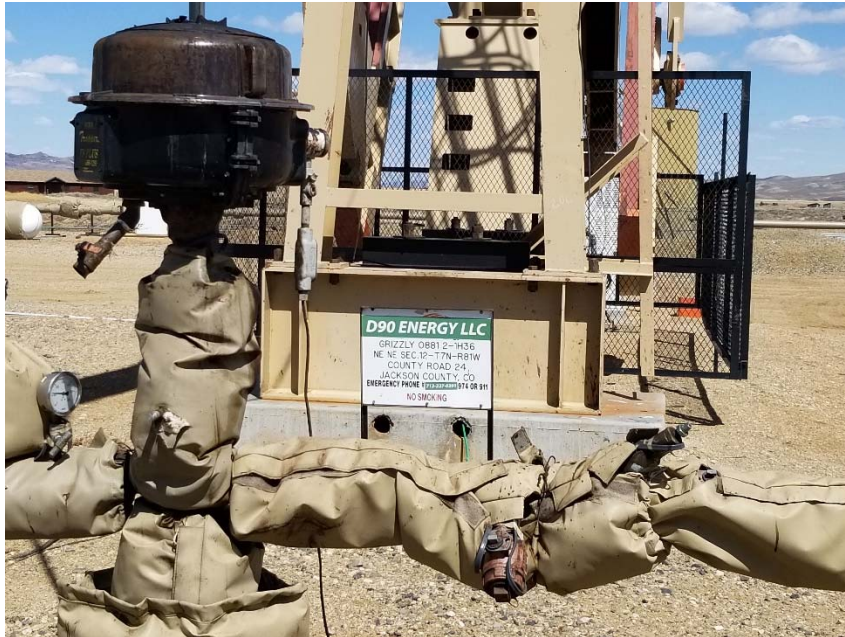
Photo 6. Incomplete wellhead sign.

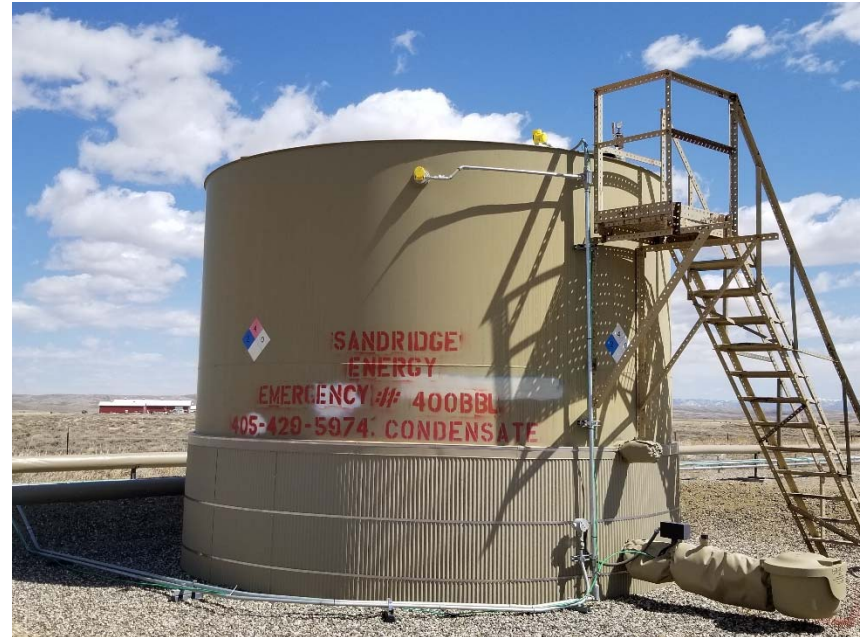
Photo 7. Incomplete/inaccurate tank label.

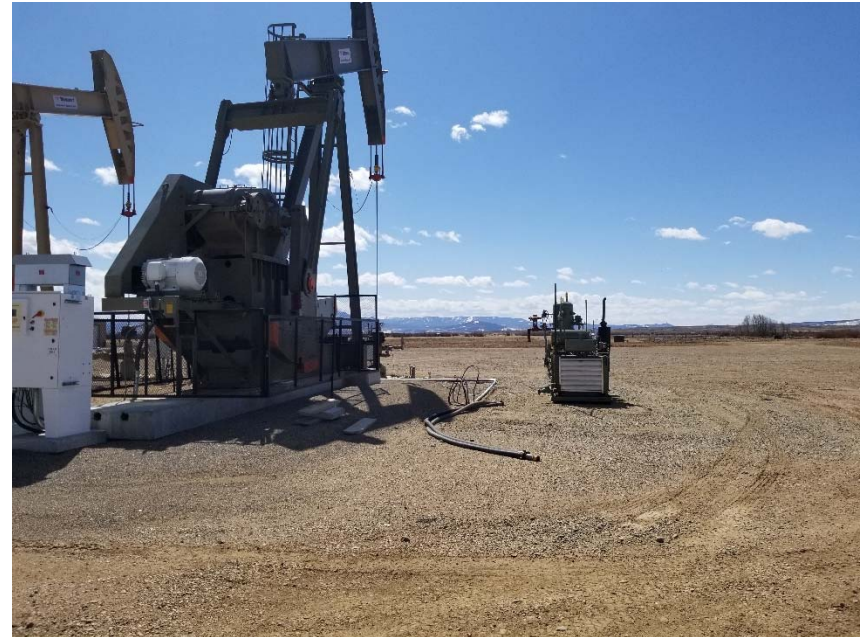
Photo 9. Equipment stored on location.
