## Inspection Photos

Location Name: CAERUS PICEANCE LLC FEDERAL-67S95W /29NESE

Location ID: 322309

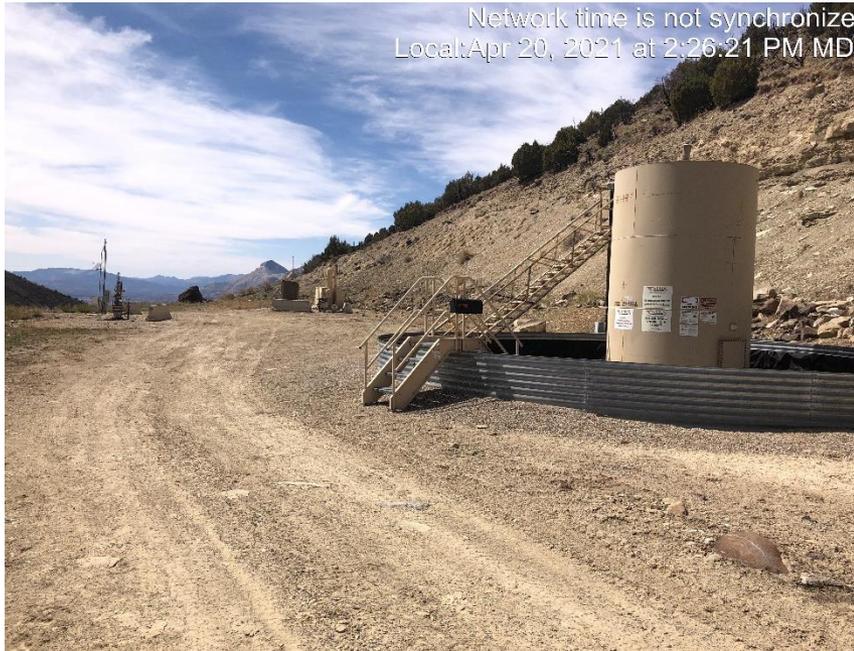
Photo #3565 from entrance to location.

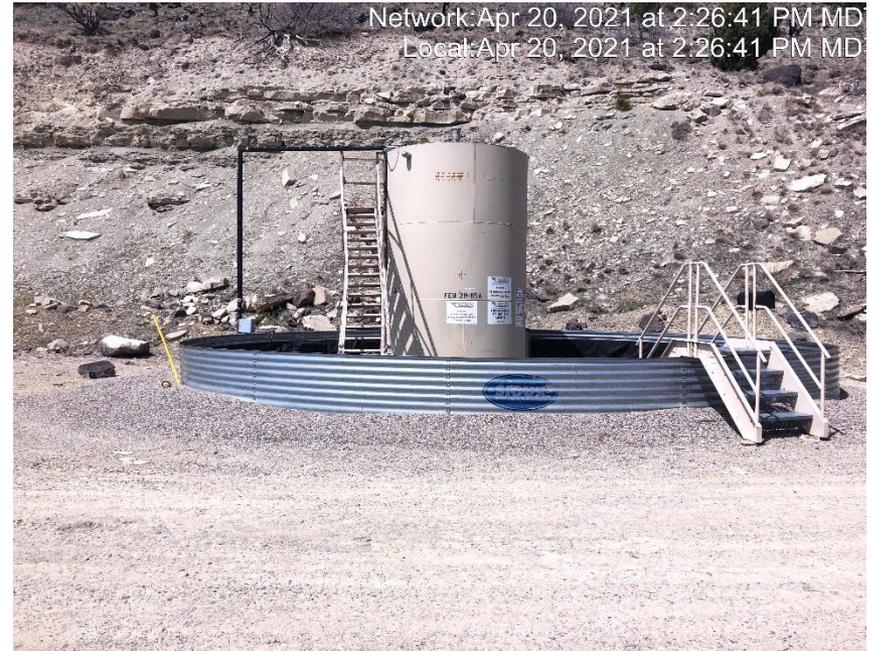
Photo #3566 No battery sign located at the tank battery

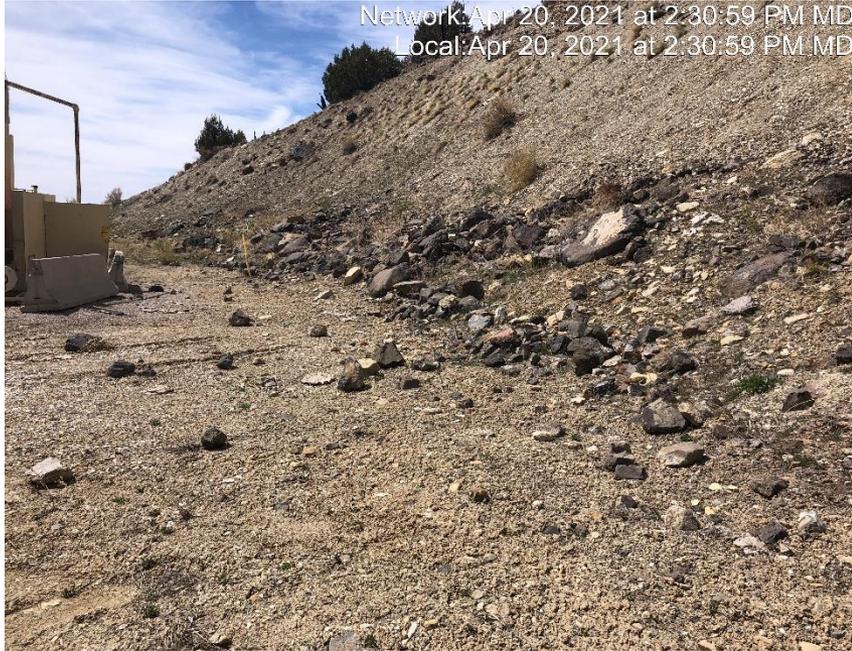
**Photo #3567 Cut slope lacks stabilization**

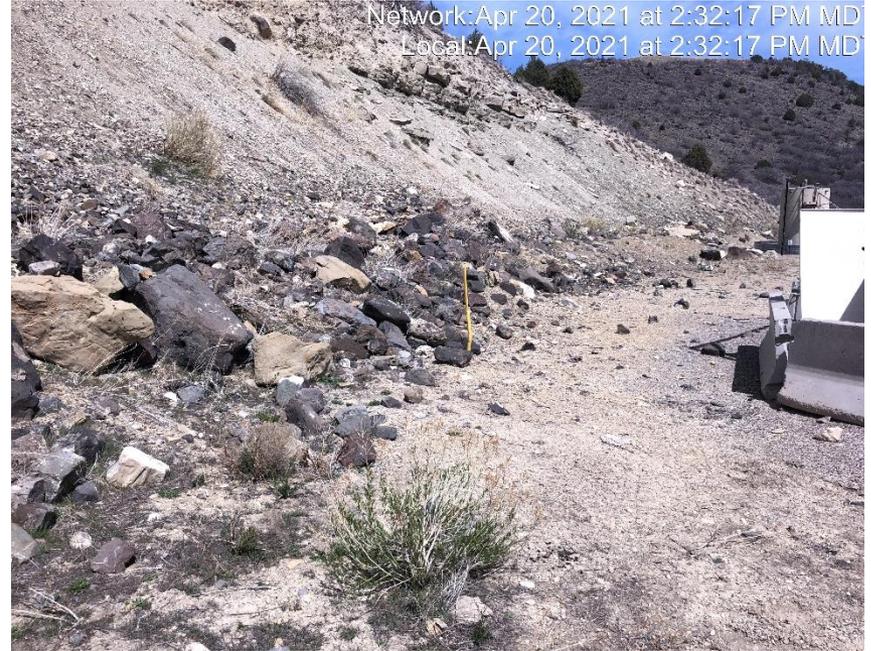
**Photo #3568 Cut slope lacks stabilization**

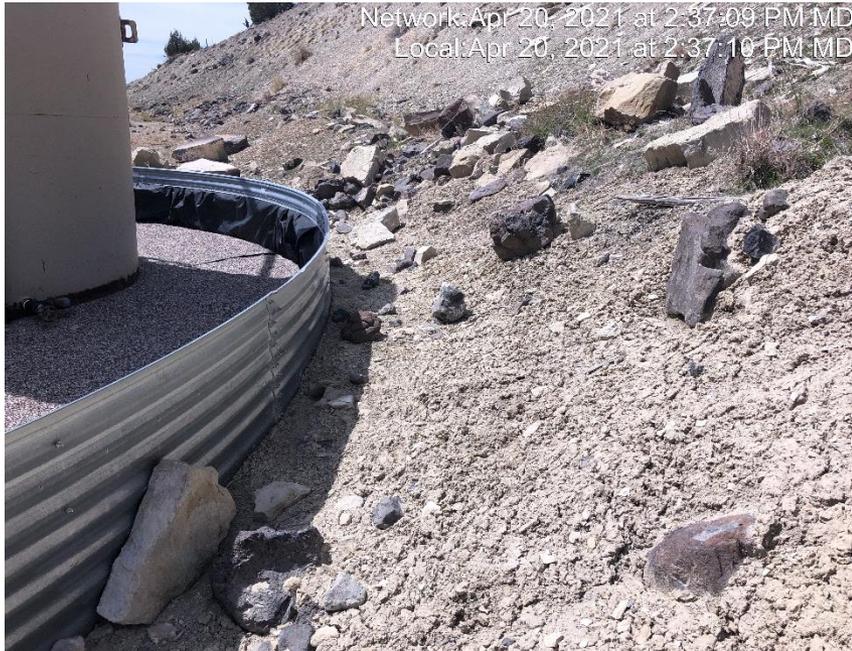
**Photo #3569 Run on to location is not being effectively controlled.**

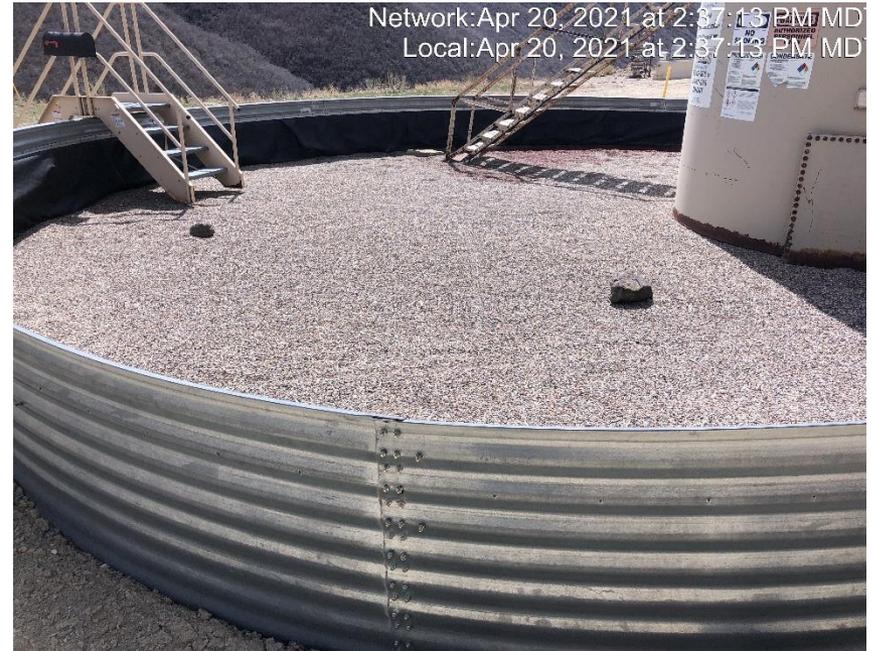
**Photo #3570 Rocks and debris are encroaching on production equipment.**
