Inspection Photos

4/16/2021

Operator: TEP ROCKY MOUNTAIN LLC #
96850

Location ID: 324218
Garfield County, CO

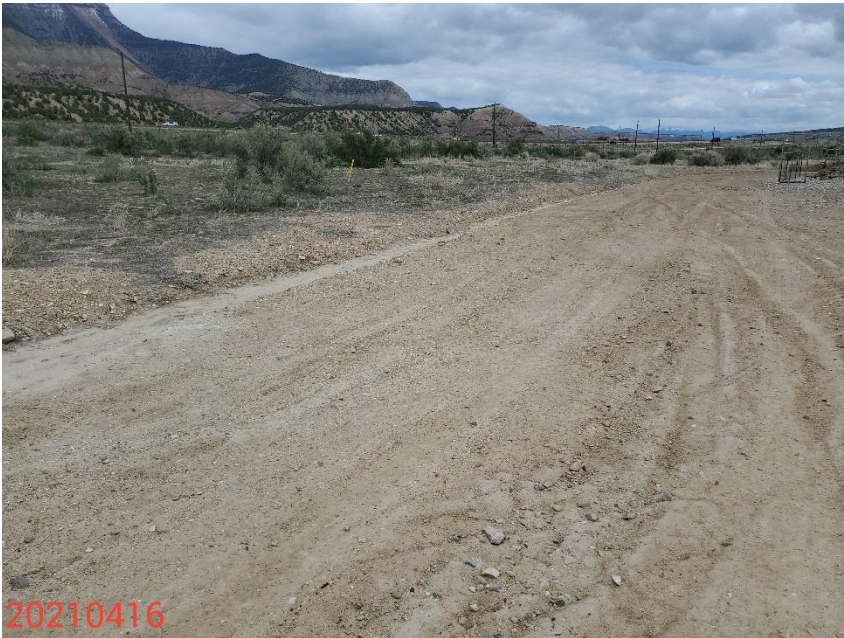
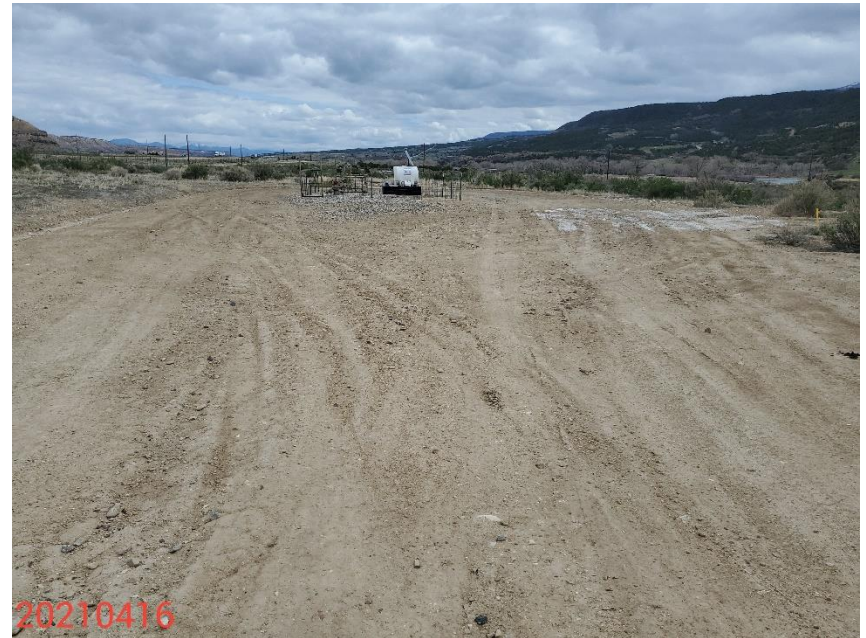
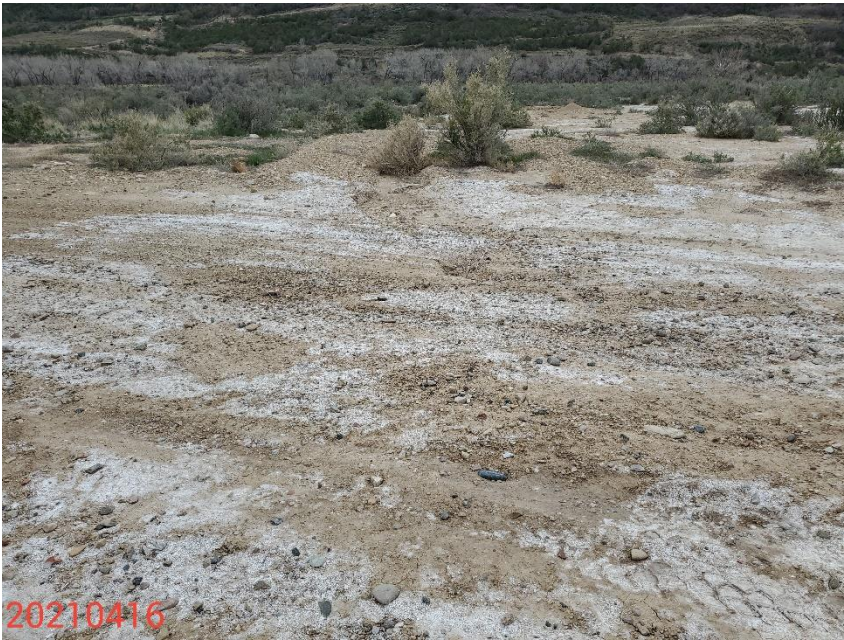
Photo 1: Photo taken from the west end of the Location, facing northeast. Photos 1-3 provide an overview of the Location from northeast, east to south

Photo 2: See comments under photo 1.

Photo 3: See comments under photo 1.

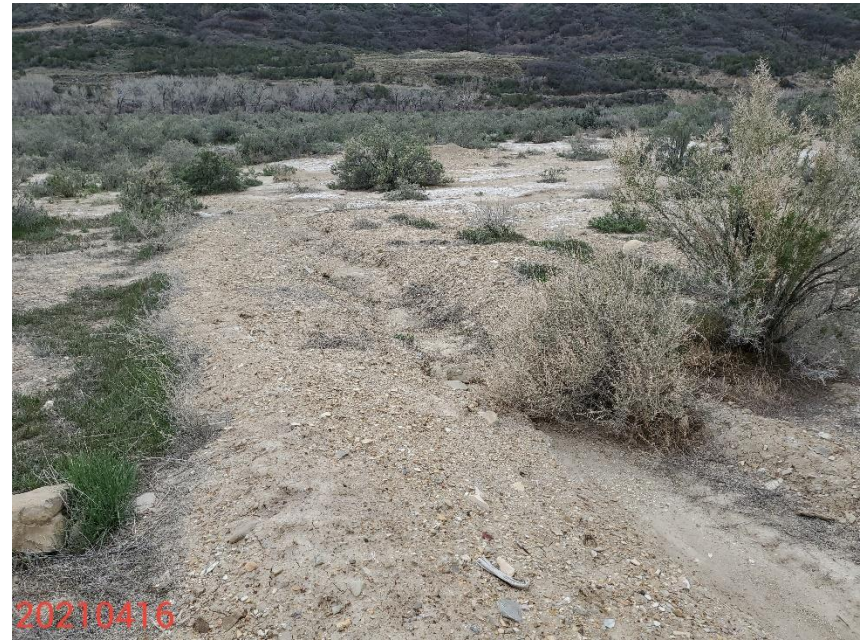
Photo 4: Photo taken from the south end of the Location, facing south. Photo shows erosion degradation on interim areas due to stormwater runoff from the Location and access road; stormwater and erosion control measures on the Location missing or insufficient.

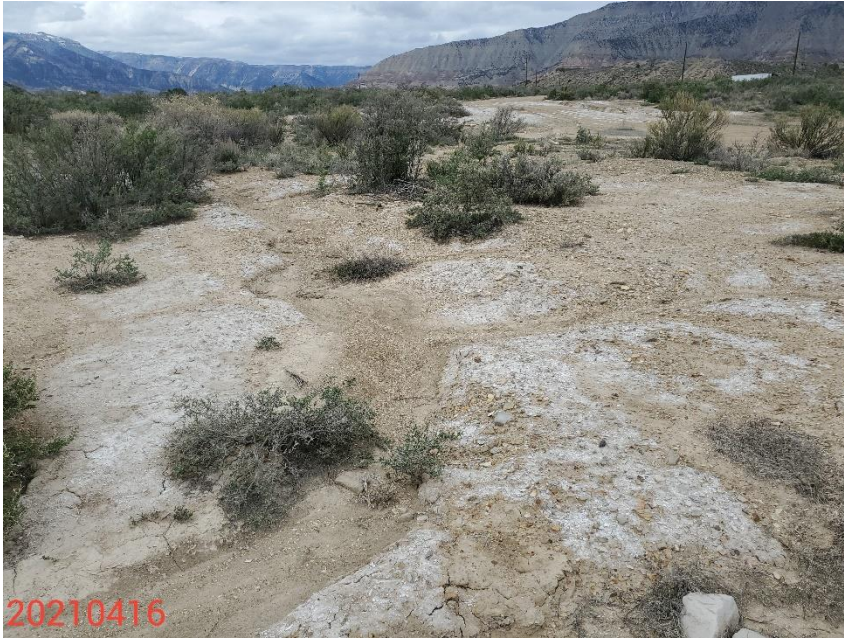
Photo 5: Photo taken from the interim areas on the south end of the Location, facing northwest. Photo shows erosion degradation on interim areas due to stormwater runoff from the Location and access road; stormwater and erosion control measures on the Location missing or insufficient. Additional reclamation required.

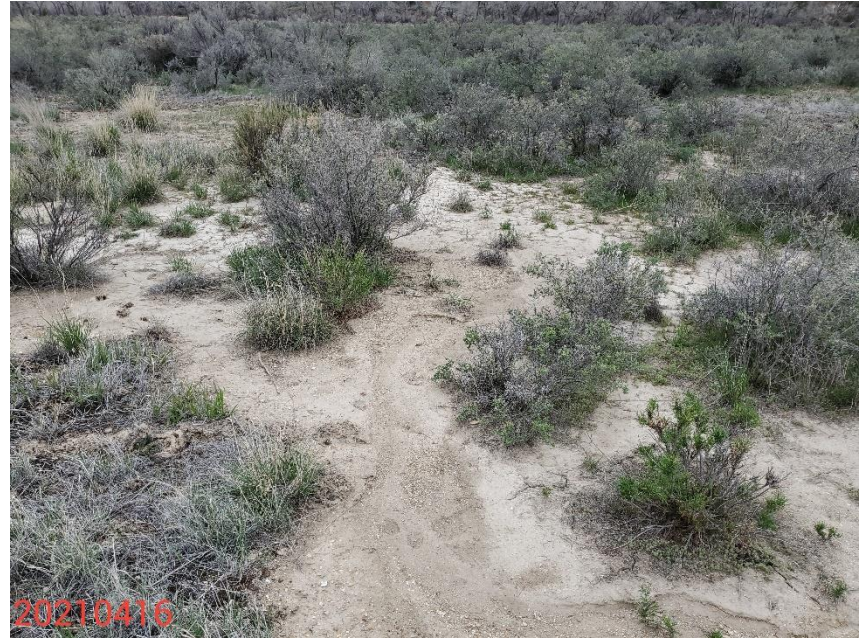
Photo 6: Photo taken from the interim areas on the south end of the Location. Photo shows erosion degradation and sediment deposition from stormwater runoff.

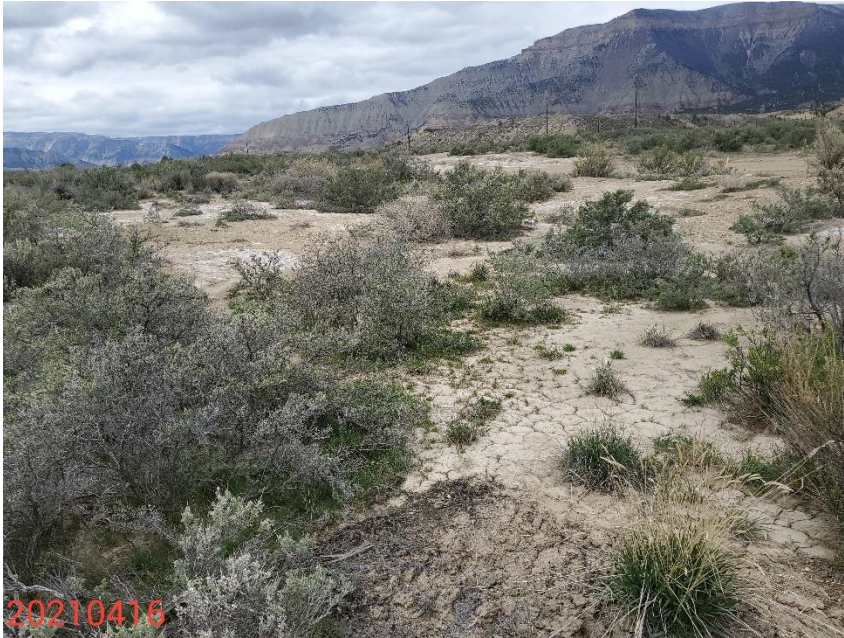
Photo 7: Photo taken from the interim areas on the south end of the Location, facing northwest. Photo shows erosion degradation and sediment deposition from stormwater runoff. Additional reclamation required.

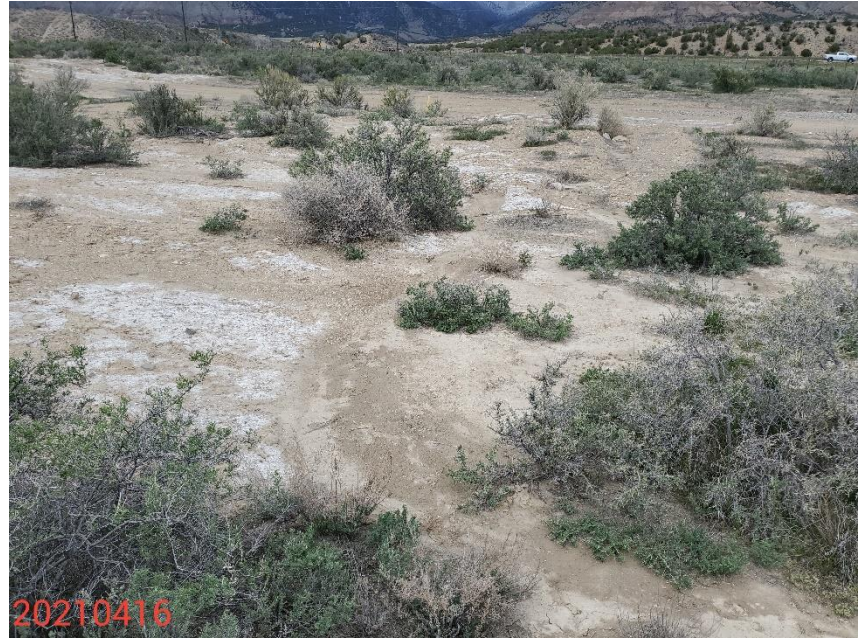
Photo 8: Photo taken from the interim areas on the south end of the Location, facing north. Photo shows erosion degradation and sediment deposition from stormwater runoff. Additional reclamation required.

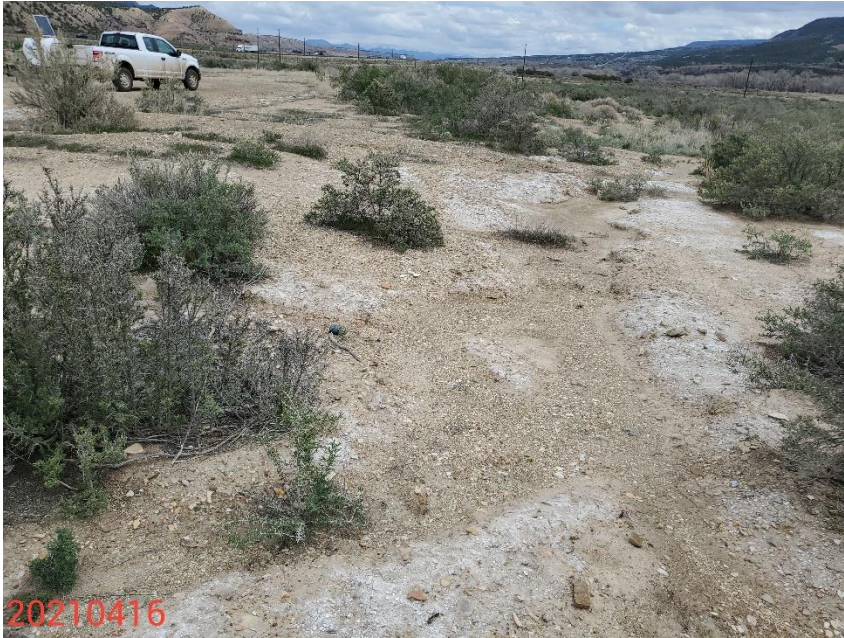
Photo 9: Photo taken from the interim areas on the southwest end of the Location, facing east. Photo shows erosion degradation and sediment deposition from stormwater runoff. Additional reclamation required.

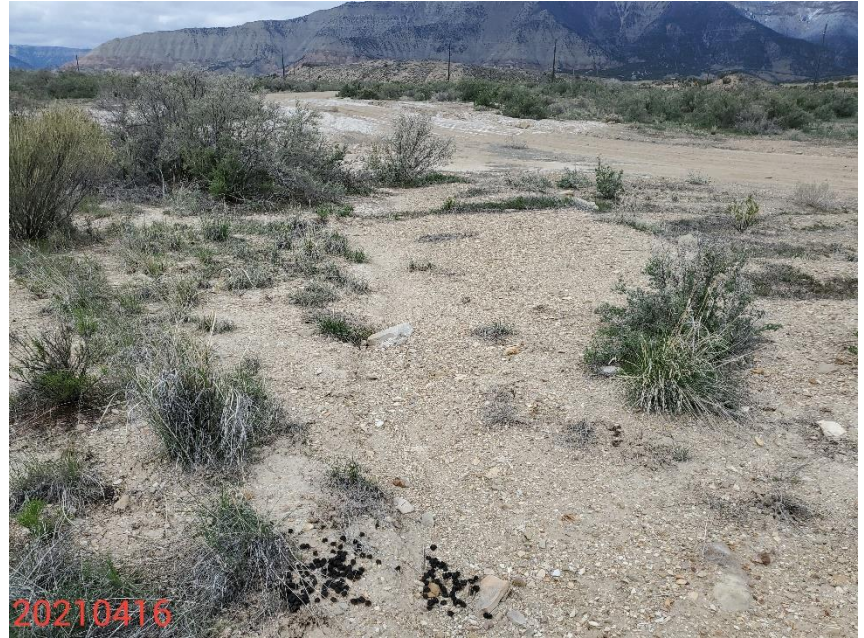
Photo 10: Photo taken from the interim areas on the southwest end of the Location, facing northwest. Photo shows erosion degradation and sediment deposition from stormwater runoff. Additional reclamation required.

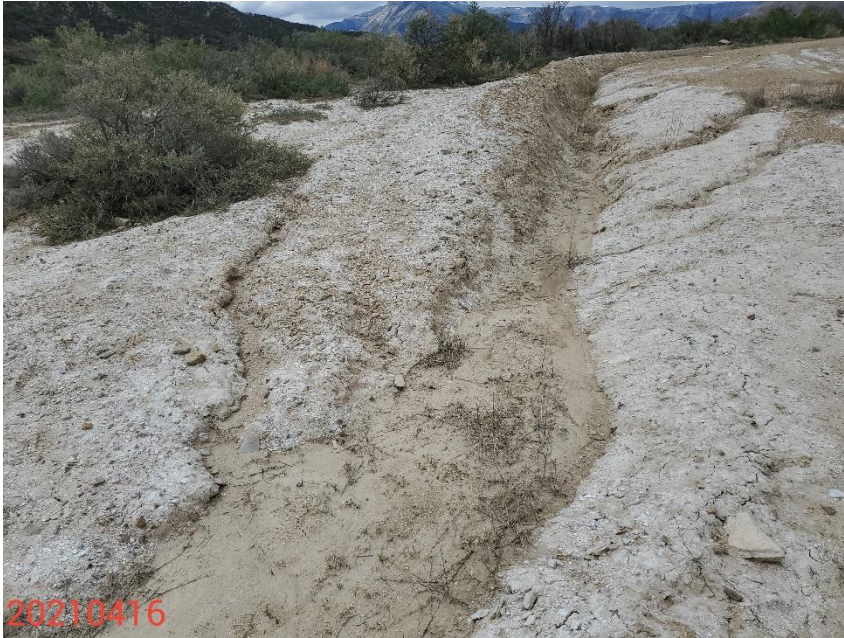
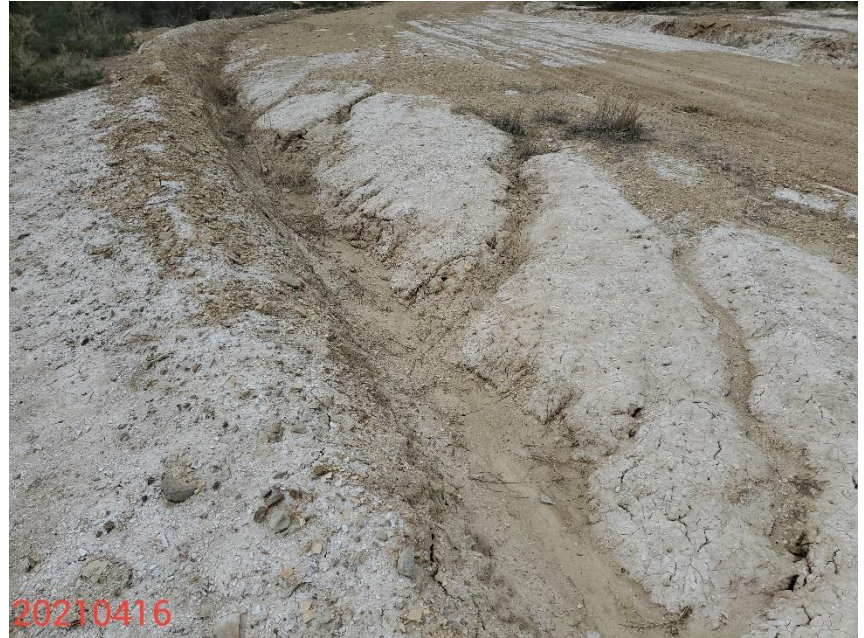
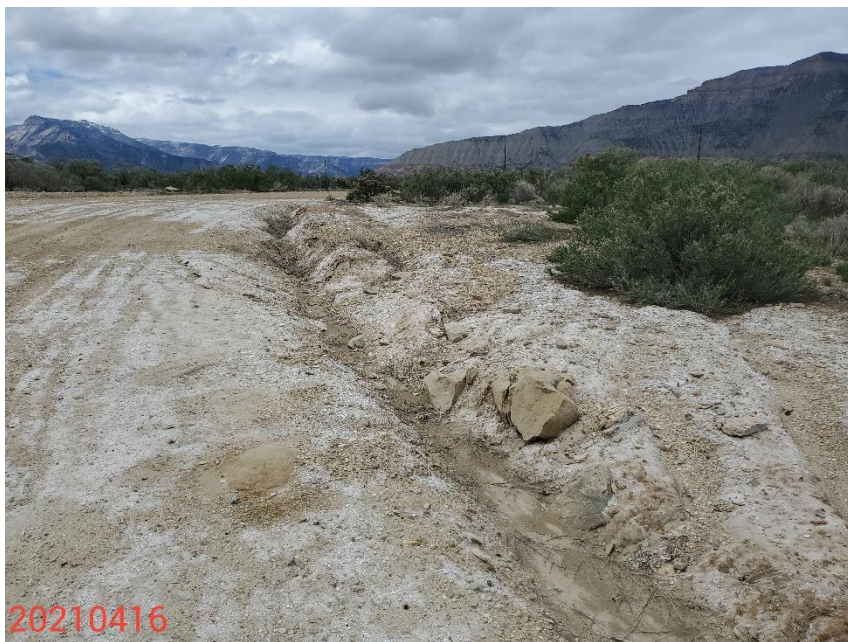
Photo 11: Photo taken from the ditch along the access road, on the west end of the Location, facing west. Photo shows erosion degradation at ditch, and interim areas of the Location; control measure has not been maintained in proper functioning condition. Stormwater ditch has not been constructed with an appropriate outlet; control measure has not been installed in accordance with good engineering practices. Additional reclamation required on interim areas.

Photo 12: See comments under photo 11.

Photo 13: See comments under photo 11.

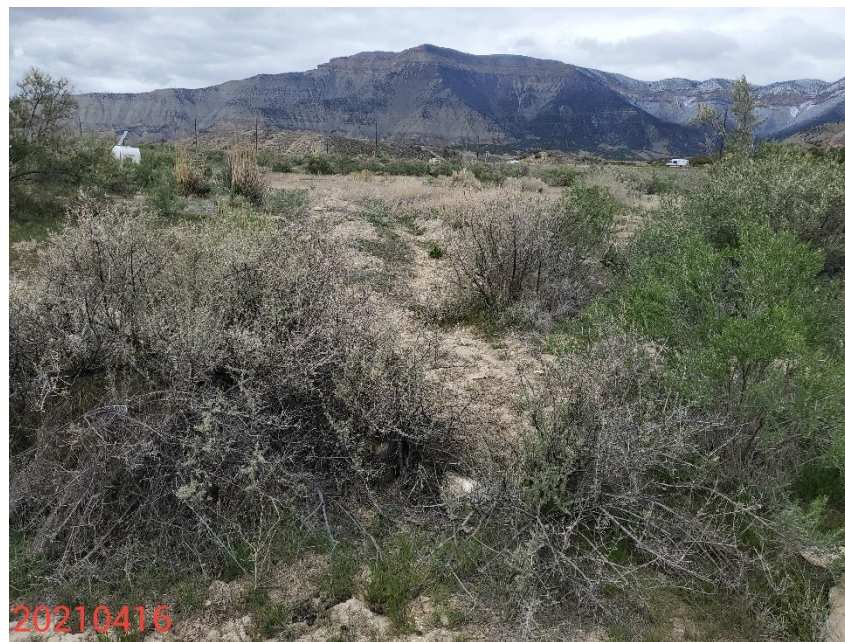
Photo 14: Photo taken from east end of the Location, facing northwest. Photo shows outlet of the stormwater diversion ditch that runs along the north end of the Location. Stormwater ditch has not been constructed with an appropriate outlet; control measure has not been installed in accordance with good engineering practices.

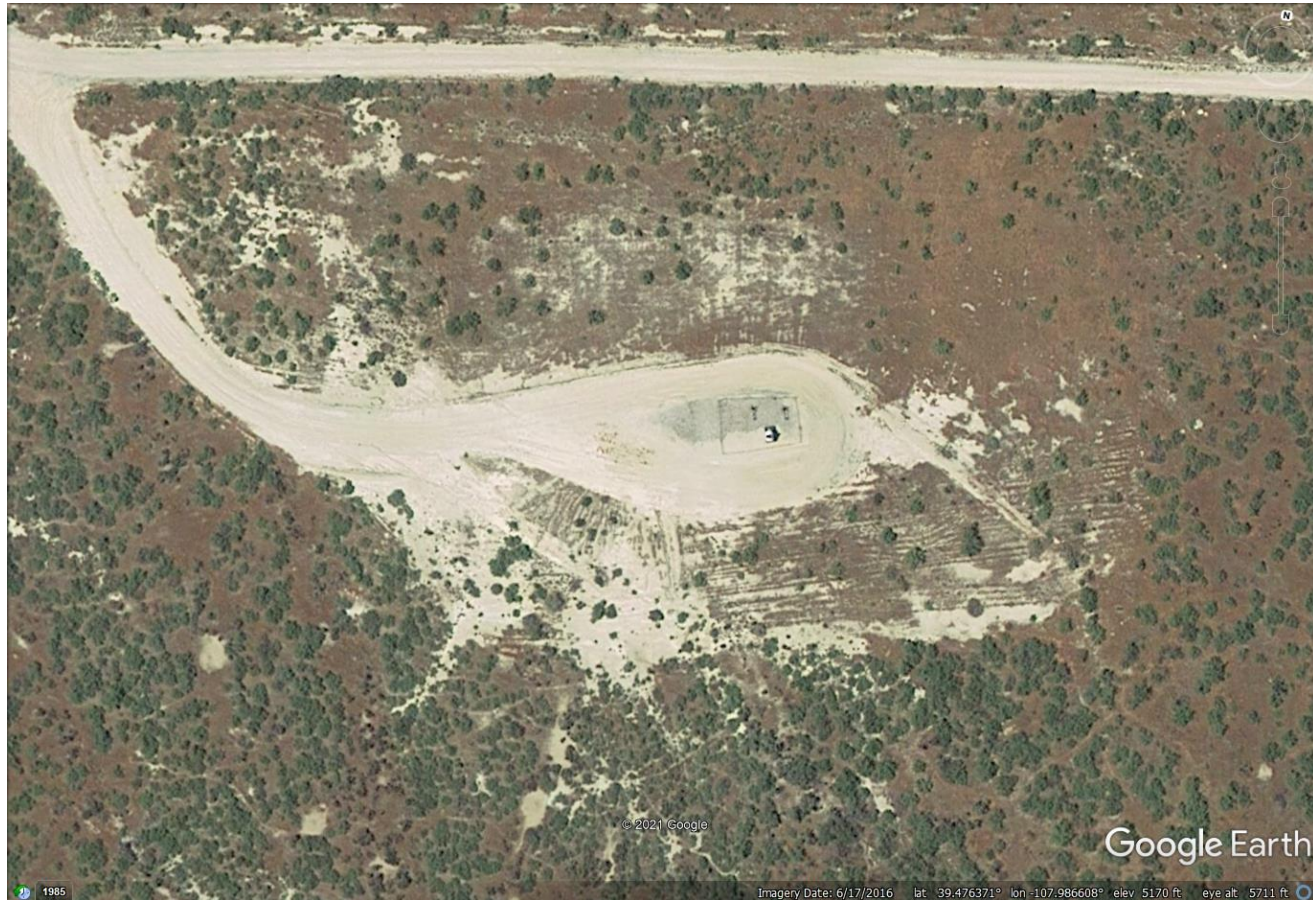
Photo 15: 2016 Google earth aerial image. Photo shows overview of the Location. Photo shows southern interim areas where degradation due to strowmater is evident.
