Inspection Photos

Location Name: CAERUS PICEANCE LLC ENCANA-67S95W /21SENW

Location ID: 334750

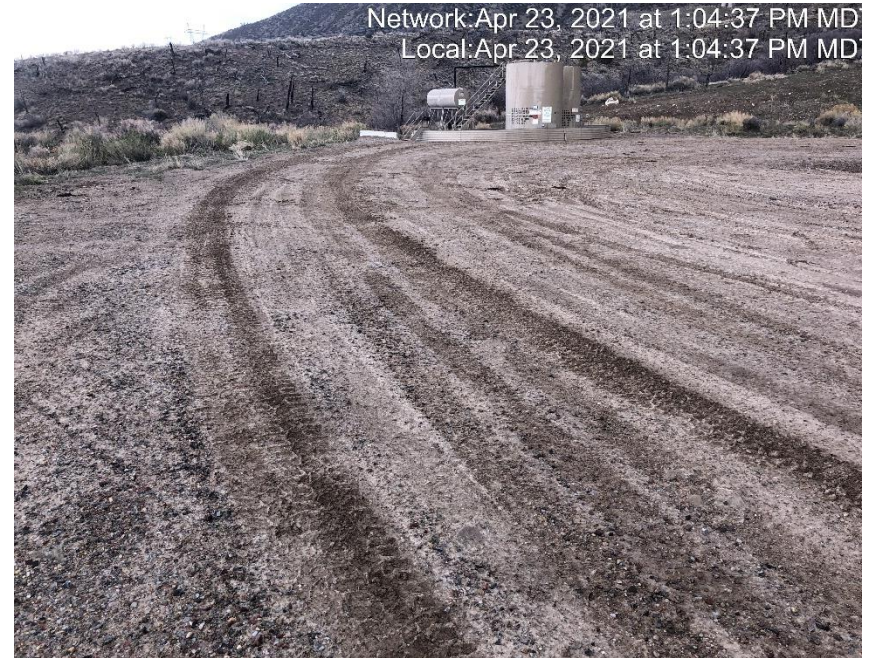
Photo #3601 Location lacks stabilization

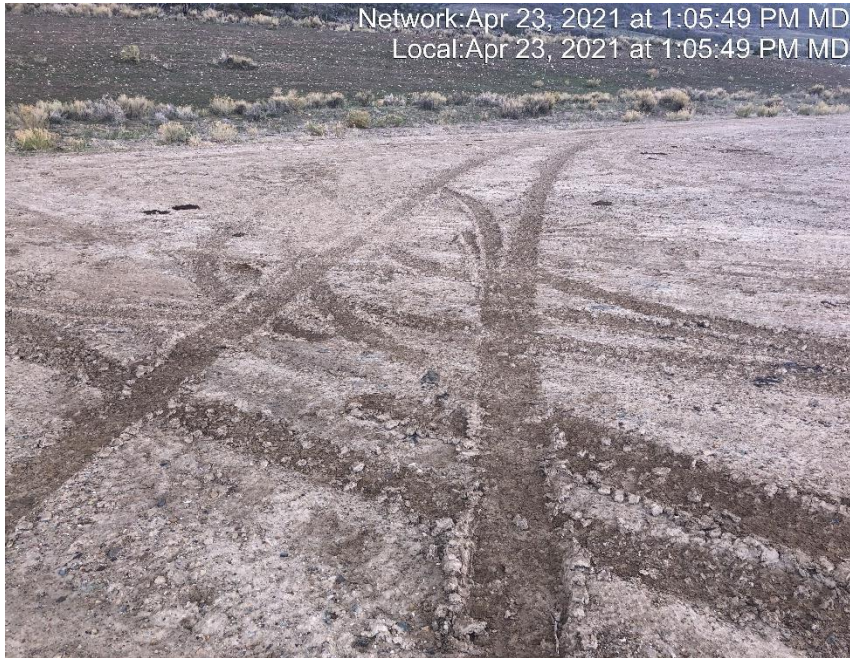
Photo #3603 location lacks stabilization

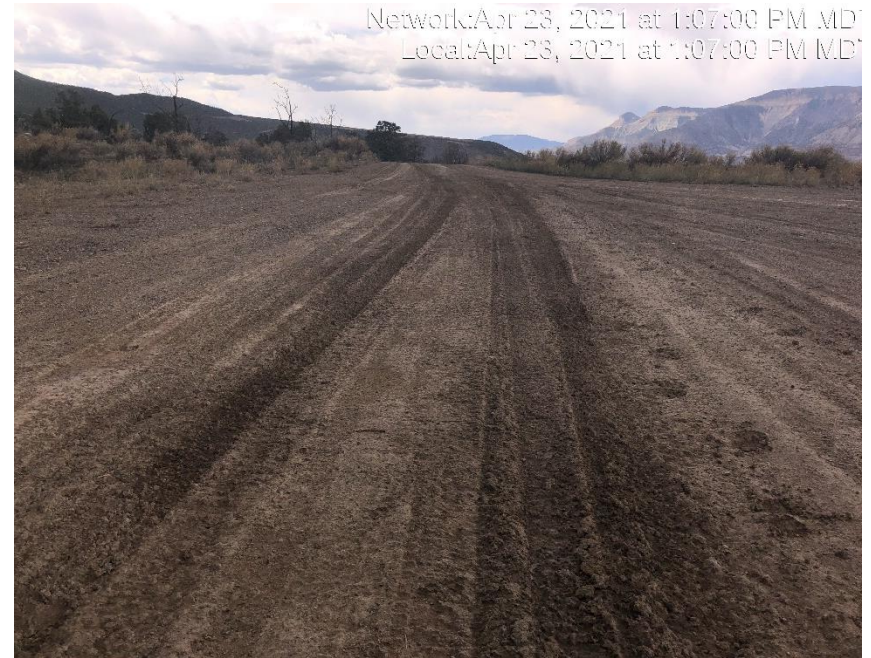
Photo #3604 No form of tracking BMP at entrance to location.

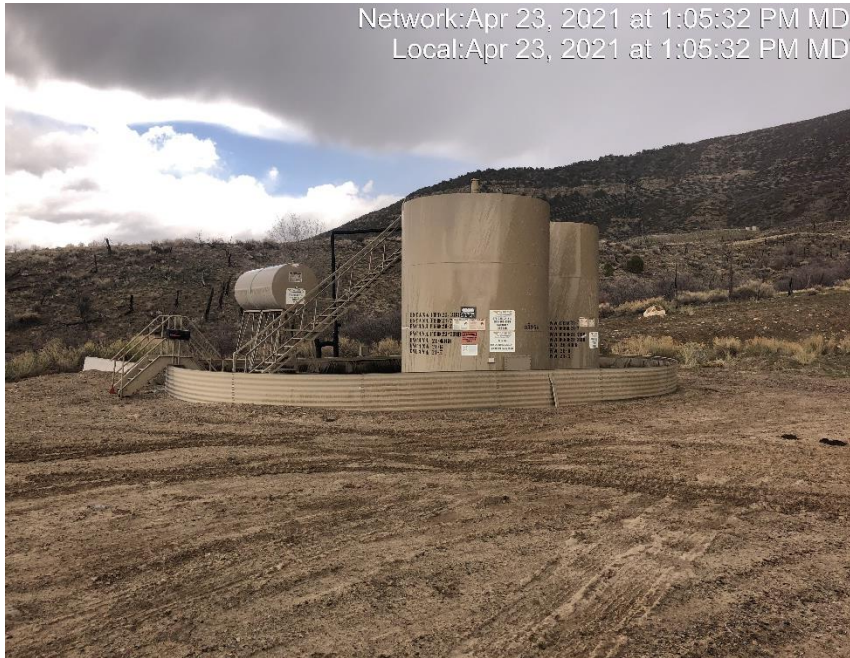
Photo #3602 No tank battery sign located at the tank battery.
