Inspection Photos

API: 043-06231

Operator: AUSCO PETROLEUM INC

Inspection Date: 4/22/2021

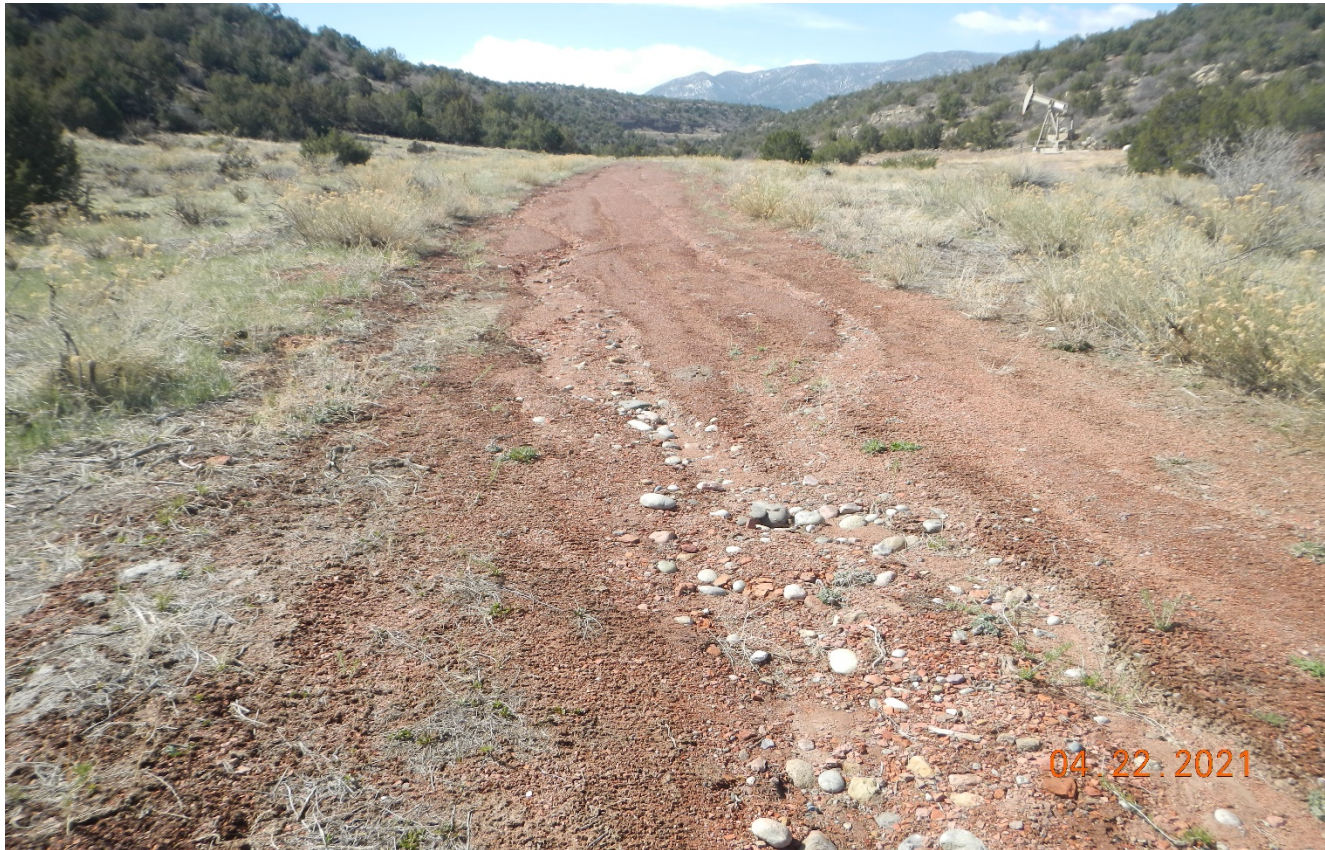
Photo 1. Facing south along the access road. There is erosion occurring down the road which needs to be repaired and stormwater needs to be diverted off the road. Previous corrective action has not been performed.

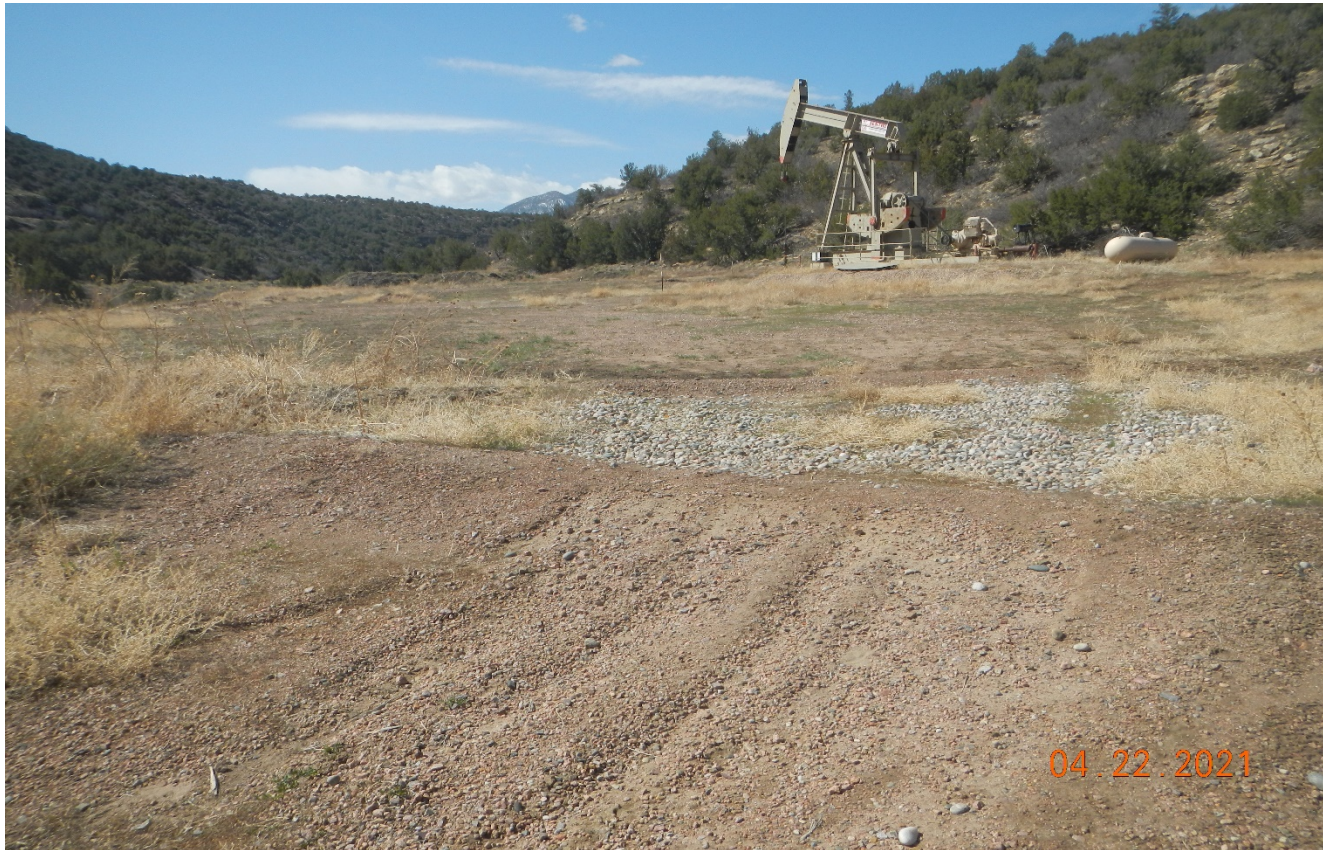
Photo 2. Facing southwest toward the location. There is undesirable weeds throughout the location. Interim reclamation has not been performed.

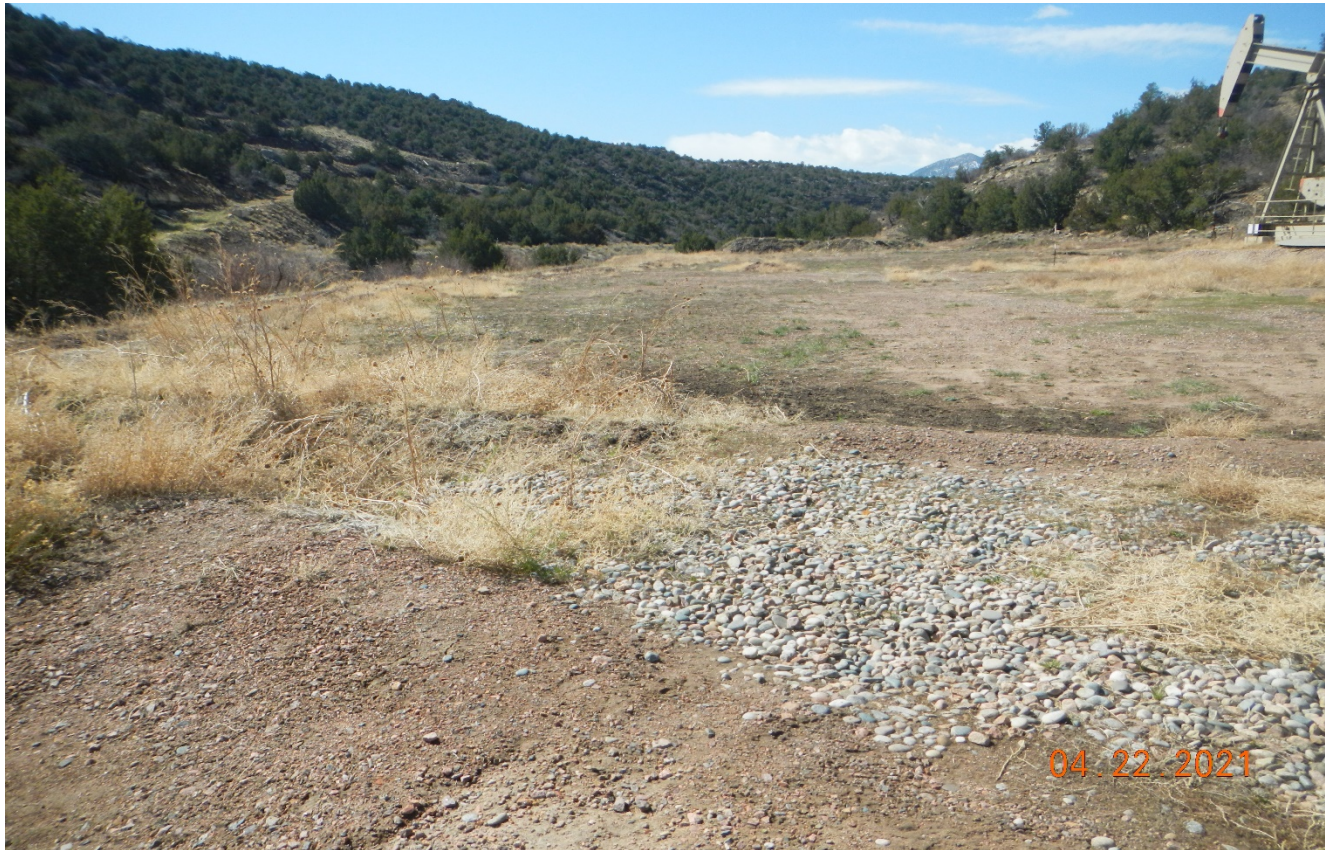
Photo 3. Facing southeast at the location. Unused areas of the location have not been reclaimed. Previous corrective action has not been performed.

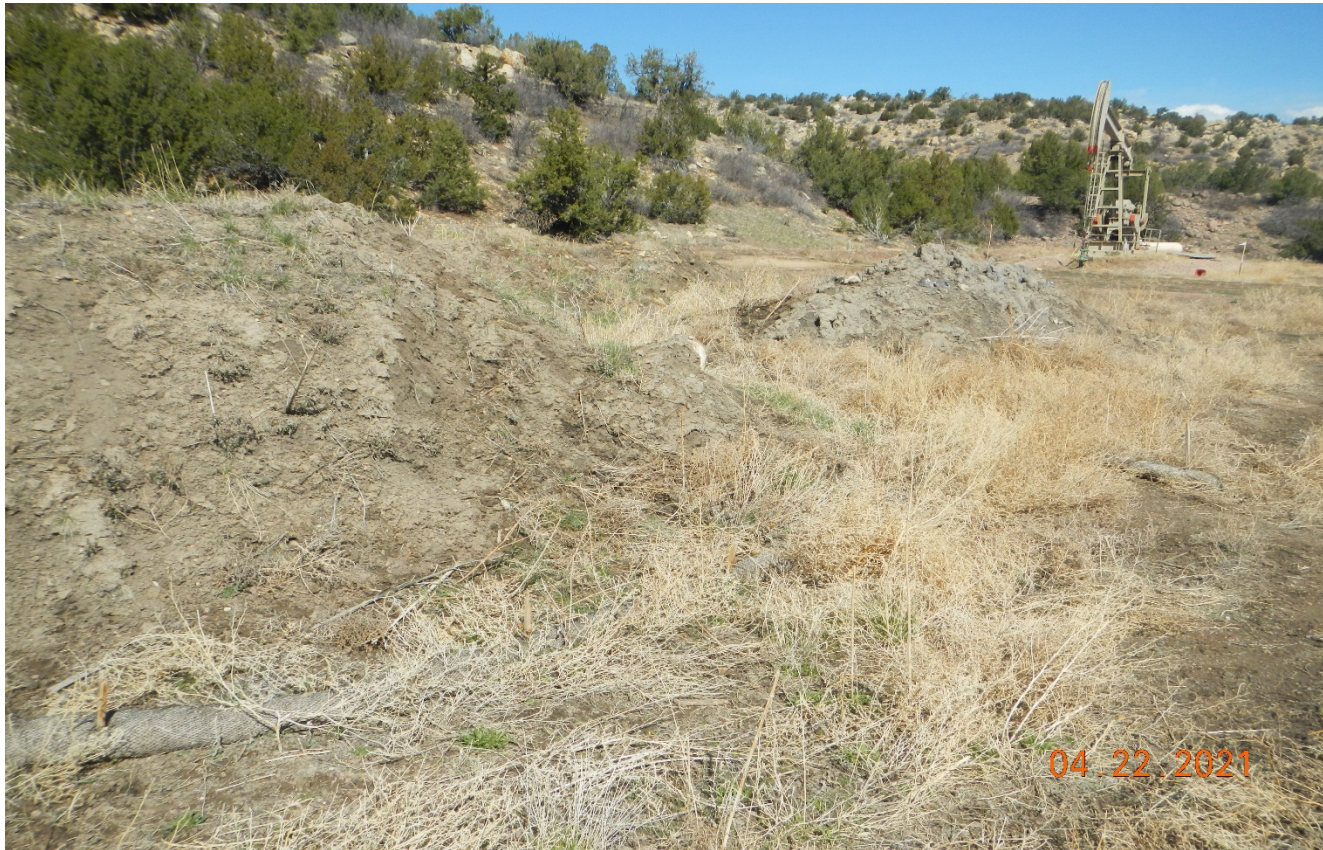
Photo 5. The soil piles are not maintained and have undesirable weeds. The soil piles need to be replaced for interim reclamation. Previous corrective action has not been performed.

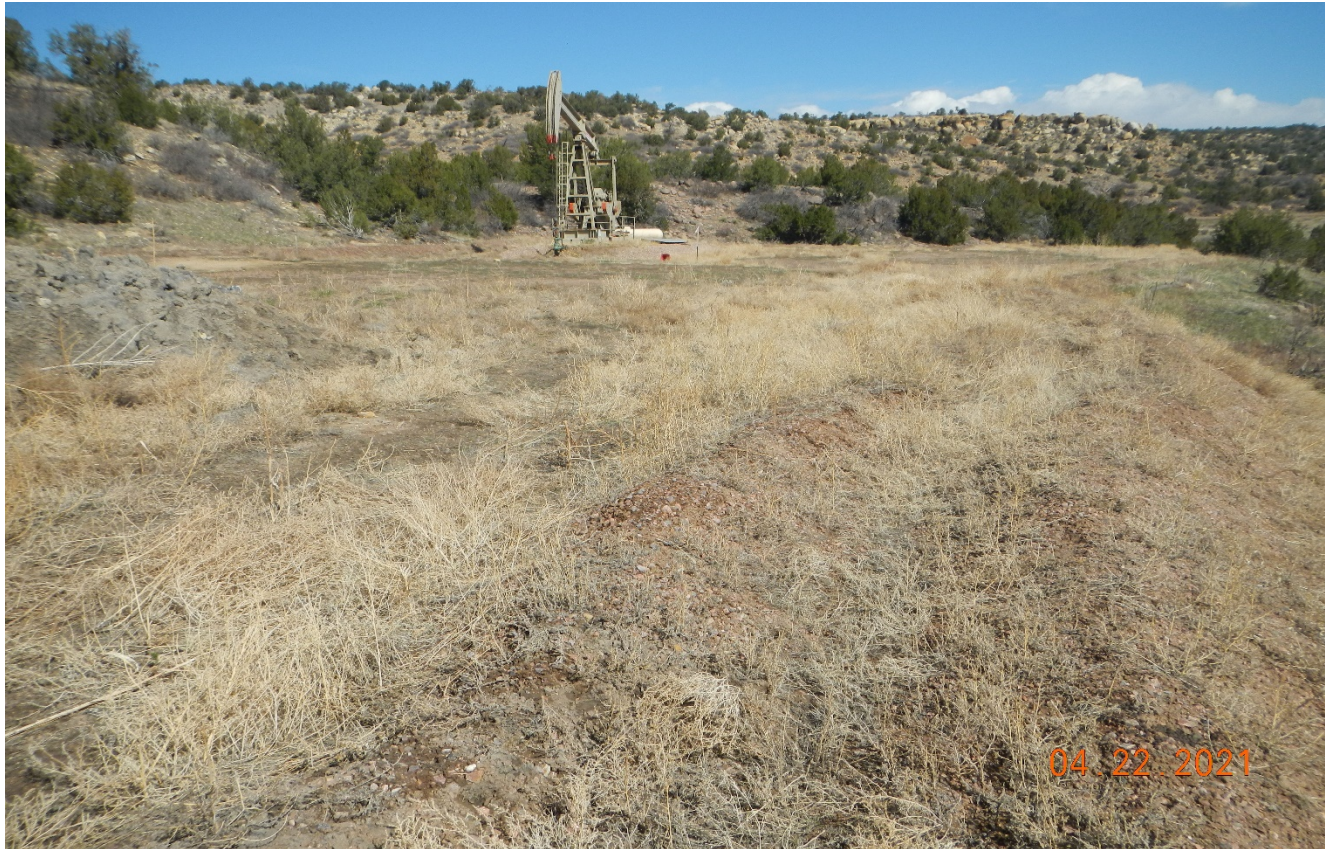
Photo 6. Facing north along the fill slope of the location. There is undesirable weeds (Russian thistle) throughout the location.

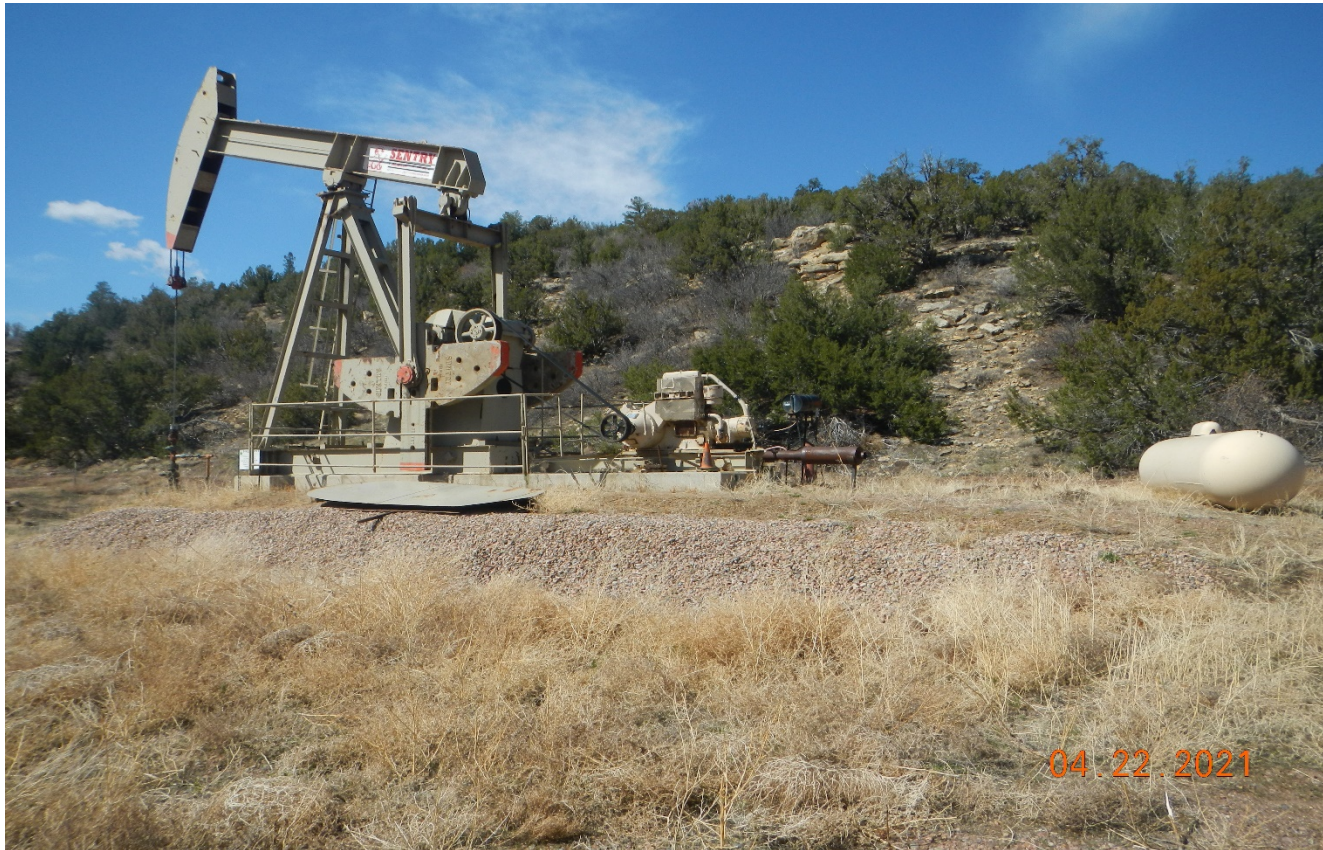
Photo 8. Facing southwest toward the production equipment. Undesirable weed debris needs to be removed.

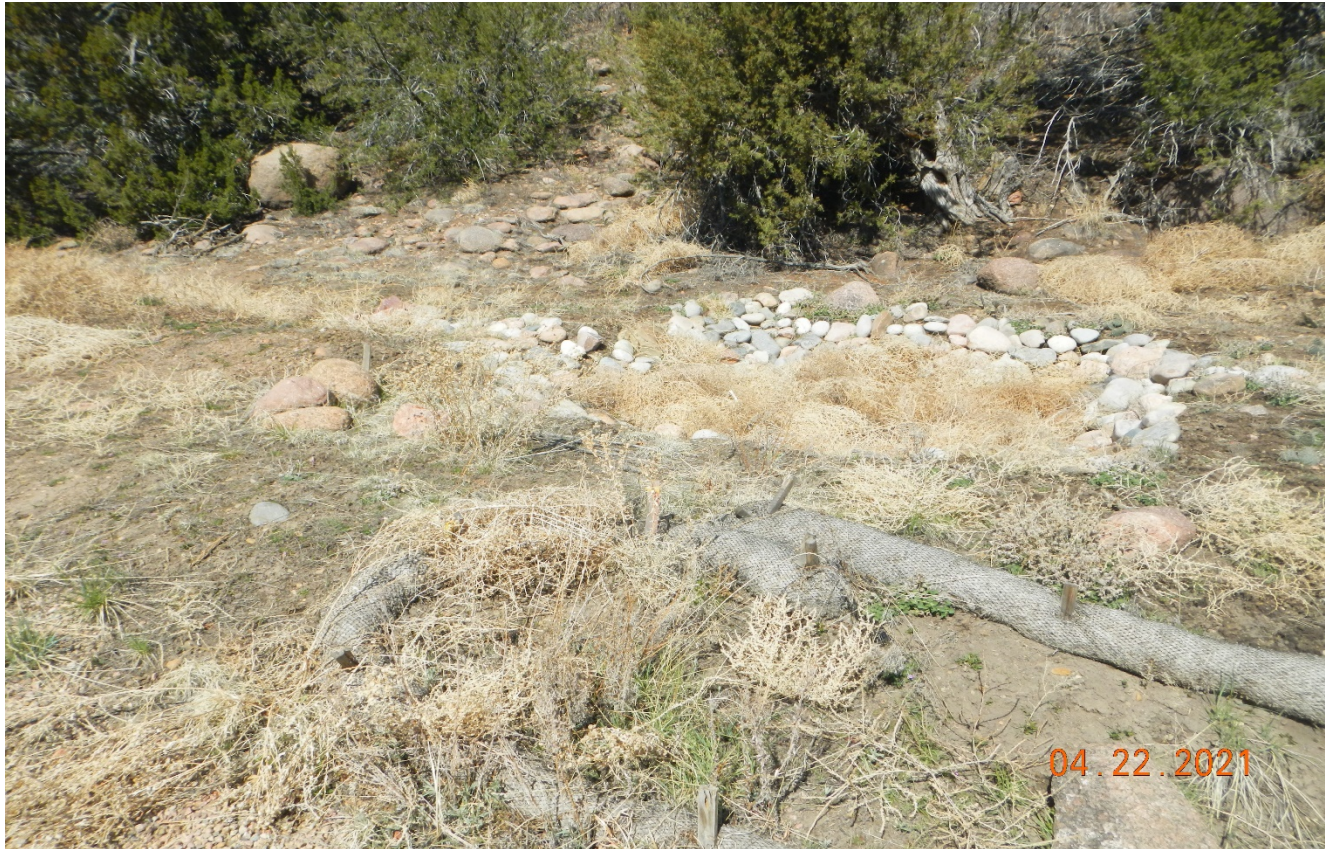
Photo 9. Facing toward the sediment trap. Undesirable weed debris needs to be removed out of sediment trap.
