# Inspection Photos

API: 043-06219

Operator: AUSCO PETROLEUM INC

Inspection Date: 4/22/2021

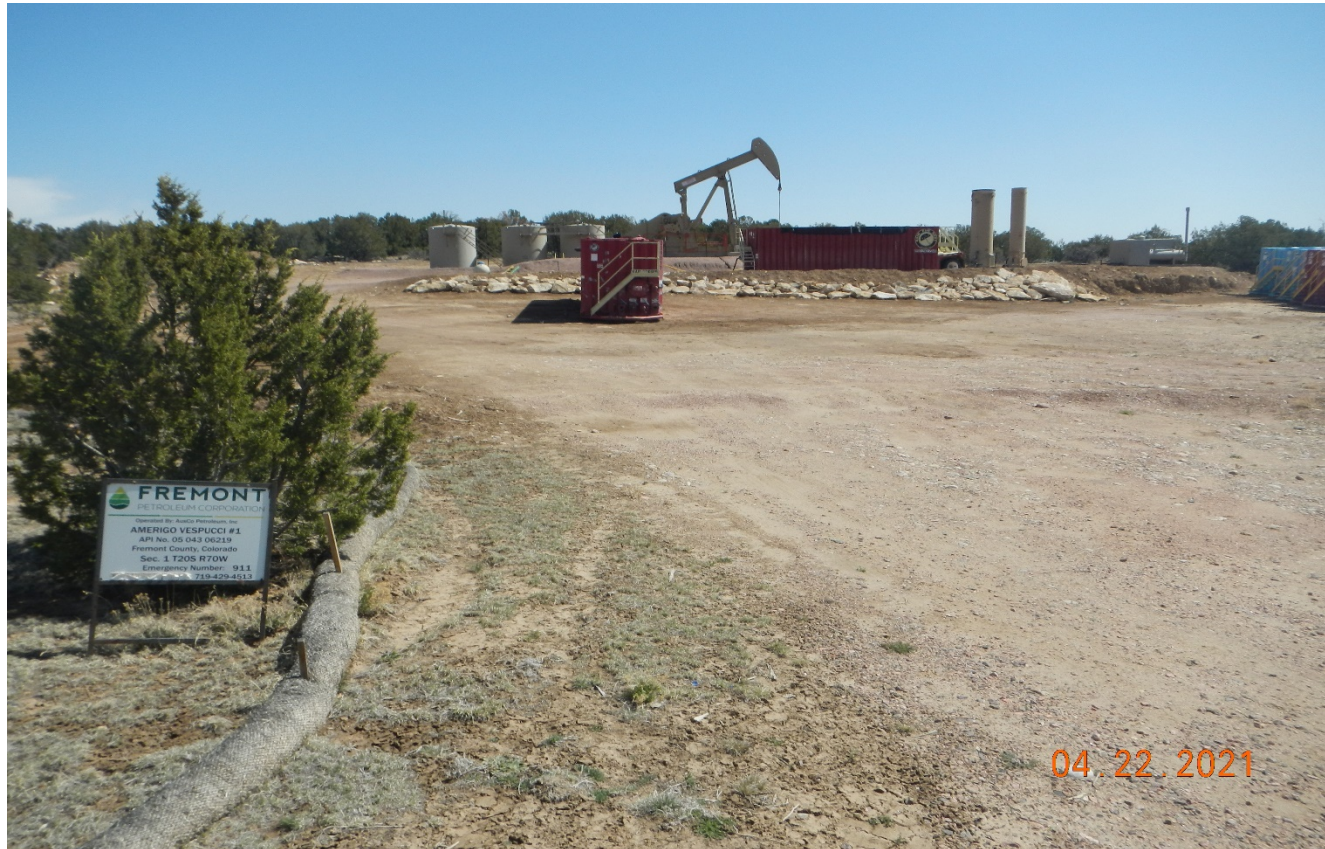
**Photo 1.** Facing northeast toward the location. Unused equipment has not been removed and interim reclamation has not been performed.

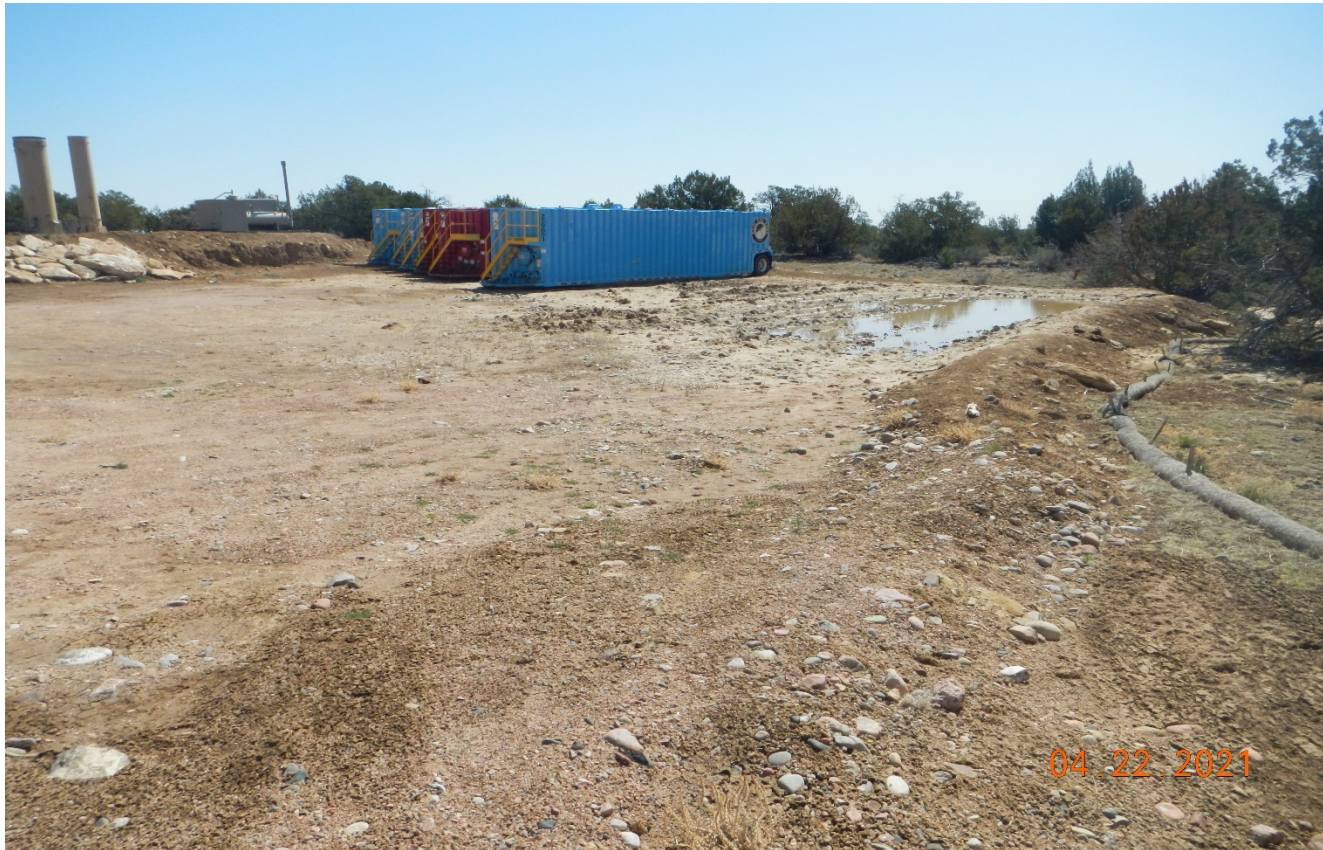
**Photo 2.** Facing east at the location. There is 5 frac tanks staged that remain at east side of the location. The tanks have not been removed since previous inspection. Previous corrective actions have not been performed.

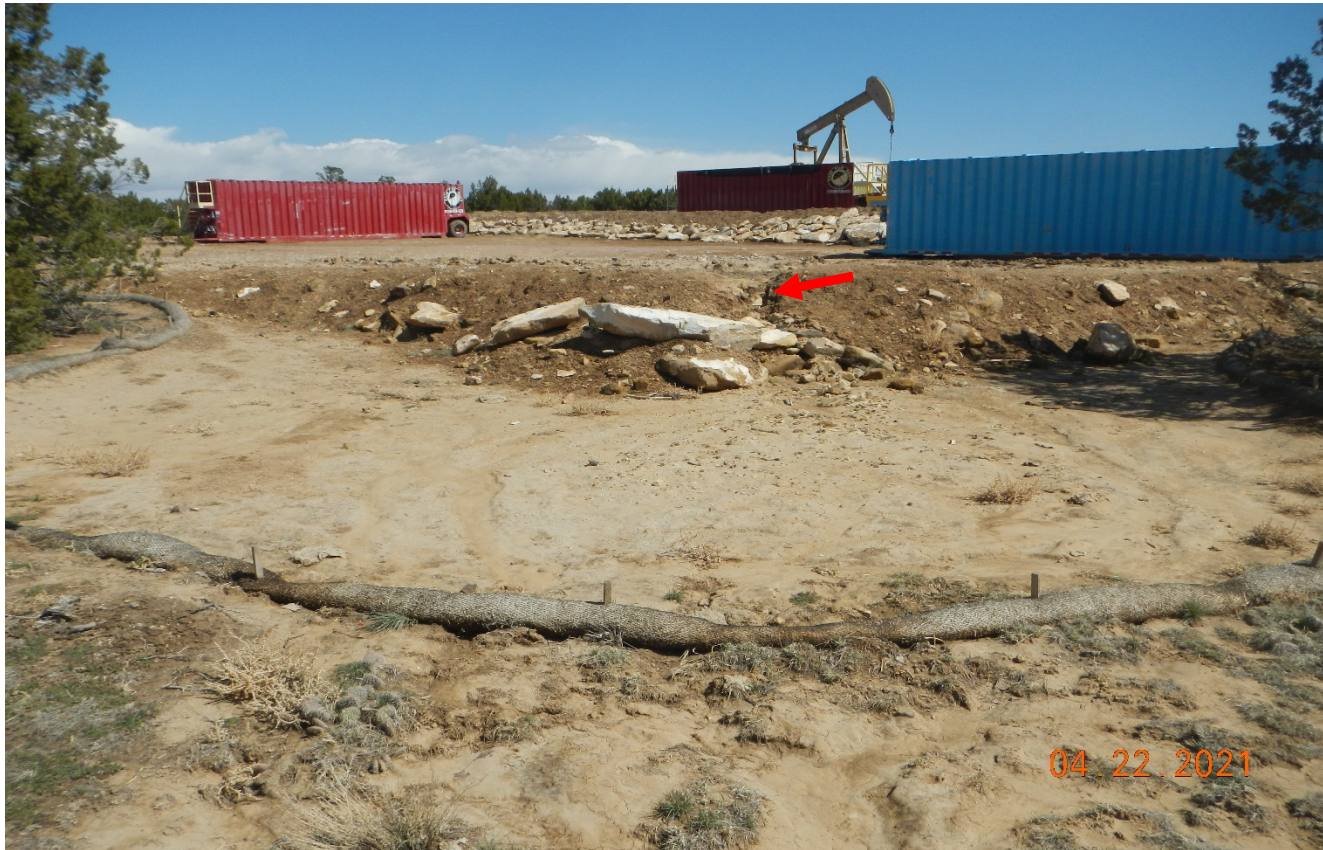
**Photo 3.** Facing north at the south corner of the location. There is erosion occurring from the disturbed pad site which is filling in the perimeter wattles. Previous corrective action has not been performed.

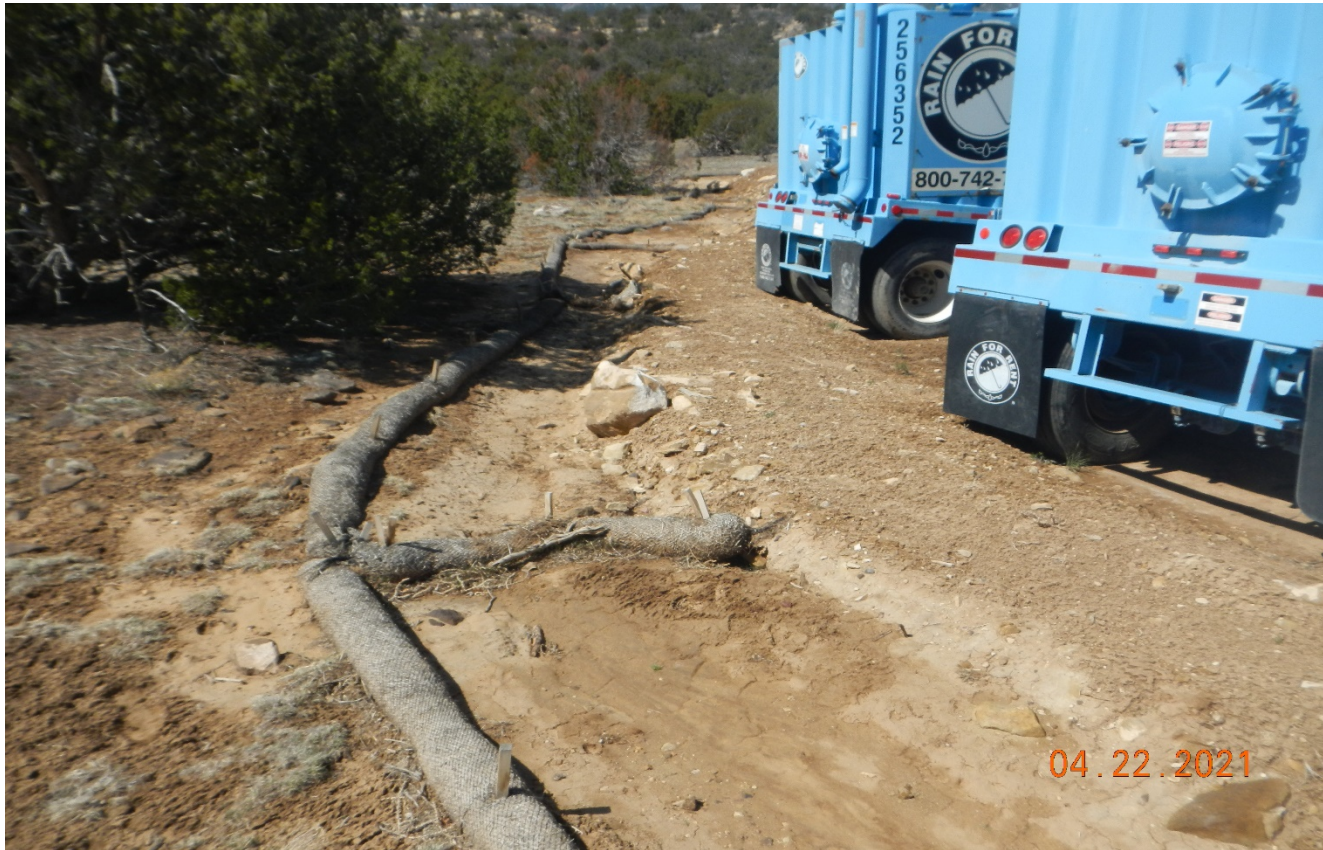
**Photo 4.** Facing southwest behind the frac tanks. The wattles have filled in with sediment. Previous corrective action has not been performed.

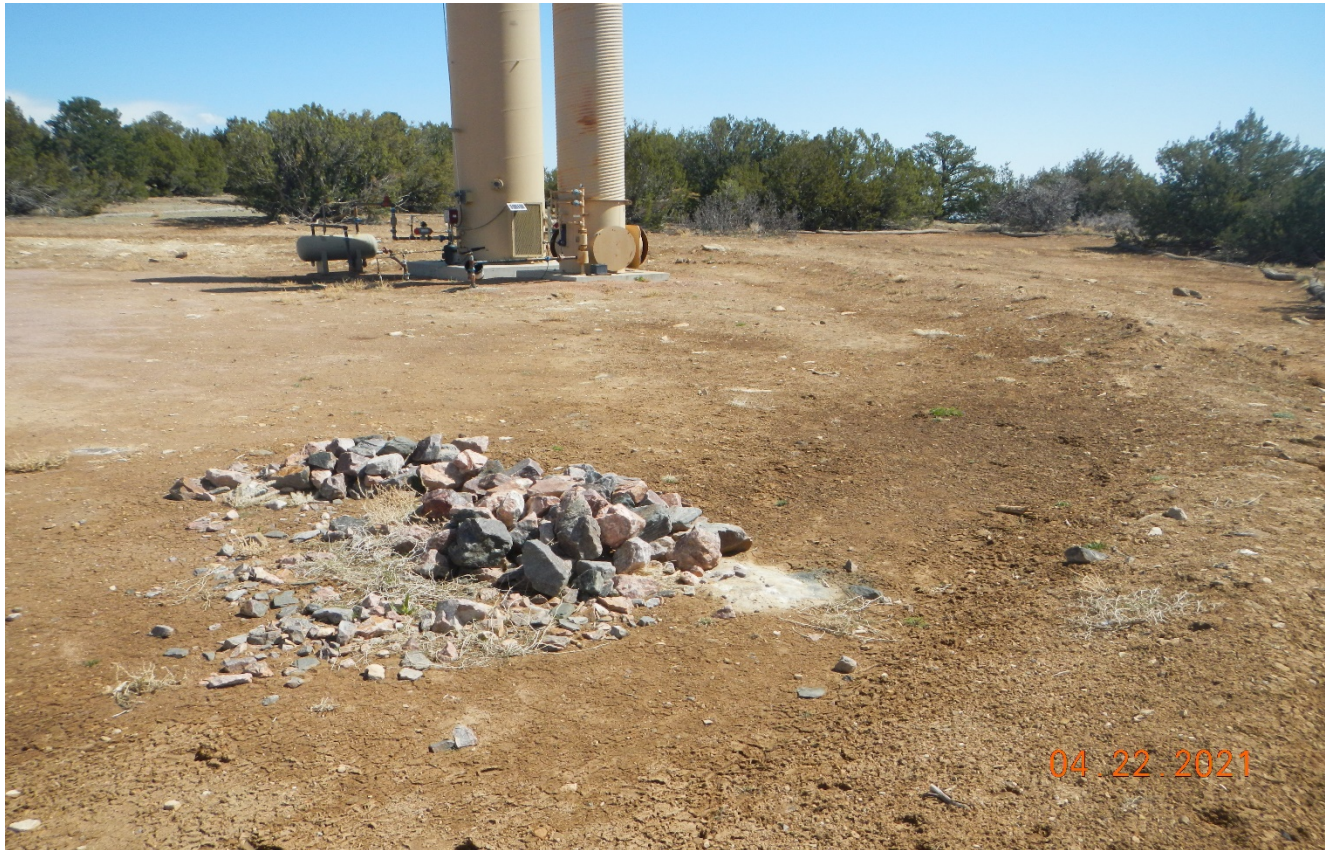
**Photo 5.** Facing north at the location. Disturbed areas around the location have not been reclaimed and stabilized. A pile of rock debris remains in this area.

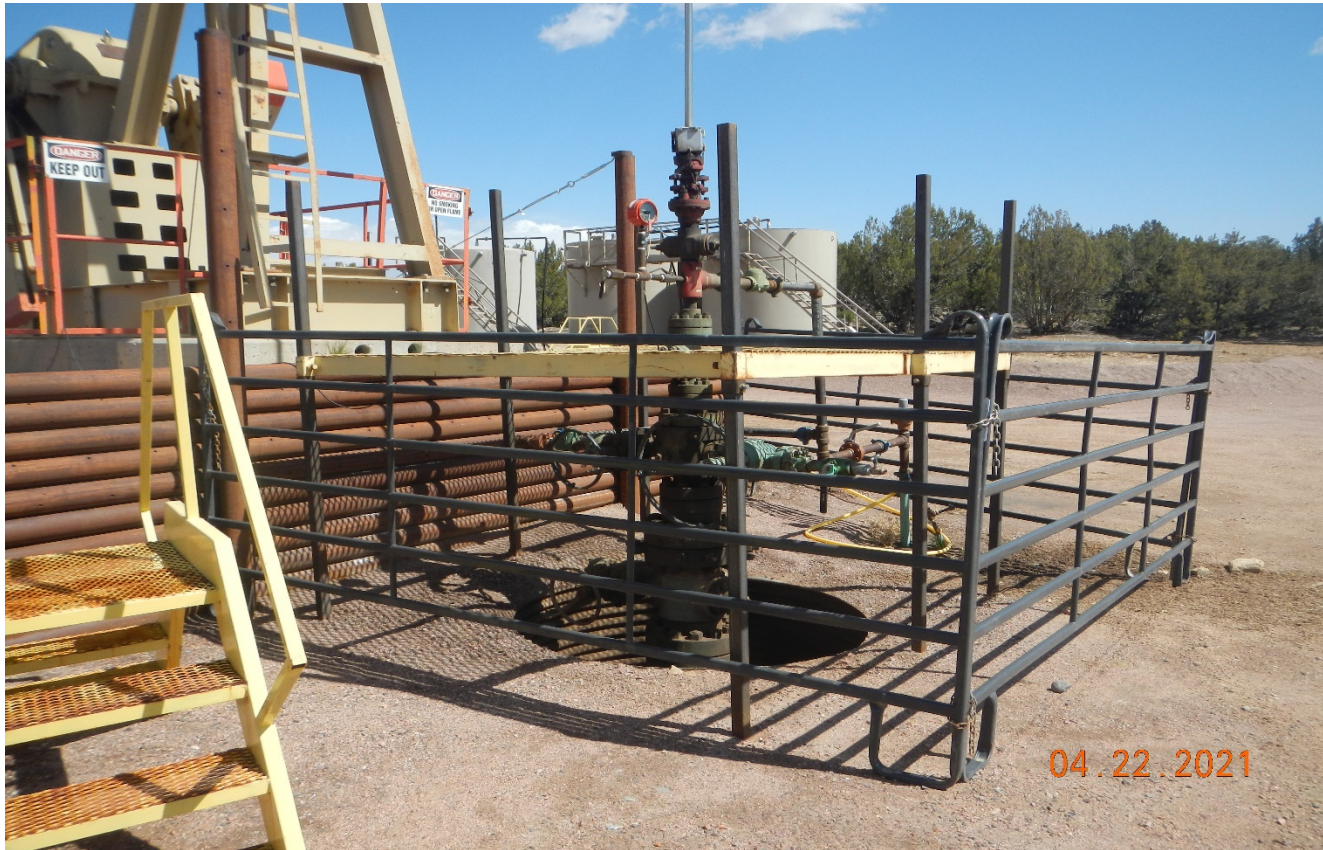
**Photo 7.** There was an audible gas leak heard from the wellhead. Operator was contacted during inspection of this issue.

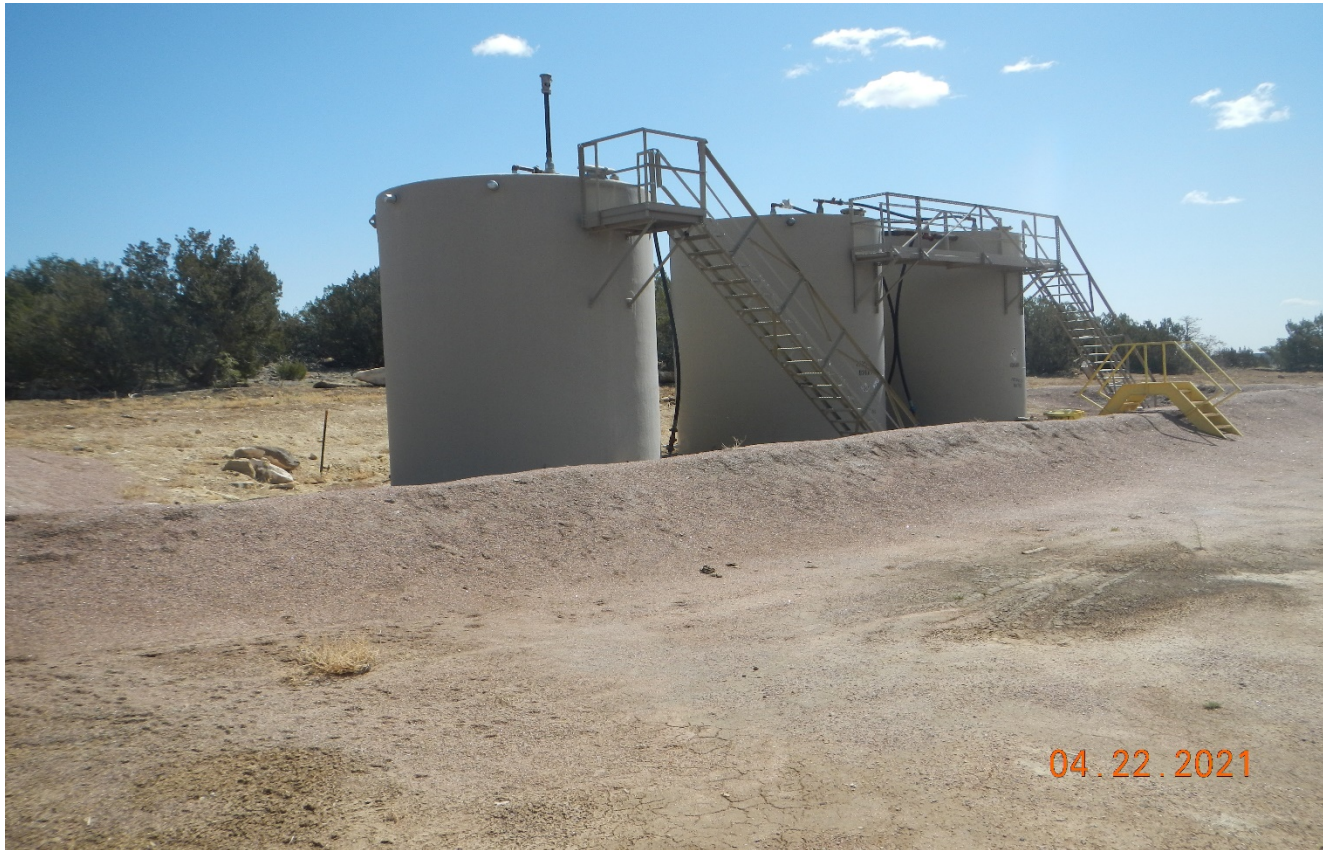
**Photo 8.** The tanks at north side of the location are not properly labeled.

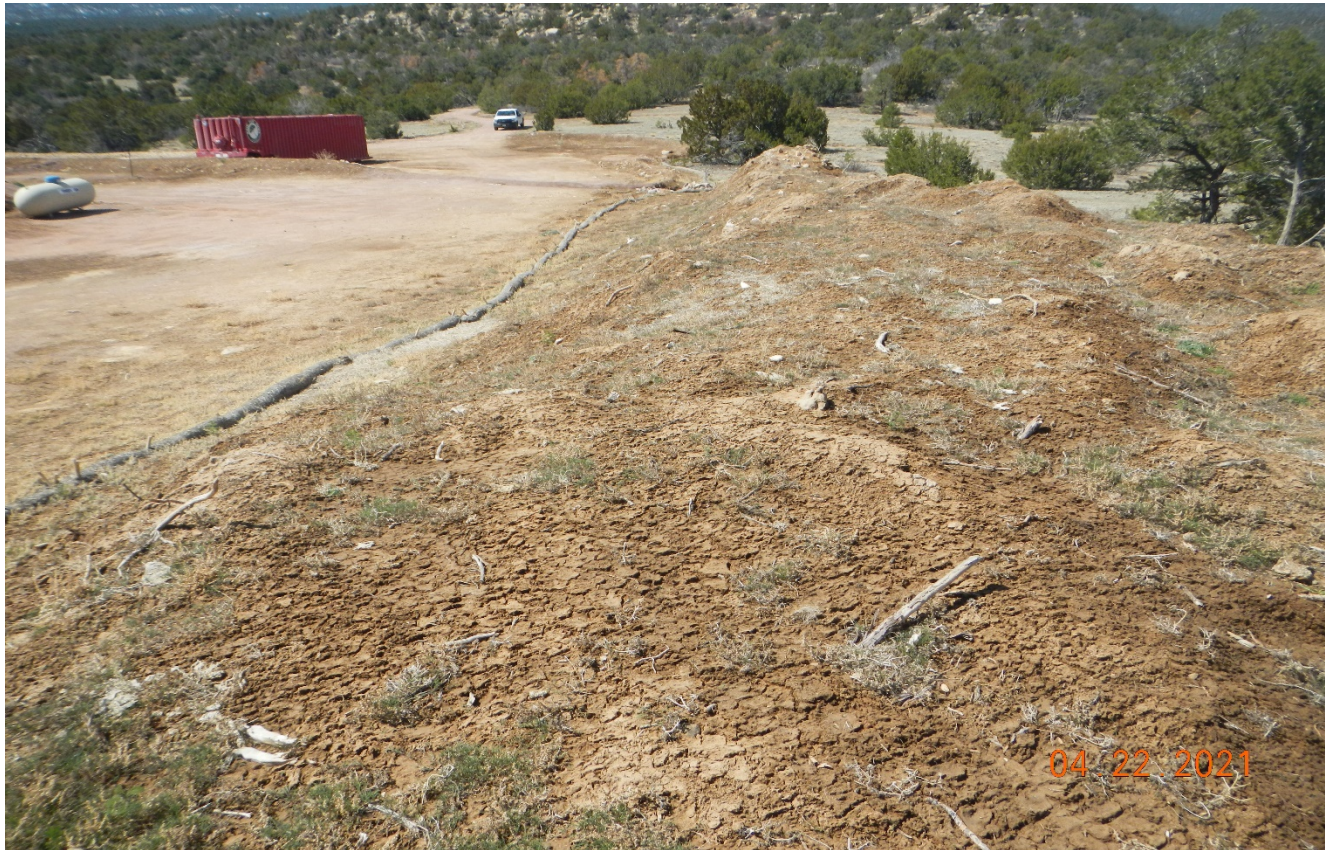
**Photo 10.** Facing toward the topsoil pile. The topsoil piles are not stabilized and protected. Topsoil piles have not been replaced for interim reclamation. There are undesirable weeds germinating on the stockpiles.

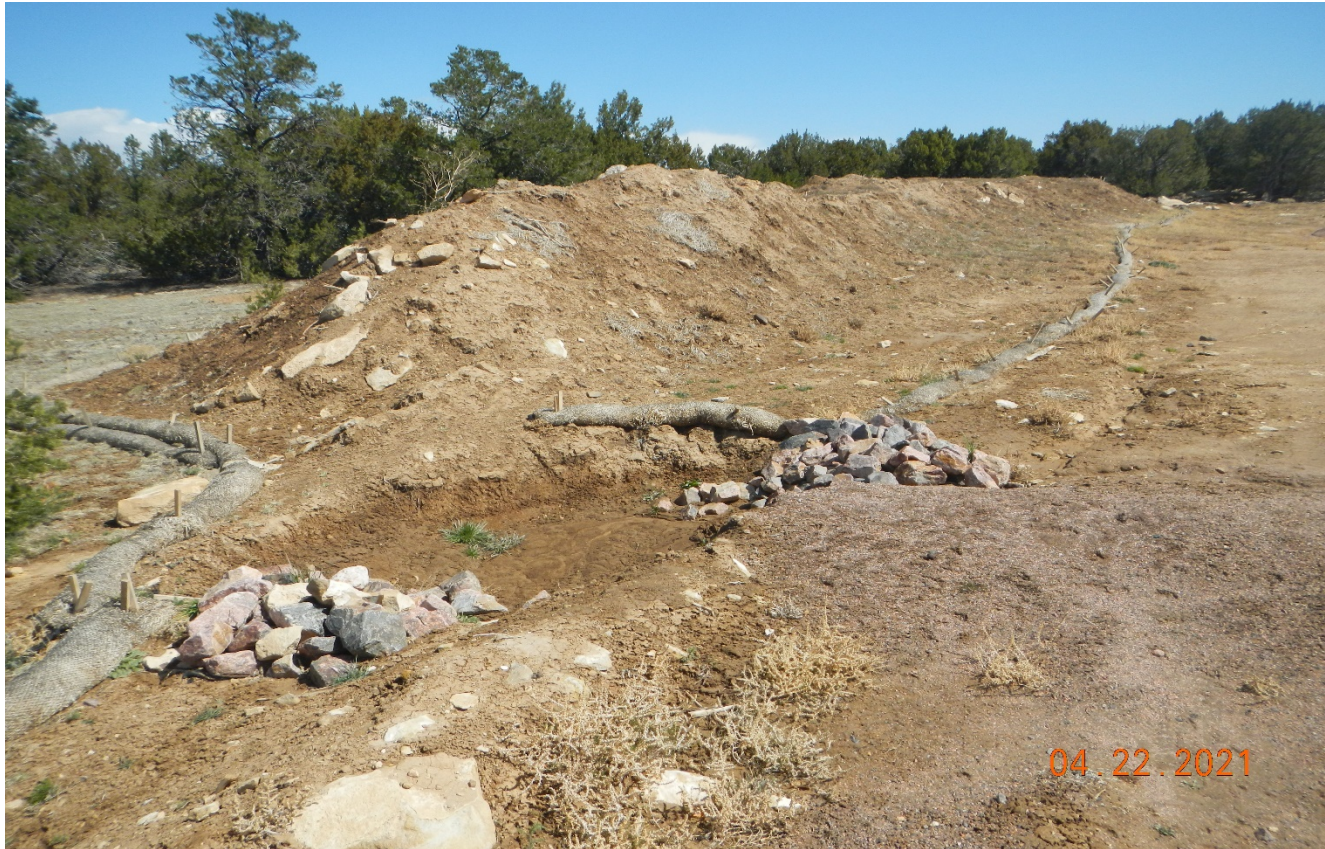
**Photo 11.** Facing northwest toward the topsoil pile which are not maintained and protected from degradation and weed infestation. Previous corrective action has not been performed. The BMP's around the stockpile are not maintained.

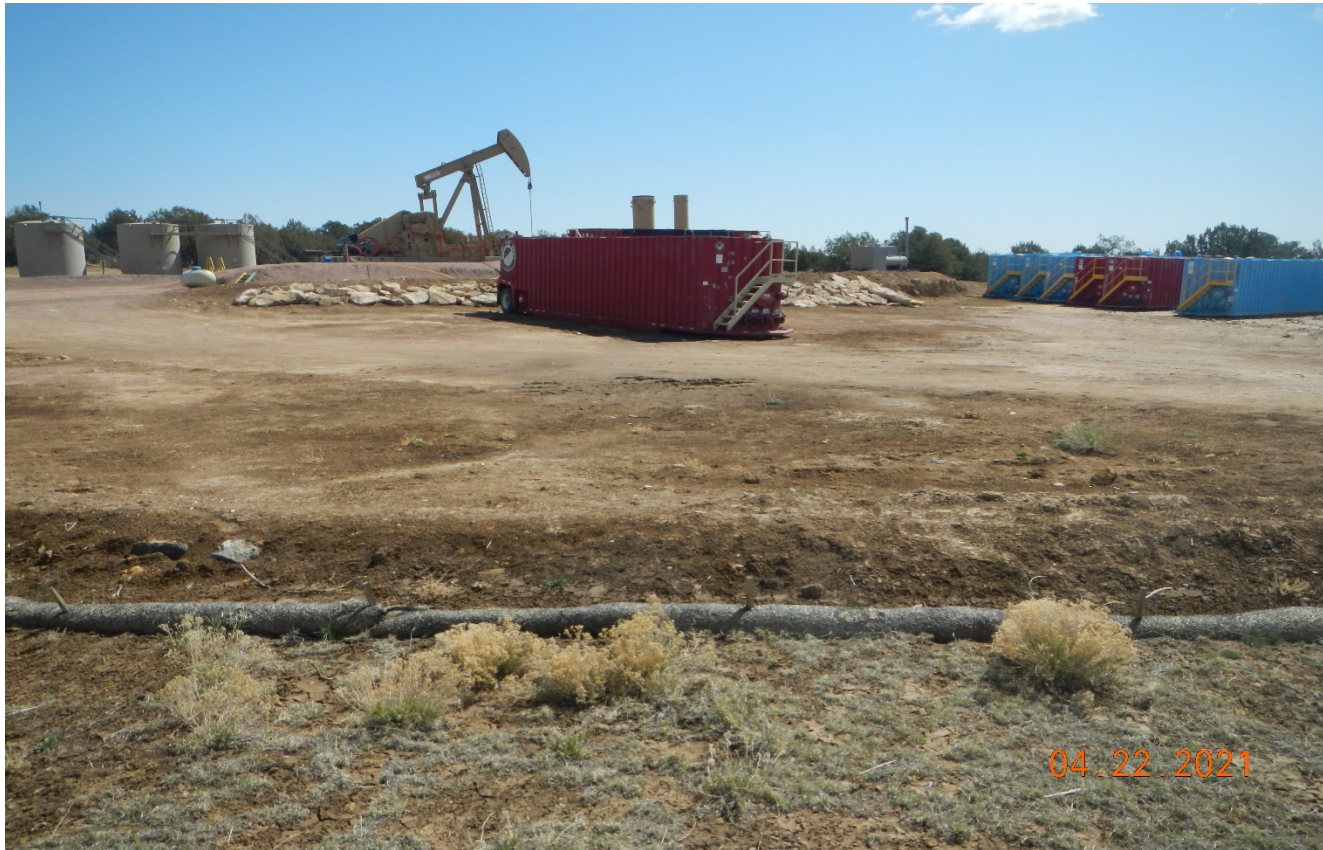
**Photo 12.** Facing northeast toward the location. The unused tanks need to be removed. Unused areas of the location need to be recontoured and reclaimed. Previous corrective actions have not been performed.
