Inspection Photos

API: 043-06221

Operator: AUSCO PETROLEUM INC

Inspection Date: 4/22/2021

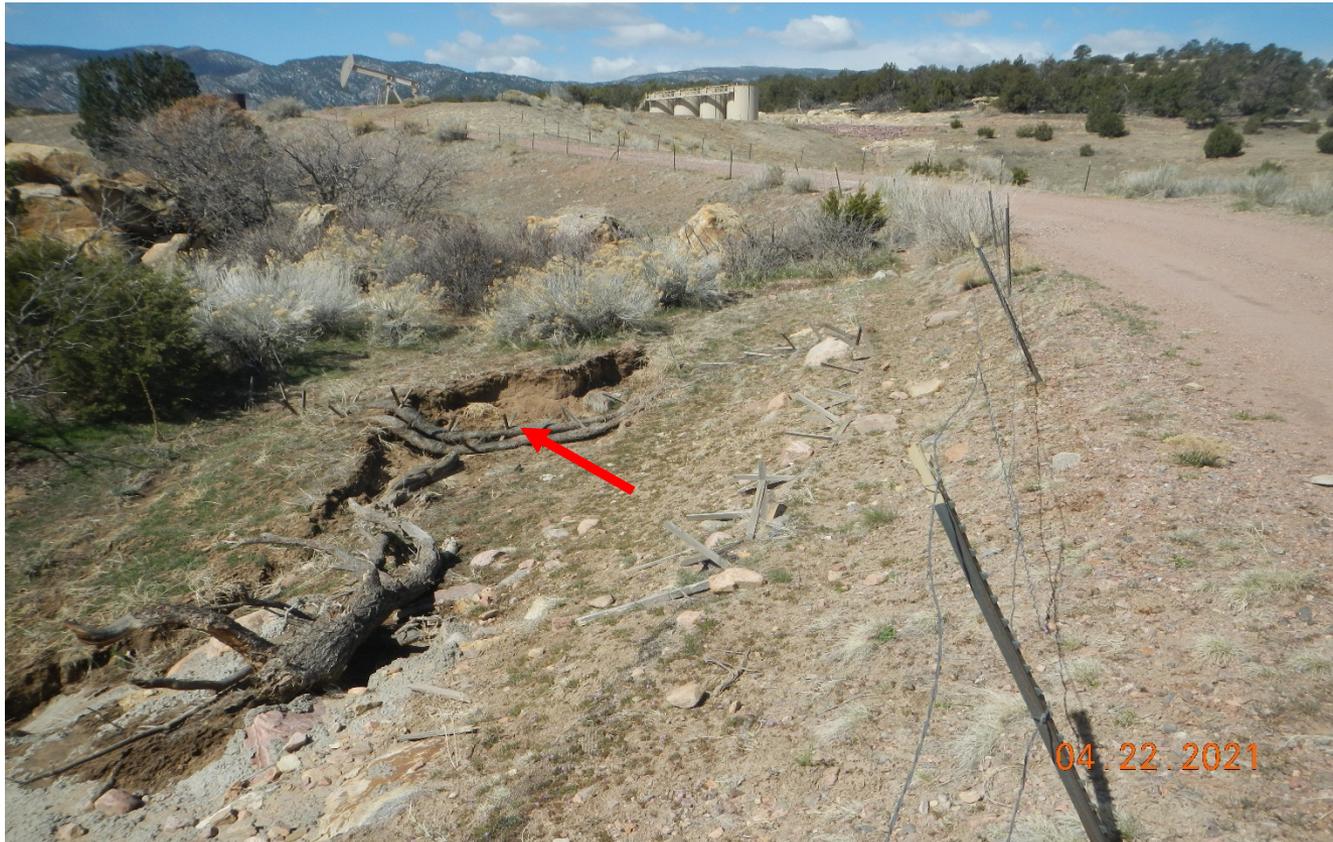
Photo 1. Facing southwest along the access road. Stormwater from the road is creating erosion in area shown at red arrow.. The wattles placed in this area are displaced and are not controlling erosion. Previous corrective action has not been performed.

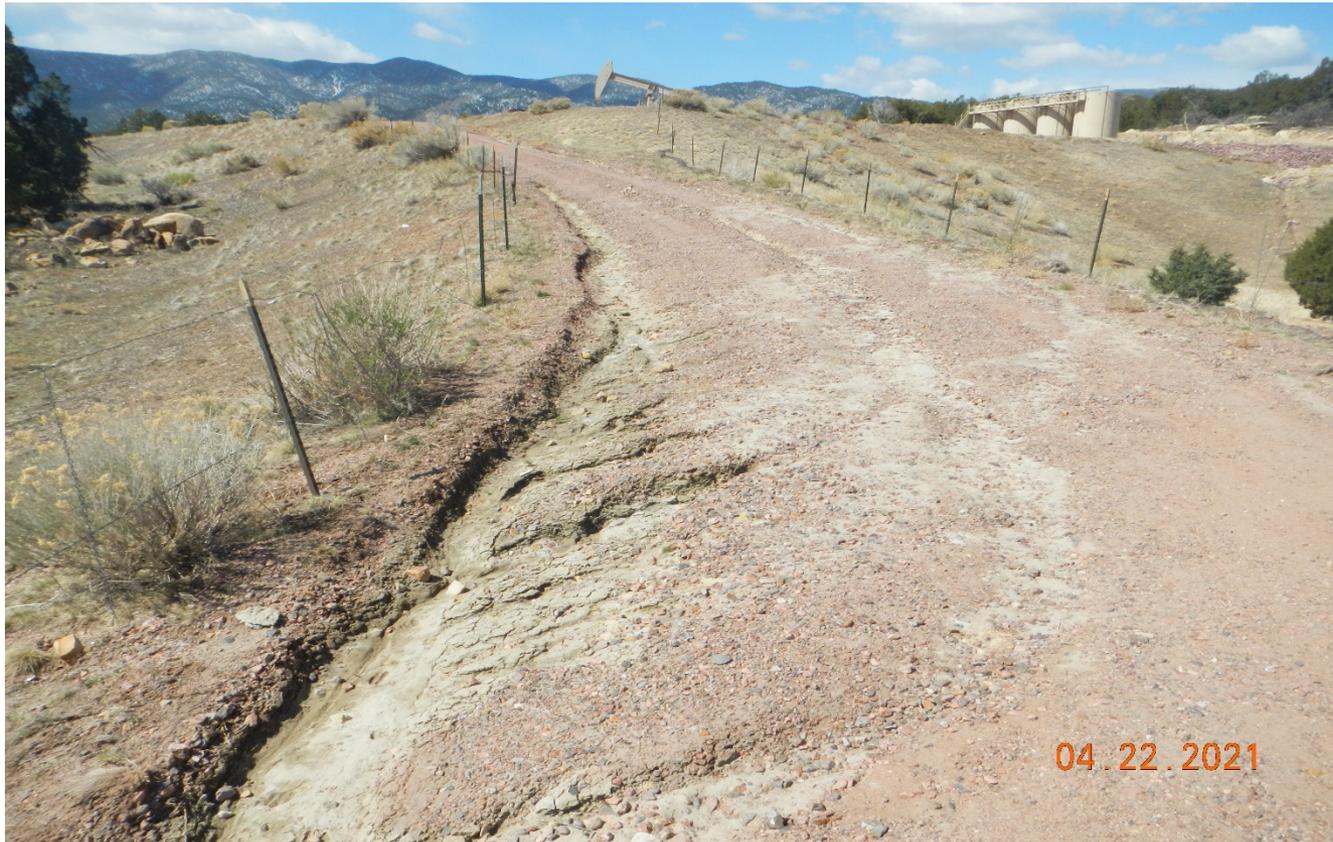
Photo 2. There is erosion along the access road. Stormwater is diverted down the road and into drainage area shown in previous photo. The erosion needs to be repaired and stormwater needs to be properly diverted. Previous corrective action has not been performed.

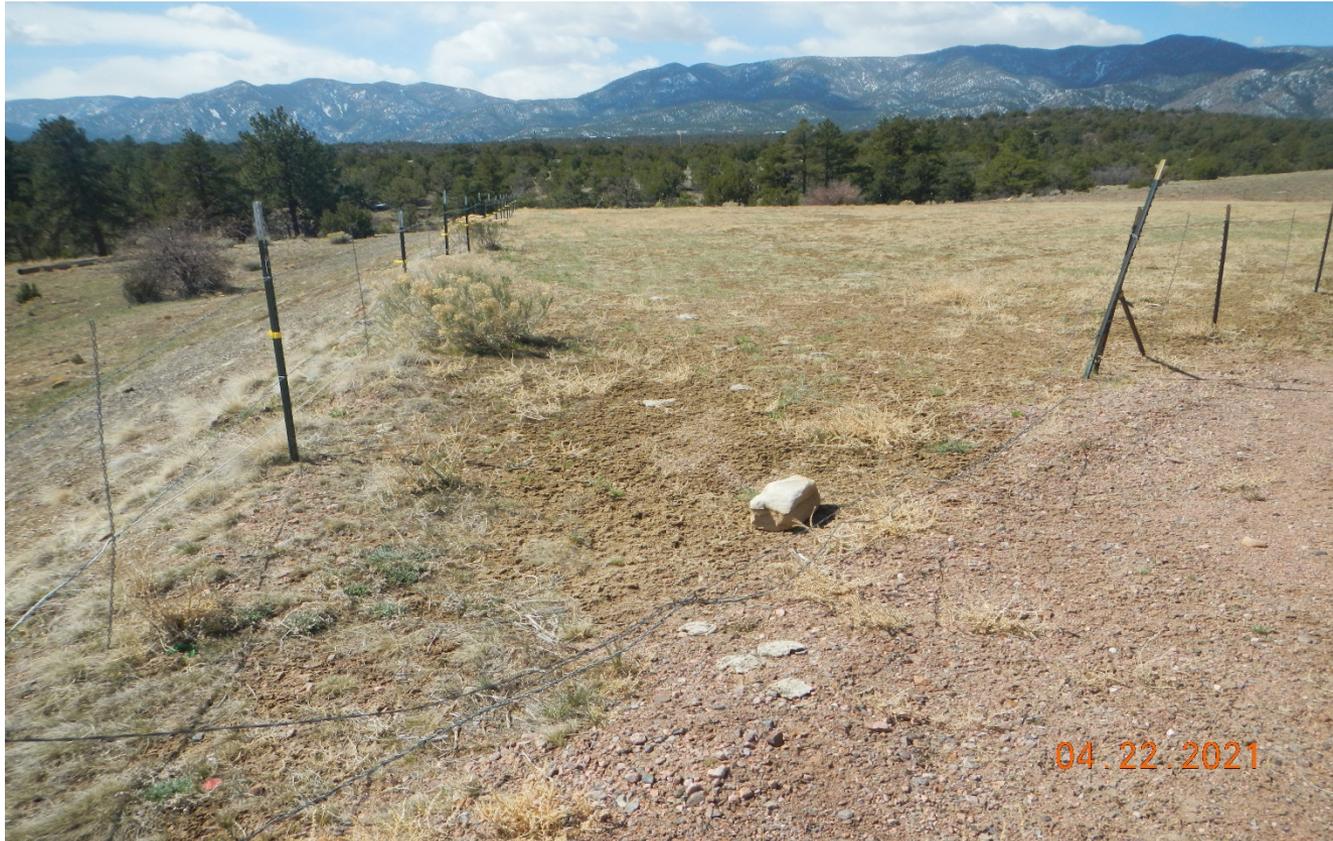
Photo 3. Facing south toward the location. The fence around the vegetated area is not maintained.

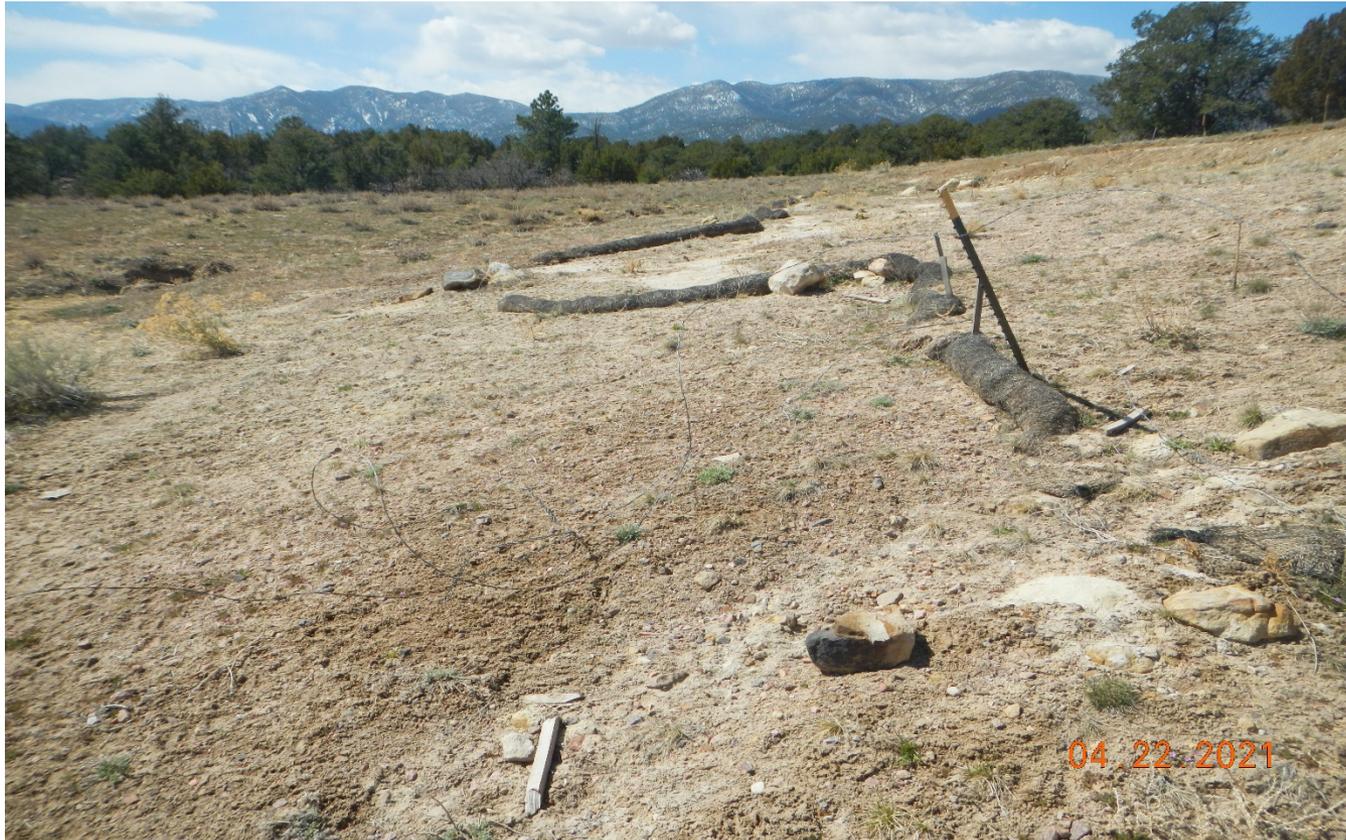
Photo 5. There are wattles displaced at the southwest side of the location. Wattles need to be repaired and maintained. Previous corrective action has not been performed.

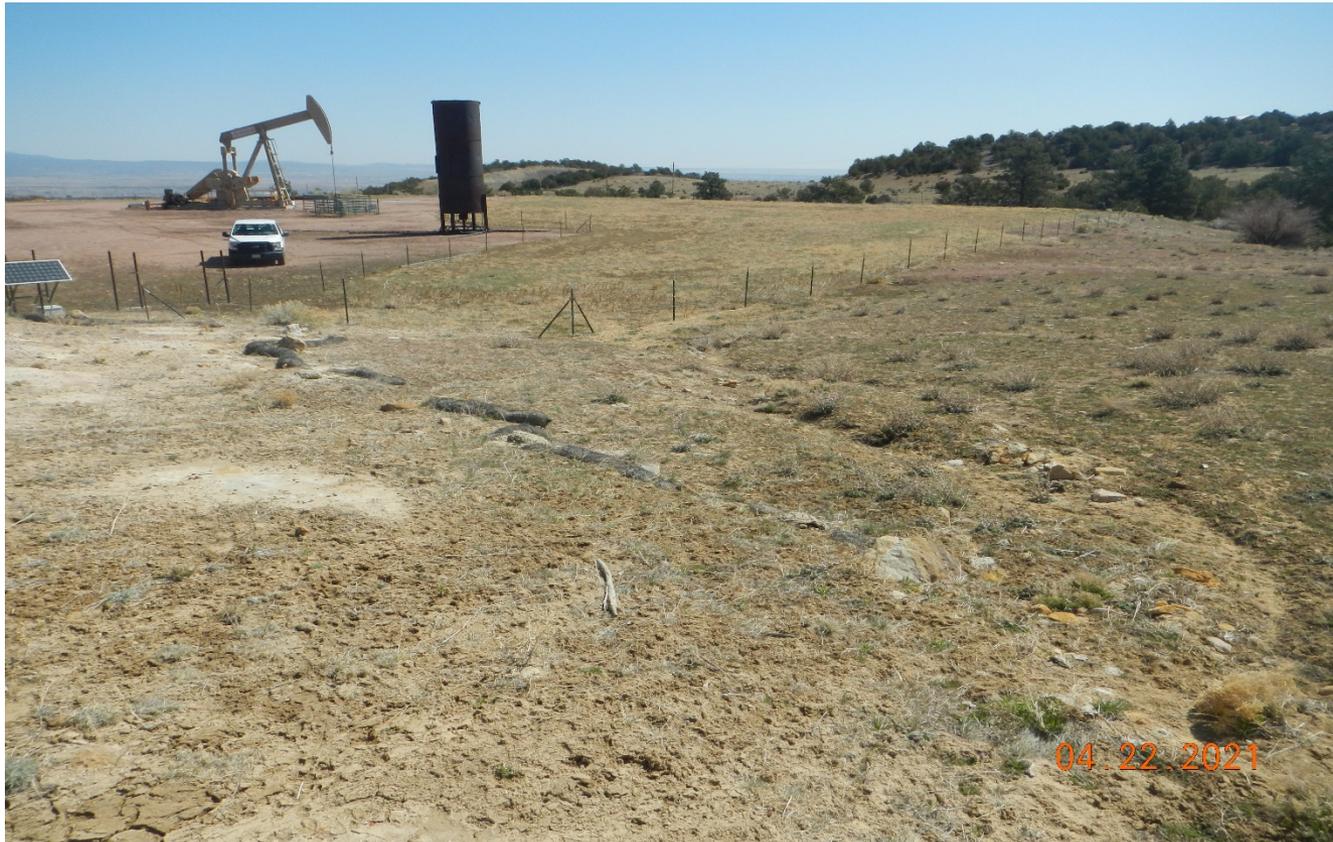
Photo 6. There is an erosion channel at the southwest side of the location. Stormwater is directed to this area from the top perimeter ditch. BMP's are needed in this area to prevent erosion.

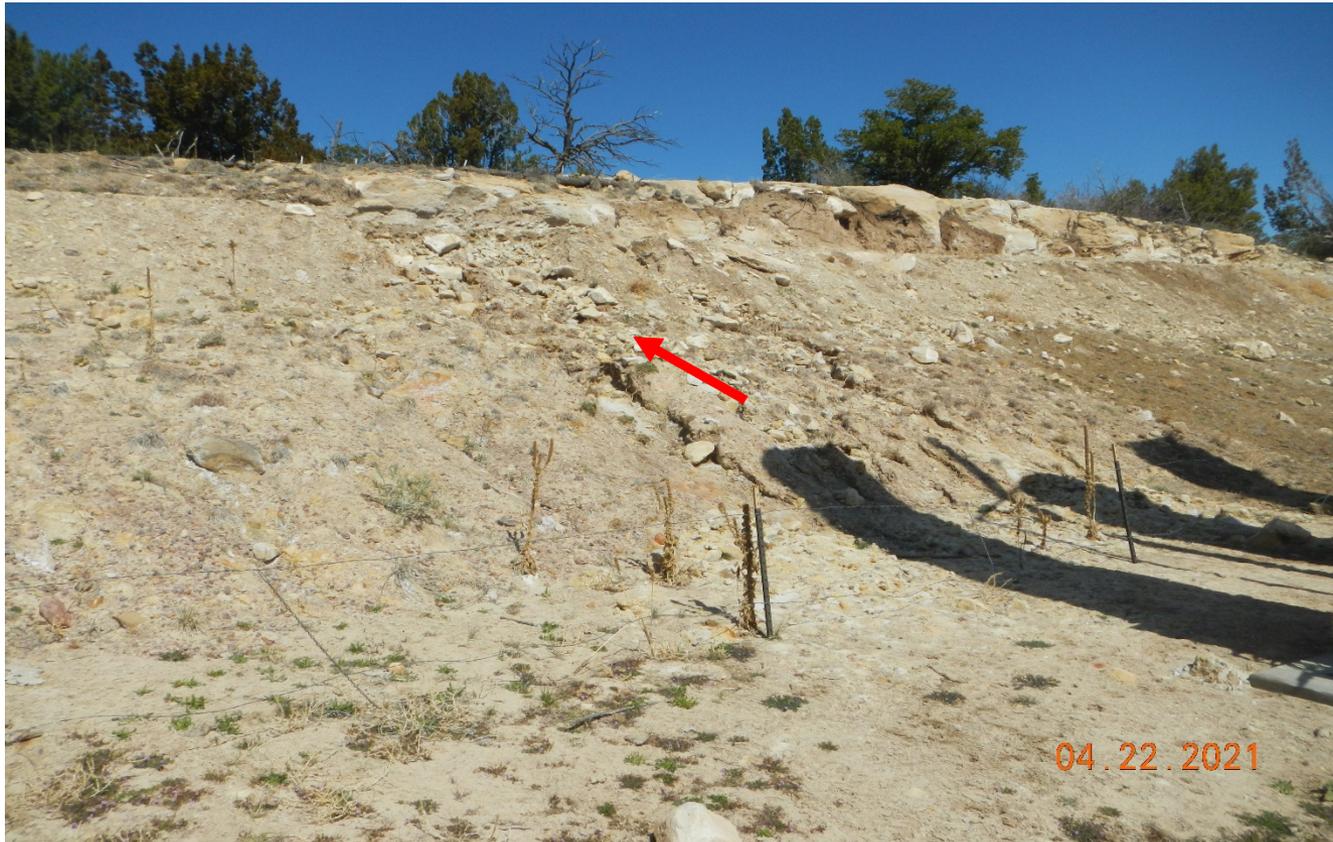
Photo 7. There is an erosion occurring off the cut slope.

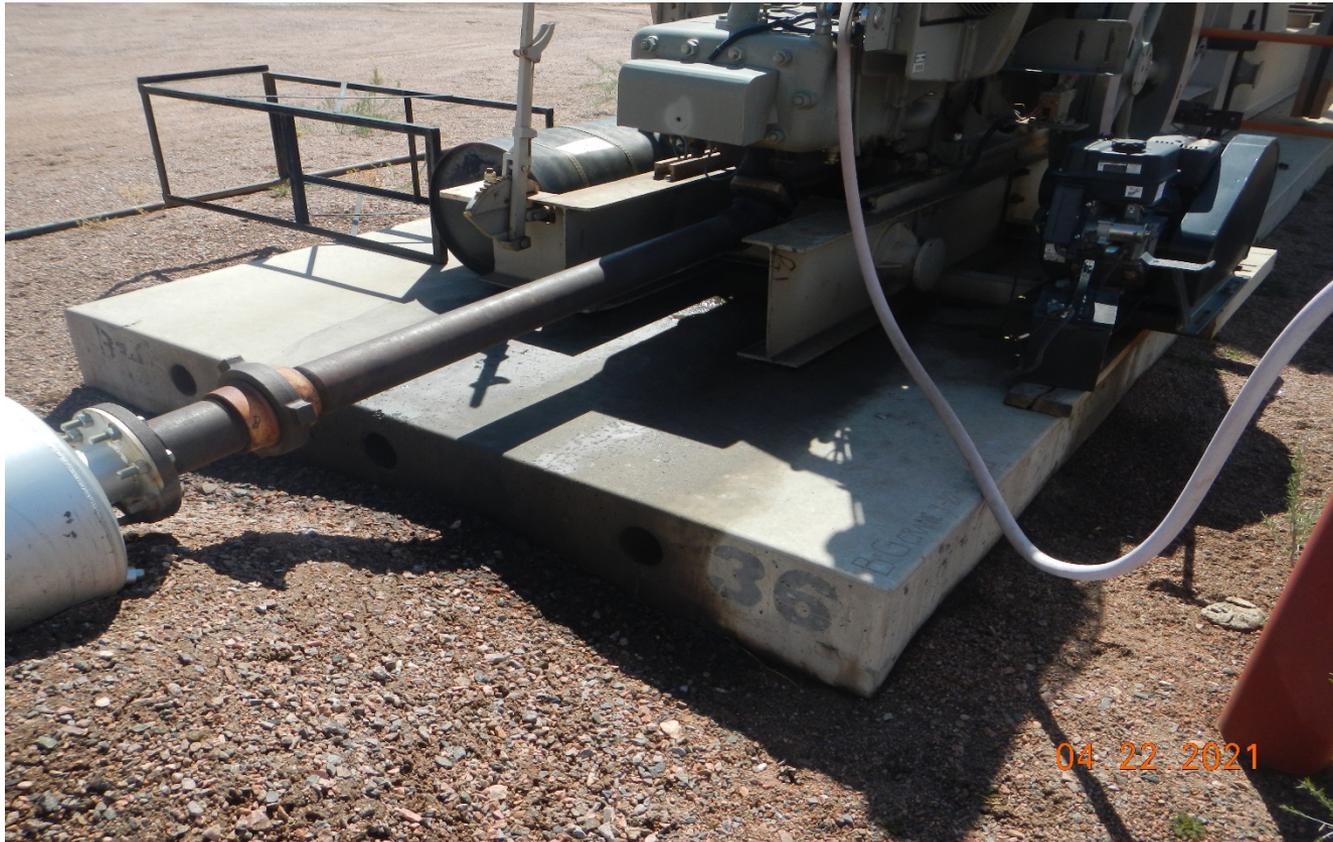
Photo 8. There is oil leaking from the pumpjack engine. Stained soil have not been cleaned up.

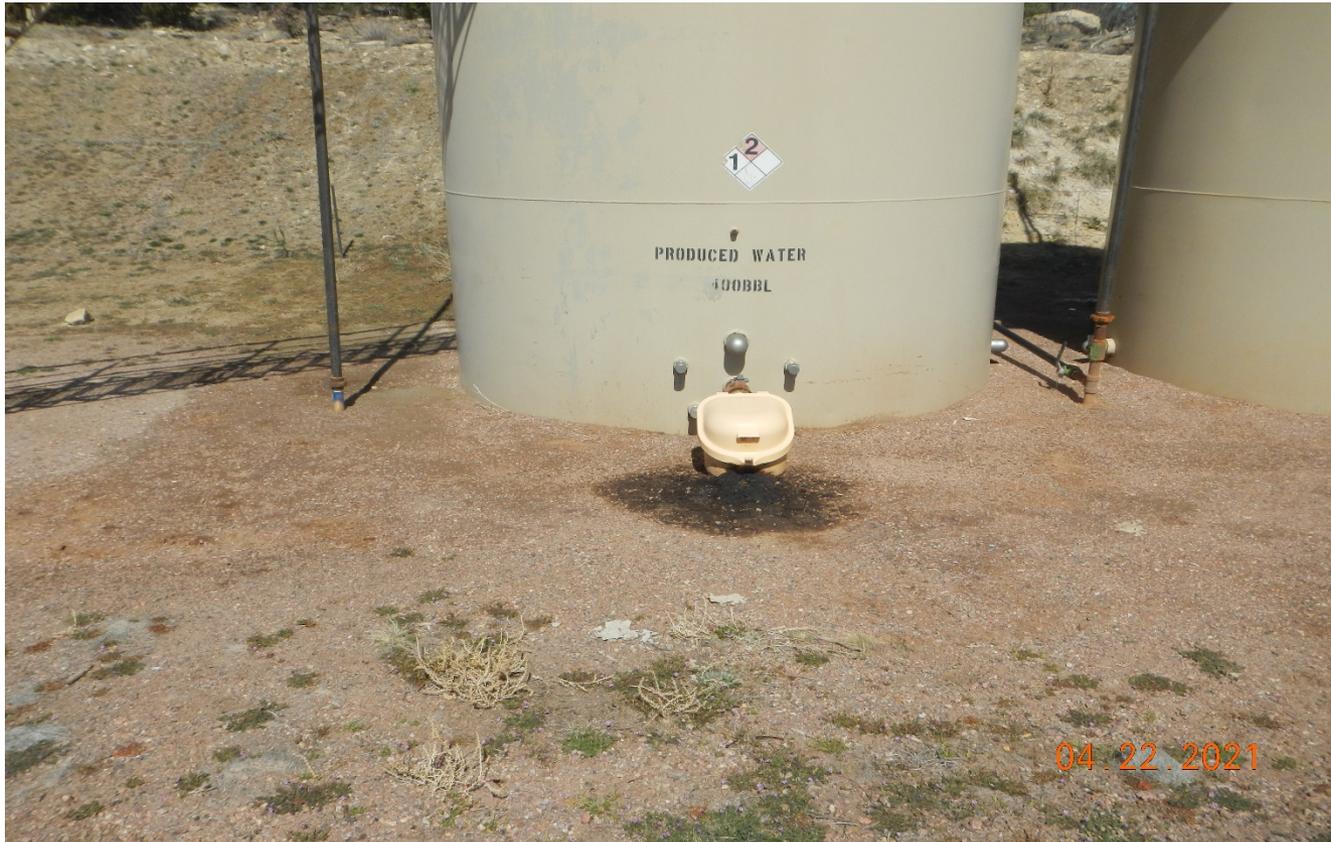
Photo 9. There is stained soil at the outlet of the PW tank.

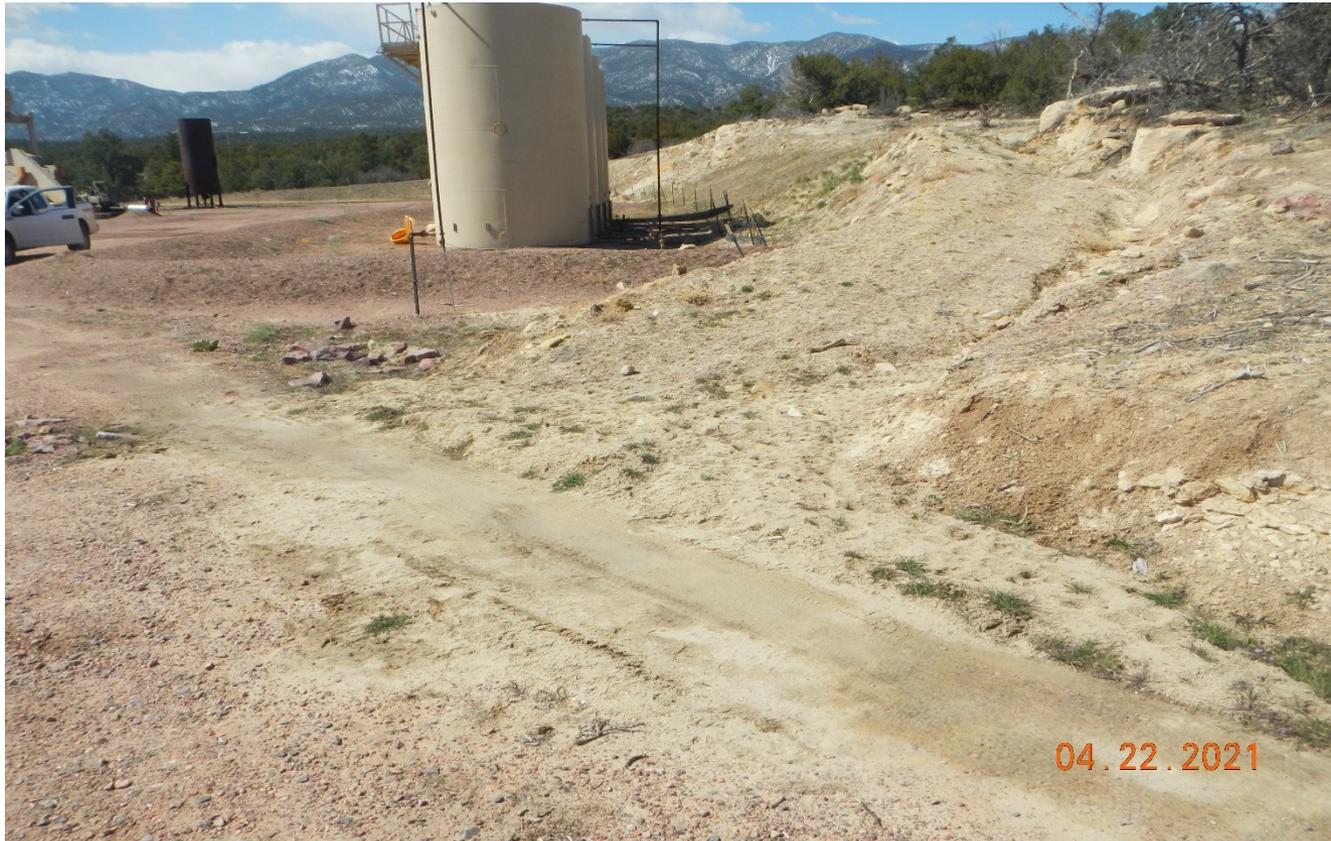
Photo 10. The top perimeter ditch is directing stormwater toward the road which has deposited sediment onto the road. BMP's are needed in this area. Previous corrective action has not been performed.

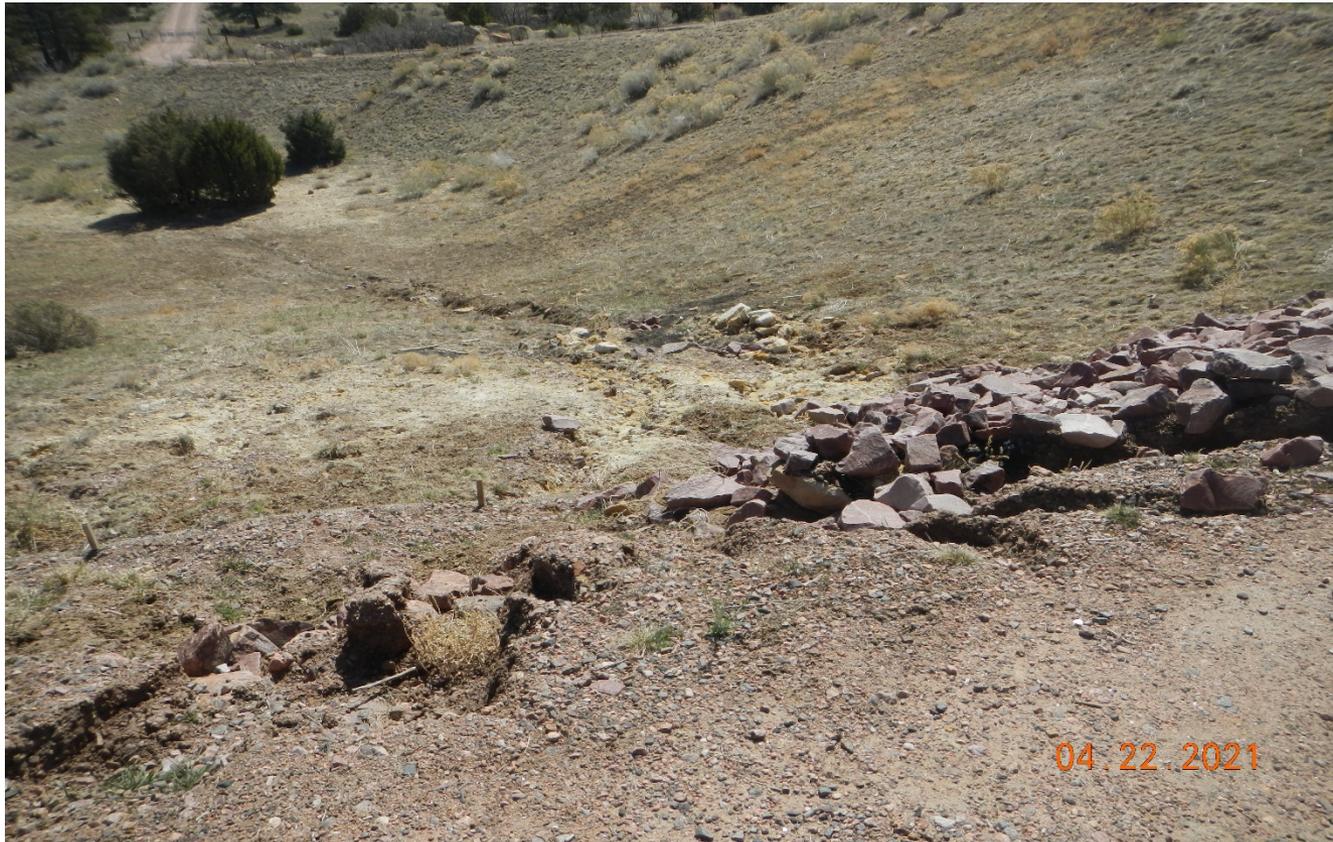
Photo 11. There is erosion occurring across the road at the north side of the location caused by stormwater directed from the top perimeter ditch shown in the previous photo. Previous corrective action has not been performed.
