Inspection Photos

API: 043-06222

Operator: INCREMENTAL OIL & GAS
(FLORENCE) LLC

Inspection Date: 4/22/2021

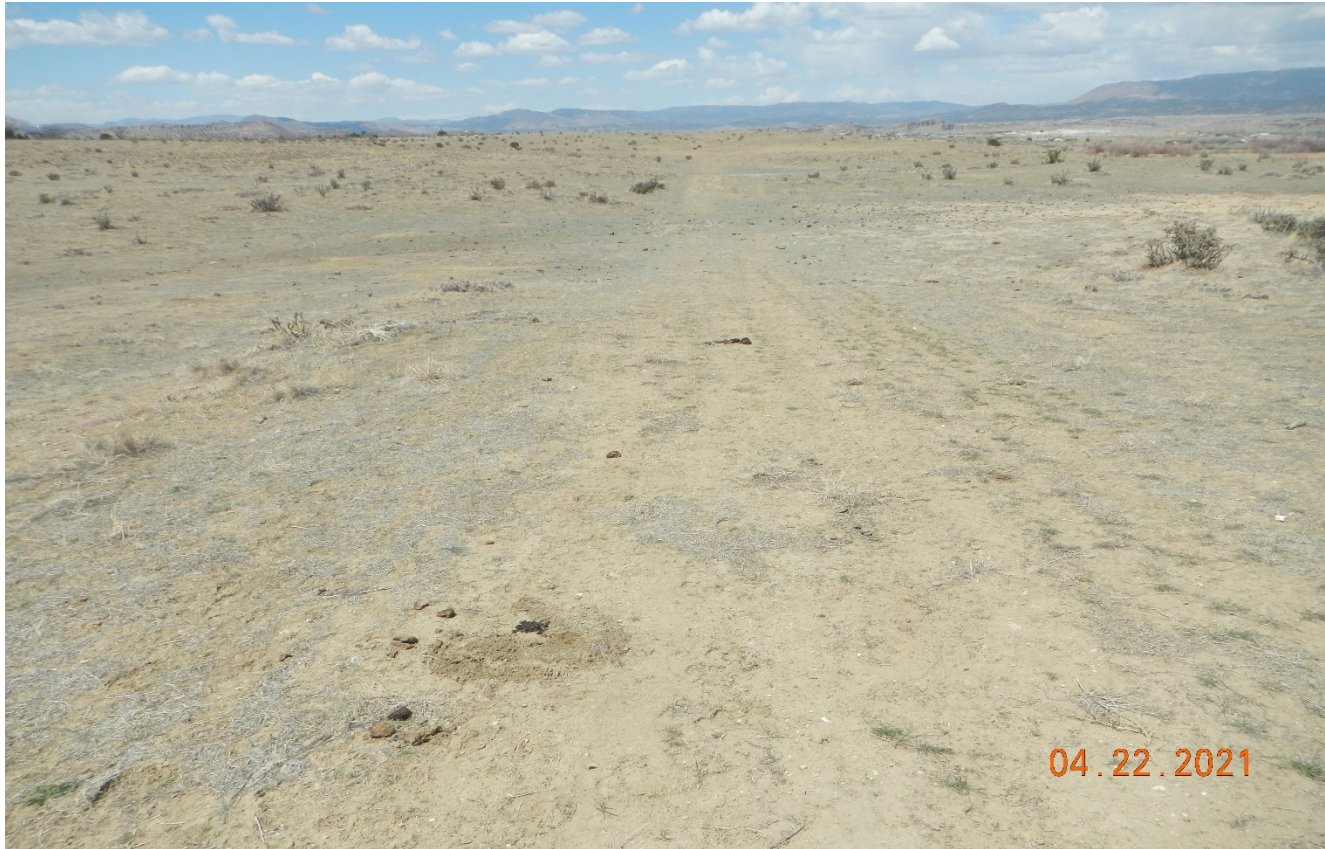
Photo 1. Facing northwest toward the former access road. There was minimal vegetation beginning to establish along the road.

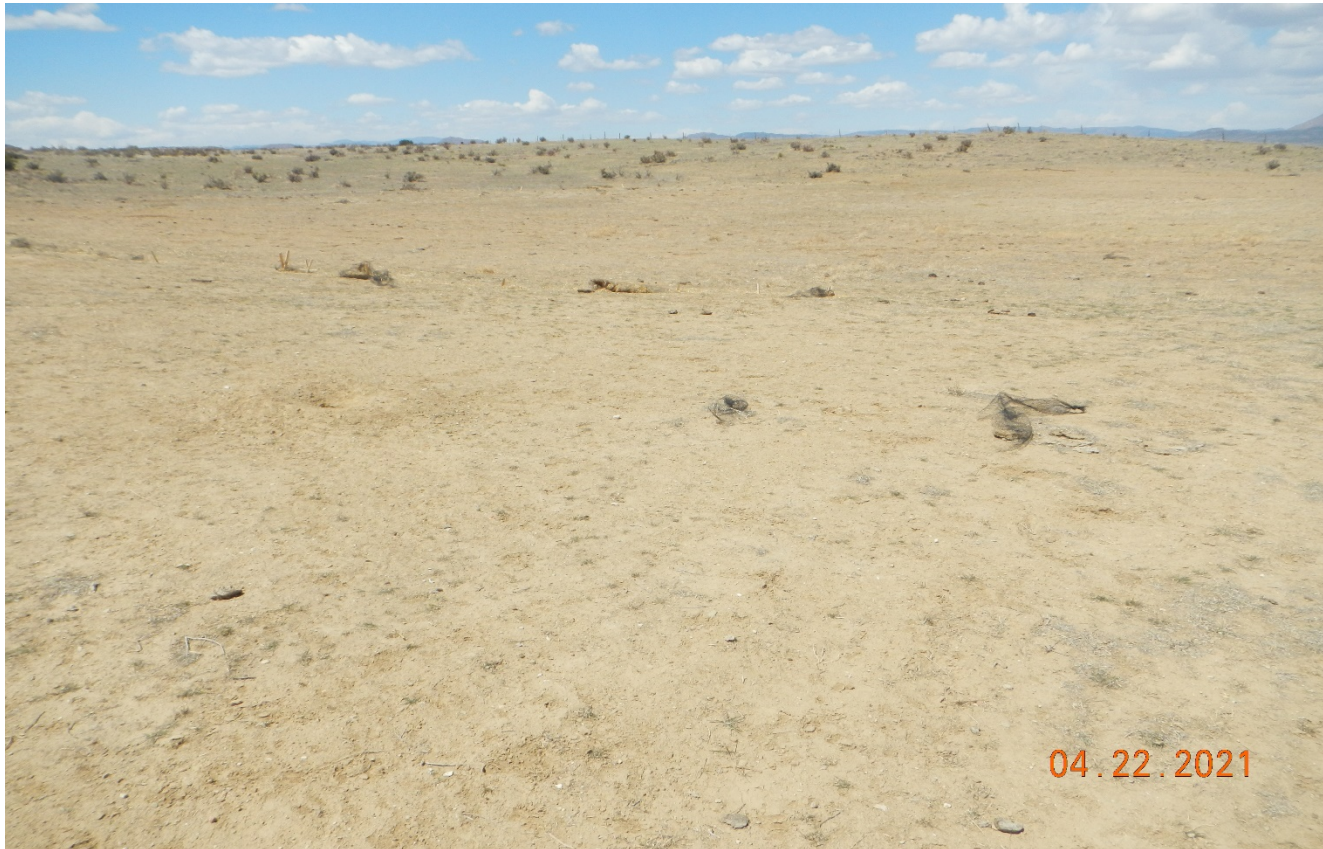
Photo 2. Facing northwest toward the location. Most of the vegetation observed was Russian thistle (undesirable weeds). There was some desirable vegetation observed.

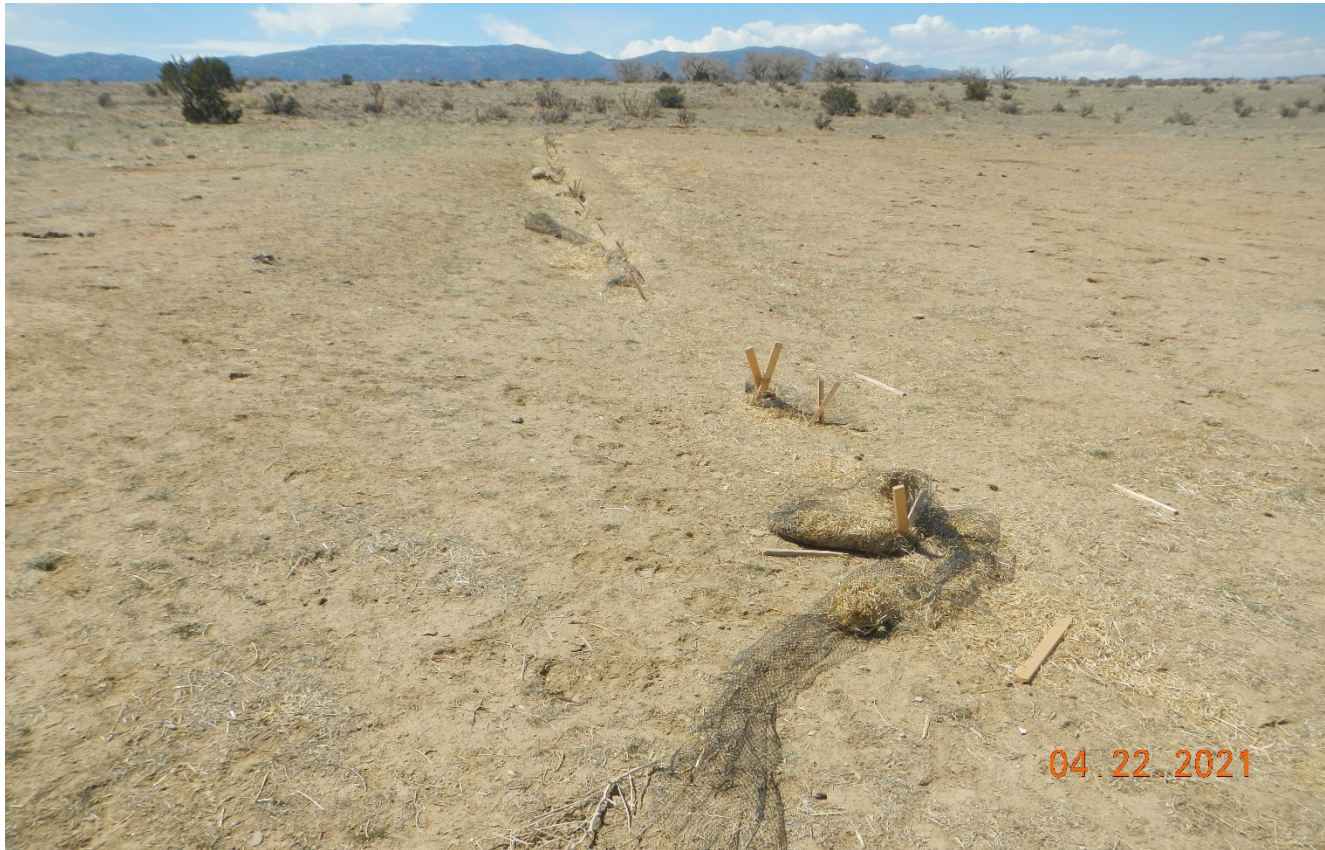
Photo 3. The wattles around the perimeter of the location are displaced and not maintained.

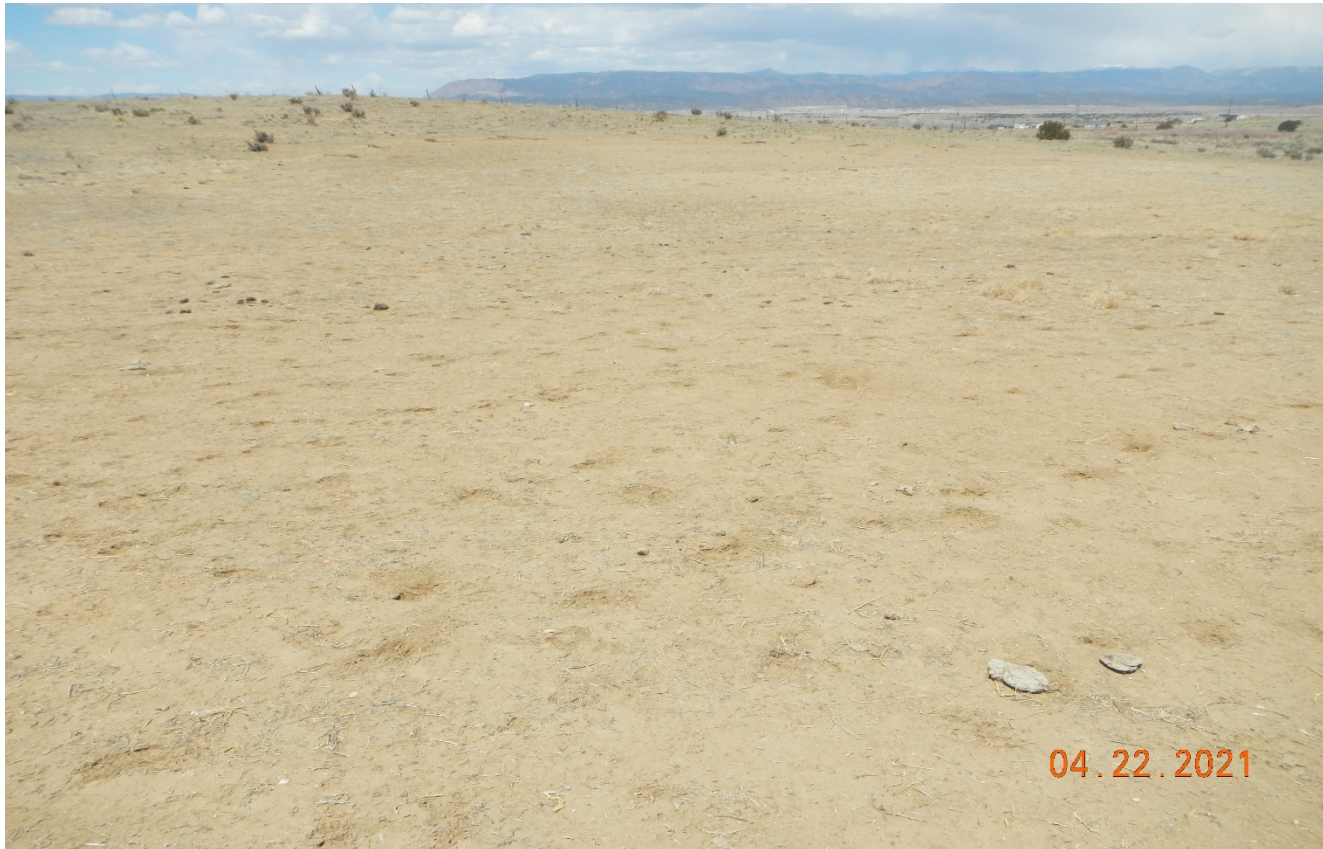
Photo 4. Facing northeast toward the location.

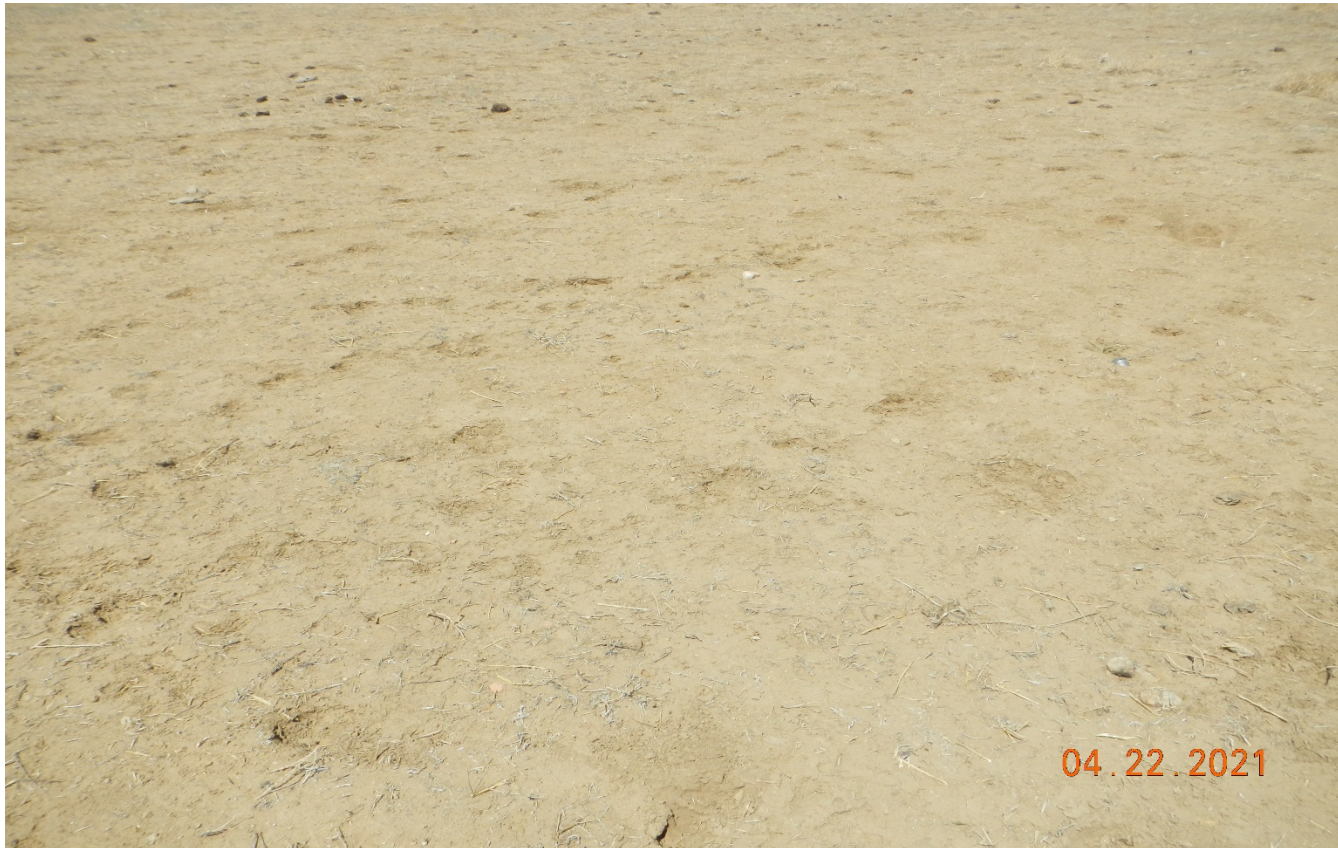
Photo 5. View of ground cover. Arrow points to desirable species beginning to establish.
