Inspection Photos
Camenisch 1 sx Flowline Release
Spill ID 479713 (AC)

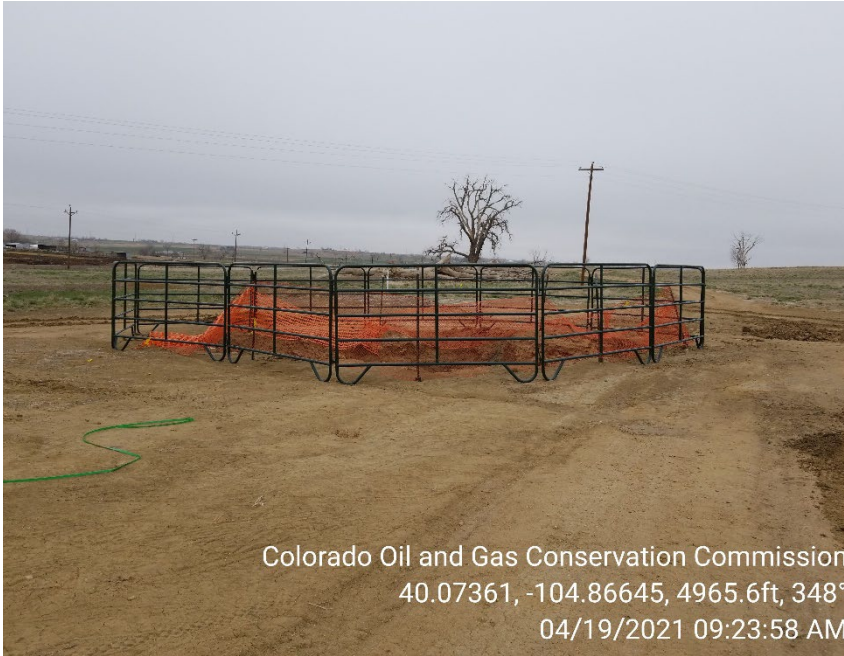
Photo 1 – Spill area. Fencing up around open excavation.

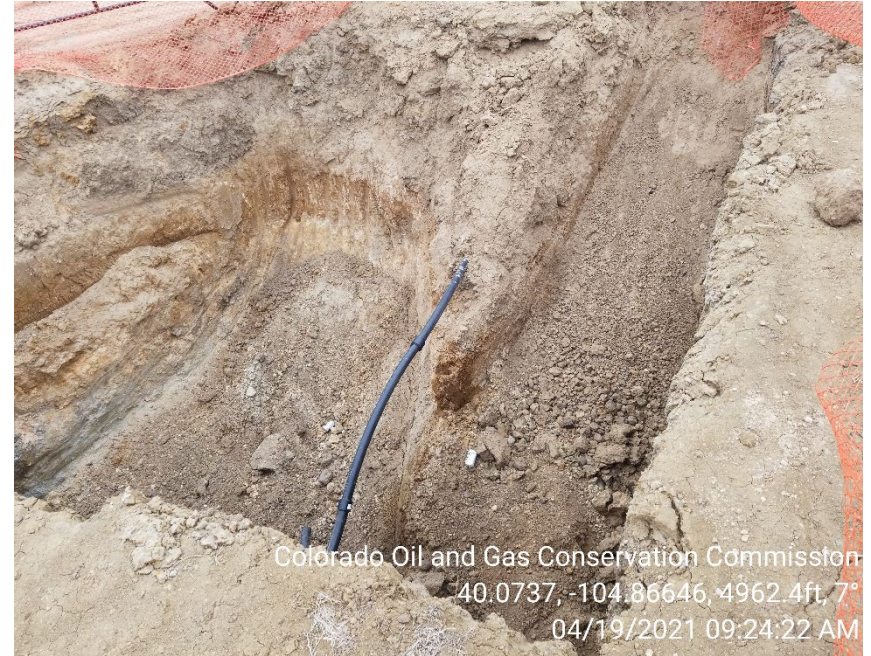
Photo 2 – Open excavation. Impacts remain in situ. Trash observed in excavation.

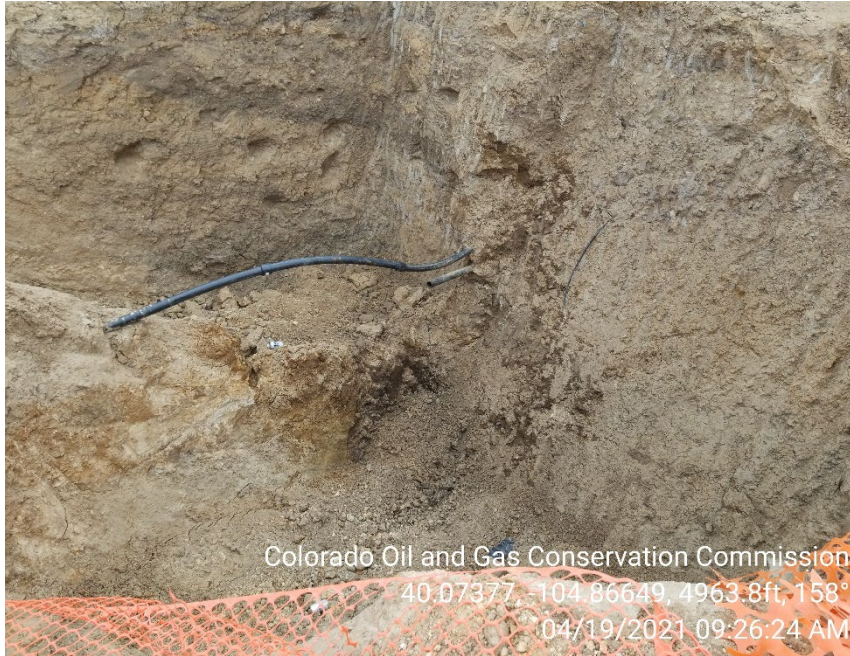
**Photo 3 – Open excavation. Impacts remain in situ.
Trash observed in excavation.**

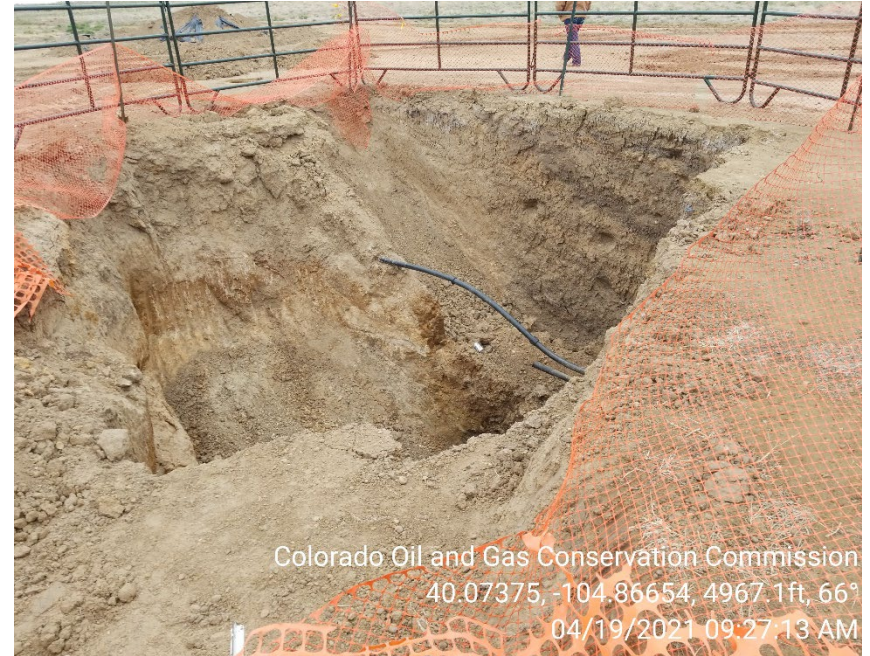
**Photo 4 – Open excavation. Impacts remain in situ.
Trash observed in excavation.**

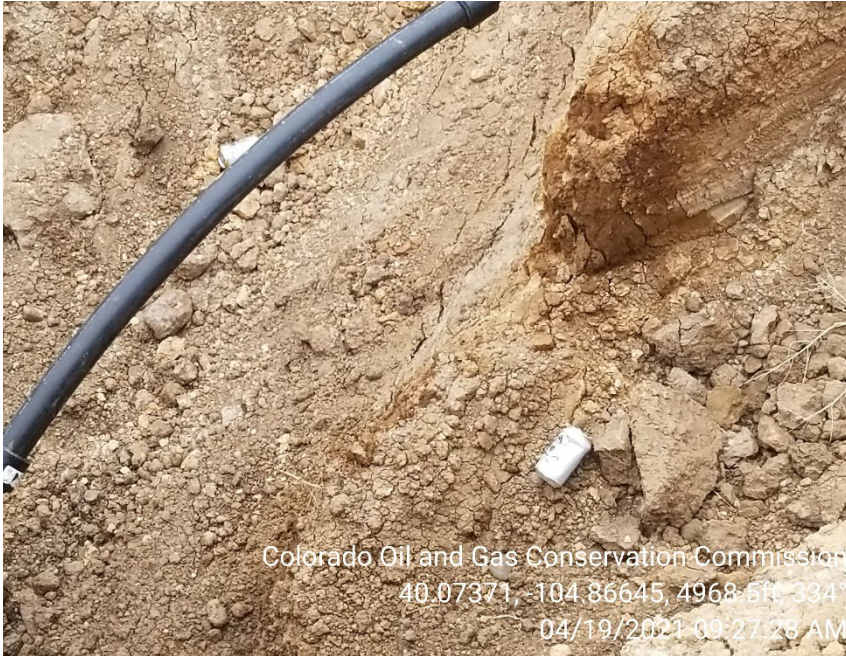
Photo 5 –Trash observed in excavation.

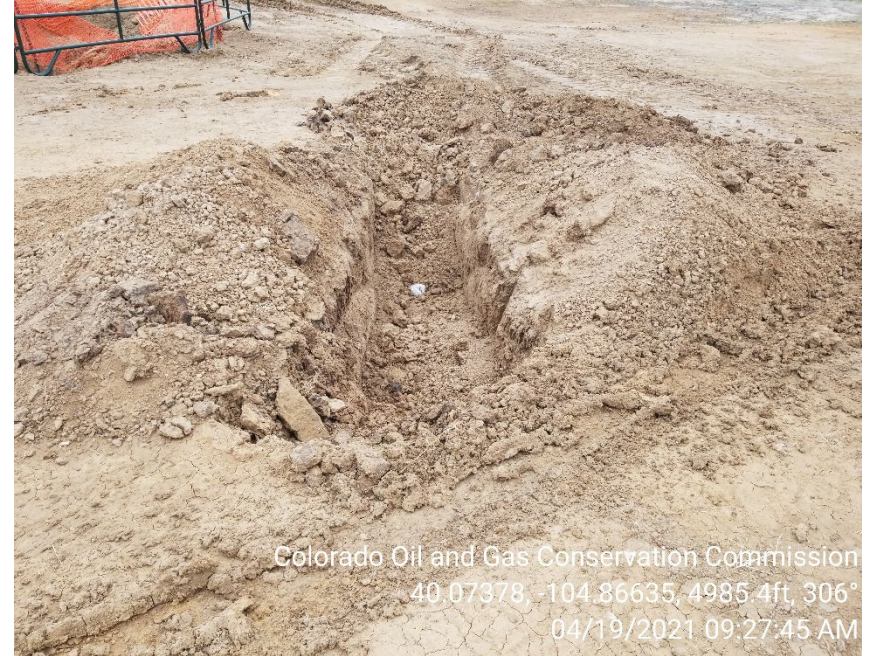
Photo 6 – Additional disturbed area on site. Trash observed in disturbed area.

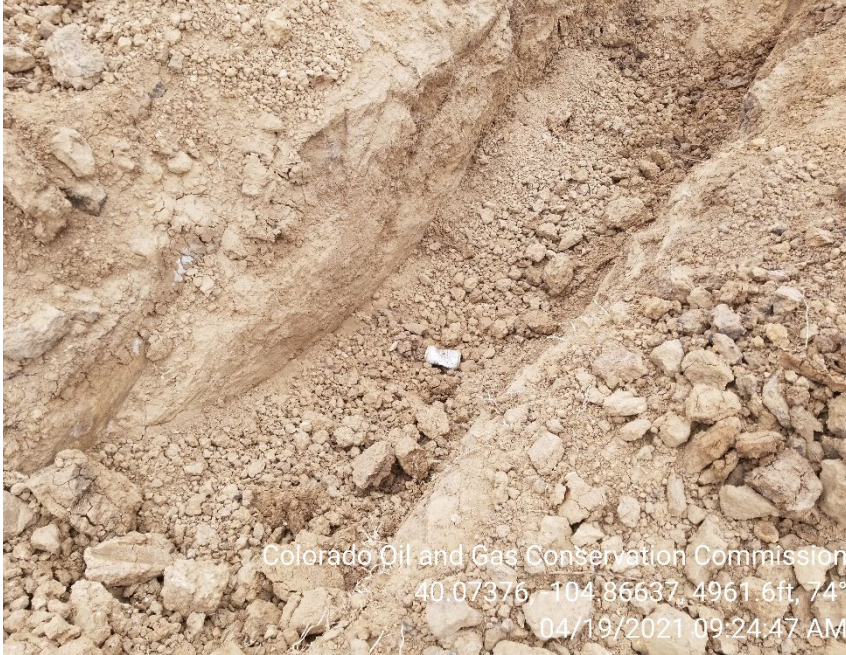
Photo 7 – Trash on location; additional area of disturbed soils.

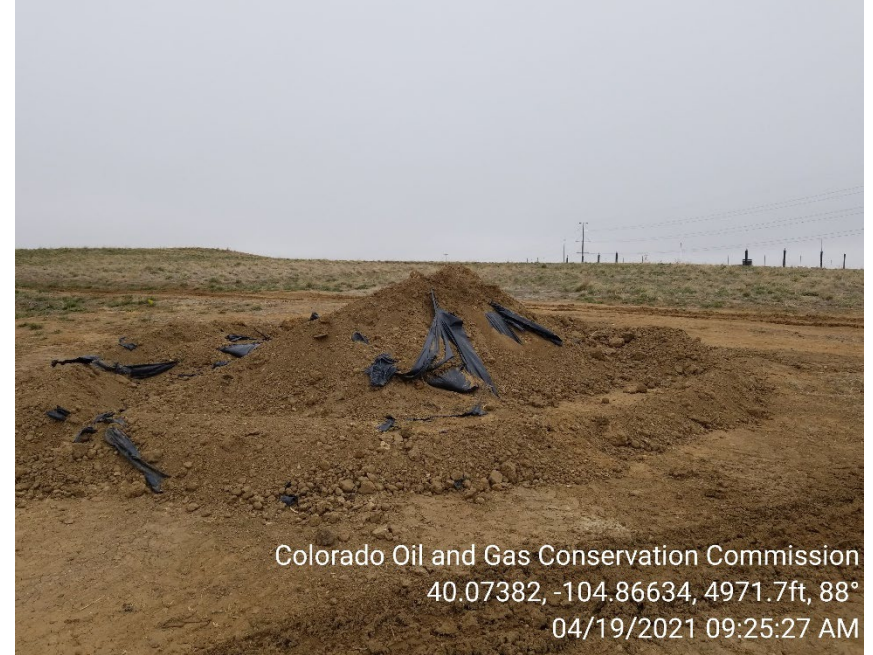
Photo 8 – Oily soils stockpiled on location. Lining not present under the entirety of soils pile.

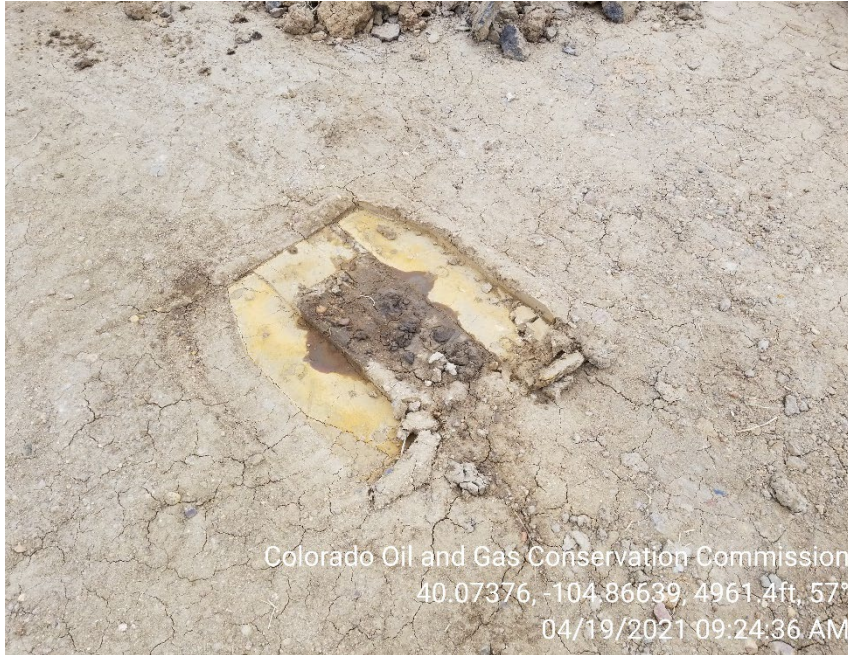
Photo 9 – Stained soil observed around open excavation.

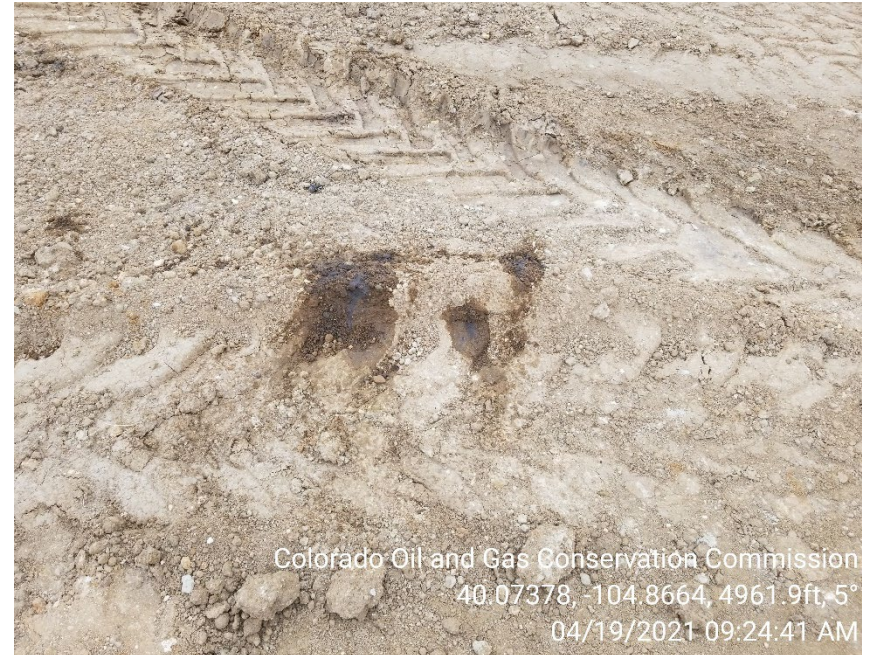
Photo 10 – Stained soil observed around open excavation.
