Inspection Photos

API: 043-06059

Operator: JAVERNICK OIL

Inspection Date: 4/22/2021

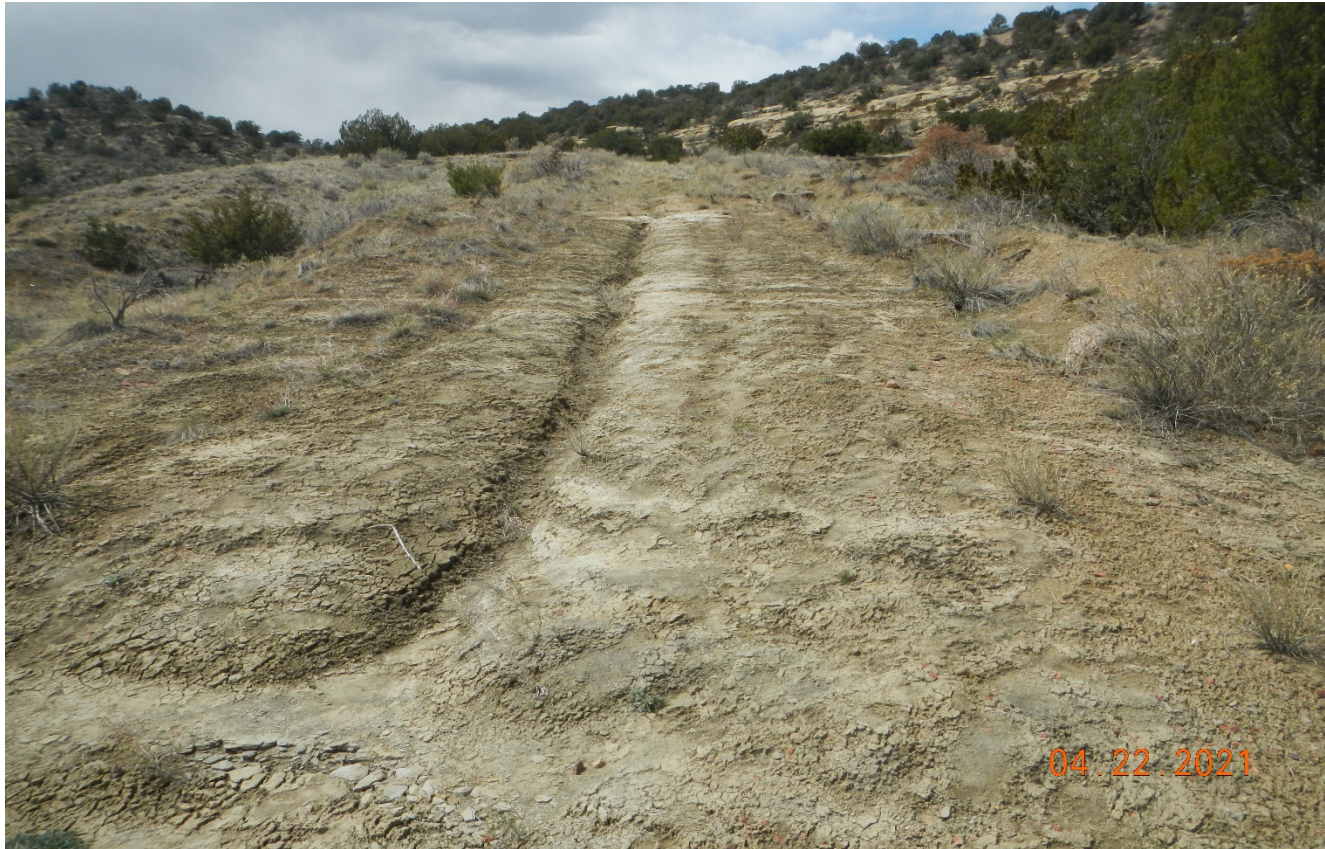
Photo 1. Facing southwest toward the former access road. This area is not stabilized with vegetation and there is erosion occurring.

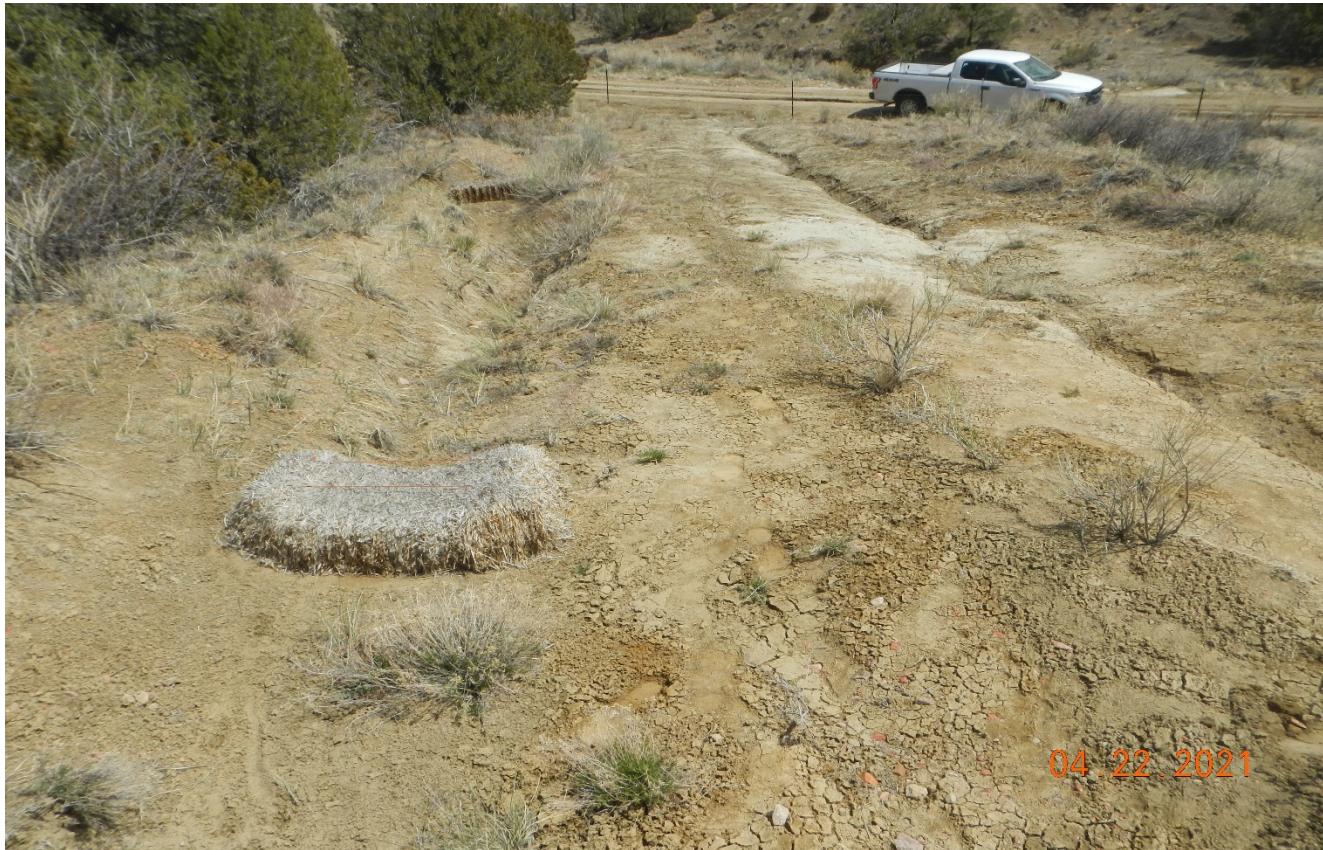
Photo 2. Facing back to the northeast toward the road. There has been straw bales placed along this area however, straw bales are not a long term erosion control and have filled in with sediment. There is an erosion channel directed down toward the main road.

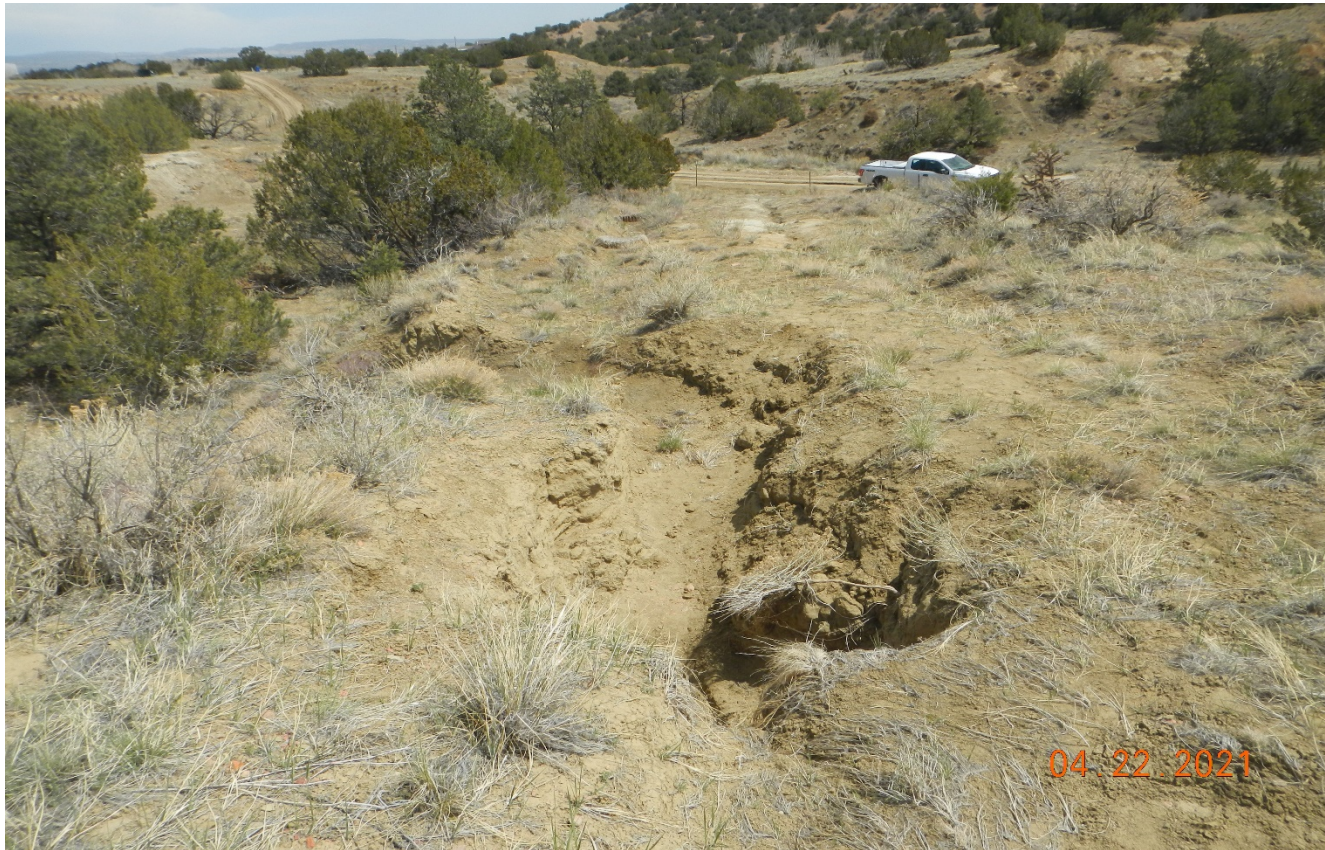
Photo 3. There is an erosion gully along the road that is approximately 2-3 ft. deep. This area needs to be filled in and stabilized. Previous corrective action was not performed.

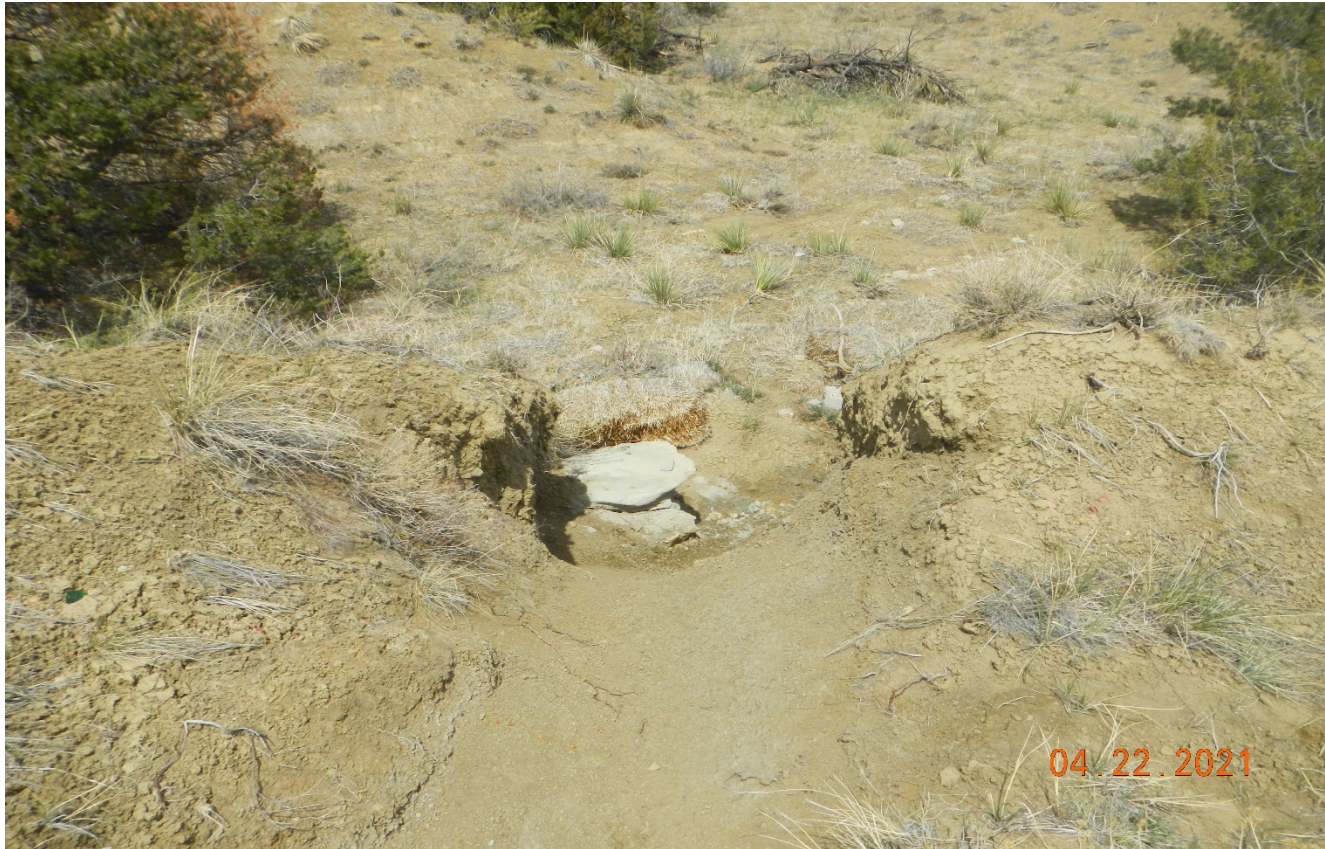
Photo 4. Facing toward the bottom of the erosion shown in previous photo. There is straw bales that appear to have washed out of gully. The gully needs to be filled in and stabilized.

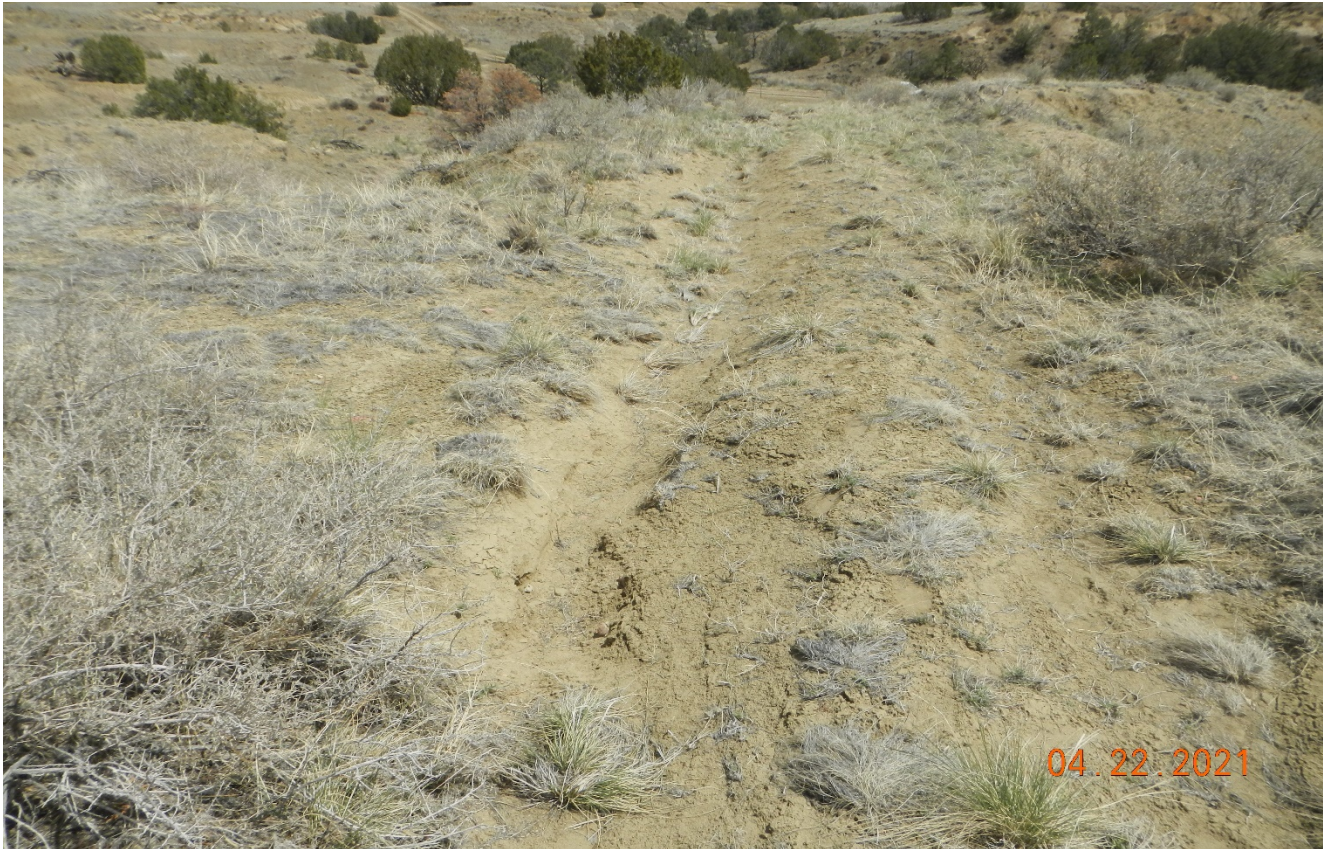
Photo 5. Facing back northeast along the former access road. It appears that the stormwater from the location is directed down the road which is causing erosion issues shown in previous photos.
