Inspection Photos

API: 043-05088

Operator: JAVERNICK OIL

Inspection Date: 4/22/2020

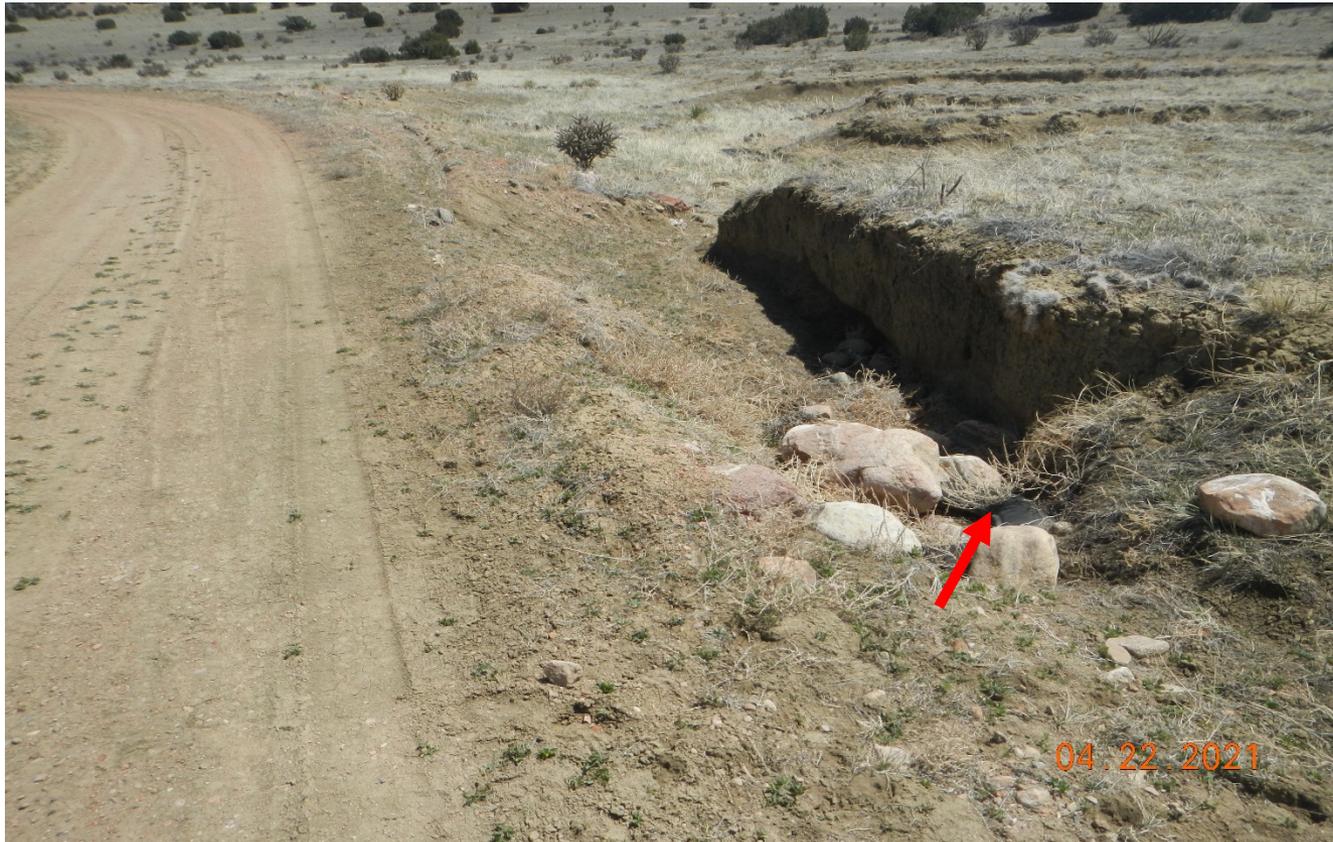
Photo 1. Facing east along the access road. The gully erosion along the road has not been repaired and stabilized. There is a tire placed in gully shown at red arrow which needs to be removed. A few rocks scattered in the gully is insufficient stabilization.

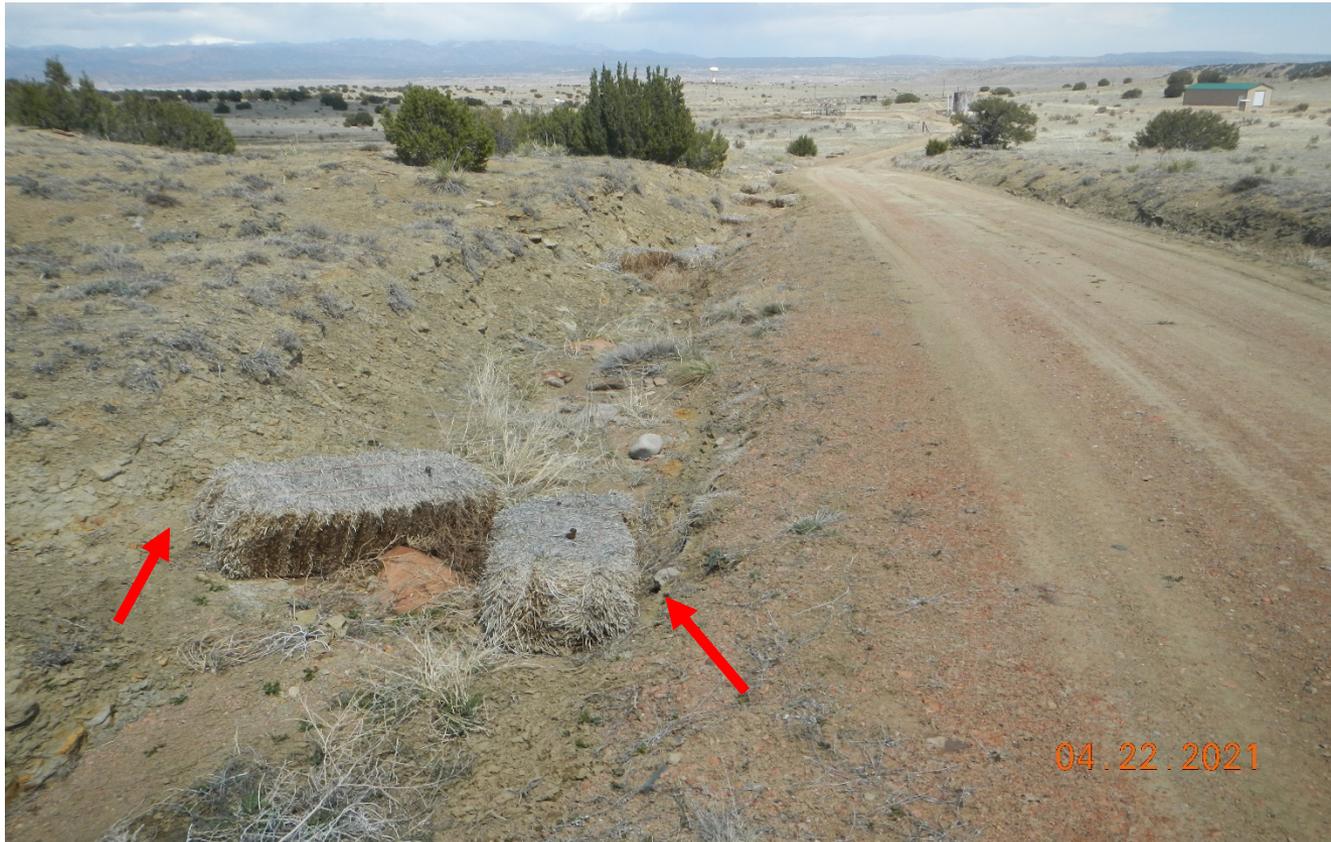
Photo 2. Facing northeast along the access road where erosion is occurring along the road. There are straw bales that are placed along the side of the road which are insufficient. Stormwater can flow around the bales show at red arrows.

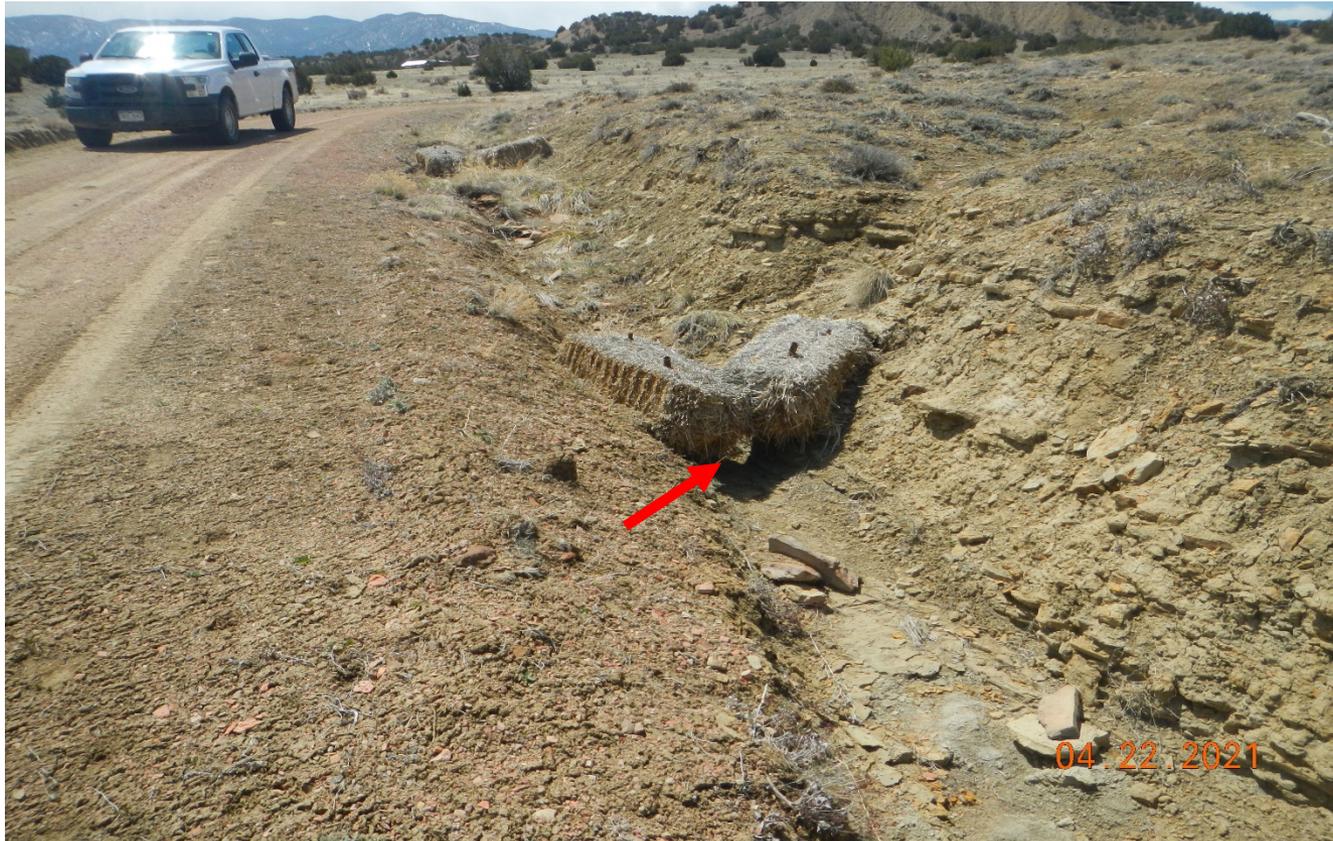
Photo 3. The bales are not installed correctly and stormwater is causing erosion underneath the bales which essentially is not working.

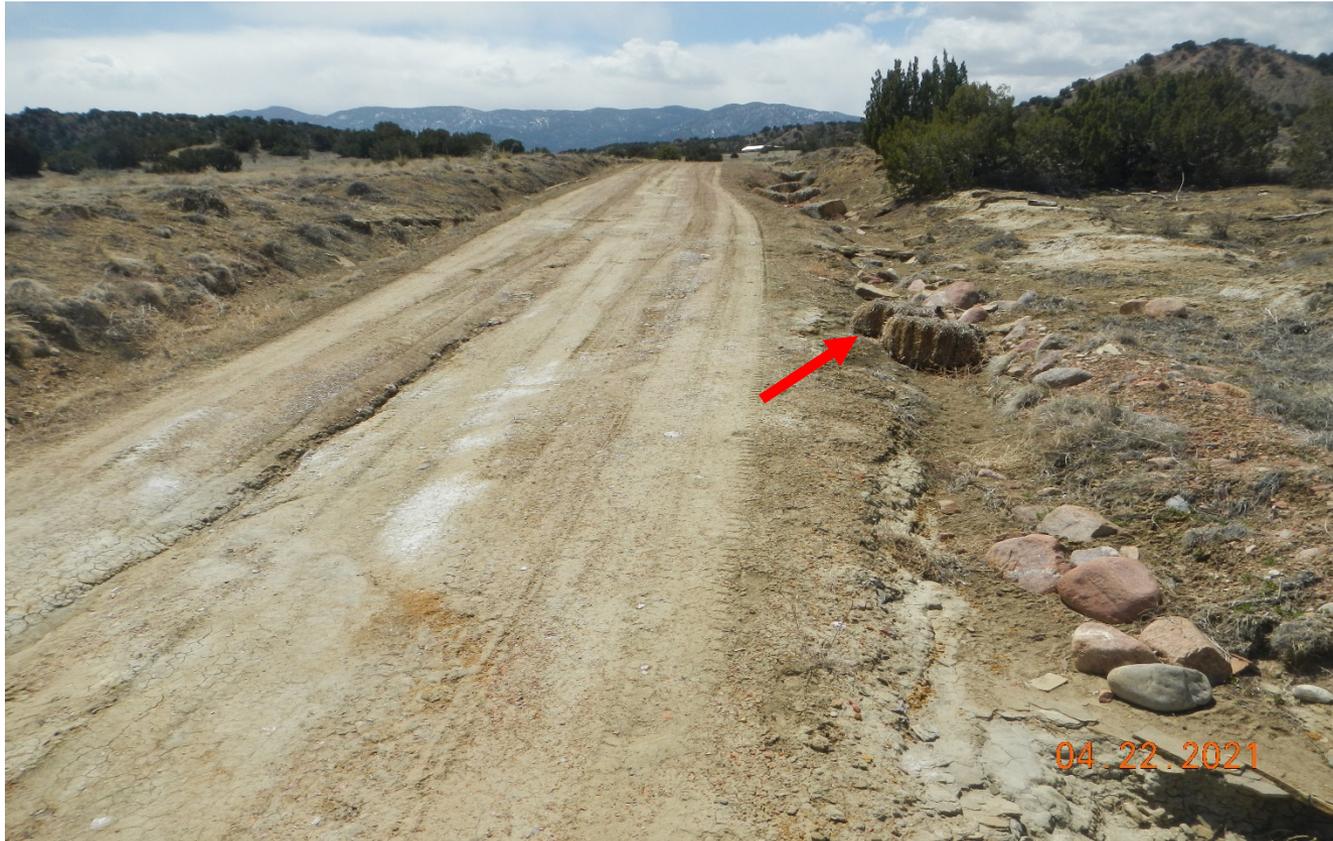
Photo 4. Facing southwest along the road. This straw bales is displaced. Stormwater erosion is not controlled along the roadside.

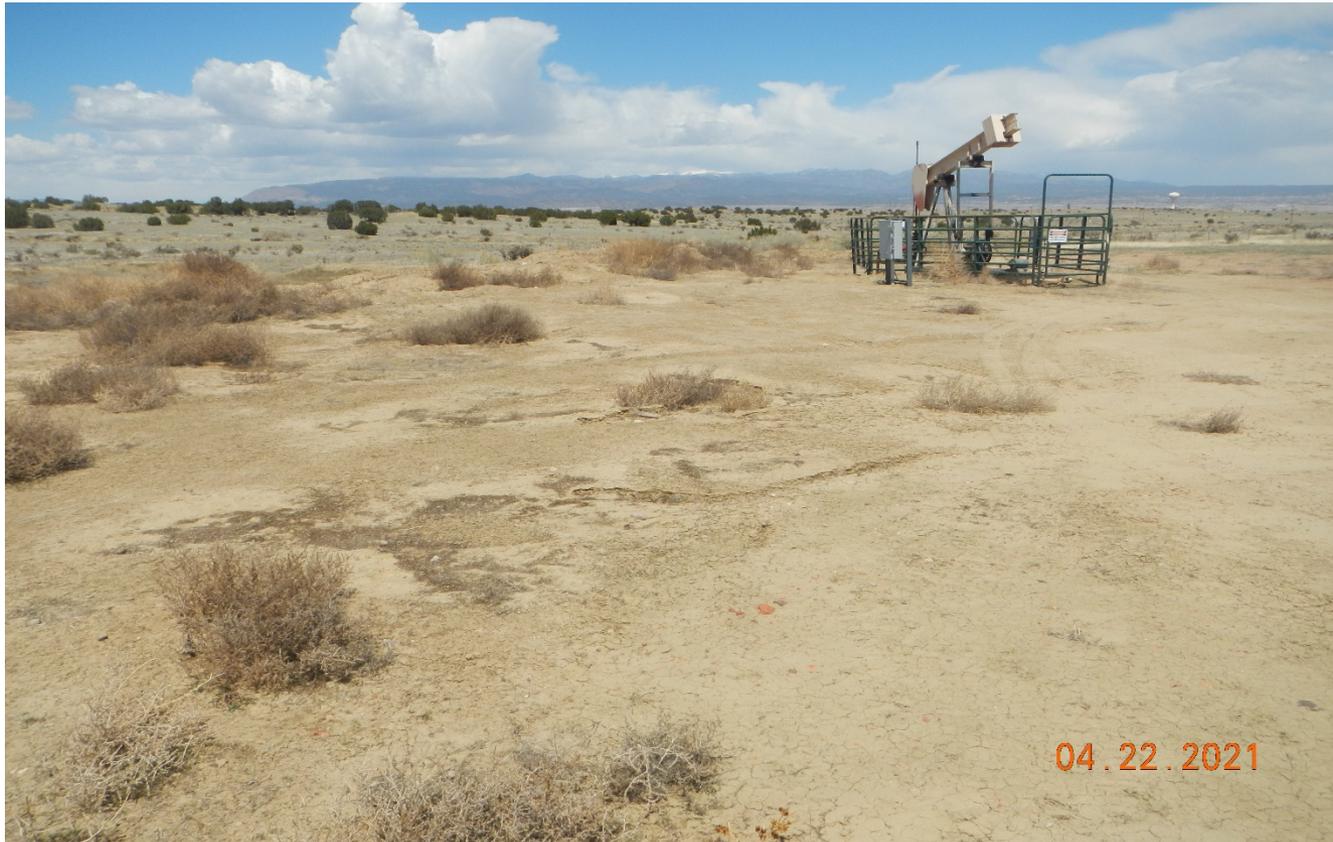
Photo 5. Facing north toward the well. This area needs to be reclaimed. There are undesirable weeds that need to be controlled.

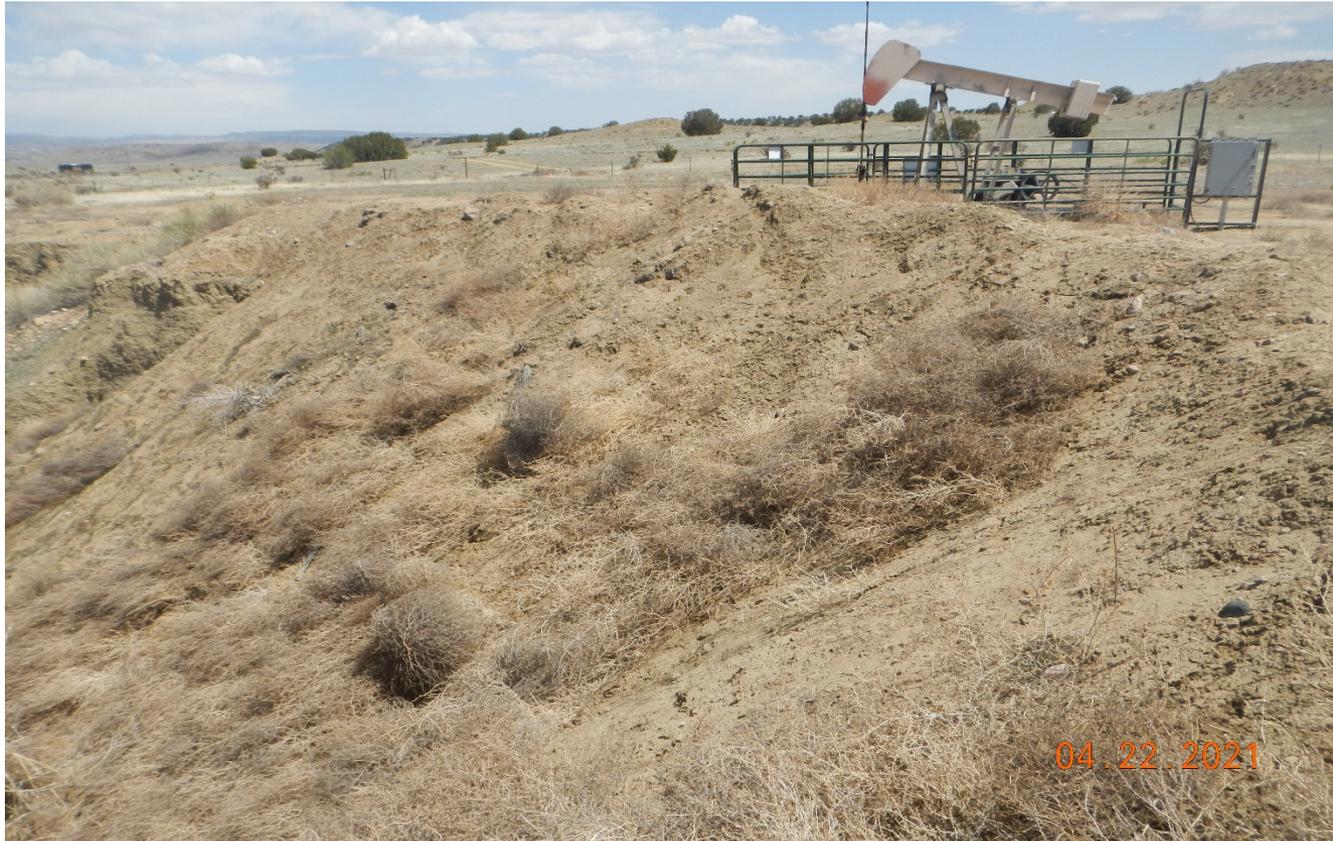
Photo 6. Facing northwest toward the embankment near the well. This area has not been stabilized.

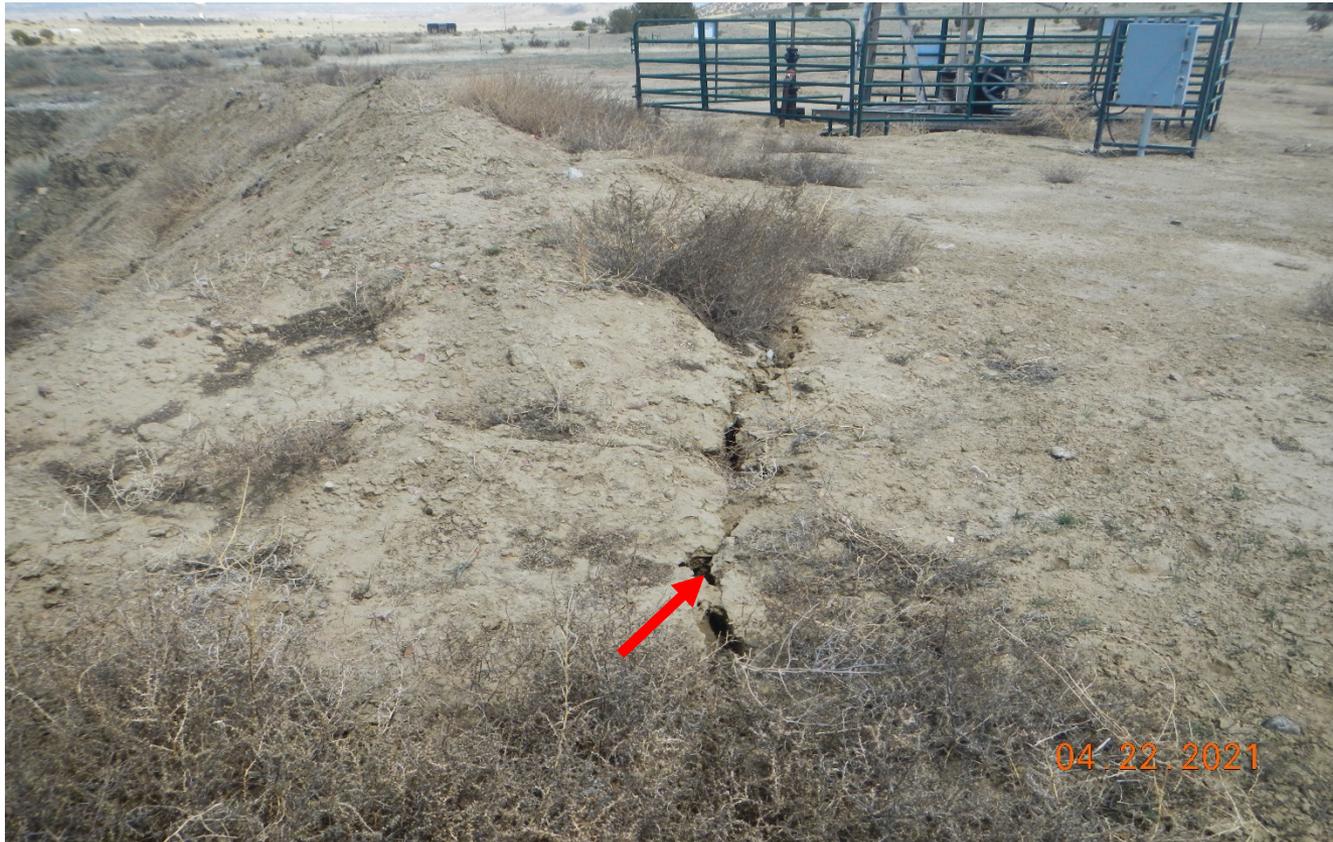
Photo 7. This crack in the soil surface near the well is an indication of potential soil sloughing. This area needs to be stabilized.

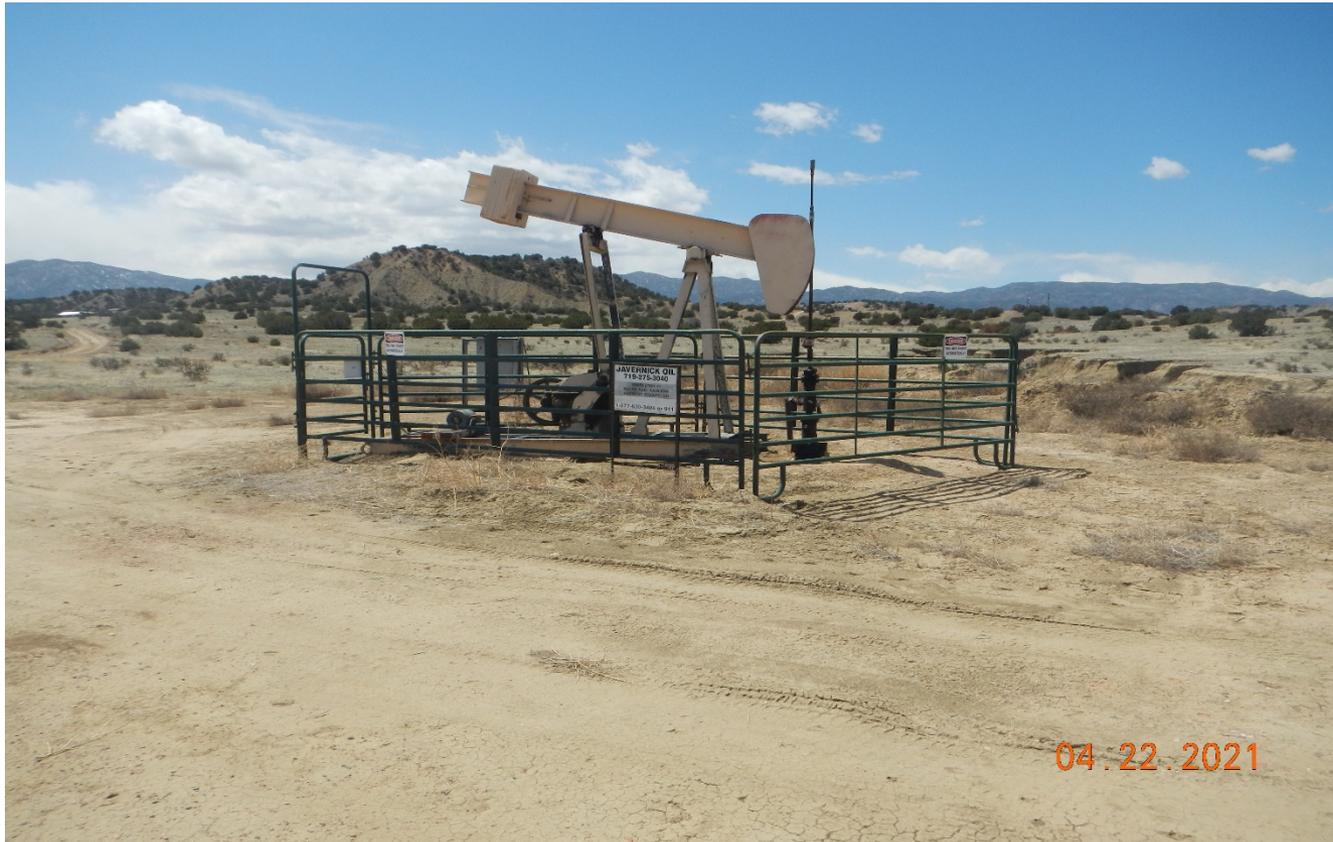
Photo 8. The well sign is posted at pumpjack.
