# Inspection Photos

API: 043-06196

Operator: JAVERNICK OIL

Inspection Date: 10/19/2020

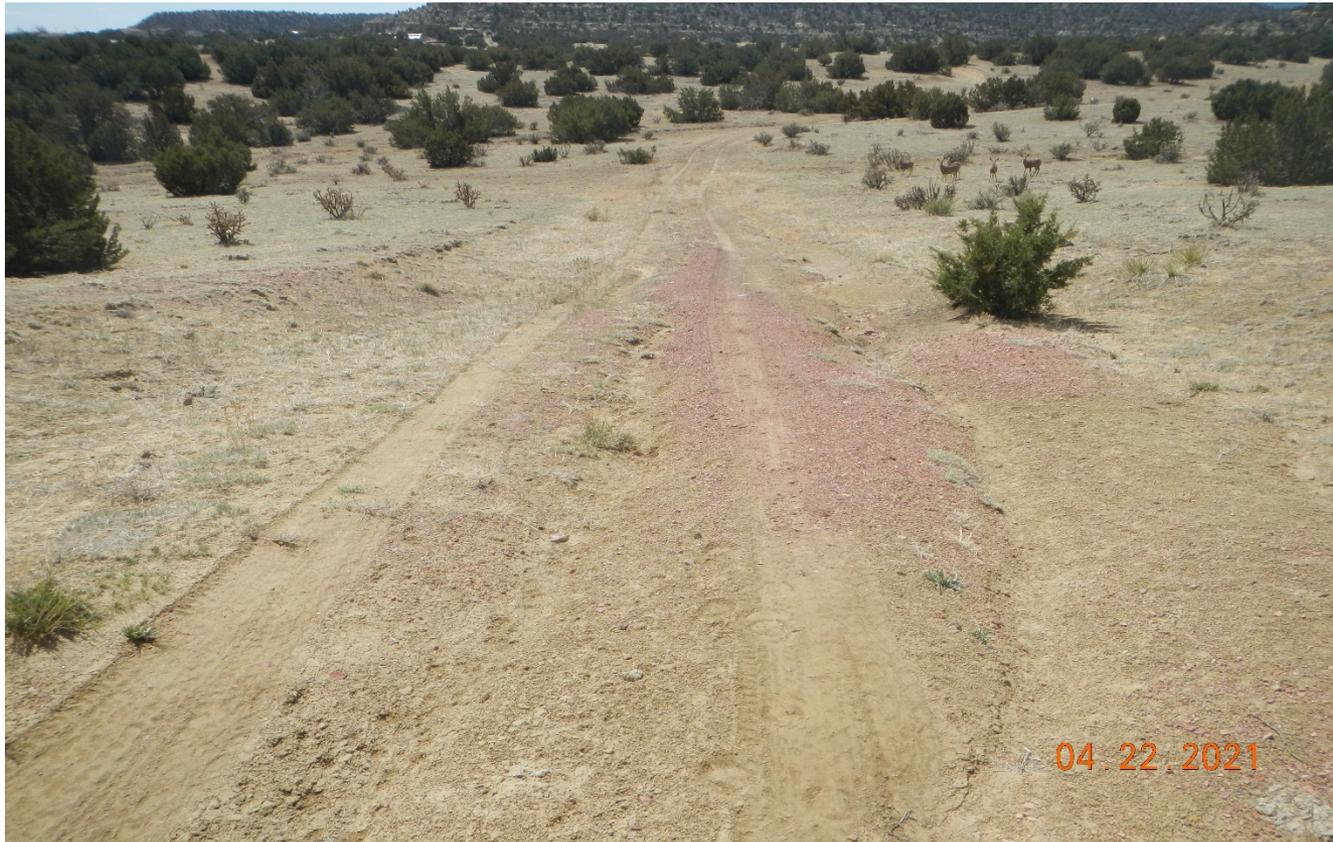
**Photo 1.** Facing south along the main access road. There is erosion along this area of the road which needs to be repaired and stabilized.

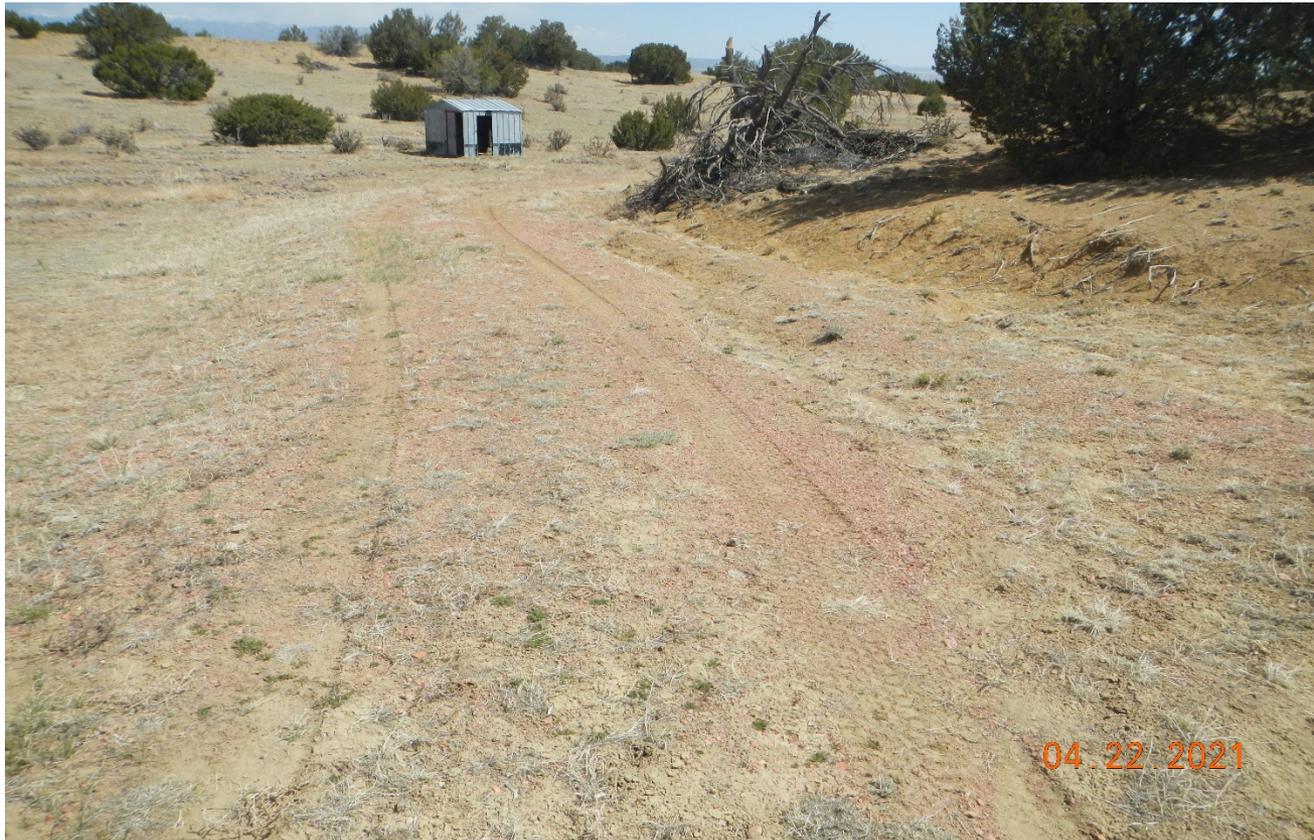
**Photo 2.** Facing northeast along the access road. The access road has not been recontoured and reclaimed.

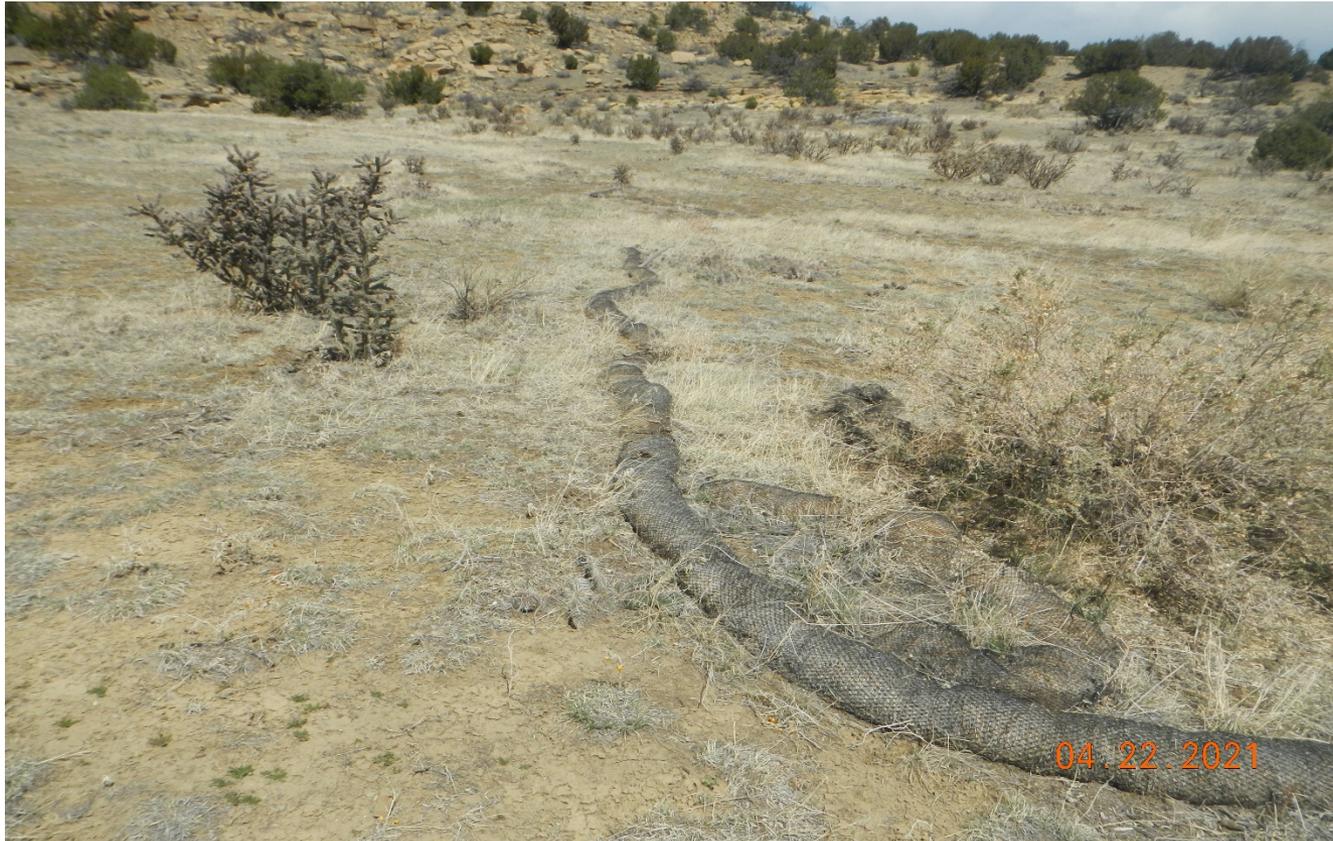
**Photo 3.** Facing northeast along the access road. The access road has not been recontoured and reclaimed.

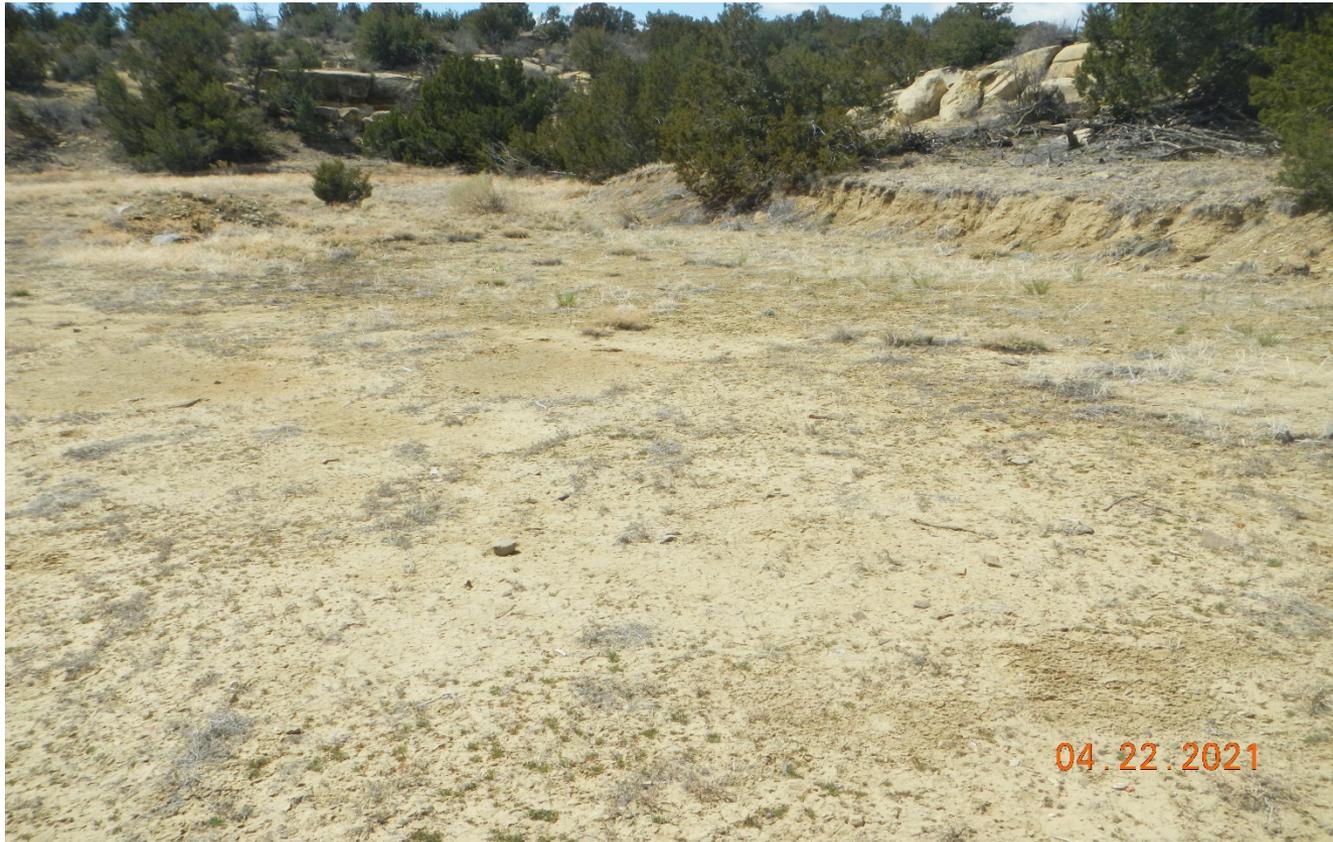
**Photo 4.** Facing southwest at the location. The cut slope is shown in the right side of the photo. The location has not been recontoured and reclaimed.

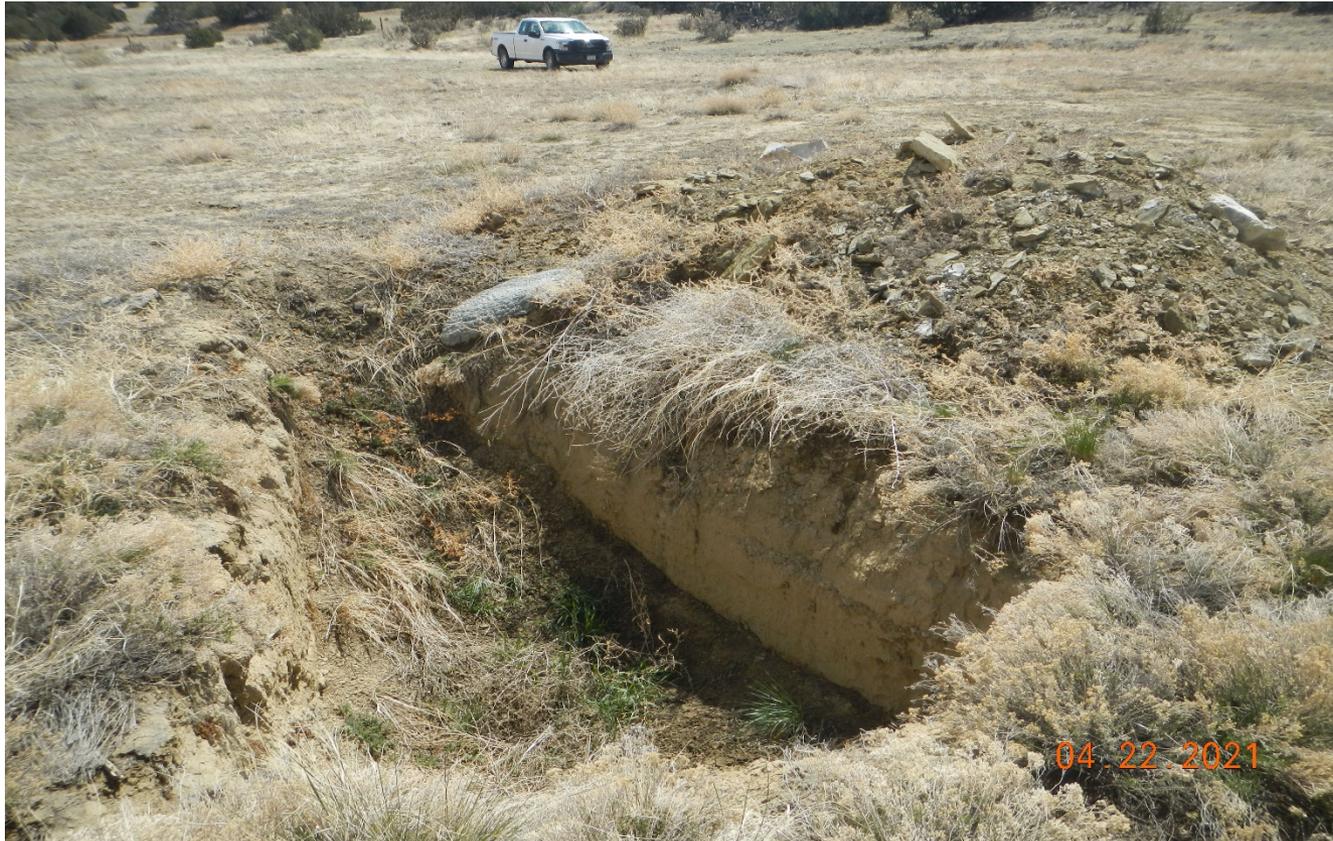
**Photo 5.** There is an open hole which is about 4.5 ft. deep. There is cement debris next to the hole which appears to be from plugging of the well.
