Inspection Photos

API: 043-40014

Operator: JAVERNICK OIL

Inspection Date: 2/9/2021

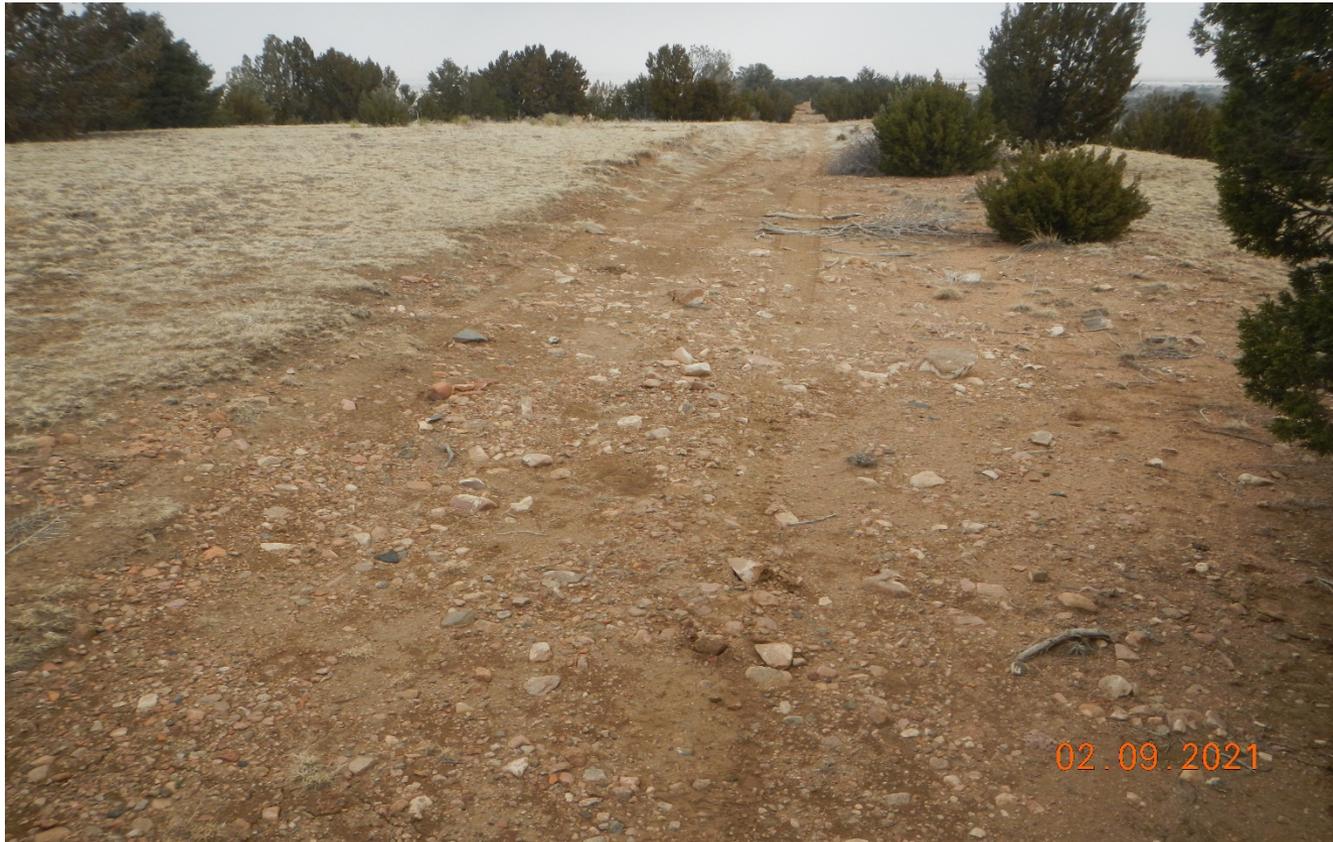
Photo 1. Facing northeast along the access road. The road has not been recontoured and reclaimed. Previous corrective action was not performed.

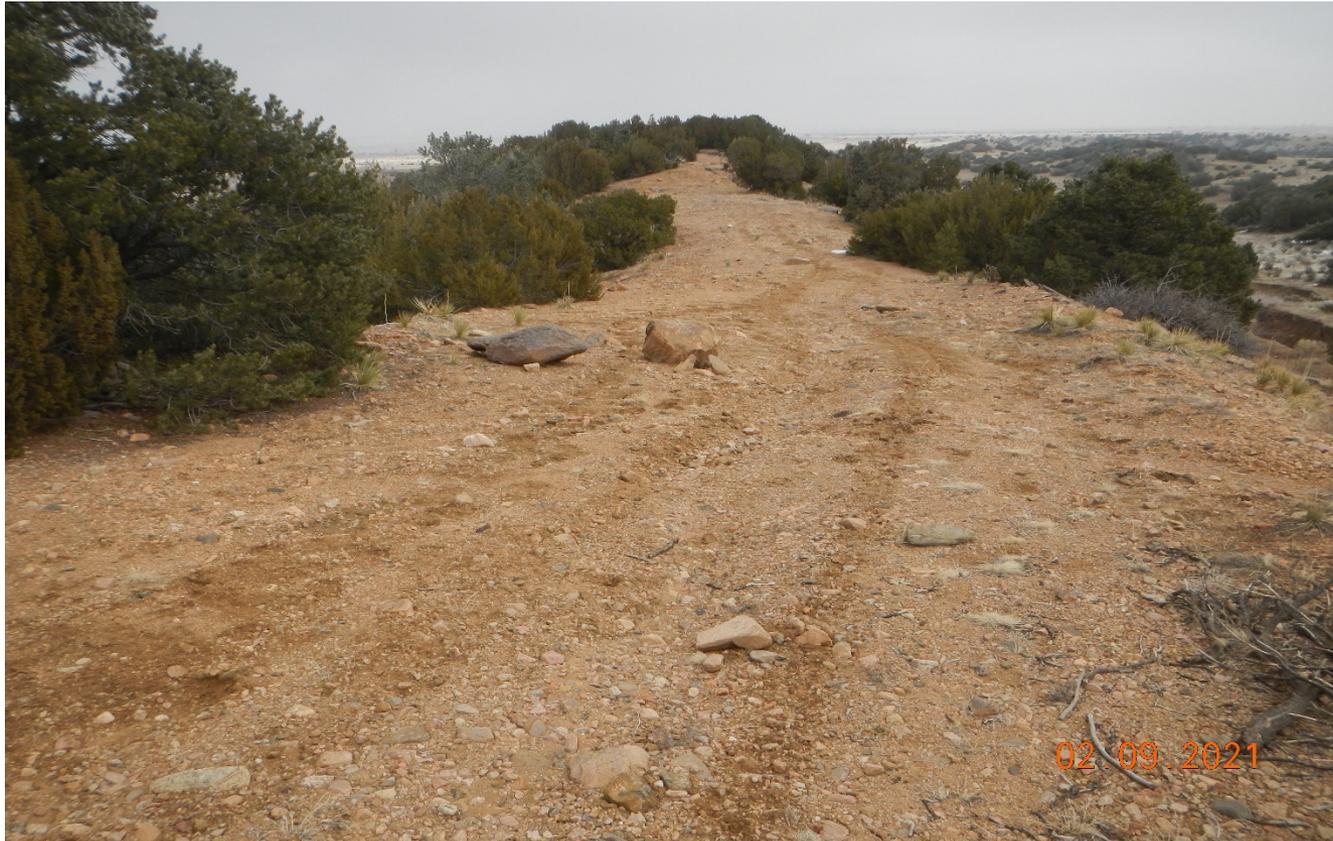
Photo 2. Facing northeast along the access road. The road has not been recontoured and reclaimed. The soils are bare of vegetation and susceptible to erosion.

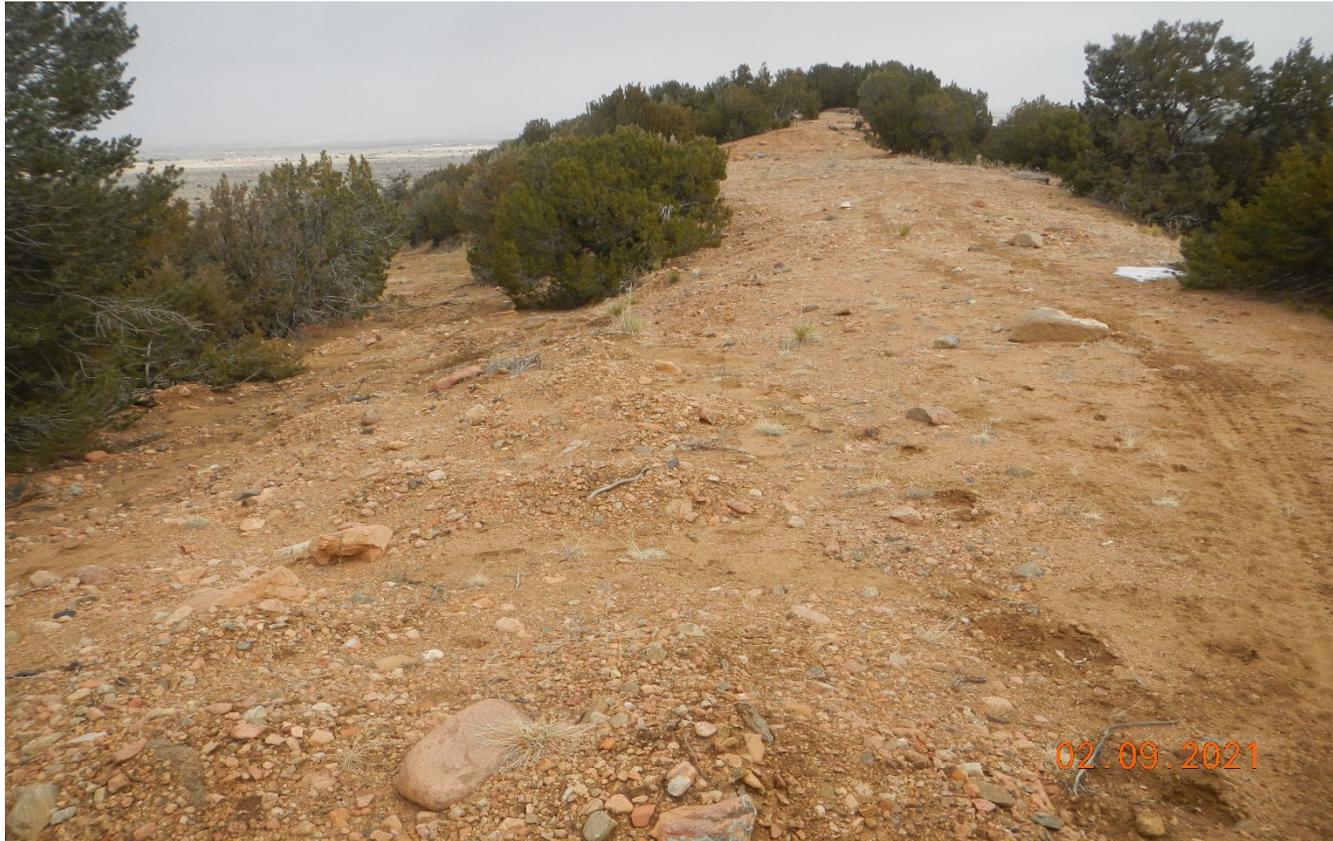
Photo 3. There is an access road that leads northeast to the Drapper4 well site which has not been recontoured and reclaimed.

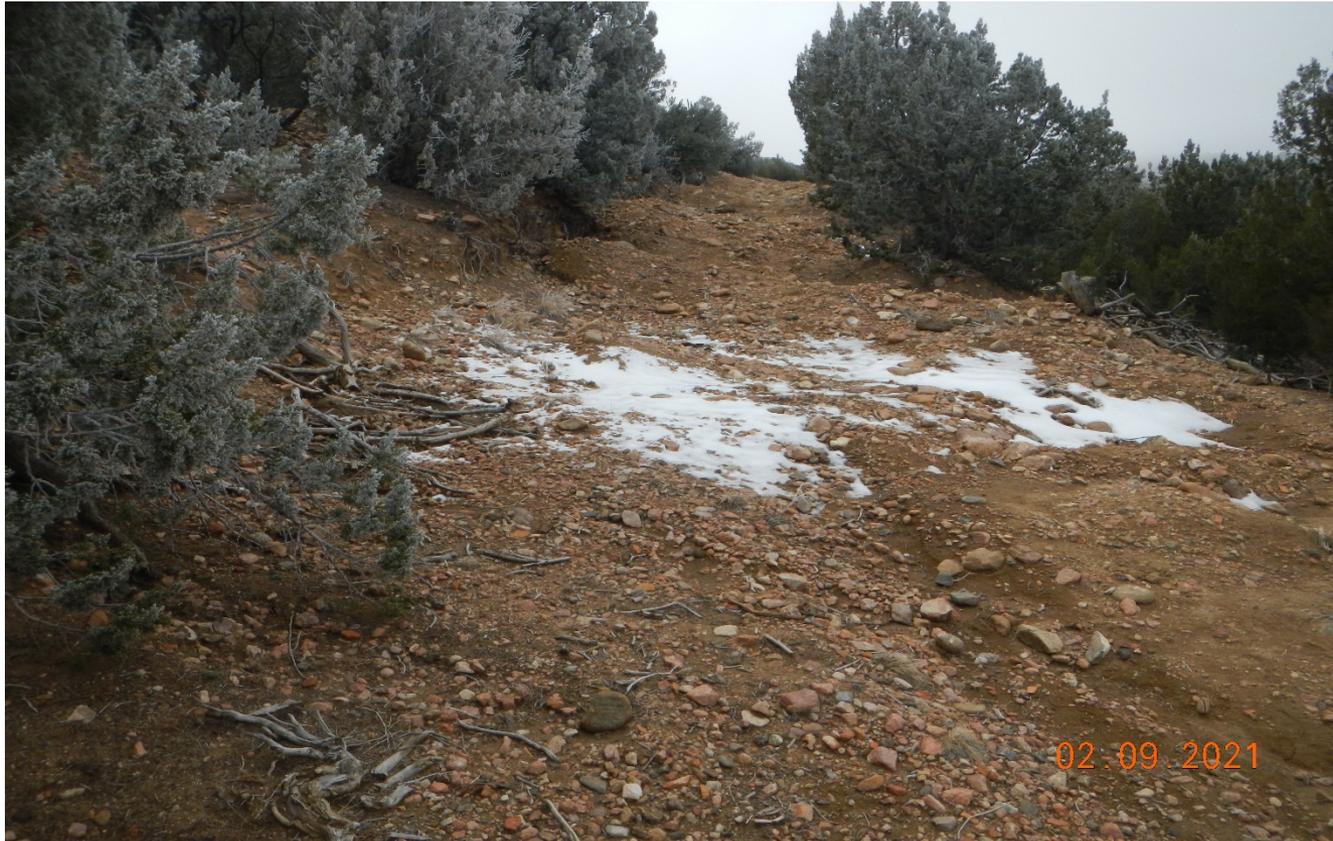
Photo 4. Facing southwest along the access road between the Hassler 24 and Drapper4 well site. This area has not been recontoured and reclaimed and is susceptible to further erosion.
