Inspection Photos
Location Name: Cosslet A 9 Flowline
Spill ID 478542

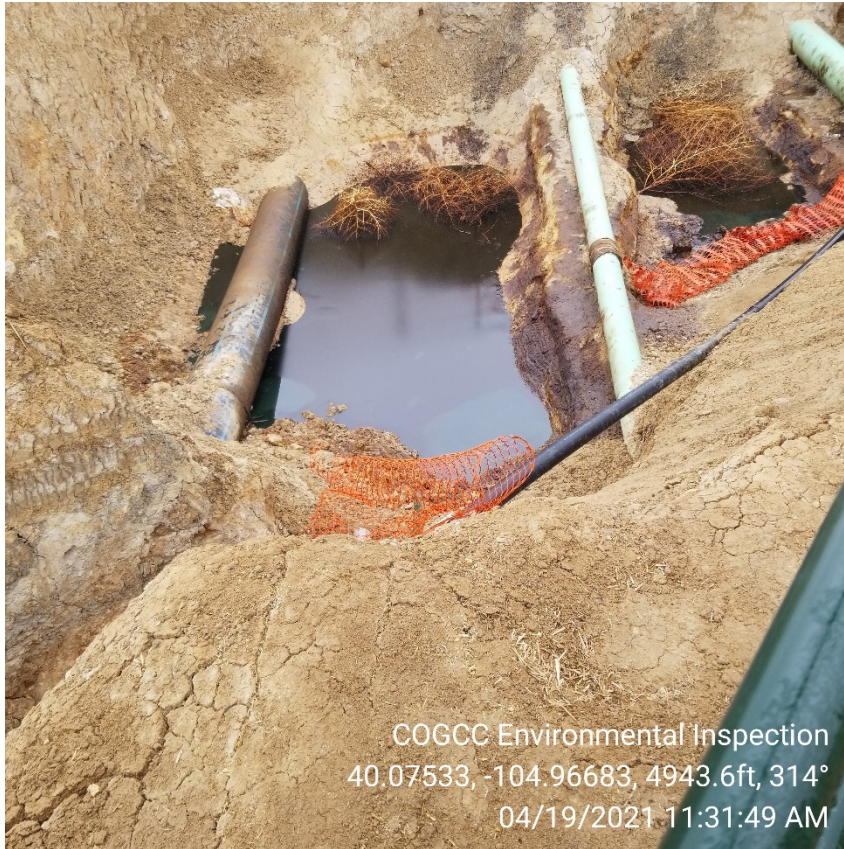
**Photo 1 – Free product observed on groundwater.
Flowlines exposed and trash in excavation.**

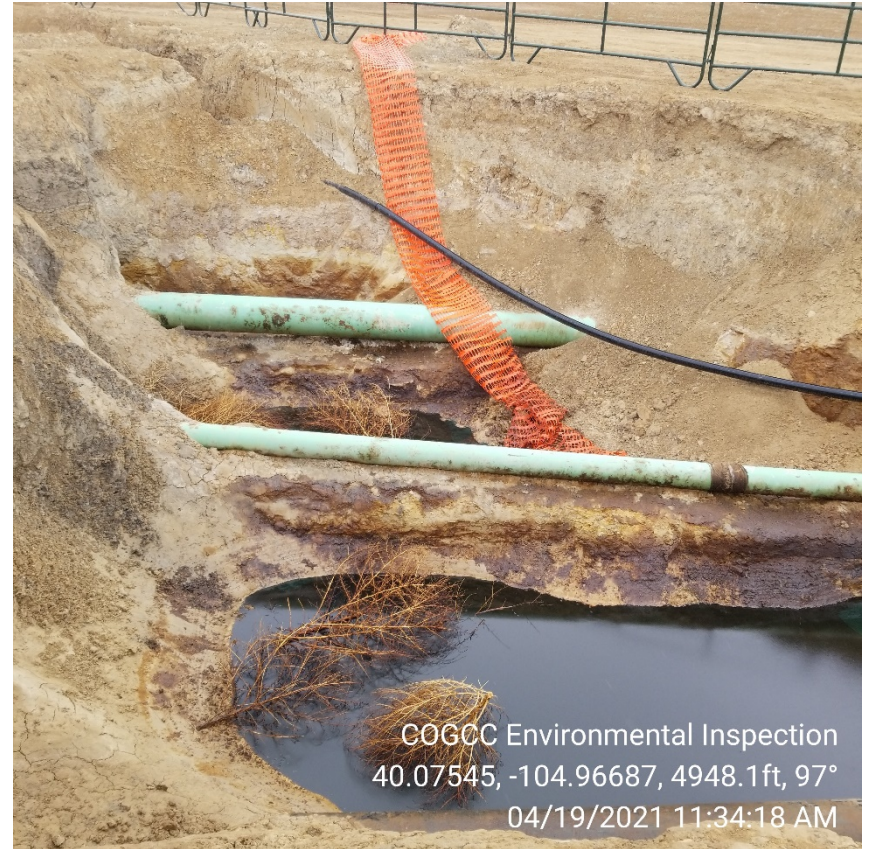
**Photo 2 – Free product observed on groundwater.
Flowlines exposed and trash in excavation.**

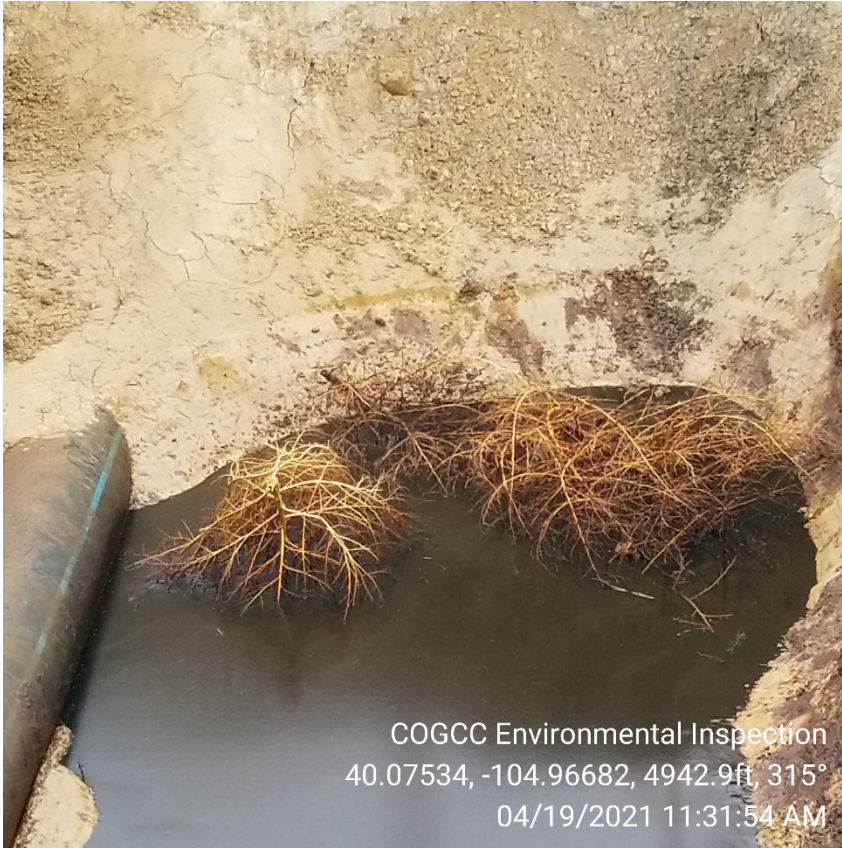
**Photo 3 – Free product observed on groundwater.
Flowlines exposed.**

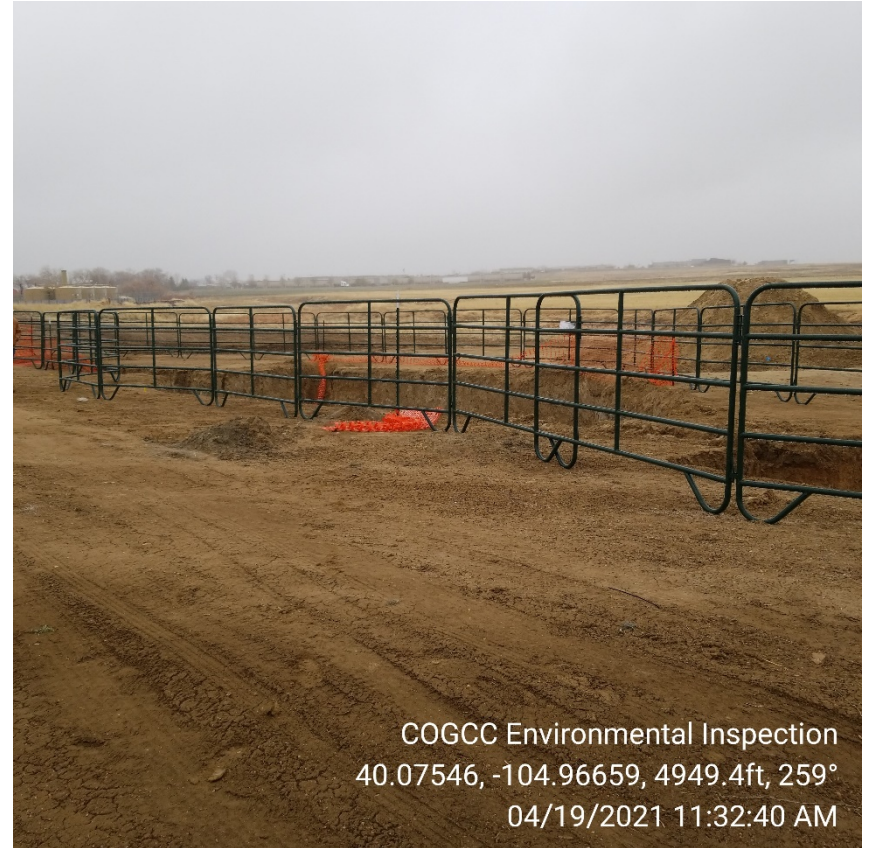
**Photo 4 – New fencing constructed, remnants of old
fence left as trash.**

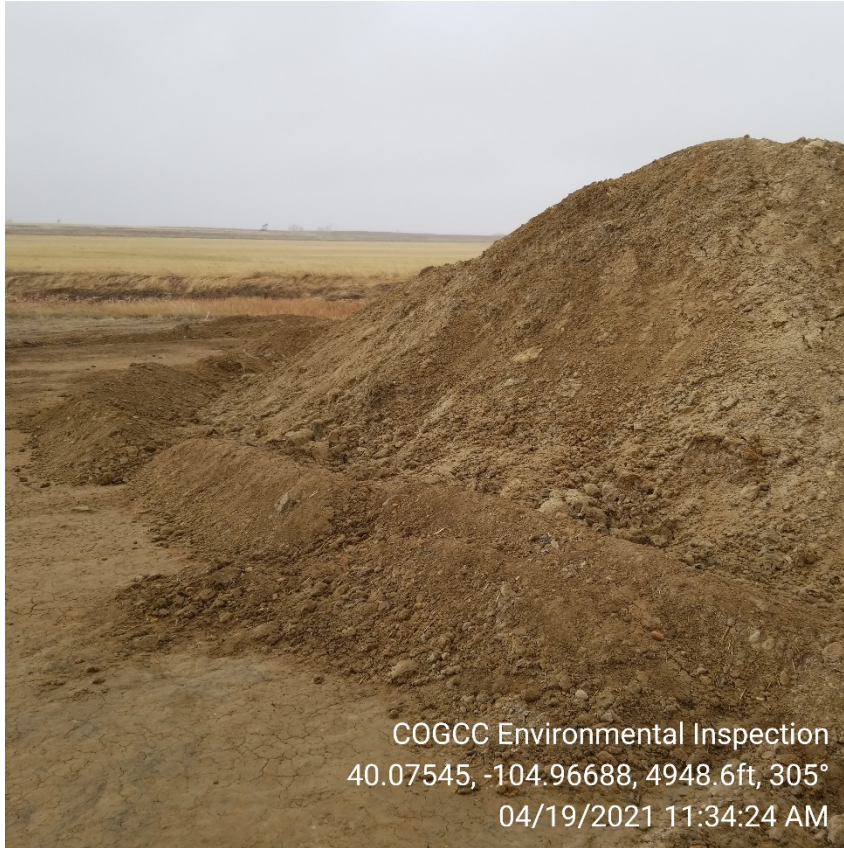
**Photo 5 – Stockpiled soils with inadequate BMP's;
wetland in background.**

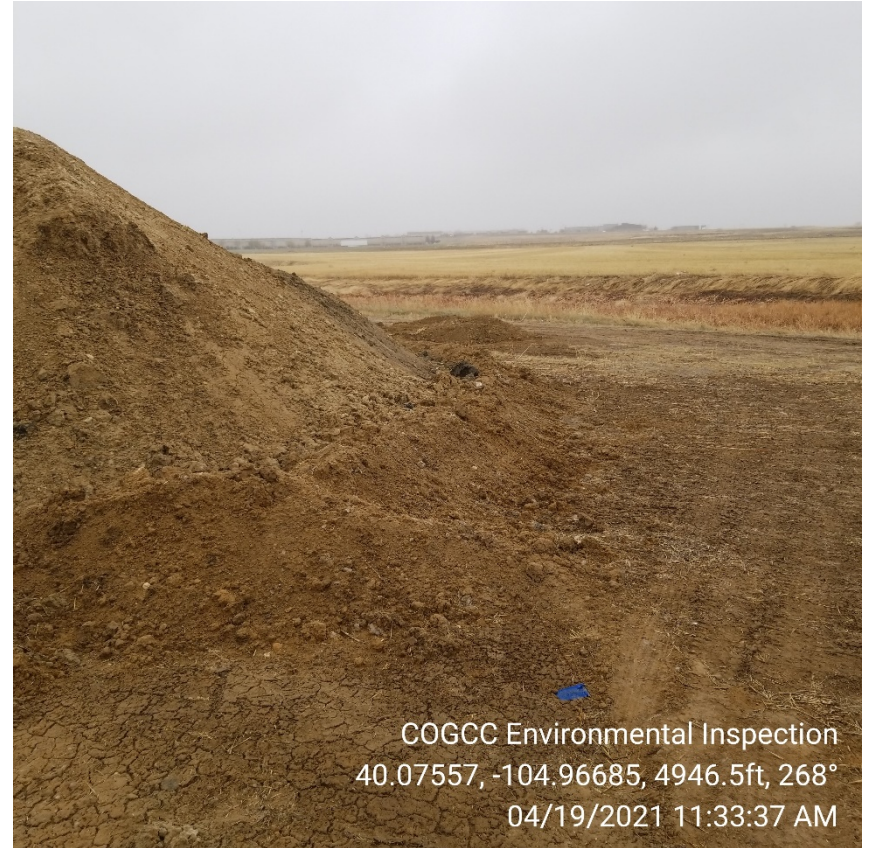
**Photo 6 – Stockpiled soils with inadequate BMP's;
wetland in background.**
