Inspection Photos

Operator: Catamount Energy
API: 007-06217
Date: 4/20/2021

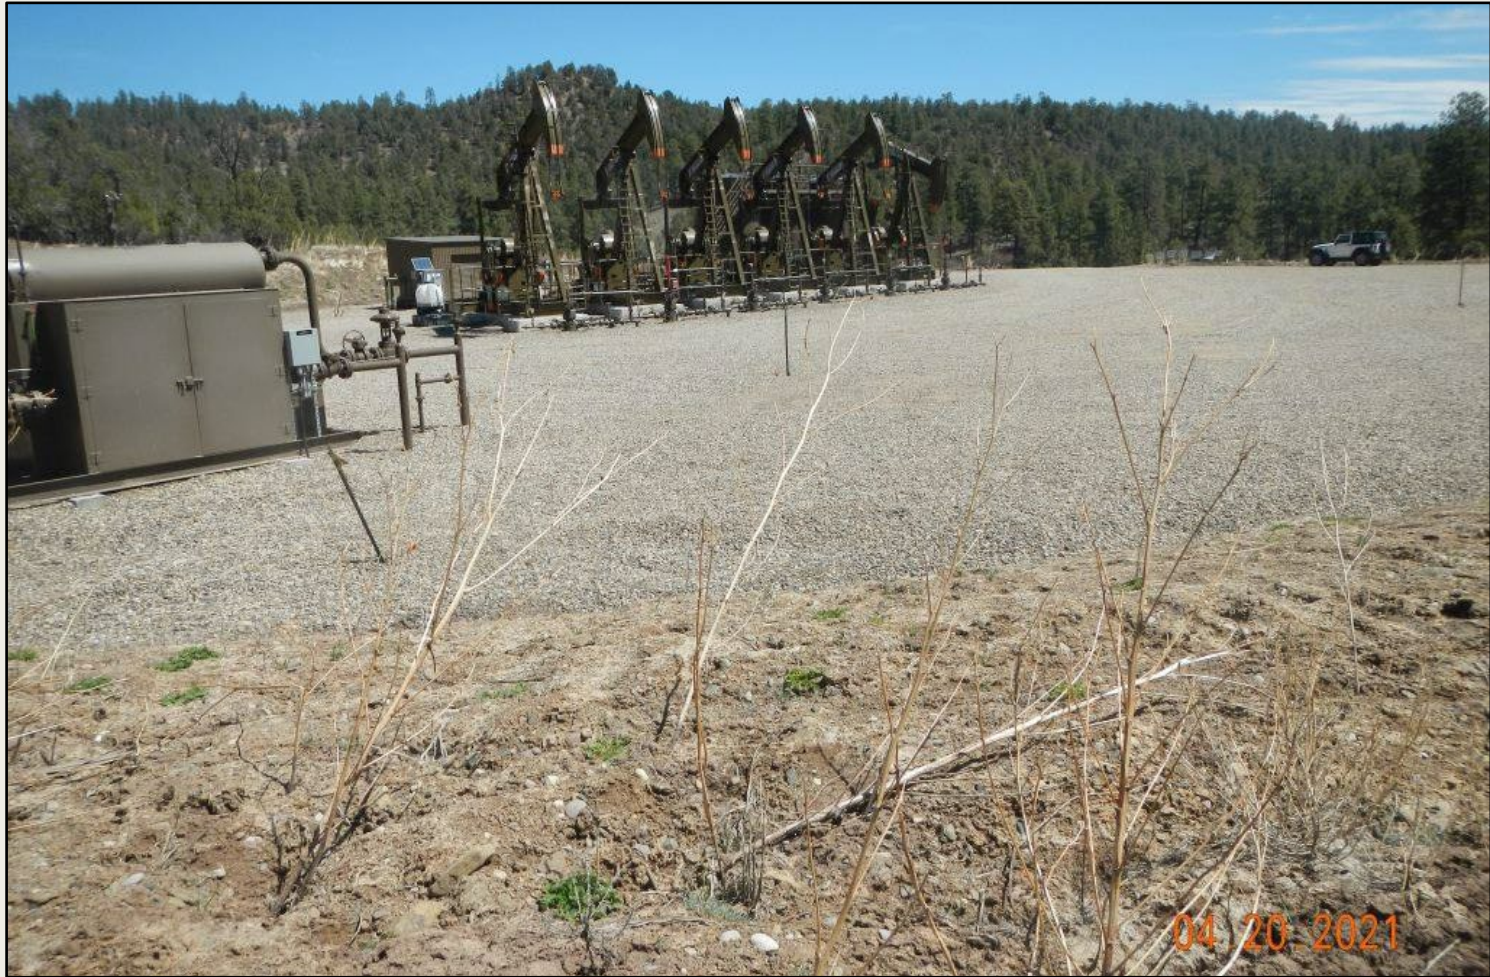
Photo 1. View of the project area from the southwestern corner of the well pad facing center.

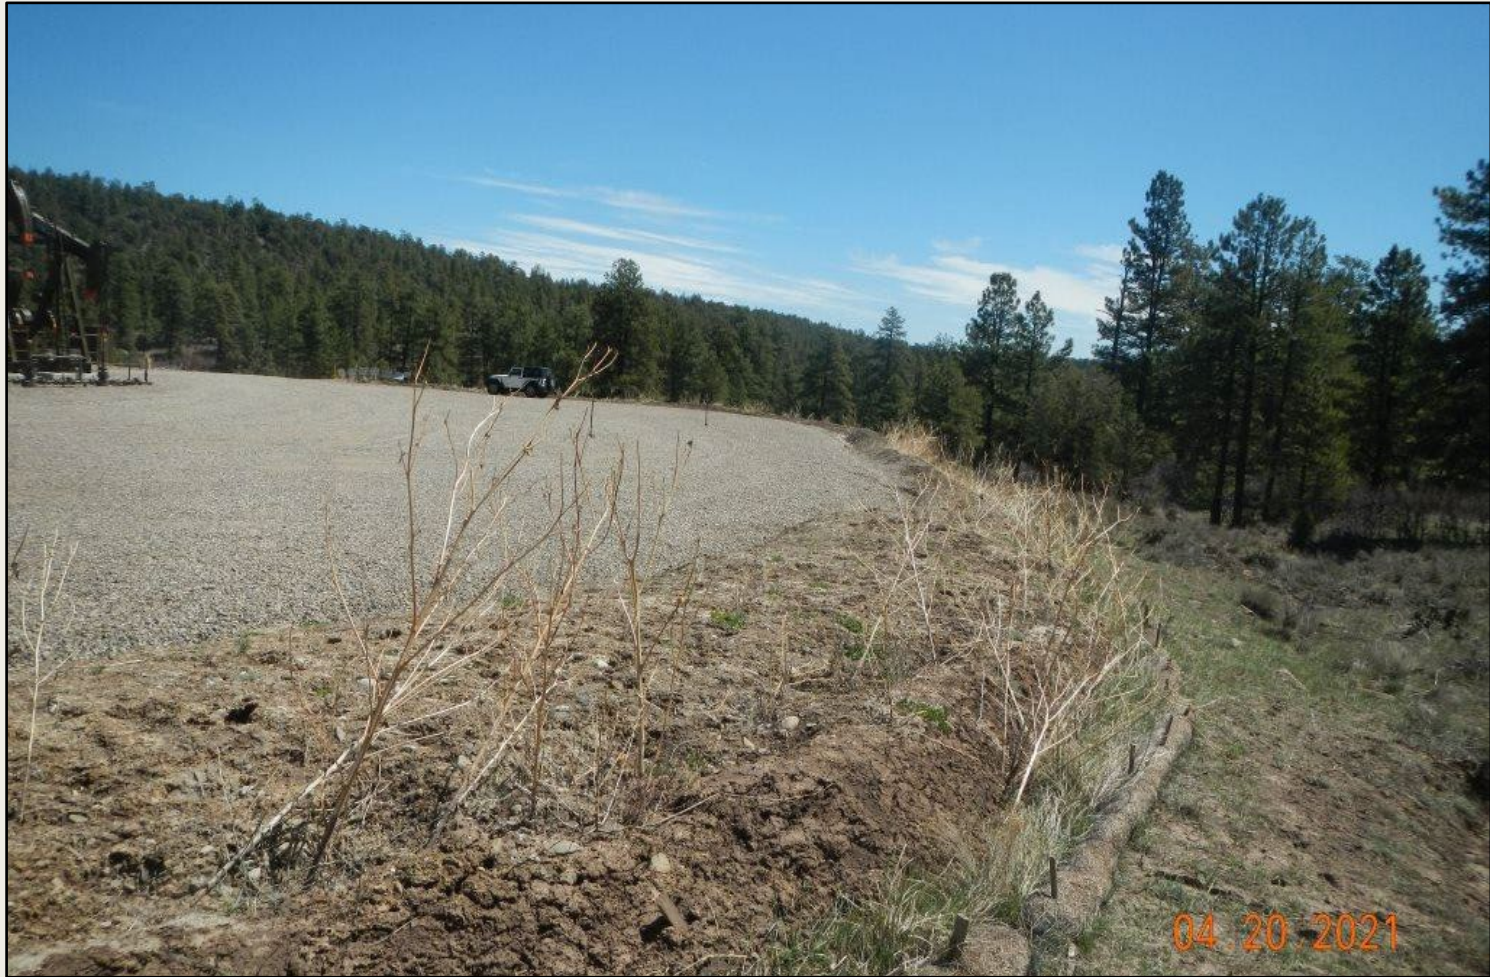
Photo 2. View of the southern project area from the southwestern corner facing eastward. Revegetation is in an early reclamation condition. Small grasses such as squirreltail and western wheatgrass, as well as clover (likely melilotus) observed within the reclamation areas.

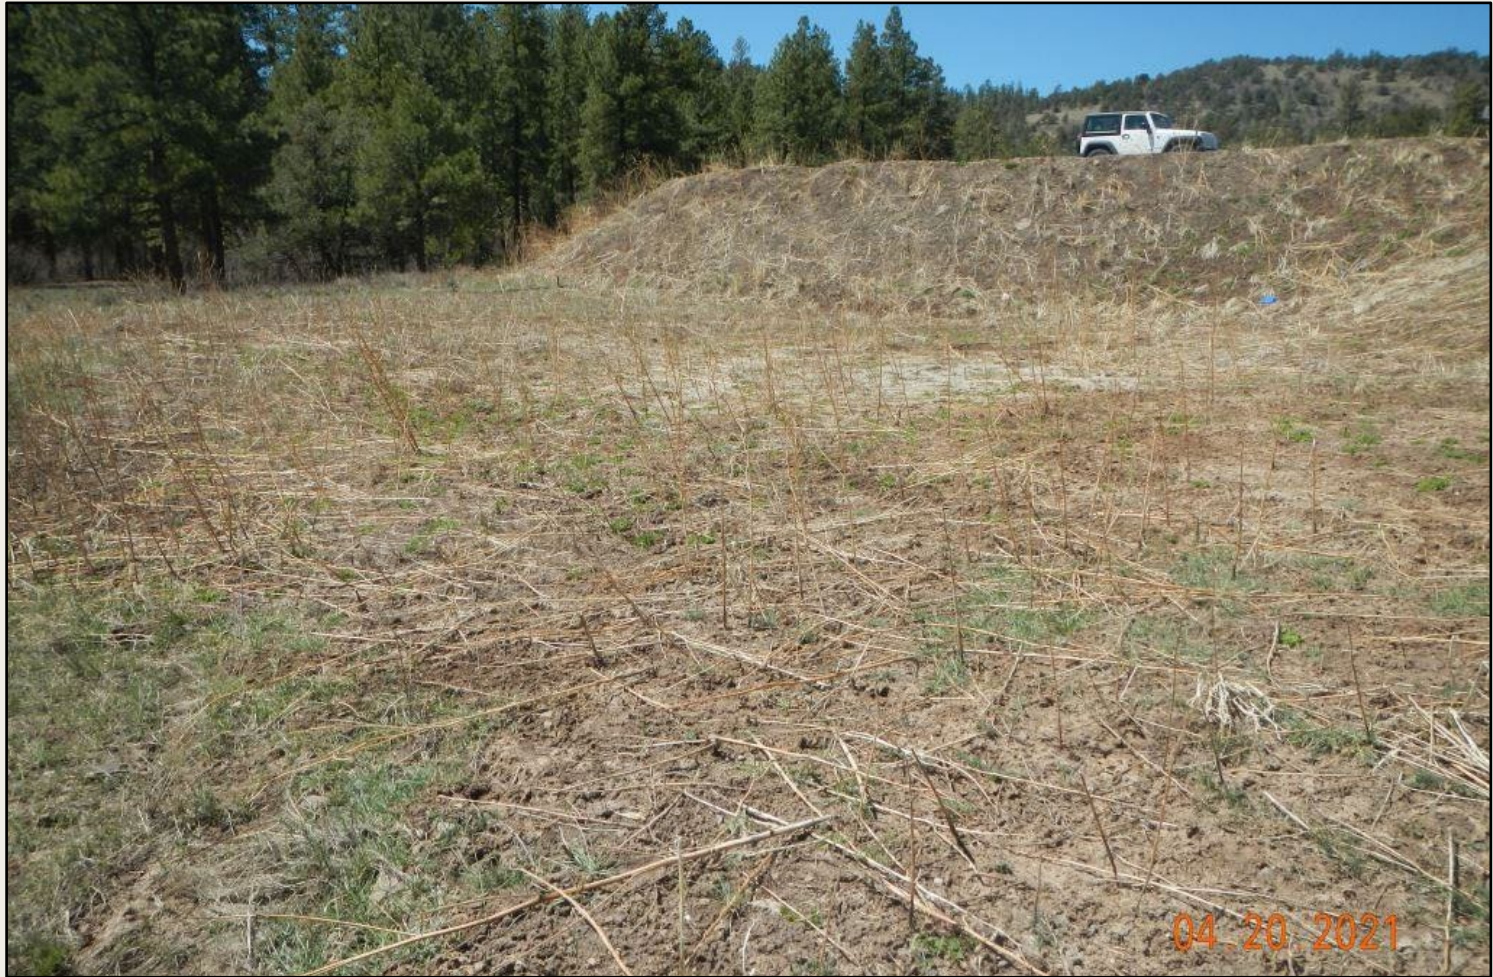
Photo 3. View of the southeastern fill slope from the edge of the access road, facing southward.

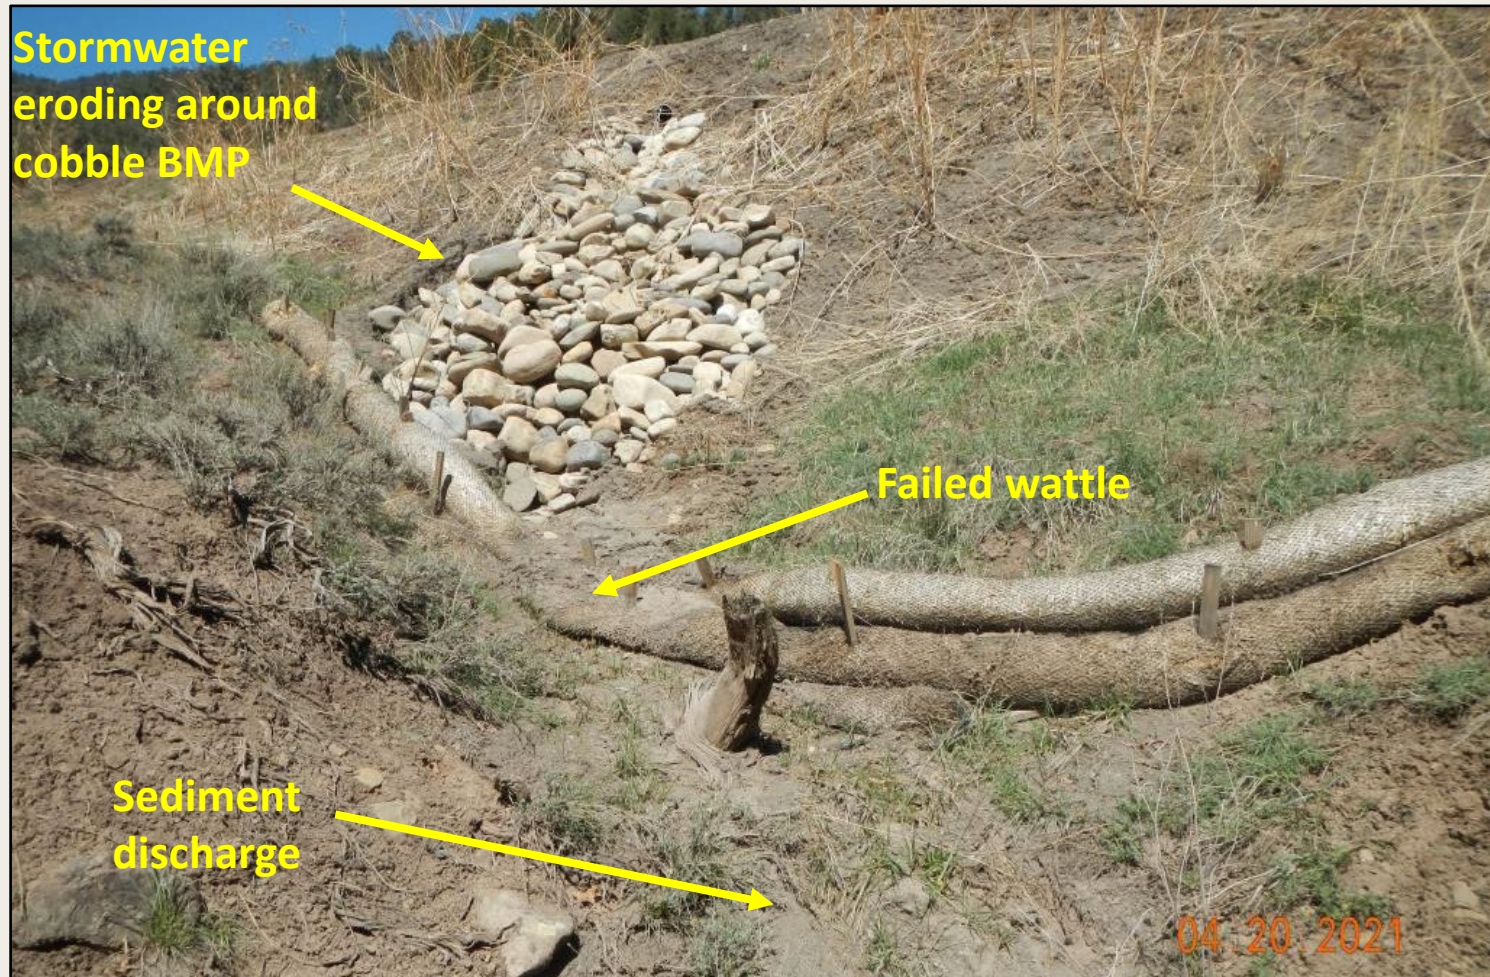
Photo 4. View of stormwater BMPs within the southern project area. Wattle is not functioning and is not the correct type of BMP for this area. Discharged stormwater from well pad is flowing around the cobble and conveying sediment from the fill slope off of the project area.

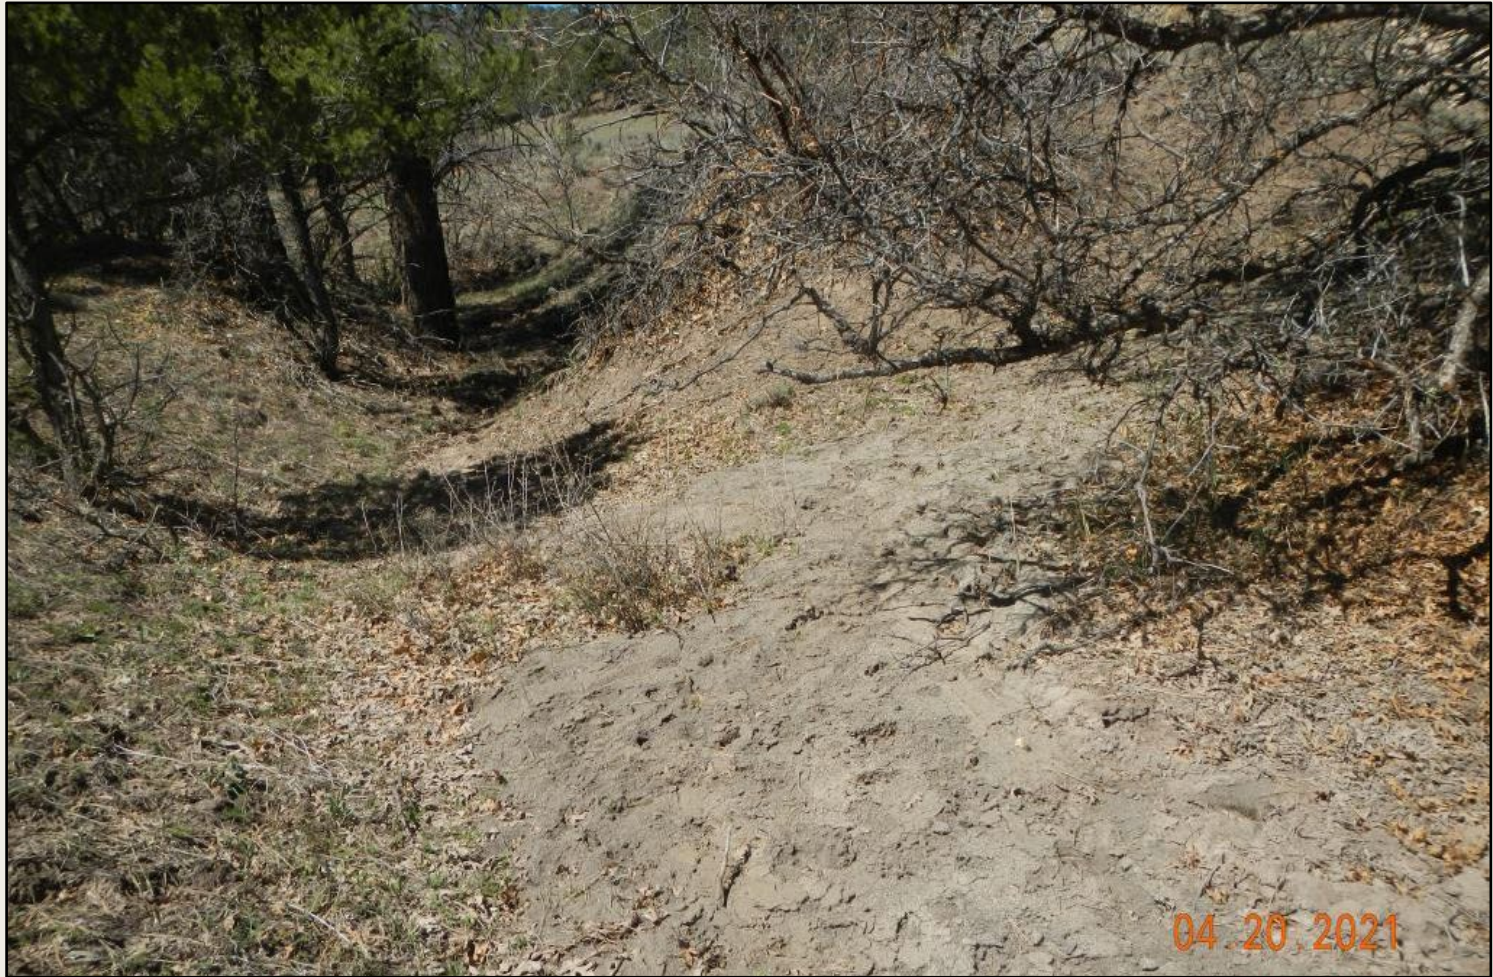
Photo 5. View of sediment discharging downstream from BMPs shown in Photo 4.

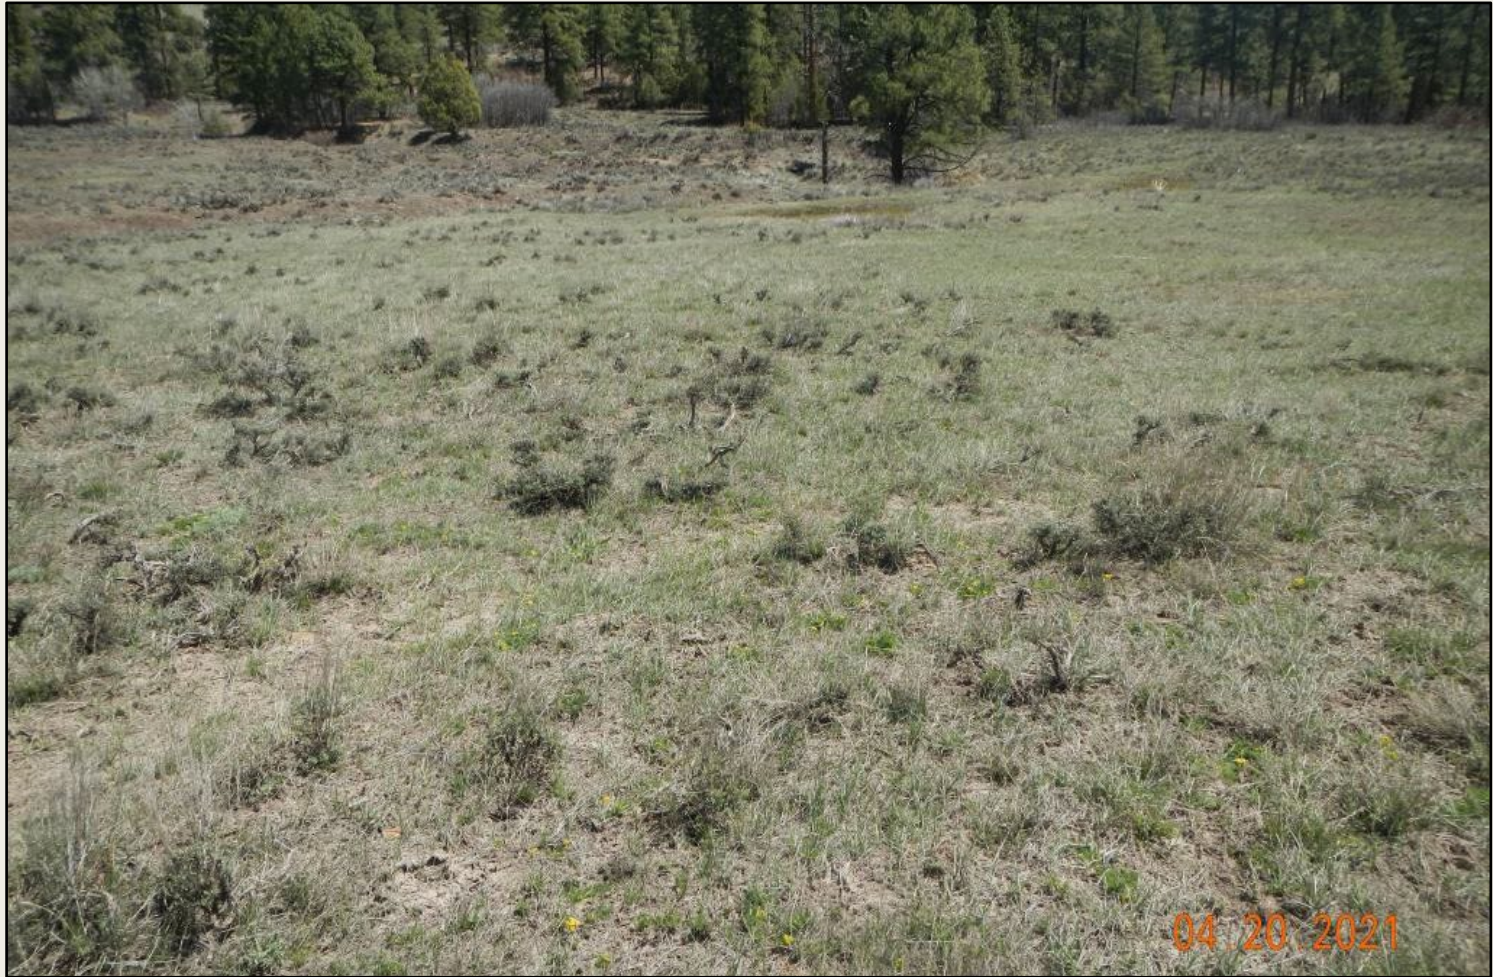
Photo 6. View of reference area vegetation comprised of Ponderosa pine savannah with western wheatgrass, squirreltail, black sagebrush, locoweed, and bisquitroot.
