Inspection Photos

Location Name: CAERUS PICEANCE LLC ENCANA-67S95W /21NWNW

Location ID: 335047

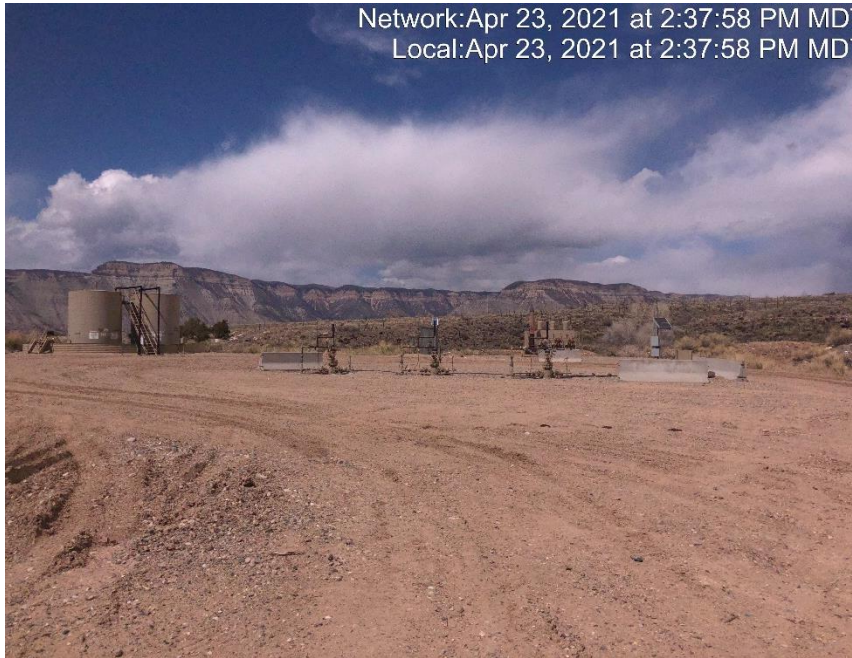
Photo #3611 from entrance to location.

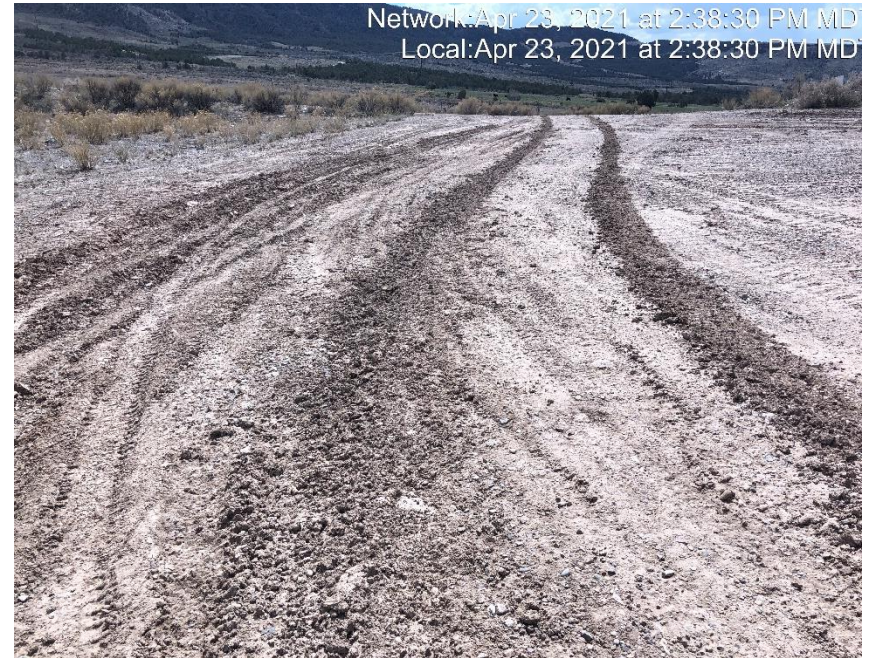
Photo #3612 Location lacks stabilization.

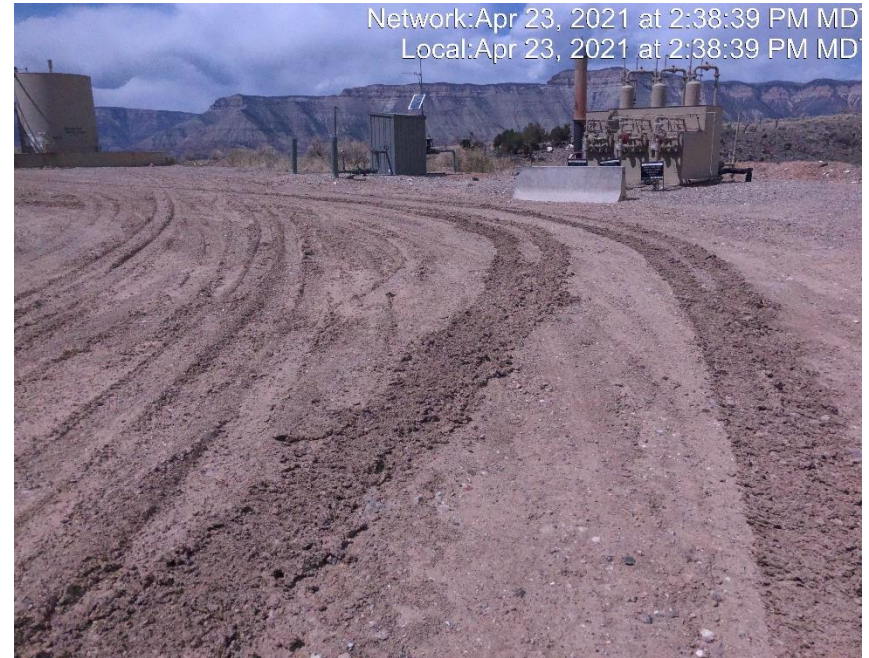
Photo #3616 location lacks stabilization.

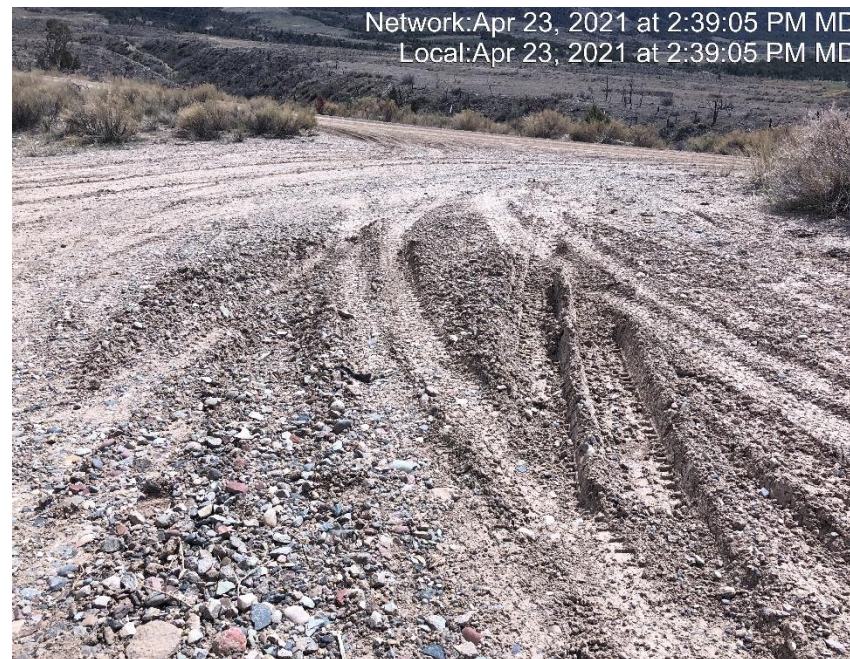
Photo #3614 No form of tracking BMP located at entrance to location.
