Inspection Photos

4/27/2021

Operator: RIO MESA RESOURCES INC - 74740

Location ID: 398846

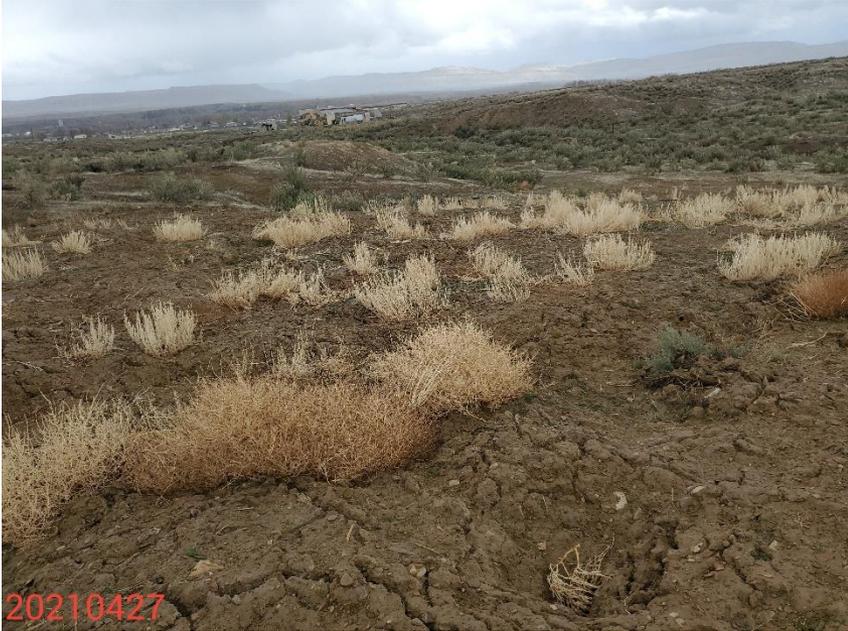
Photo 1: Photo taken from the west end of the Location, facing northeast. Photos 1-3 provide an overview of the Location from northeast, southeast to south.

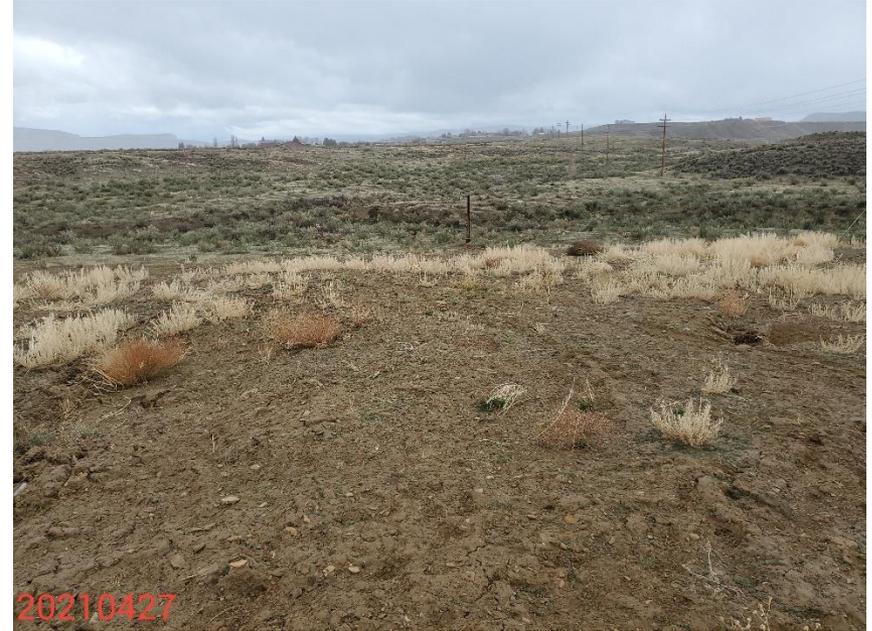
Photo 2: See comments under photo 1.

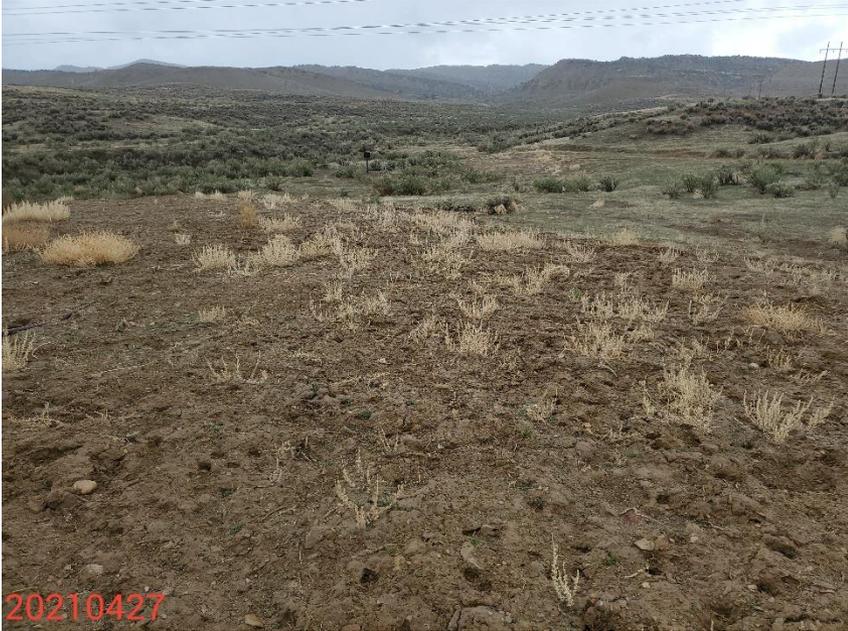
Photo 3: See comments under photo 1.

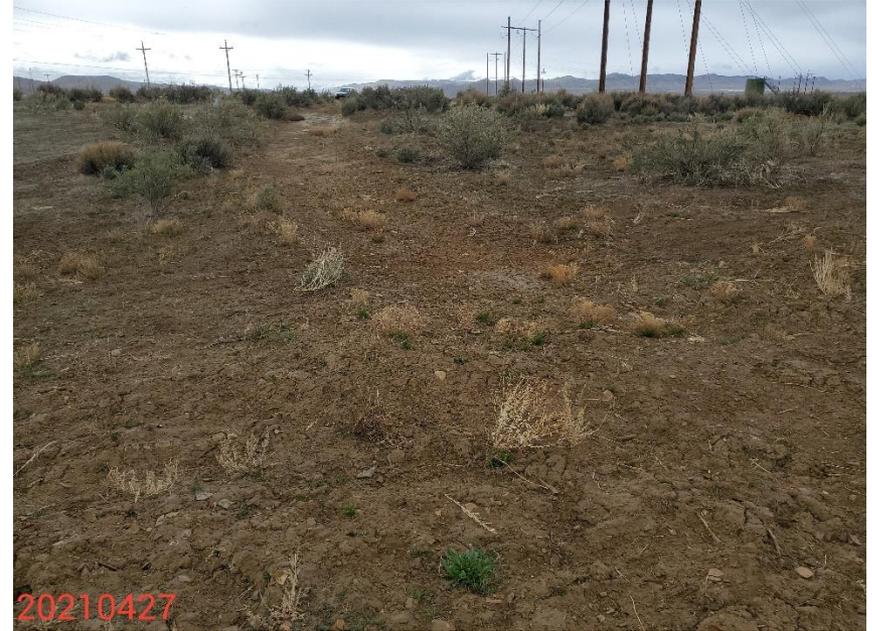
Photo 4: Photo taken from the west end of the Location, facing west. Photo shows access west access road leading to the Location has not been reclaimed .

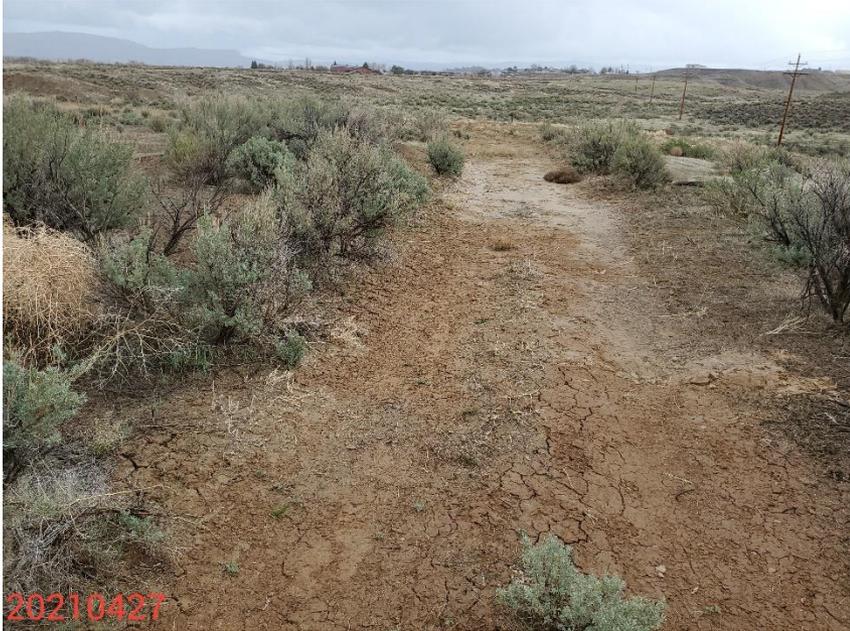
Photo 5: Photo taken from the access road west of the Location, facing east. Photo shows access west access road leading to the Location has not been reclaimed .

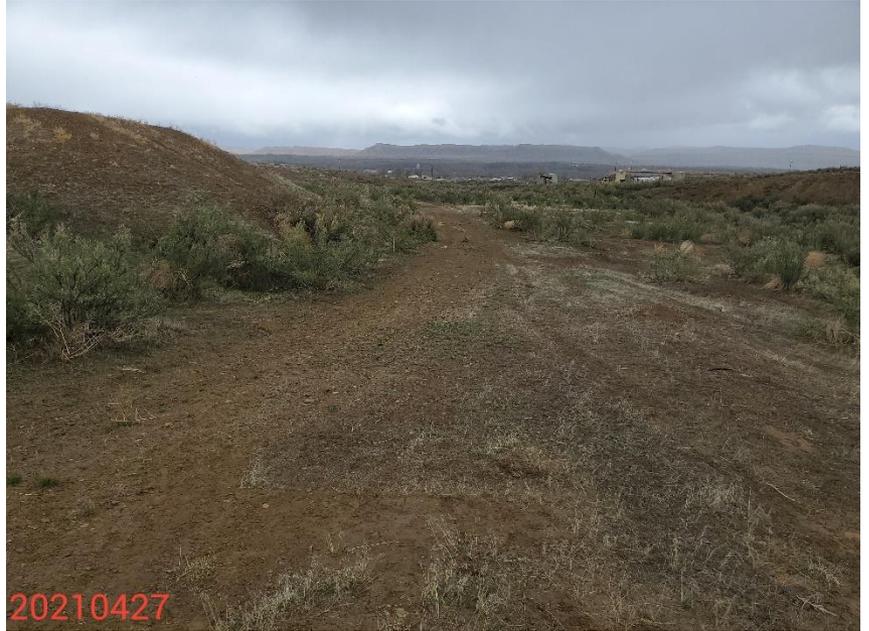
Photo 6: Photo taken from the northeast end of the Location, facing north. Photo shows access road leading to the Location has not been reclaimed.

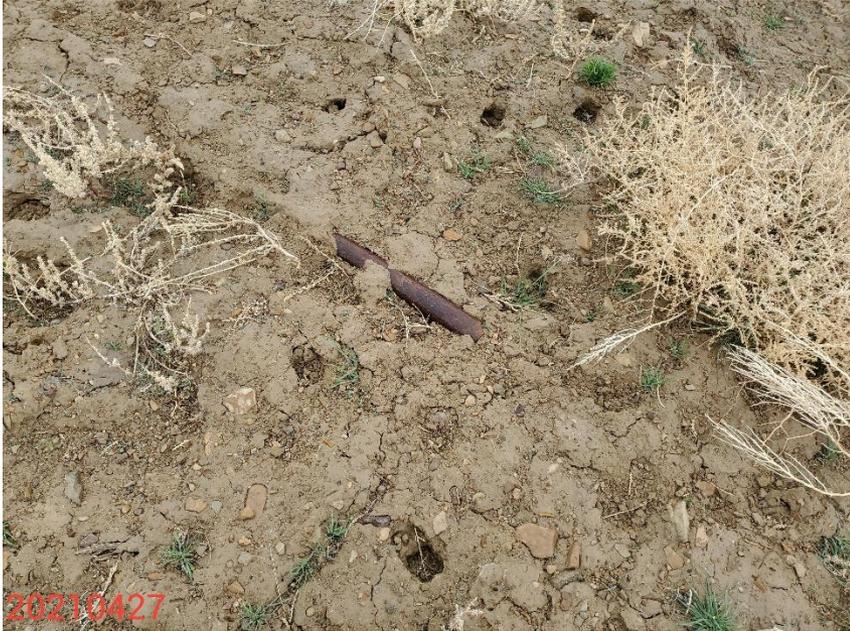
Photo 7: Photo taken from the Location. Photo shows example of pipe debris remaining on the Location.

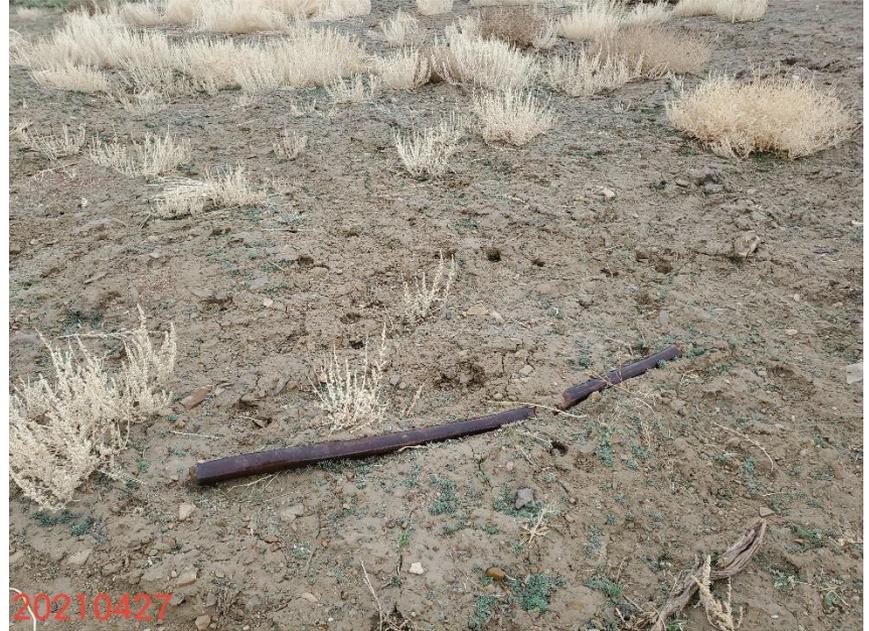
Photo 8: Photo taken from the Location. Photo shows example of pipe debris remaining on the Location.

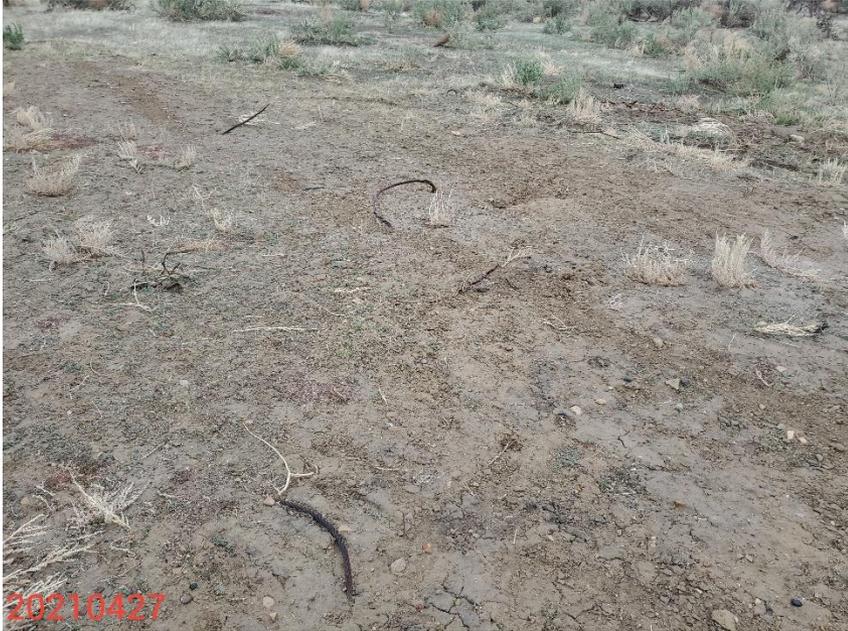
Photo 9: Photo taken from the east end of the Location. Photo shows example of cable debris remaining on the Location.

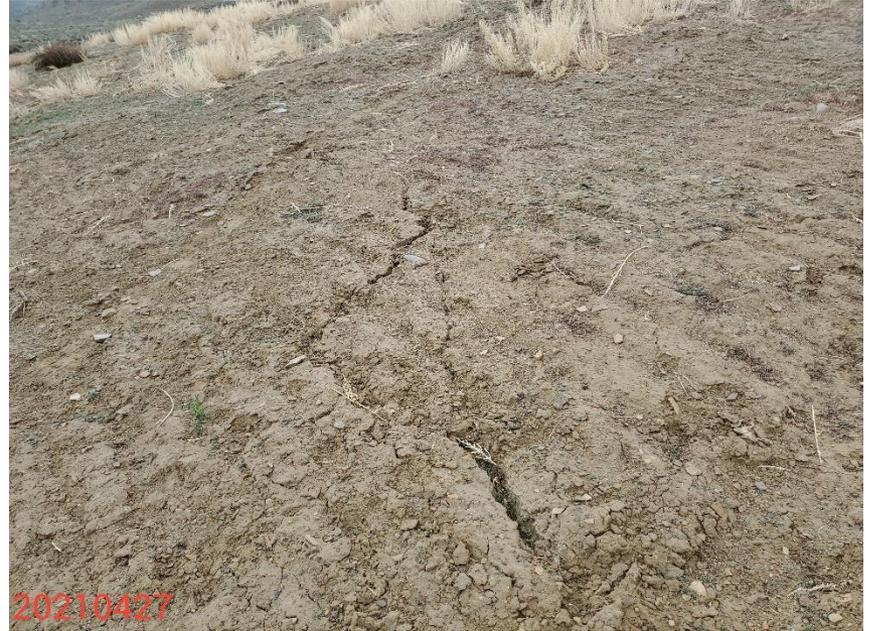
Photo 10: Previous inspections observed that stormwater erosion control BMPs were missing, or insufficient on the Location, and that cracking/rilling in soils were observed.

Photo shows control measures remain missing or insufficient to stabilize/protect the Location; erosion degradation remains evident.

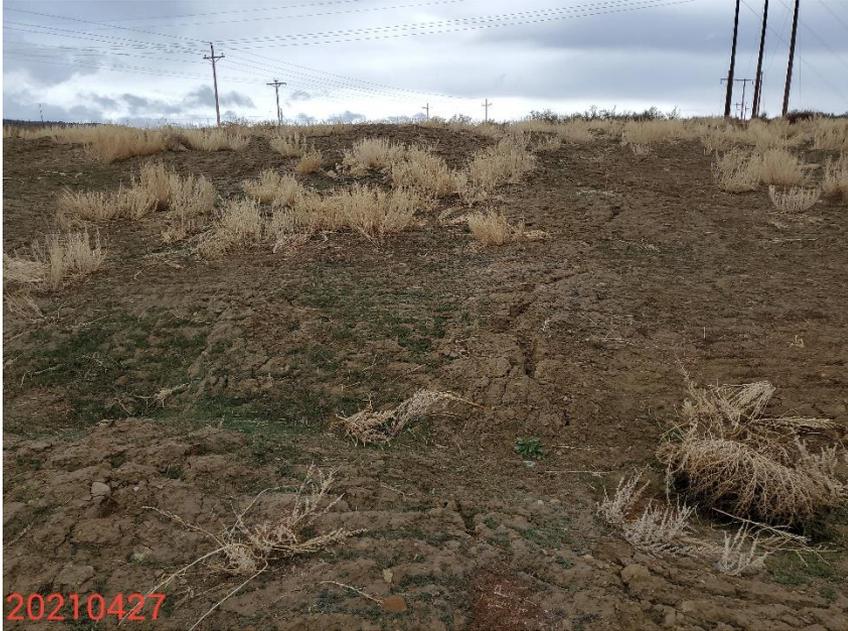
Photo 11: Previous inspections observed that stormwater erosion control BMPs were missing, or insufficient on the Location, and that cracking/rilling in soils were observed.

Photo shows control measures remain missing or insufficient to stabilize/protect the Location; erosion degradation remains evident.

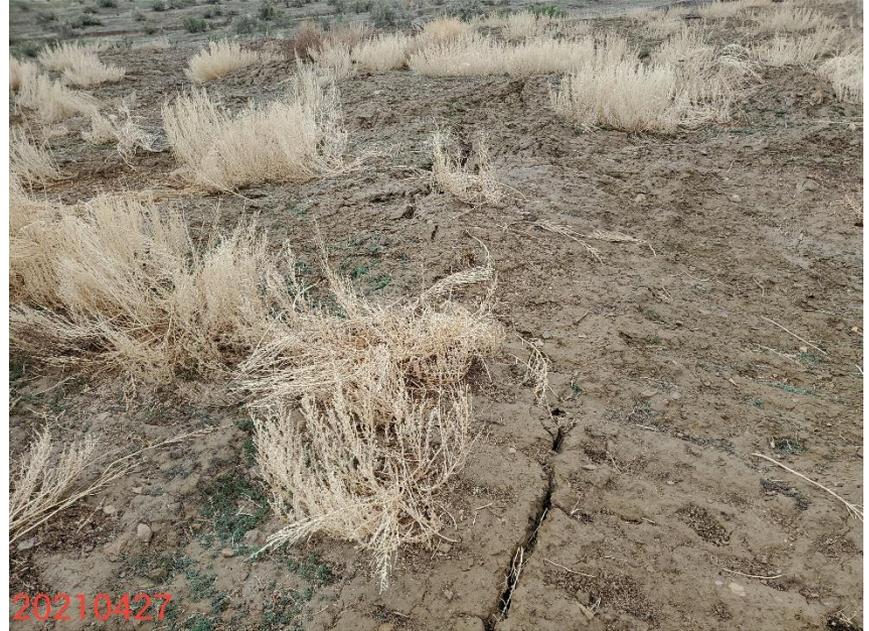
Photo 12: Previous inspections observed that stormwater erosion control BMPs were missing, or insufficient on the Location, and that cracking/rilling in soils were observed.

Photo shows control measures remain missing or insufficient to stabilize/protect the Location; erosion degradation remains evident.

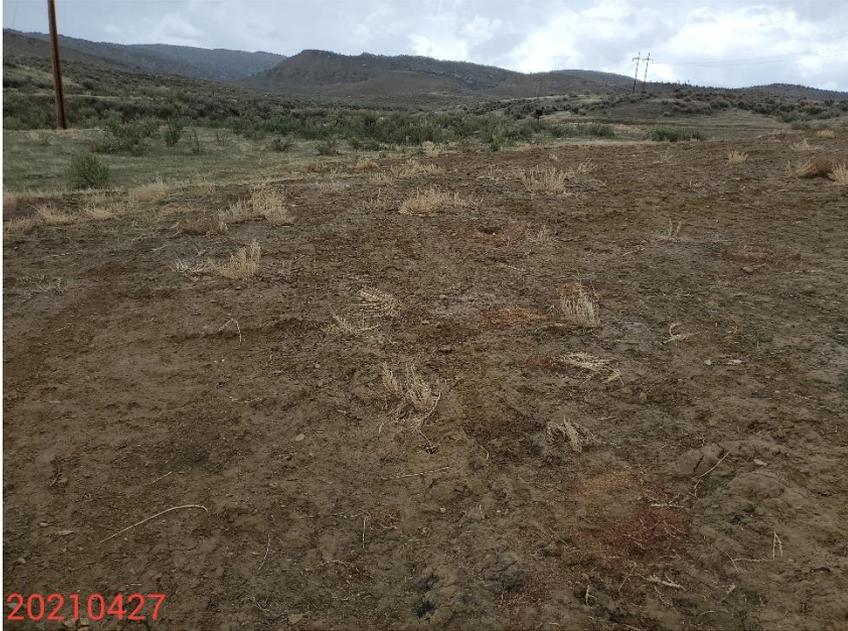
Photo 13: Photo taken from the east end of the Location, facing south. Photo shows control measures remain missing or insufficient to manage runoff from the Location.

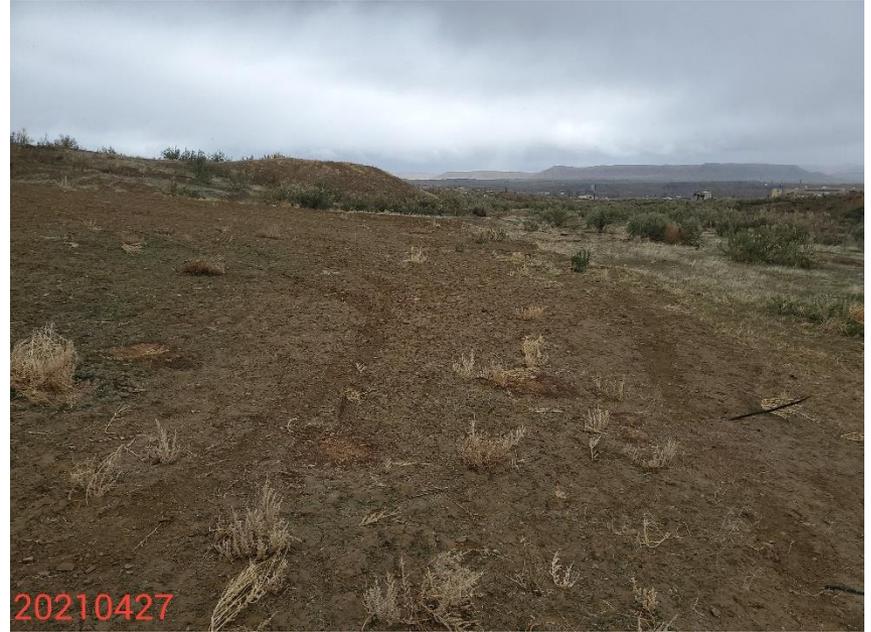
Photo 14: Photo taken from the east end of the Location, facing north. Photo shows control measures remain missing or insufficient to manage runoff from the Location.

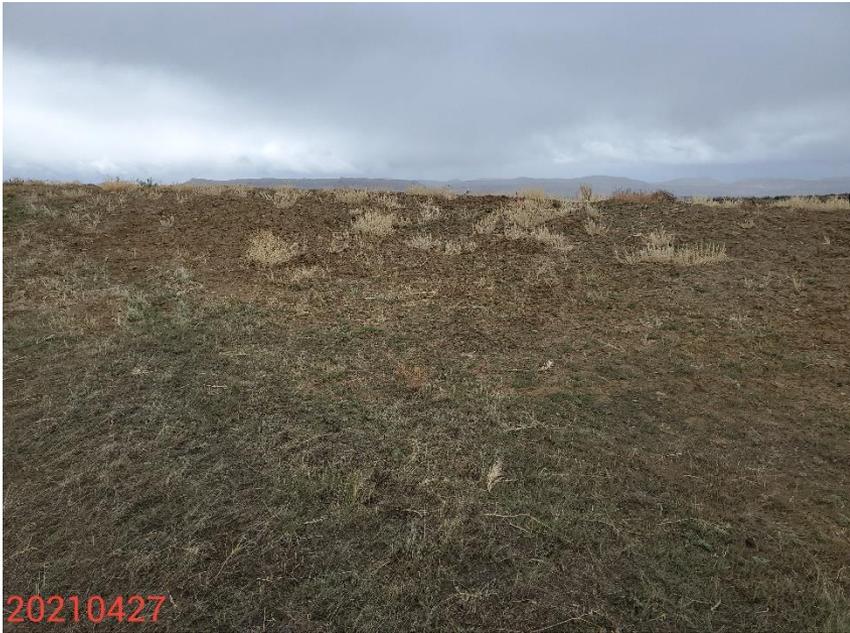
Photo 15: Photo taken from the southwest corner of the Location, facing north. Photo shows perimeter stormwater ditch. Ditch BMP has not been constructed in accordance with good engineering practices; BMP ends on the southwest end of the location and does not have a sufficient outlet to allow for sediment laden-free stormwater discharge.

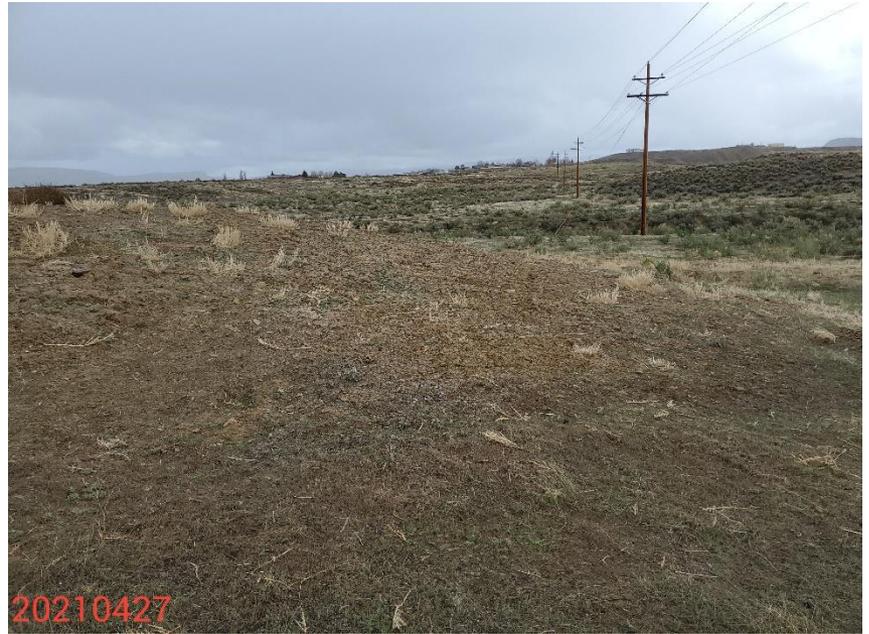
Photo 16: Photo taken from the southwest corner of the Location, facing east. See comments under photo 15.

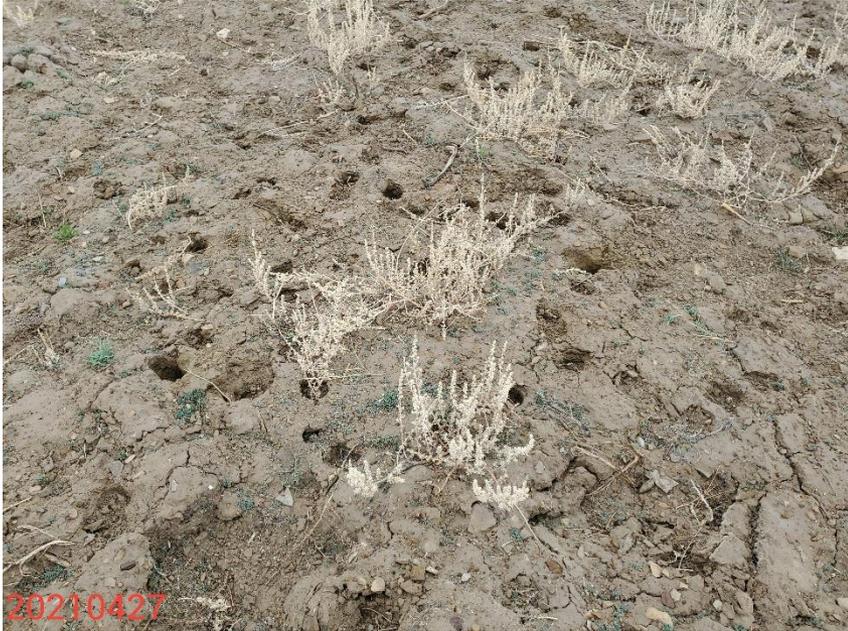
Photo 17: Photo taken from the Location. Inspector was unable to observe desirable vegetative establishment; Location is progressing towards a Halogeton monoculture. This is a Colorado State Listed noxious weed and requires management.

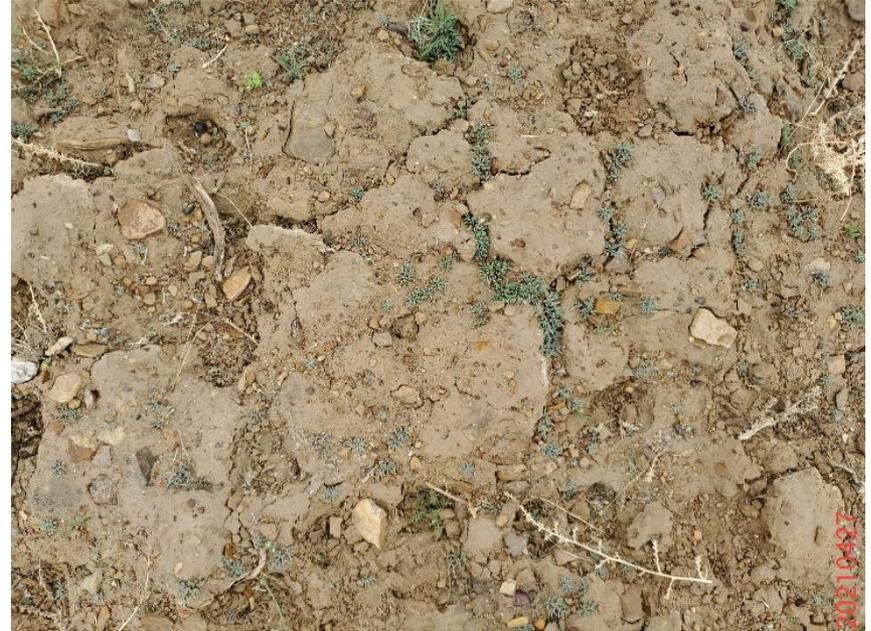
Photo 18: Continued from photo 17. Vegetative germination observed in photo is Halogeton.

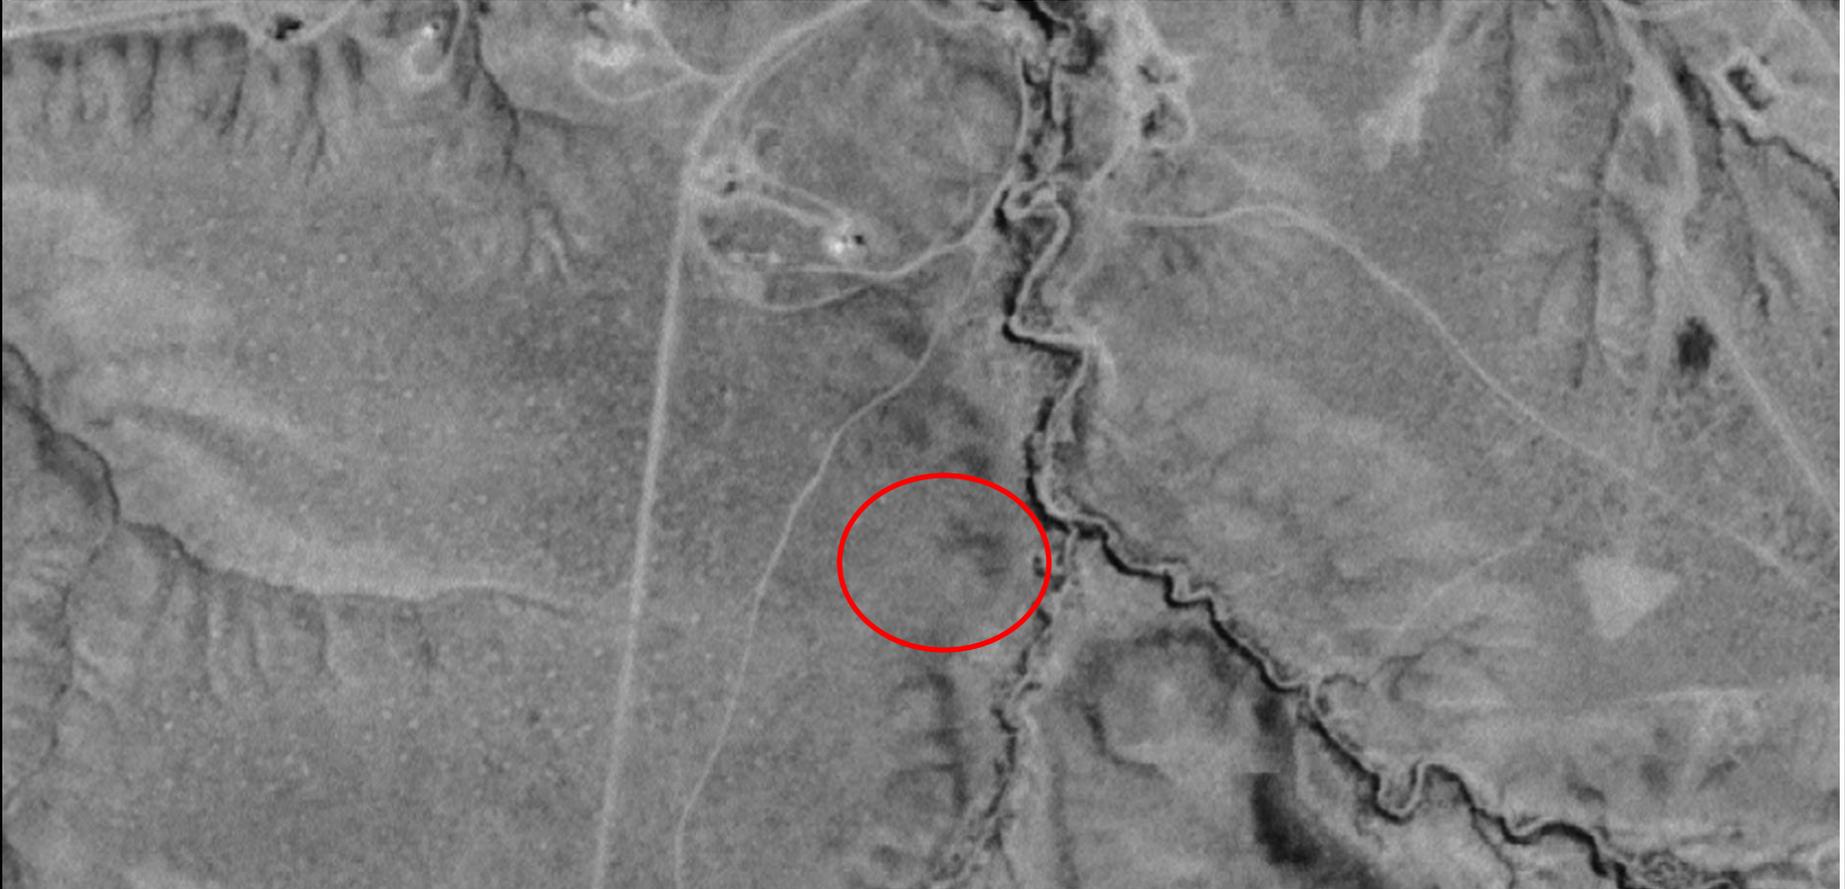
Photo 19: 1955 USGS aerial imagery. Well was spud 1957. Photo shows Location of the Lubauer 33A well prior to O&G disturbance. Photo shows access roads did not pre-exist Location.
