Inspection Photos

Operator: Hilcorp Operating
API: 067-08517
Date: 4/22/2021

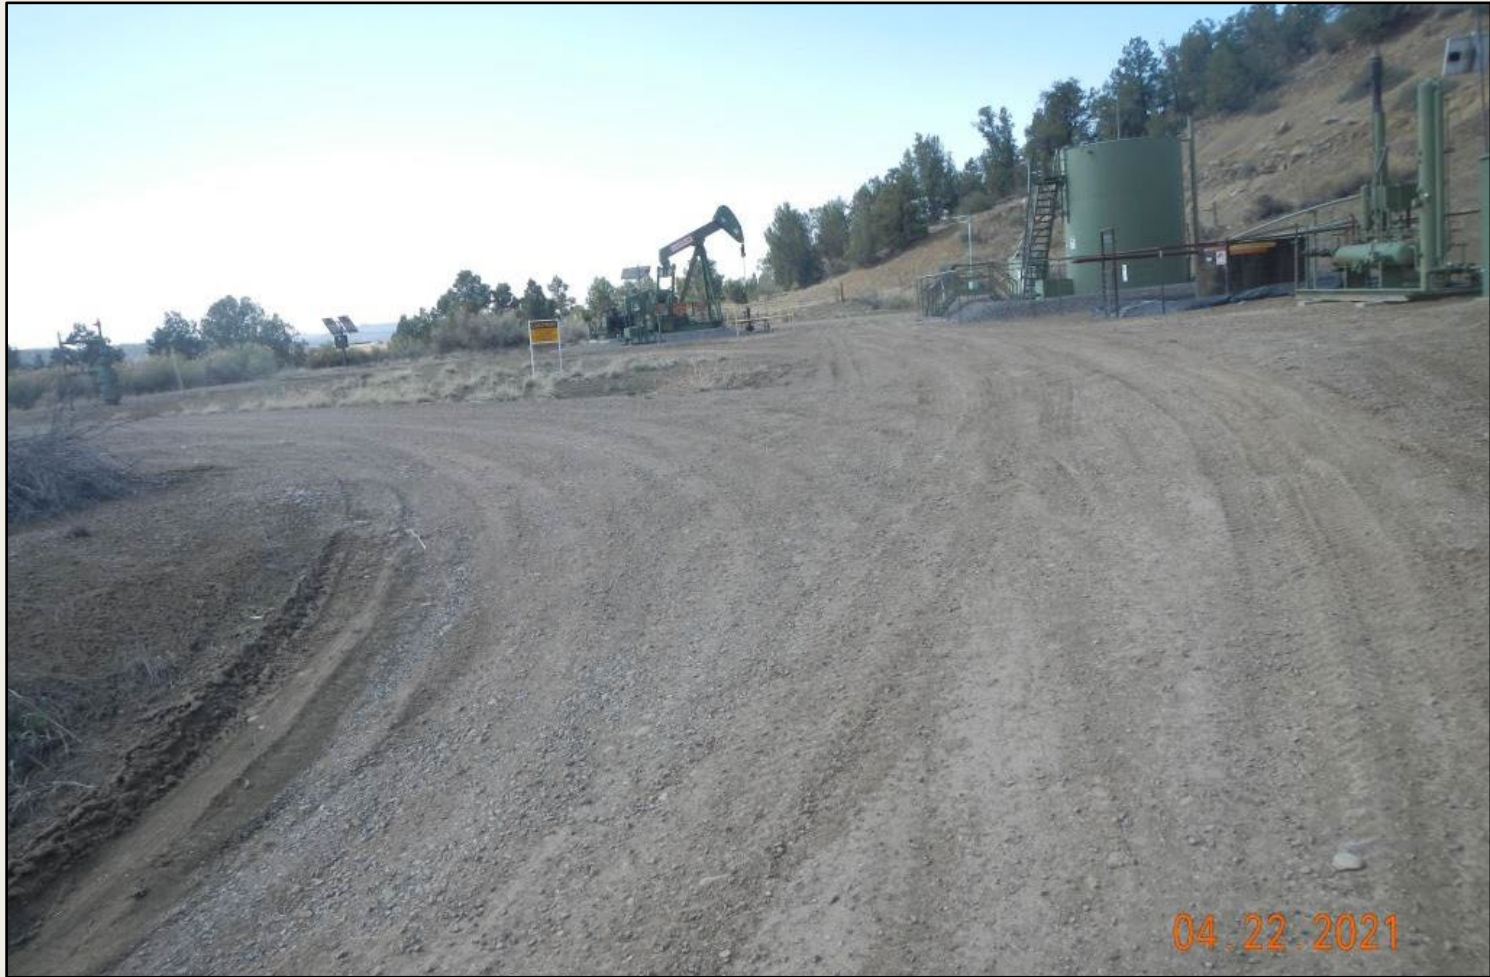
Photo 1. View of the project area from the well pad entrance facing center.

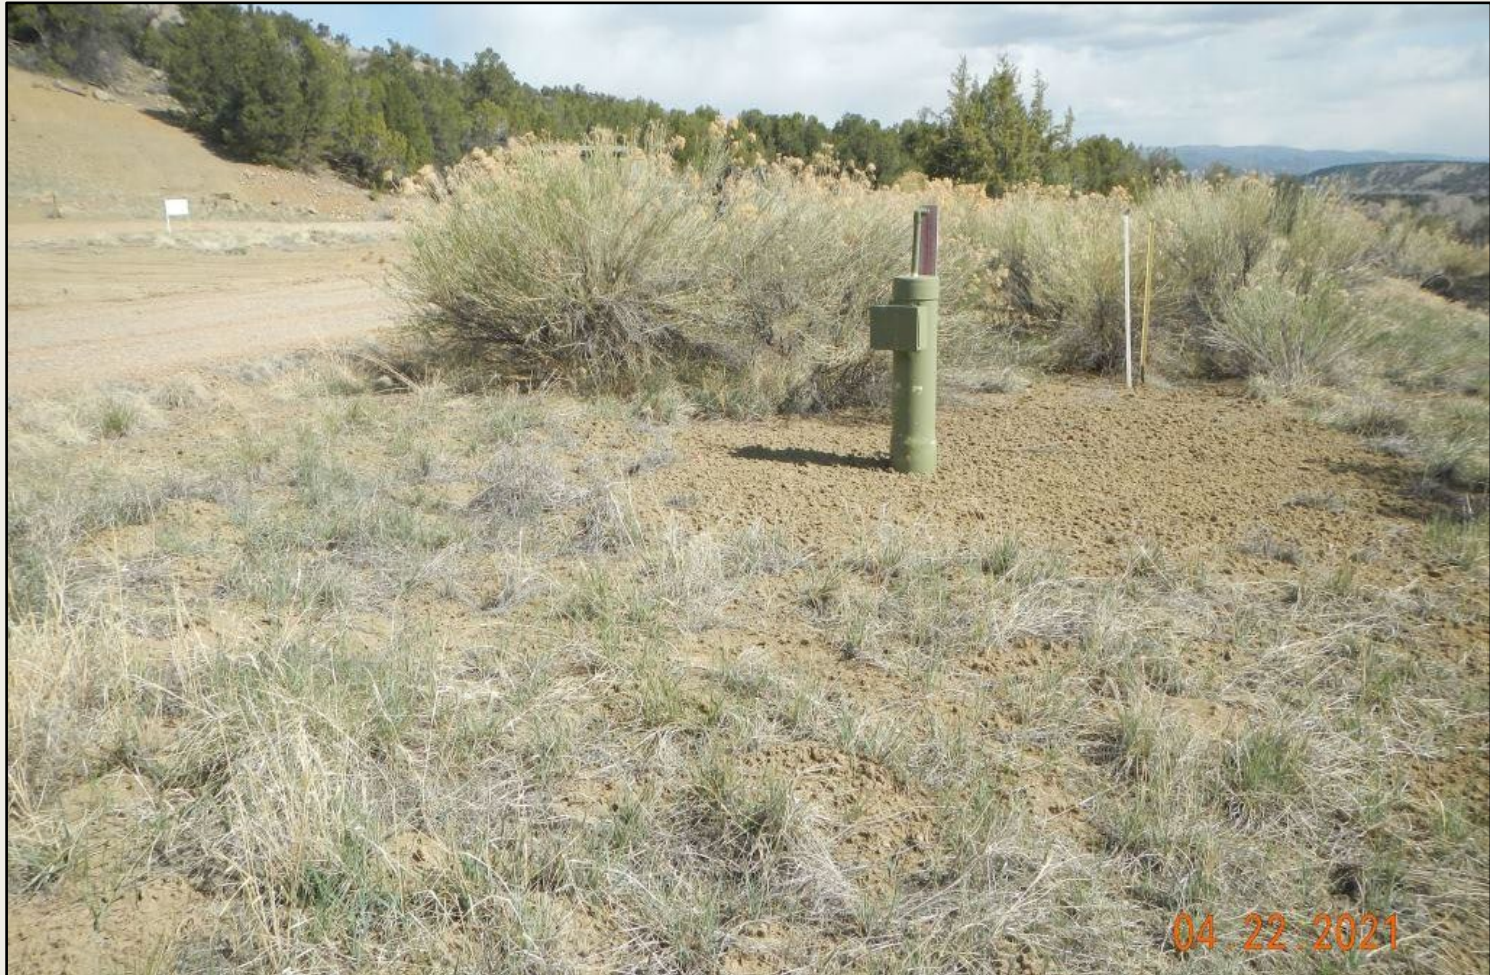
Photo 2. View of the eastern fill slope from the southeastern corner facing northward. Revegetation appears to be progressing with sand dropseed, Indian ricegrass, western wheatgrass, and rubber rabbitbrush.

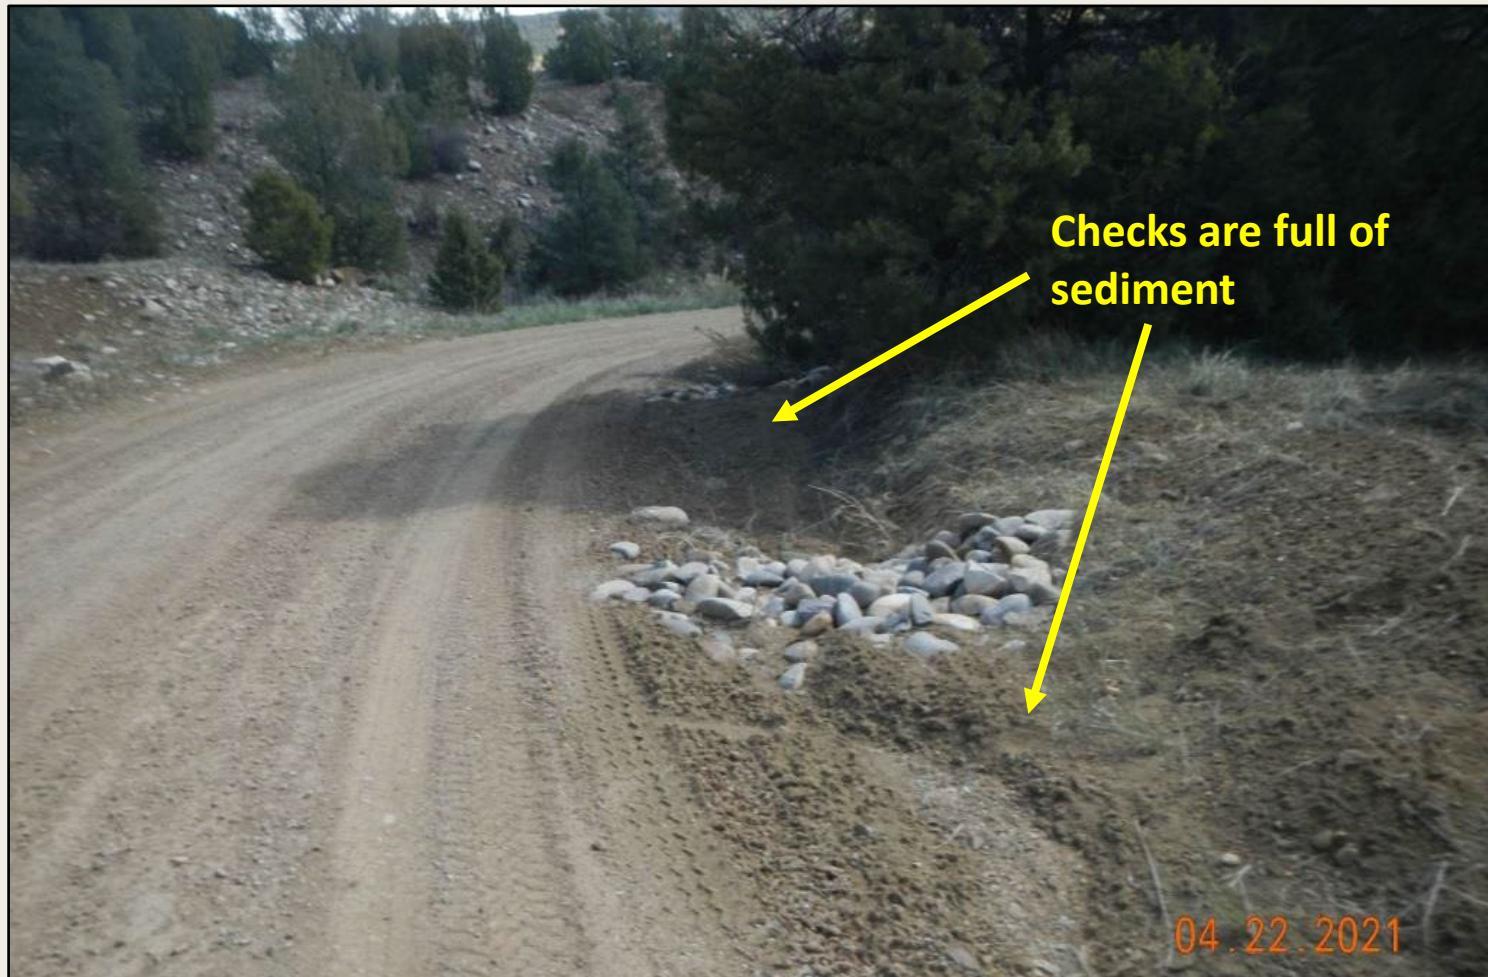
Photo 3. View of rock velocity checks along the access road that are full of sediment and are not adequate BMPs for this slope.

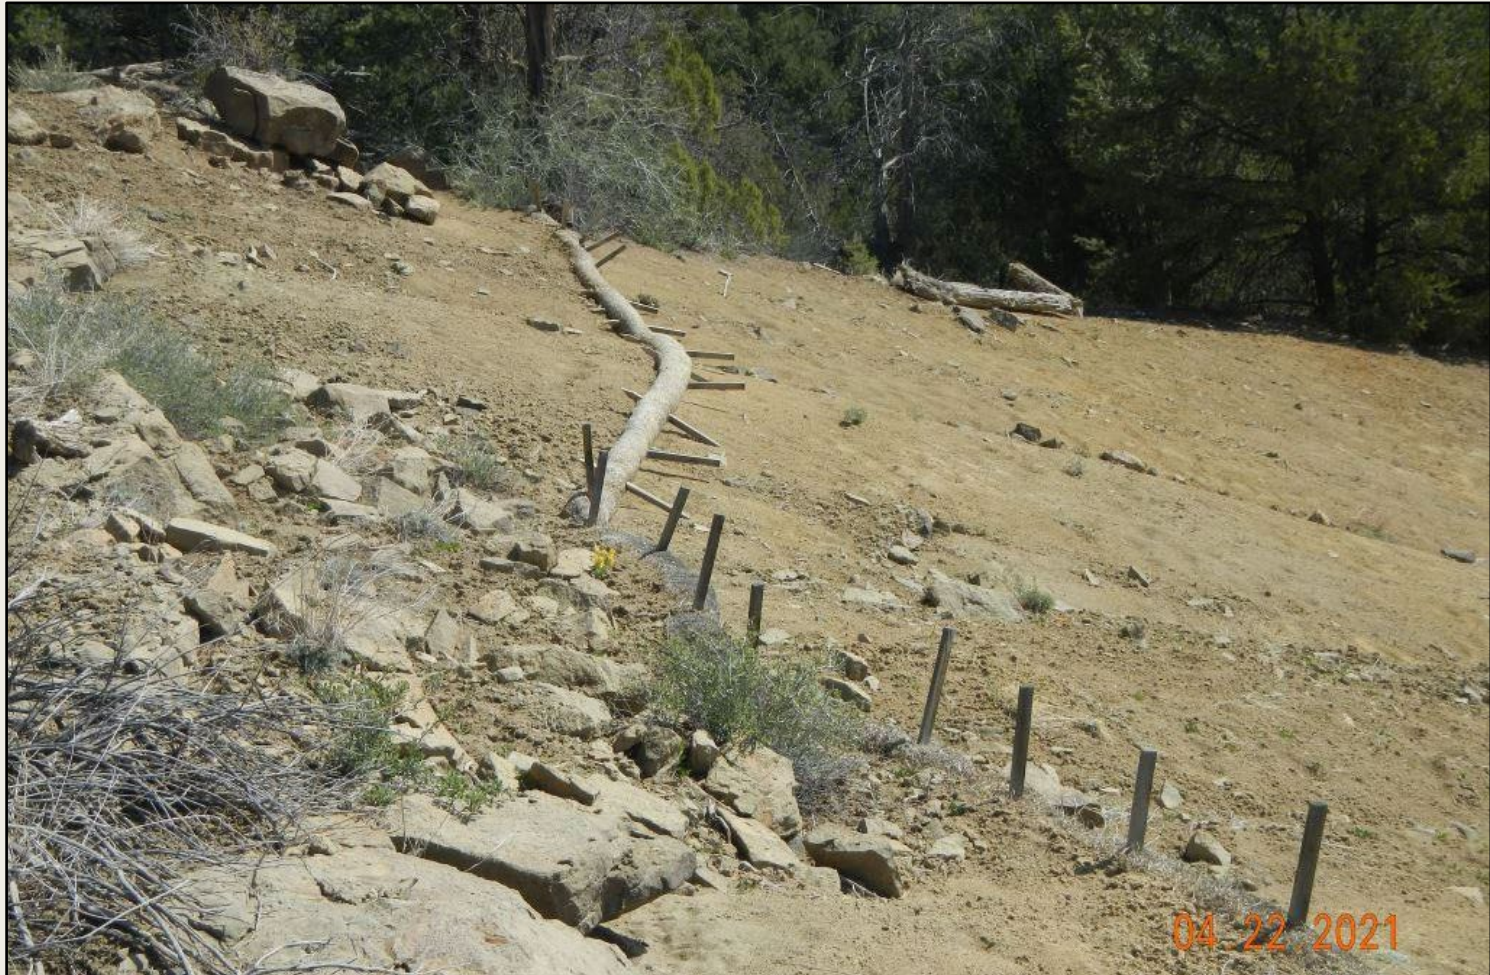
Photo 4. View of wattles at the top of the eastern cut-slope that need maintenance. Erosion controls (ie jute mat, straw blanket, etc. are needed to stabilize blare soils on the cut-slope. Care needs to be take to prevent damage to desirable perennial vegetation.

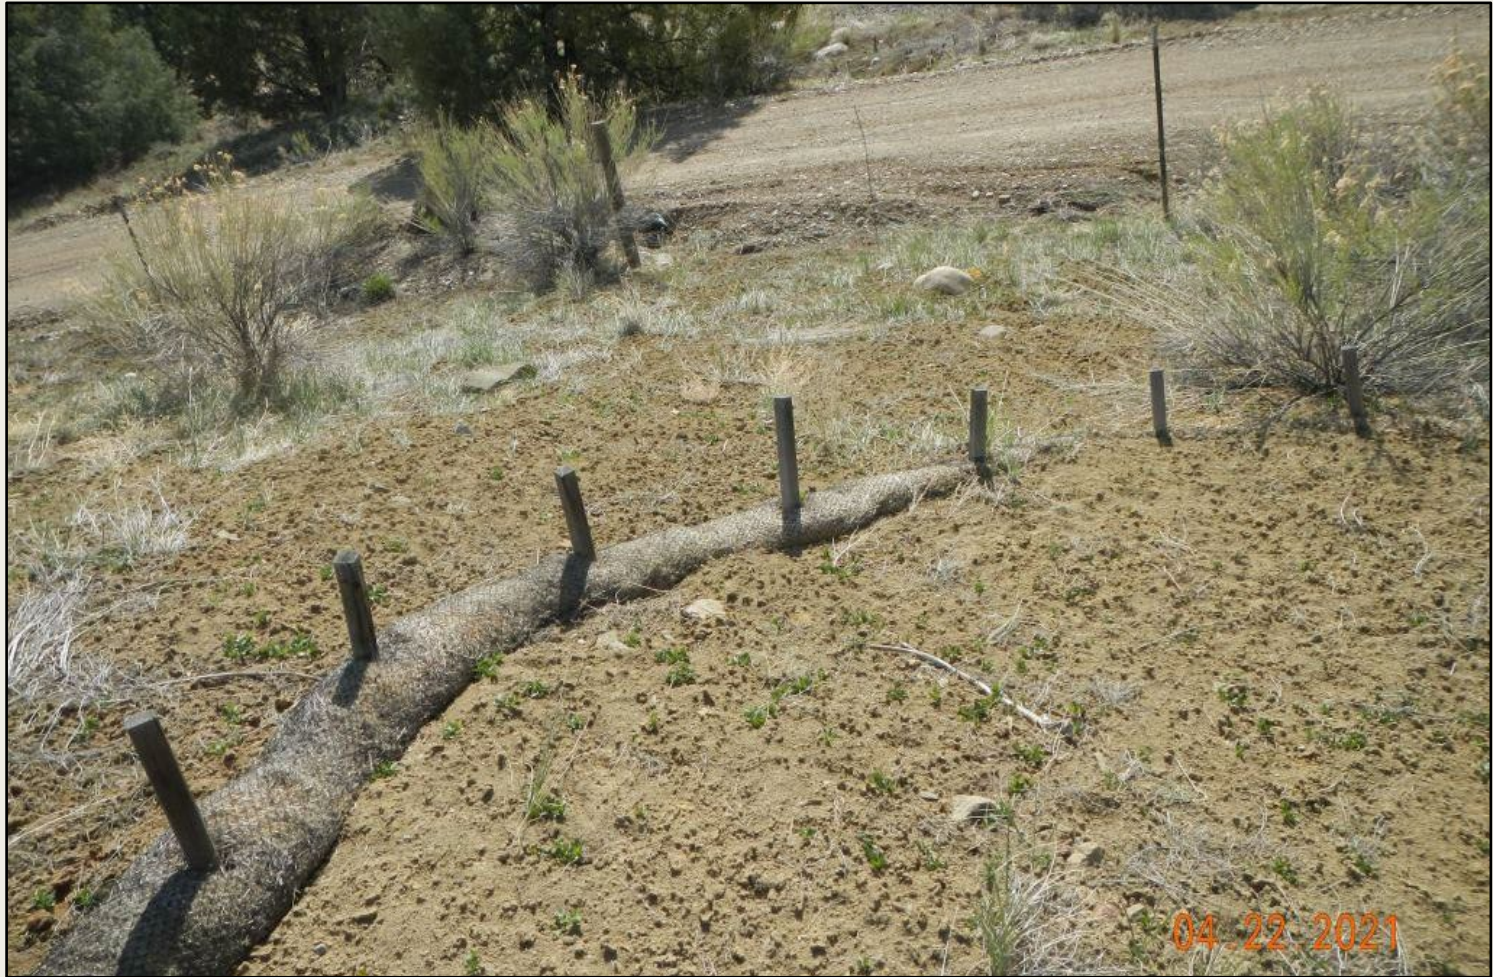
Photo 5. View of wattle in the southeastern project area, that is full of sediment and needs maintenance.

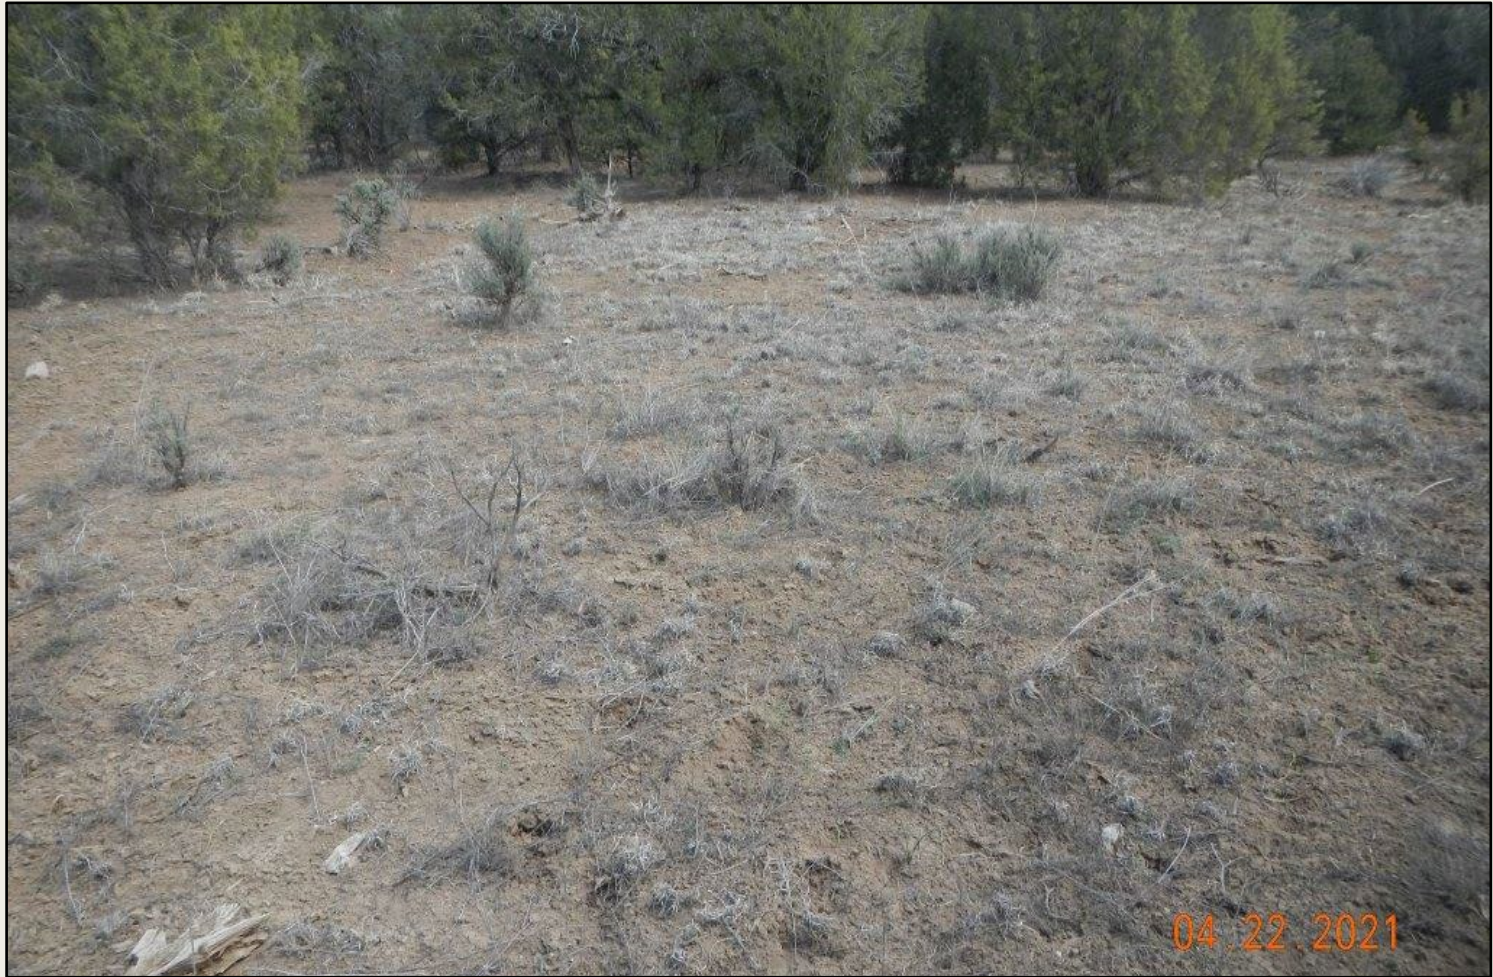
Photo 6. View of reference area comprised of pinyon and juniper woodland with sagebrush shrubland, blue grama, Indian ricegrass, and mat penstemon.
