Inspection Photos

API: 071-09287

Operator: EVERGREEN NATURAL RESOURCES

Inspection Date: 4/27/2021

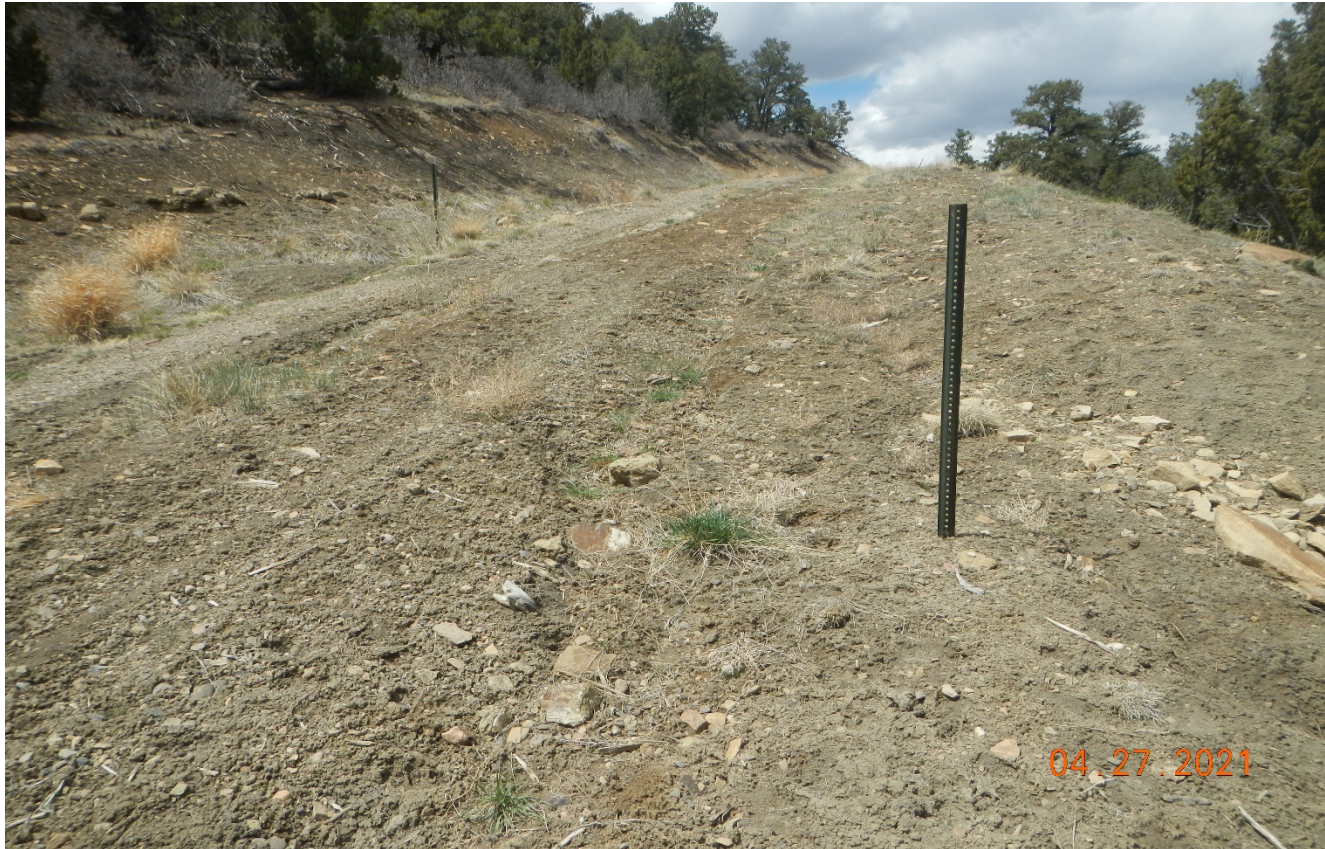
Photo 1. Facing northwest the beginning of the access road. The road has not been recontoured and reclaimed. There are signs of stormwater erosion down the road.

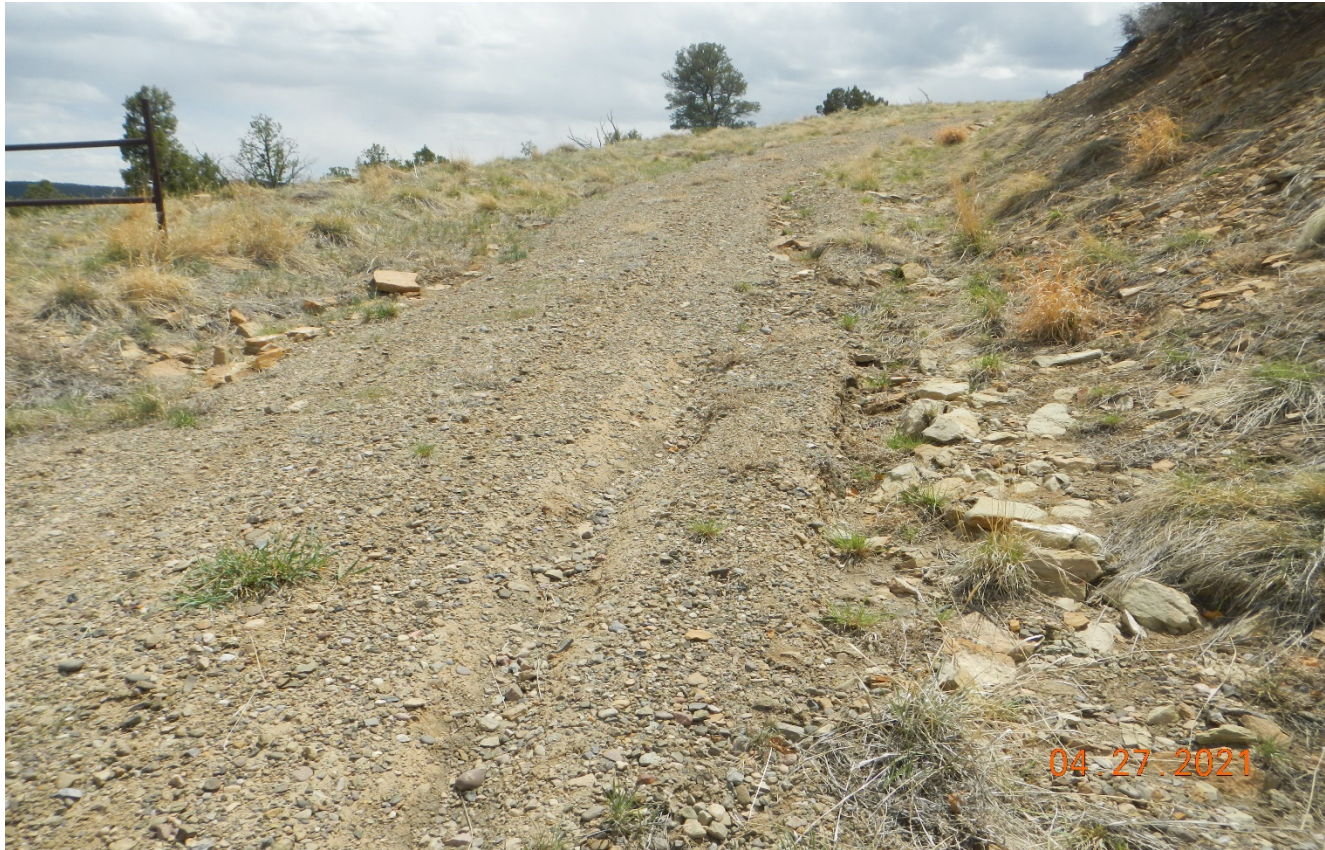
Photo 2. Facing south along the access road. The road has not been recontoured and reclaimed. There are signs of stormwater erosion down the road.

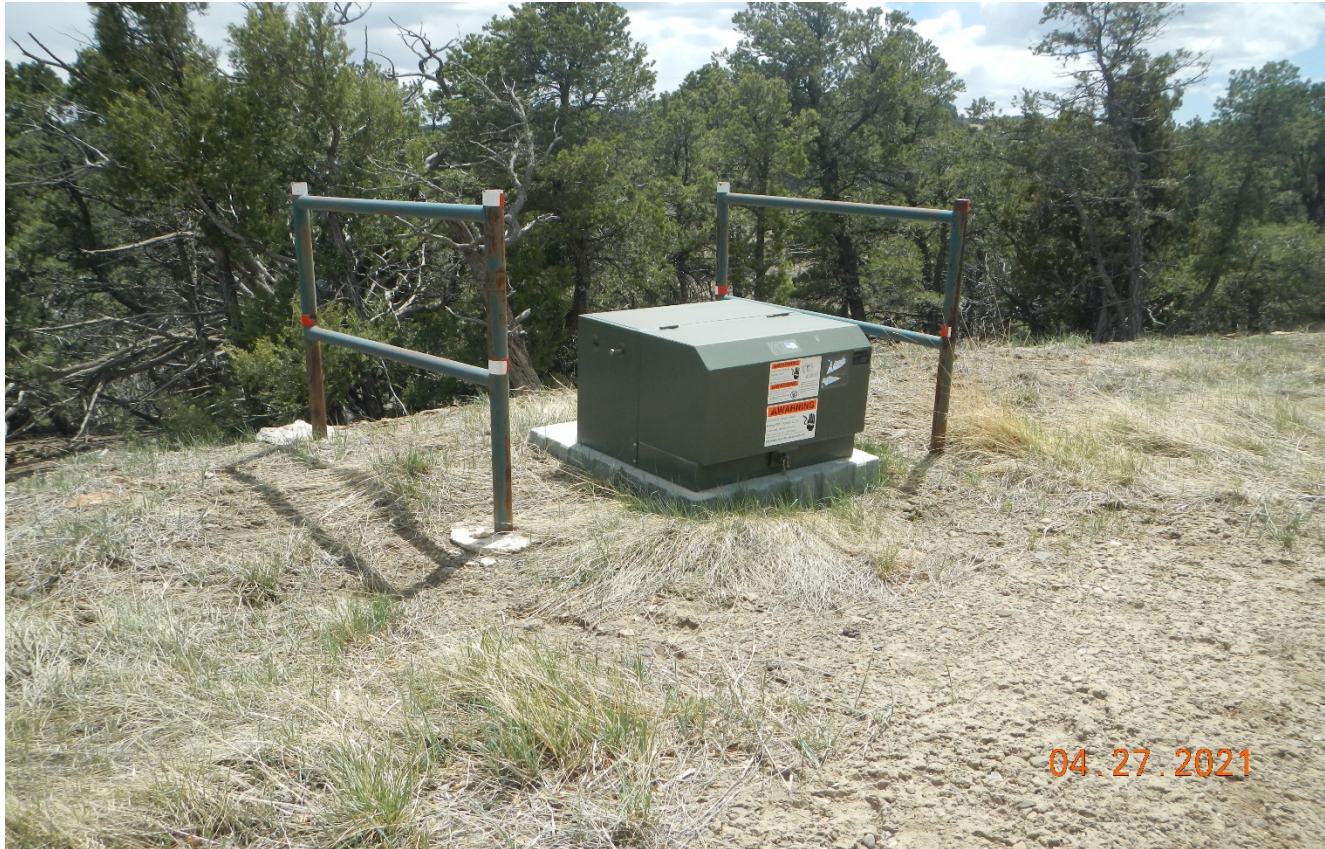
Photo 3. The electric utility remains along the road.

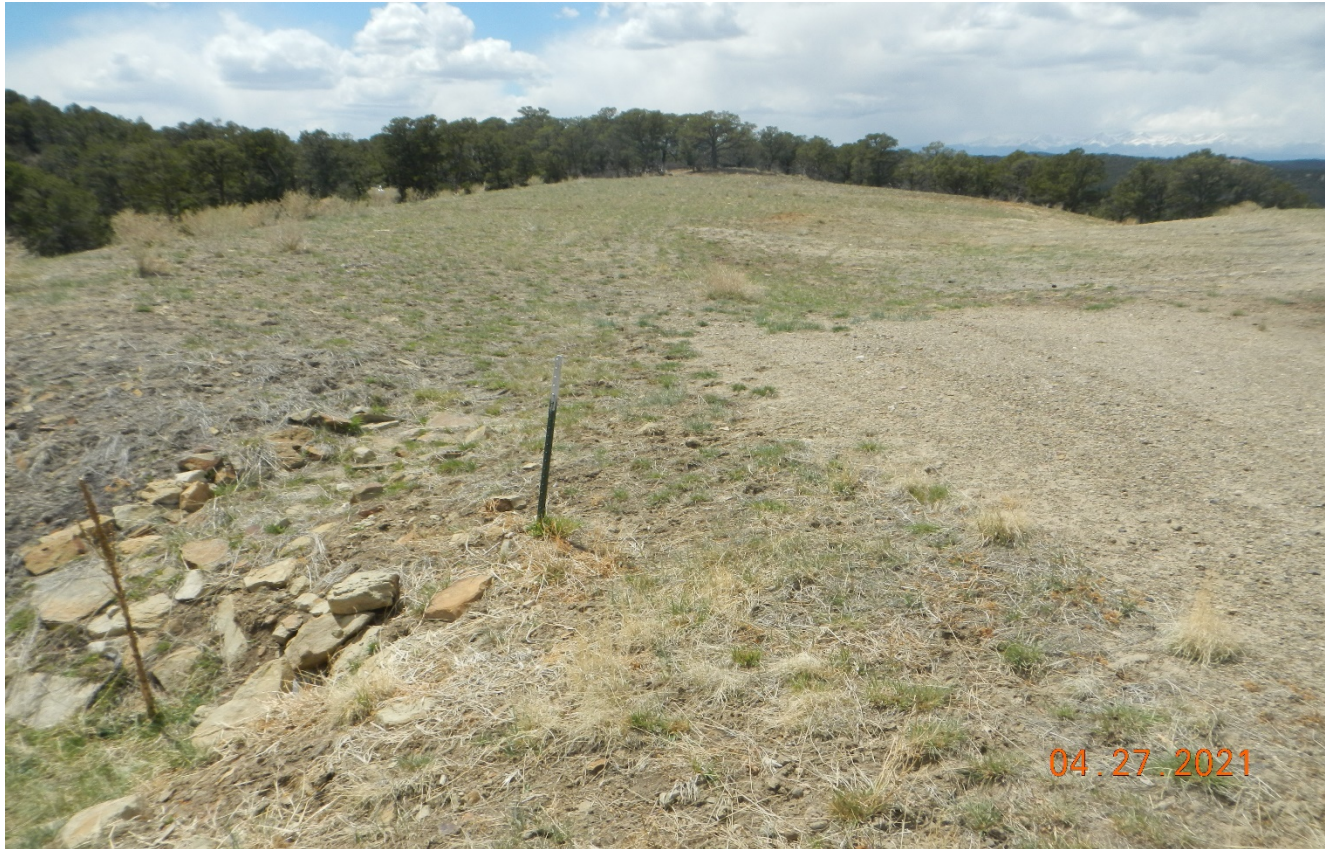
Photo 4. Facing west toward the location. The location has not been recontoured.

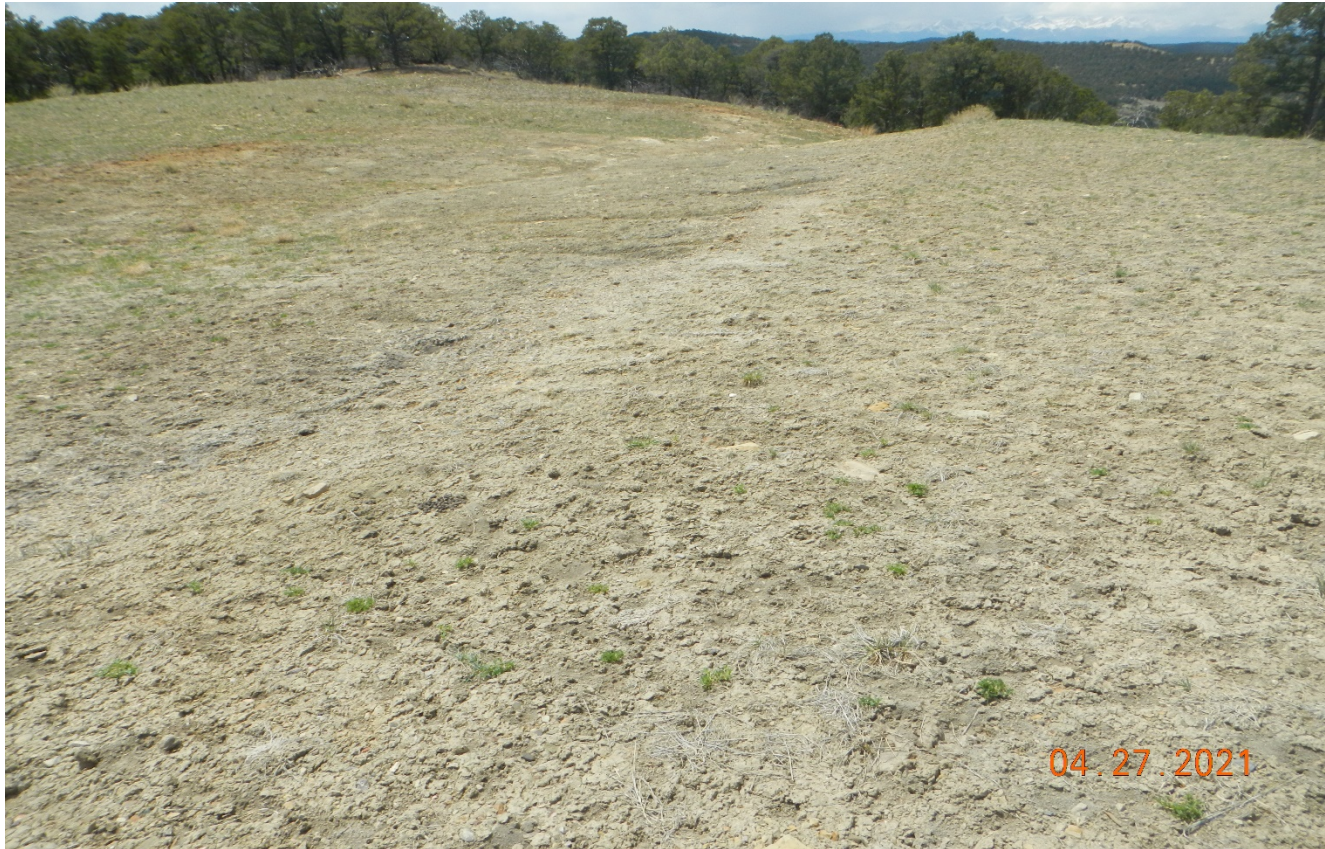
Photo 5. Facing west at the location. The soils are not stabilized and are susceptible to erosion. BMP's have not been installed.

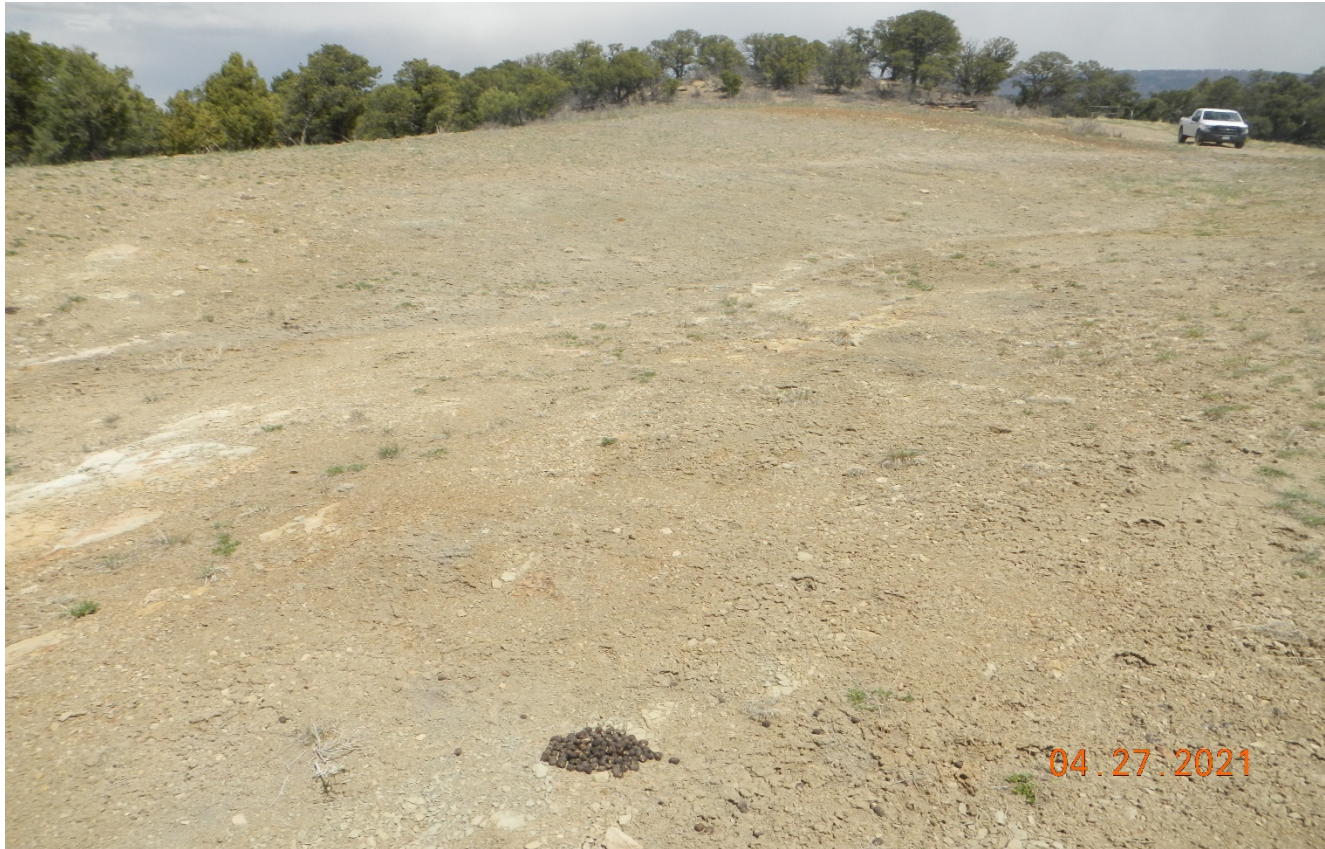
Photo 6. Facing northeast at the location. The location is not stabilized and there are signs of erosion. BMP's have not been installed.

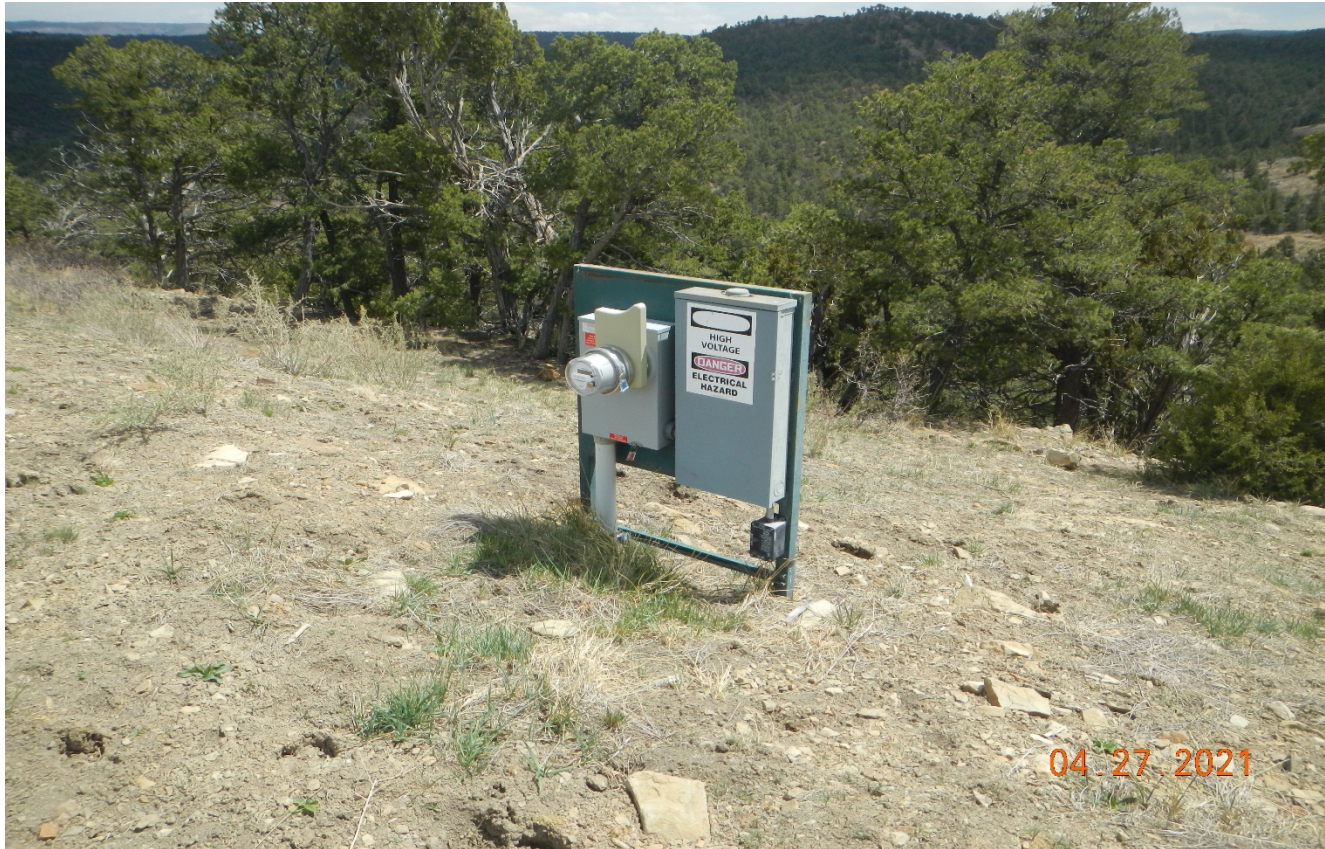
Photo 7. The electric utility remains at the southwest side of the location.
