Inspection Photos
Paul Heinze #1 Flowline
Spill ID 479232 (AC)

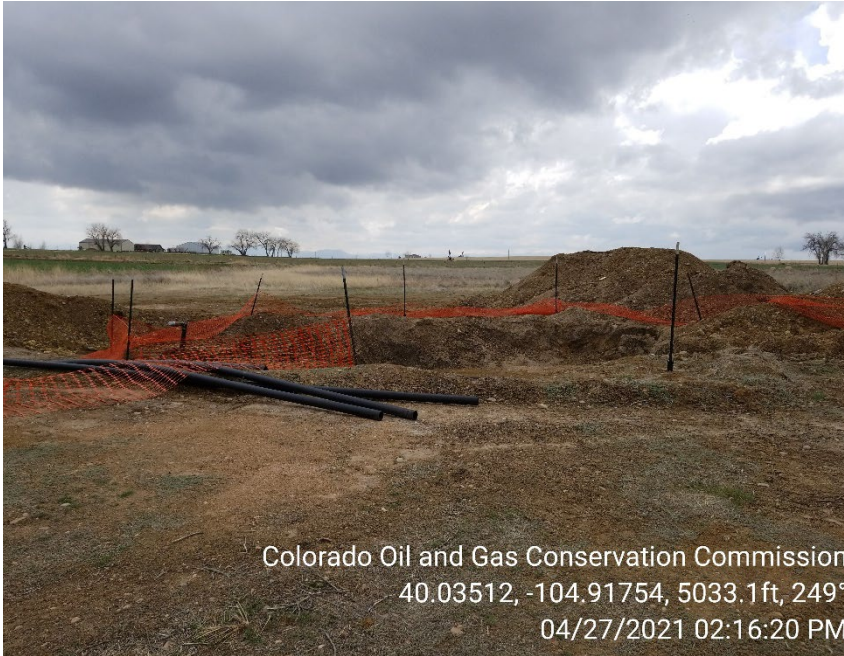
Photo 1 – Spill area. Fencing down around open excavation. Trash on location.

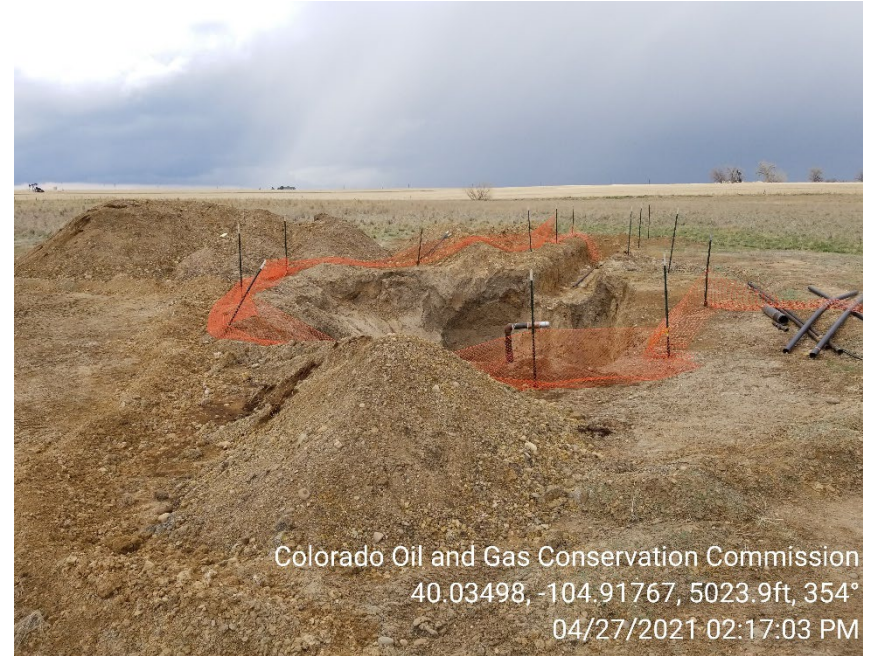
Photo 2 – Spill area. Fencing down around open excavation. Soils stockpiled on location. Trash on location.

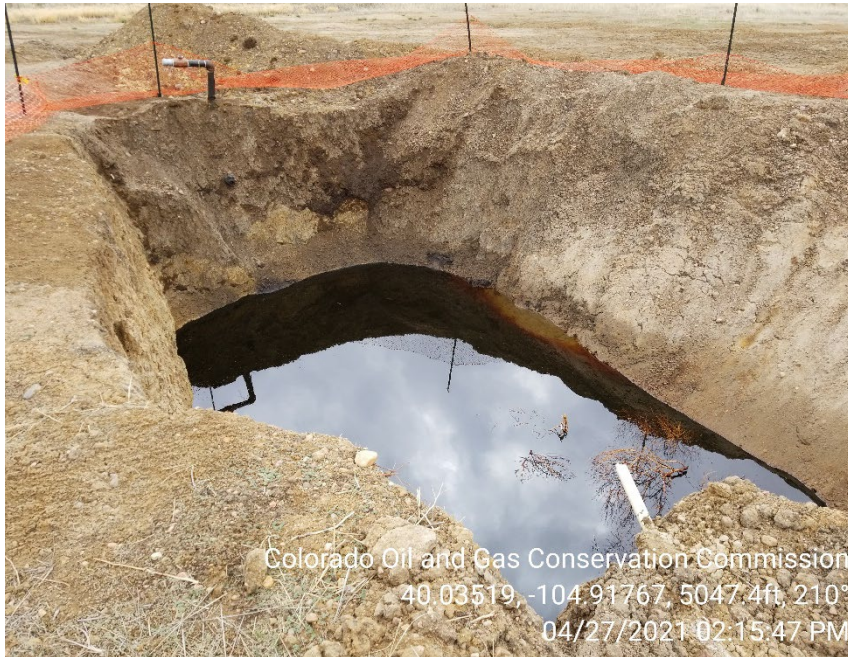
Photo 3 – Open excavation. Free product observed on groundwater. Impacts remain in situ.

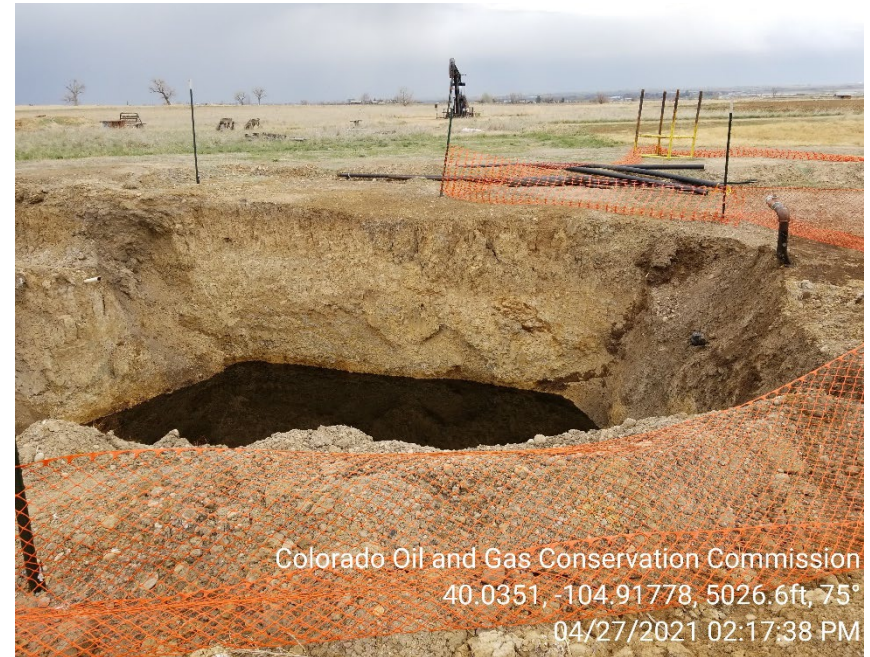
Photo 4 – Open excavation. Free product observed on groundwater. Impacts remain in situ.

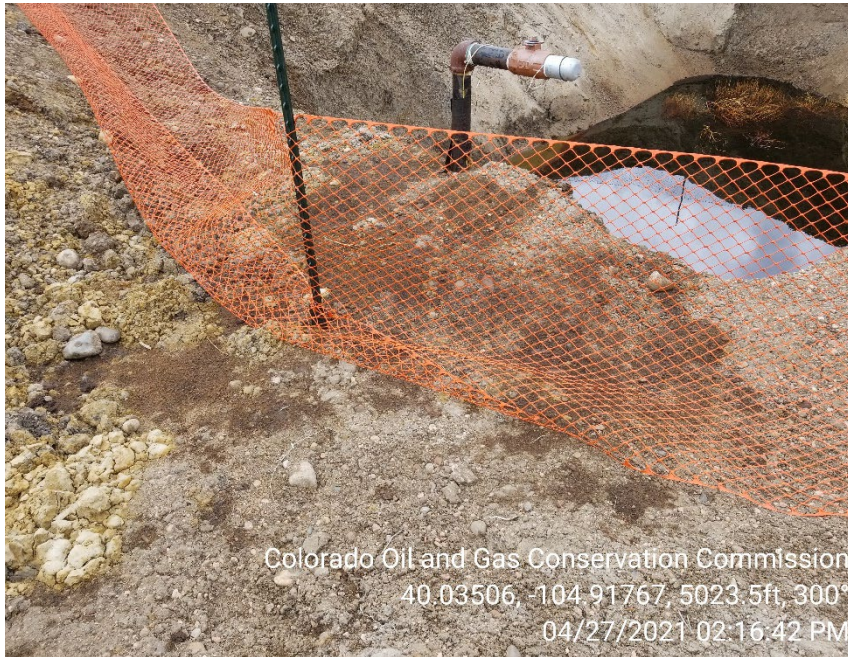
Photo 5 – Impacted soils remain on surface outside of excavation area.

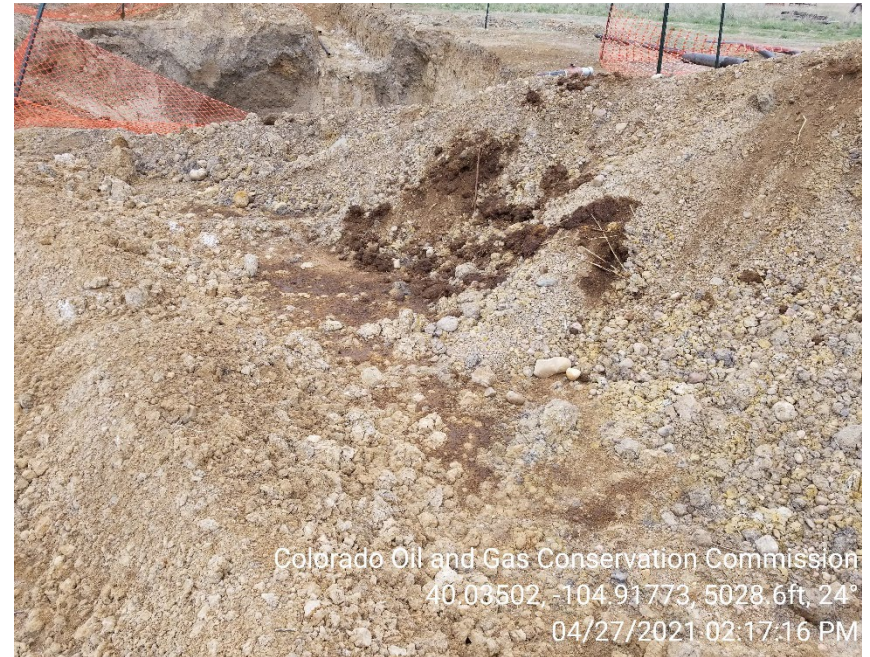
Photo 6 – Impacted soils remain on surface outside of excavation area. Soils stockpiled on location with inadequate BMPs.

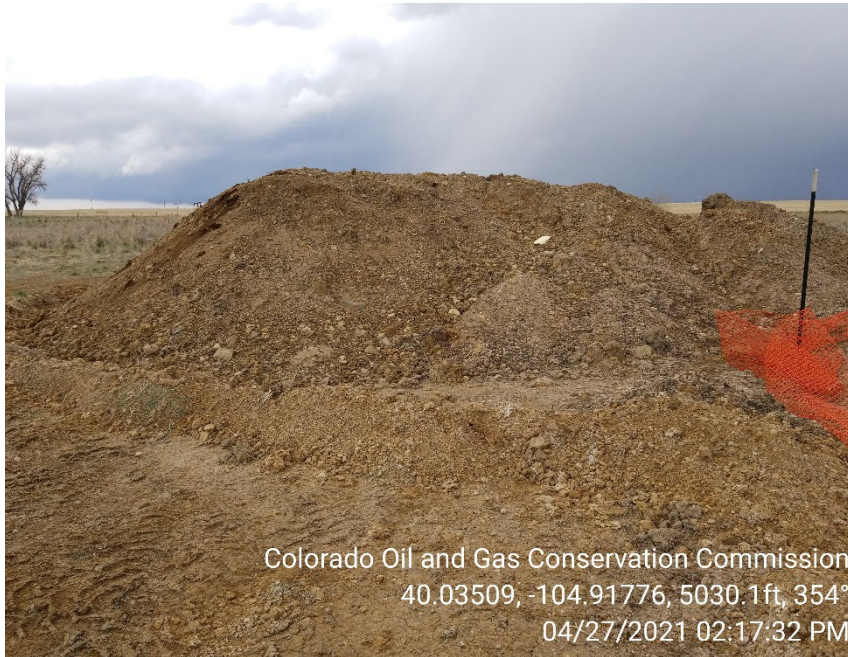
Photo 7 – Soils stored on location with inadequate BMPs

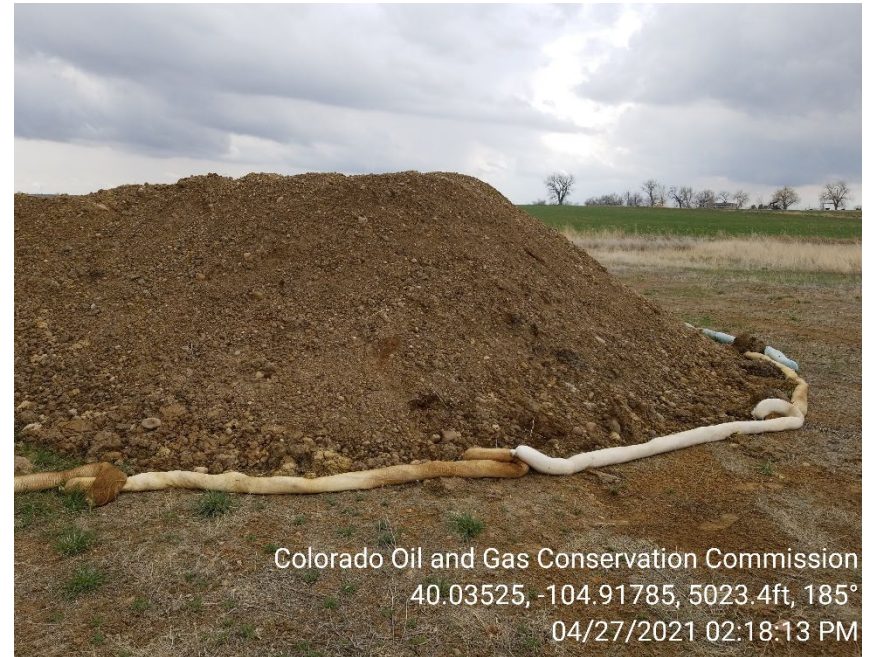
Photo 8 – Soils stored on location with inadequate BMPs

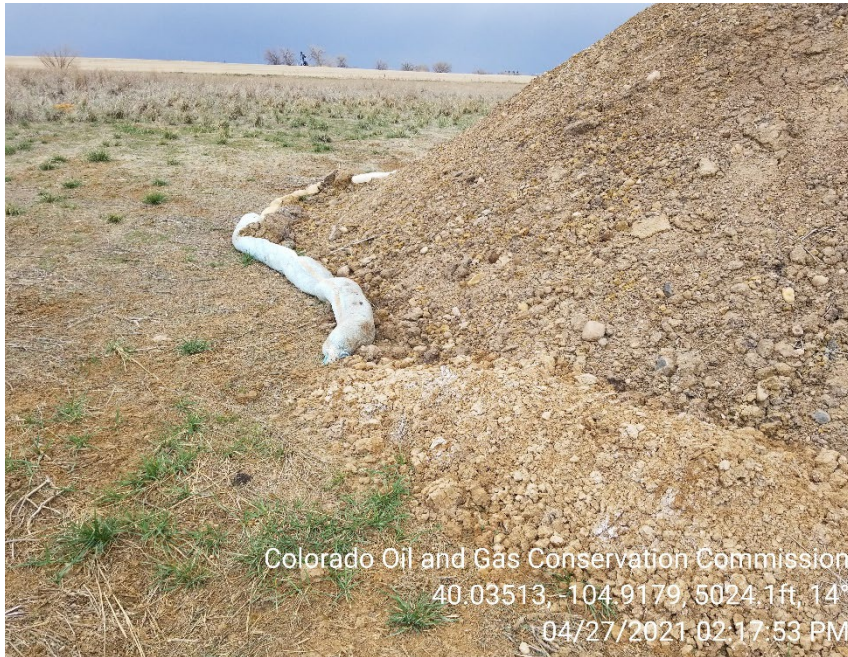
Photo 9 – Soils stored on location with inadequate BMPs

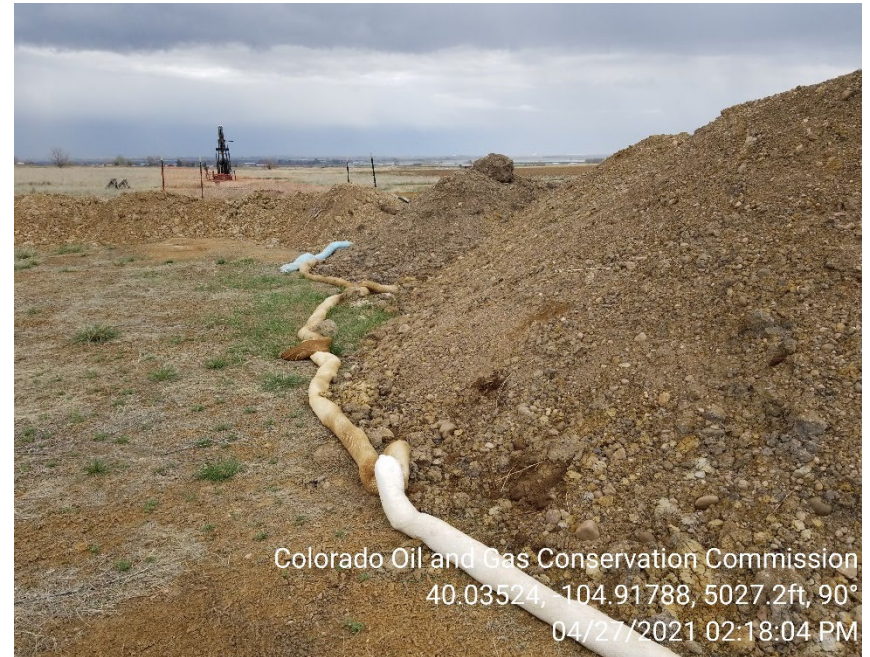
Photo 10 – Soils stored on location with inadequate BMPs
