**Inspection Photos**  
**Camenisch 1 sx Flowline Release**  
**Spill ID 479713 (AC)**

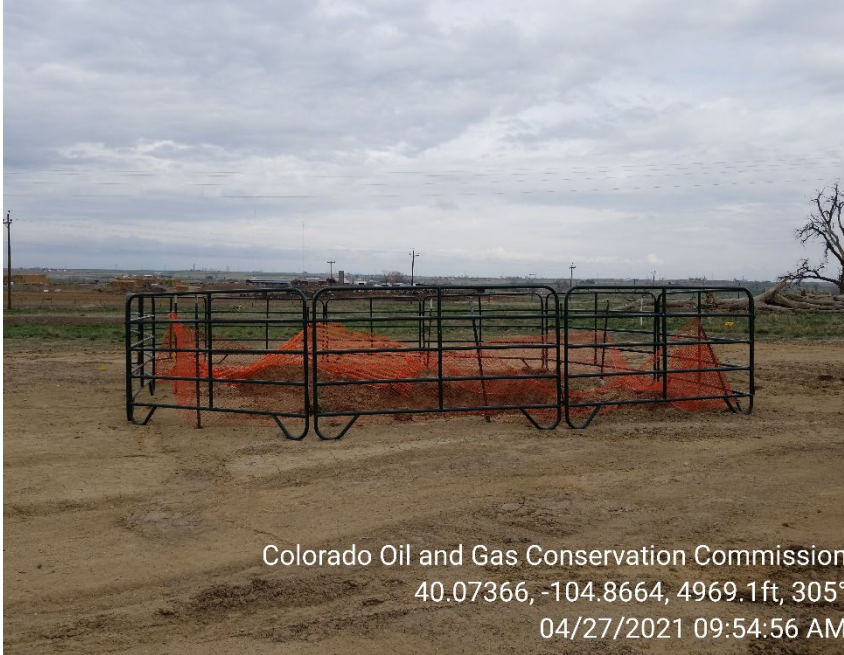
**Photo 1 – Spill area. Fencing up around open excavation.**

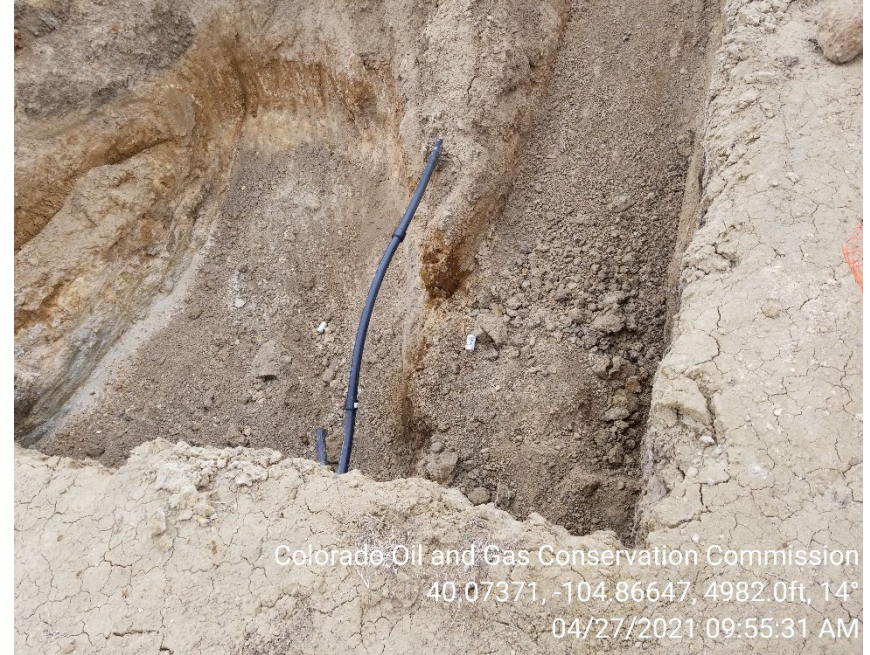
**Photo 2 – Spill excavation. Impacts remain in situ. Trash observed in open excavation.**

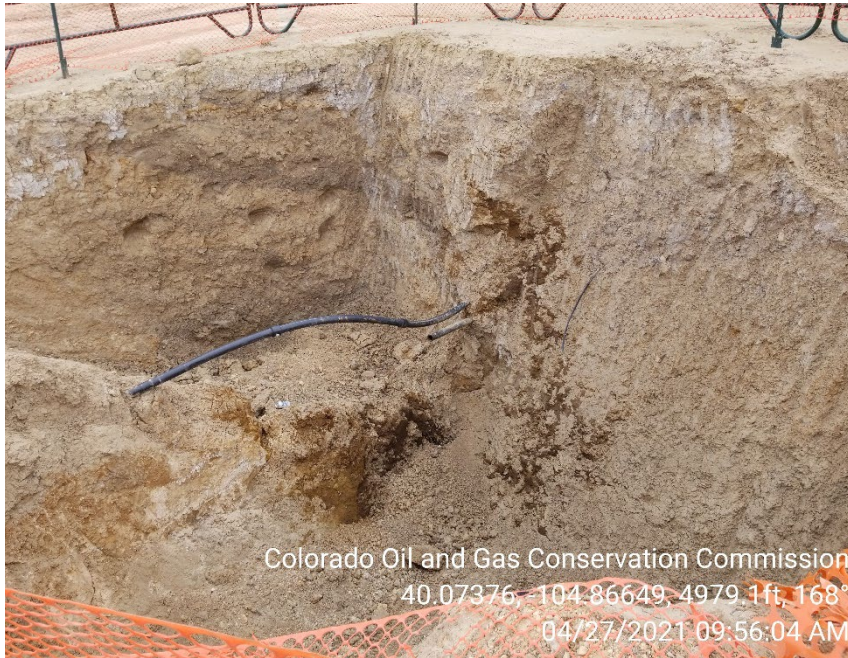
**Photo 3 – Spill excavation. Impacts remain in situ.  
Trash observed in open excavation.**

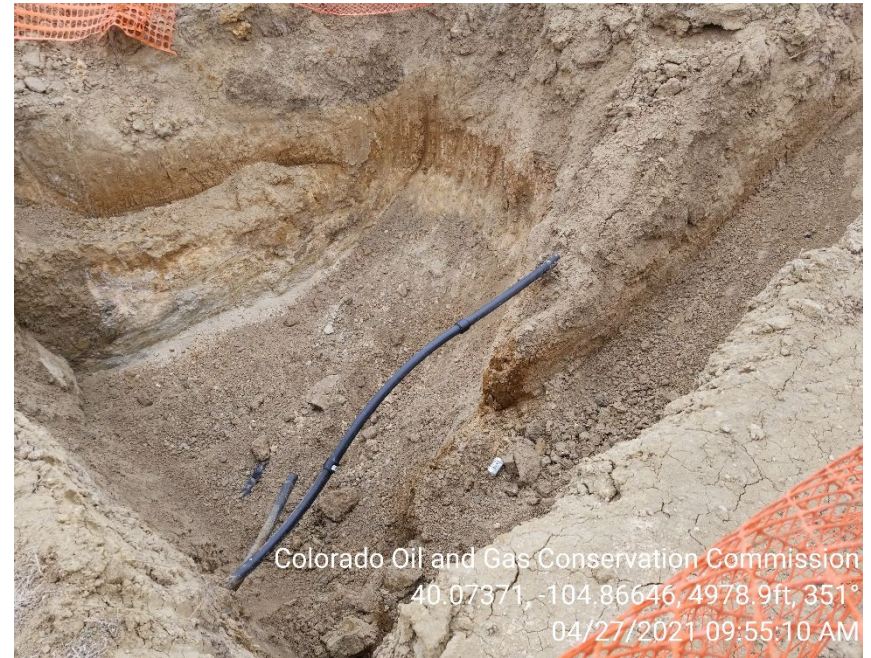
**Photo 4 – Spill excavation. Impacts remain in situ.  
Trash observed in open excavation.**

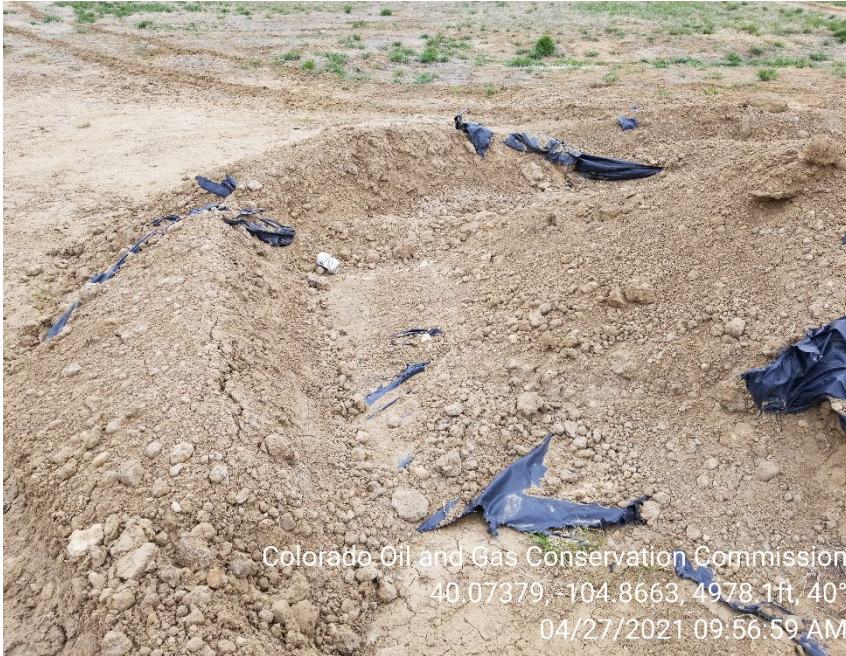
**Photo 5 – Oily soils stockpiled on location. Lining does not adequately protect surface soils.**

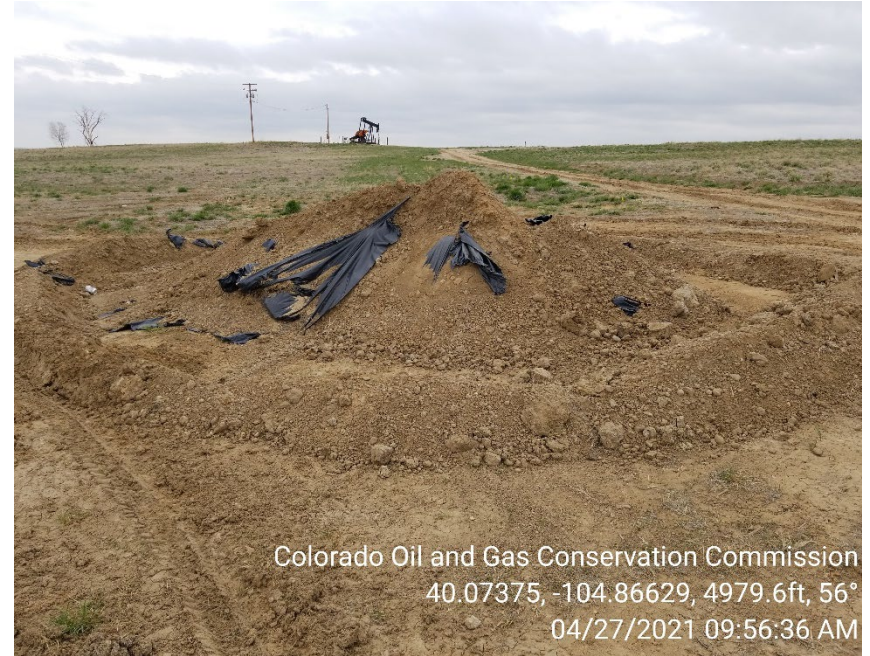
**Photo 6 – Oily soils stockpiled on location. Lining does not adequately protect surface soils.**

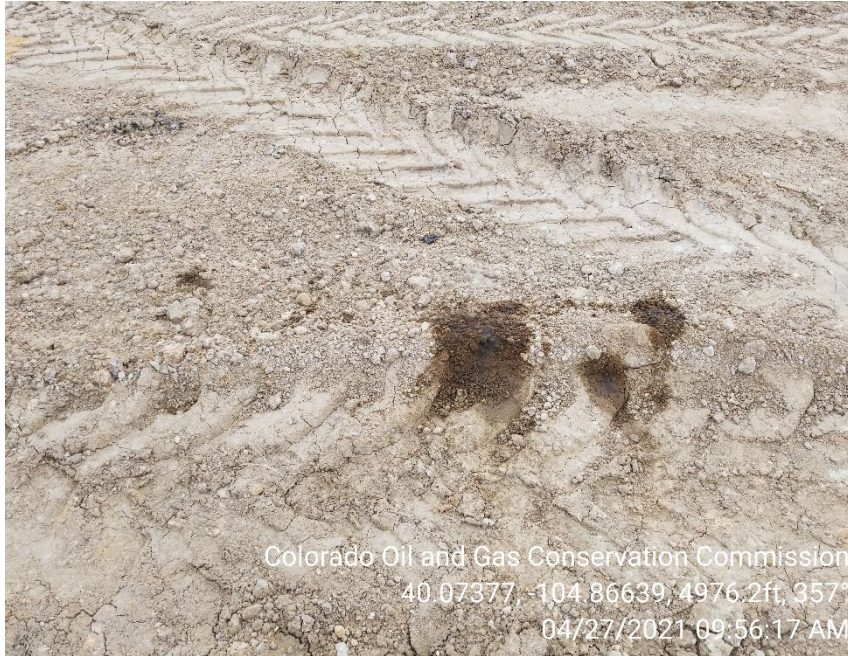
**Photo 7 – Stained soil observed around open excavation.**

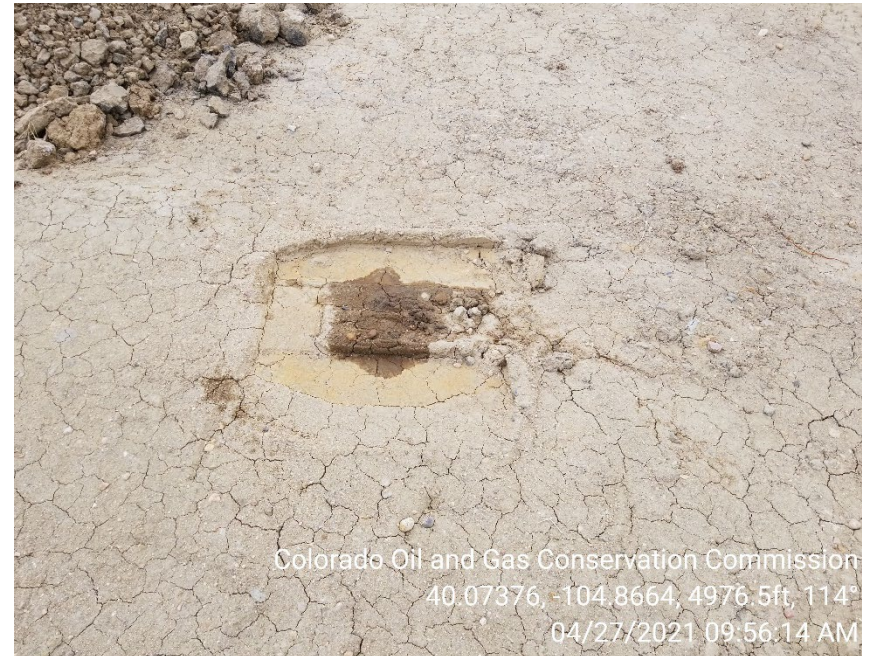
**Photo 8 – Stained soil observed around open excavation.**

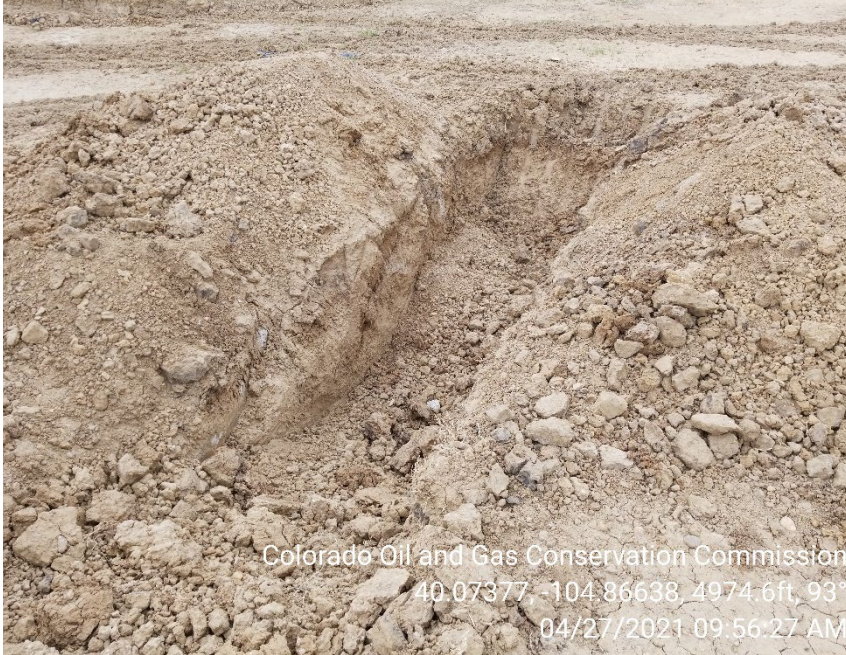
**Photo 9 – Additional disturbed area on site. Trash observed in disturbed area.**

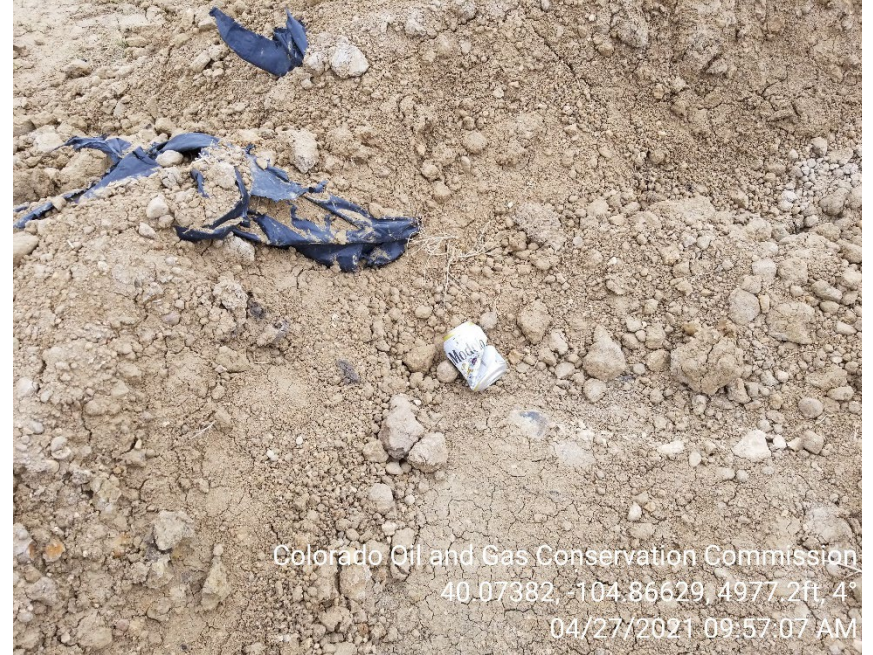
**Photo 10 – Trash on location.**
