Inspection Photos

Operator: C & J FIELD SERVICES - 10027

Location ID: 311787

Rio Blanco County, CO

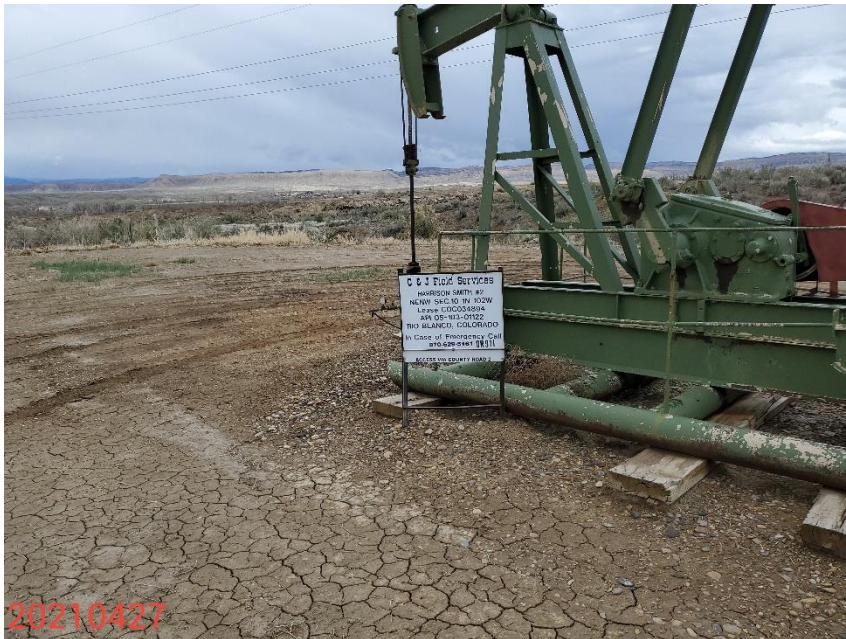
Photo 1: Photo of sign and wellhead.

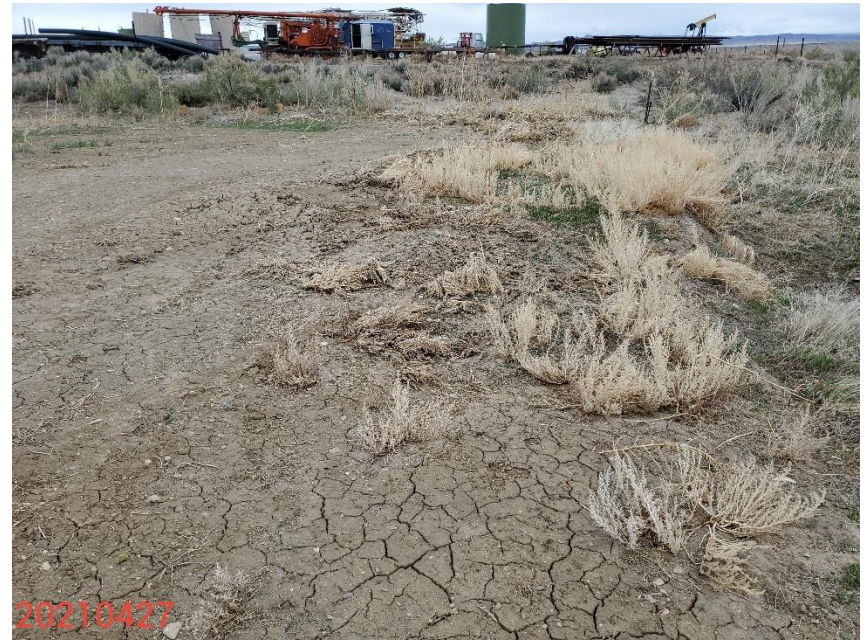
Photo 2: Photo taken from north end of the Location Location, facing northwest. Photo shows Halogeton and undesirable weedy plant establishment that was observed on the interim and production areas of the Location.

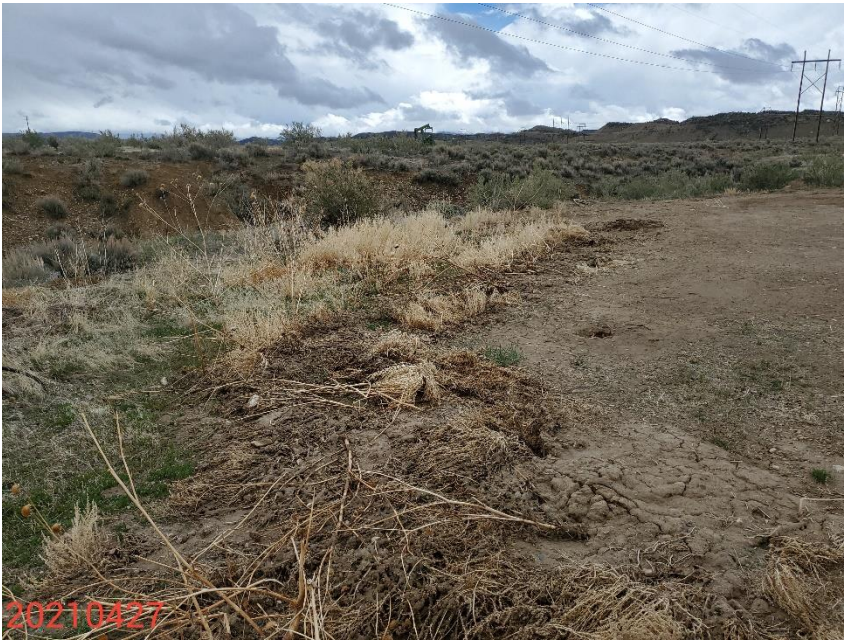
Photo 3: Photo taken from north end of the Location Location, facing southeast. Photo shows Halogeton and undesirable weedy plant establishment that was observed on the interim and production areas of the Location.

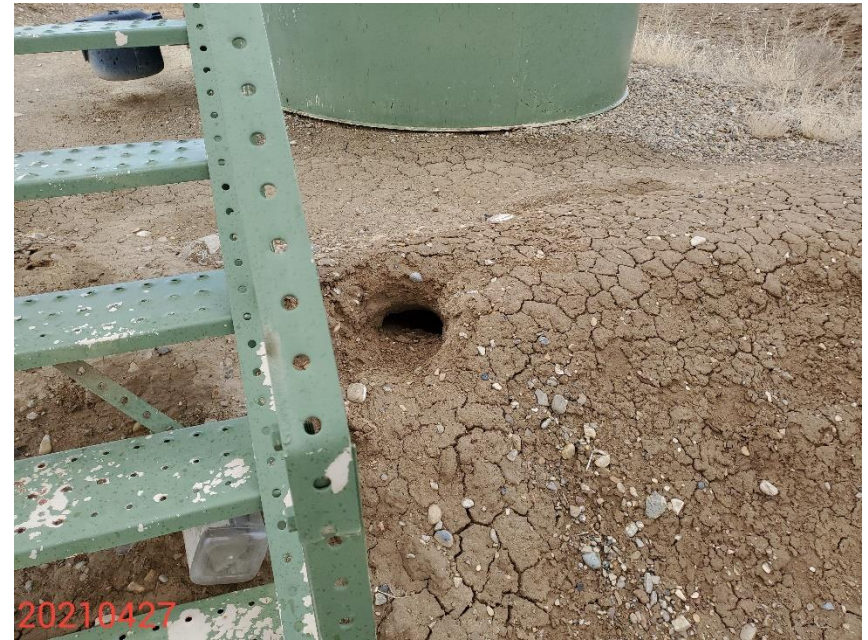
Photo 4: Photo taken from the containment berm at the tank. Photo shows example of wildlife burrows observed on the BMP; BMP permeability has been compromised.

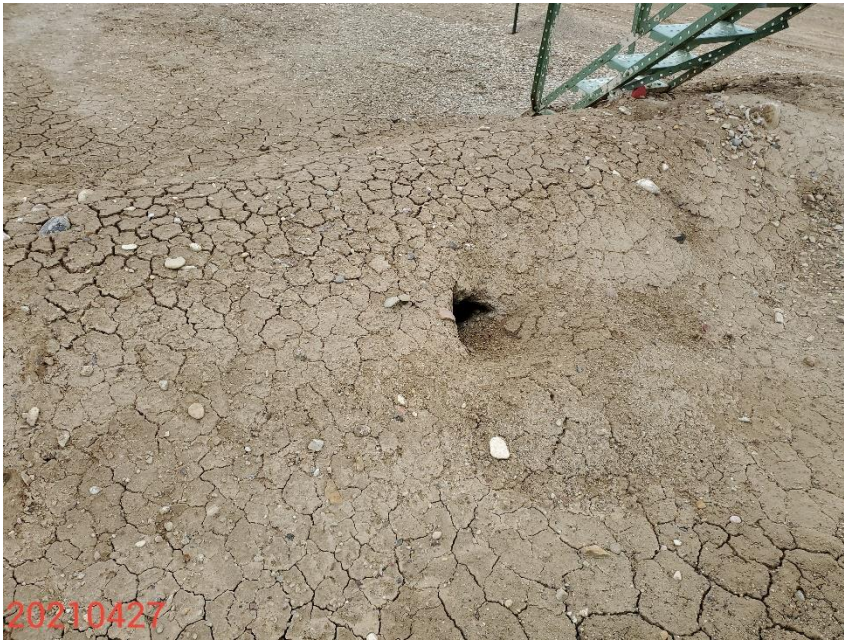
Photo 5: See comments under photo 4.

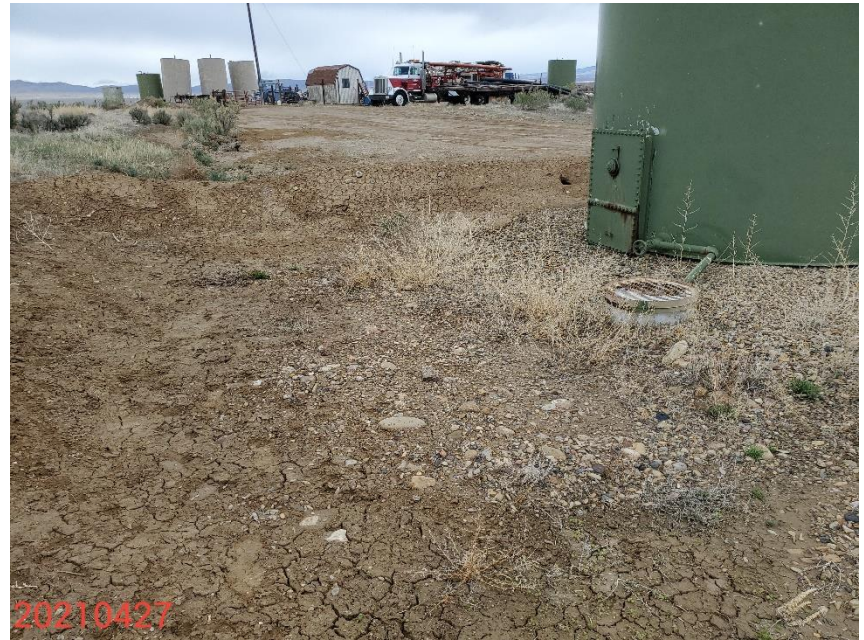
Photo 6: See comments under photo 4. Photo also shows weed/plant establishment within the containment BMP

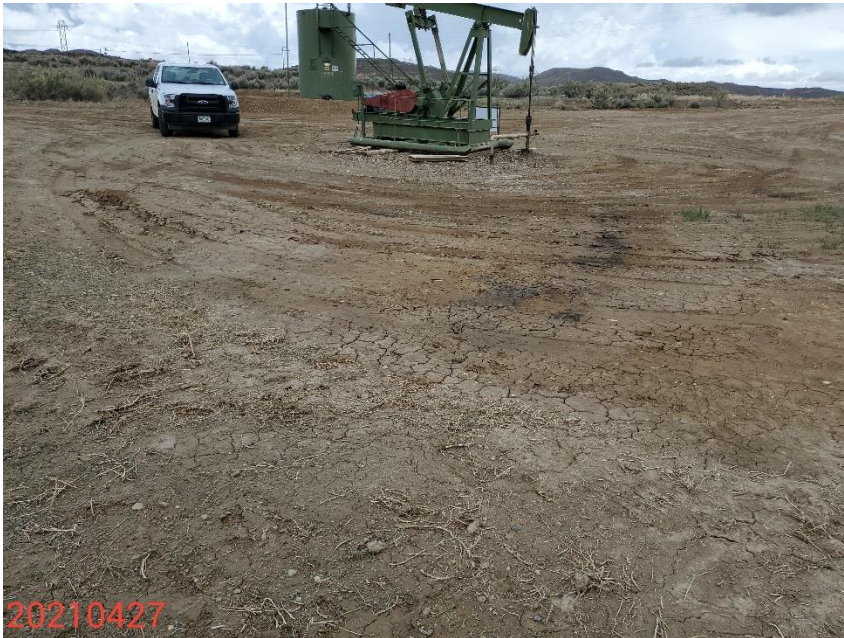
Photo 9: Photo taken from northeast of the well, facing southwest. Photo shows example of stained soils observed on the Location.

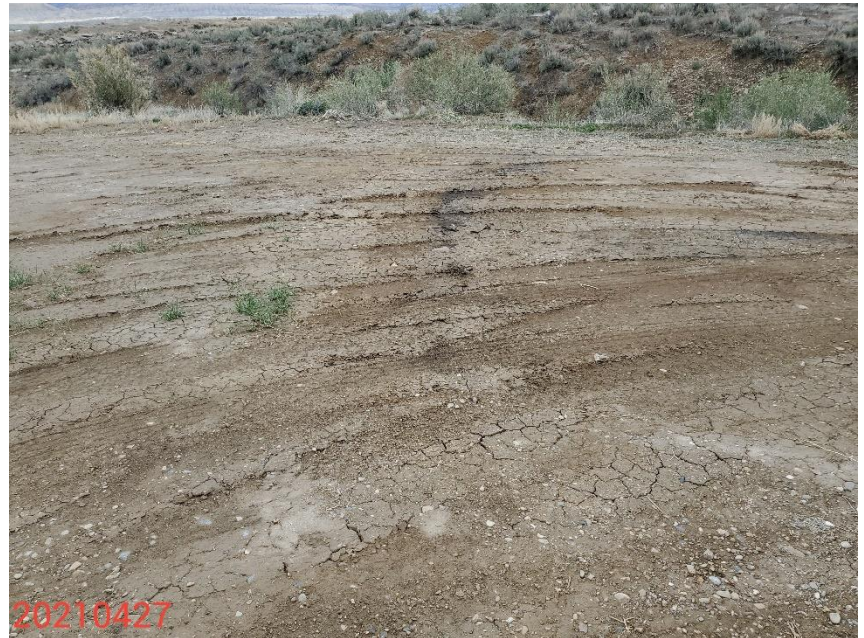
Photo 10: Photo taken from the northeast end of the Location, facing northeast. See comment under photo 9.

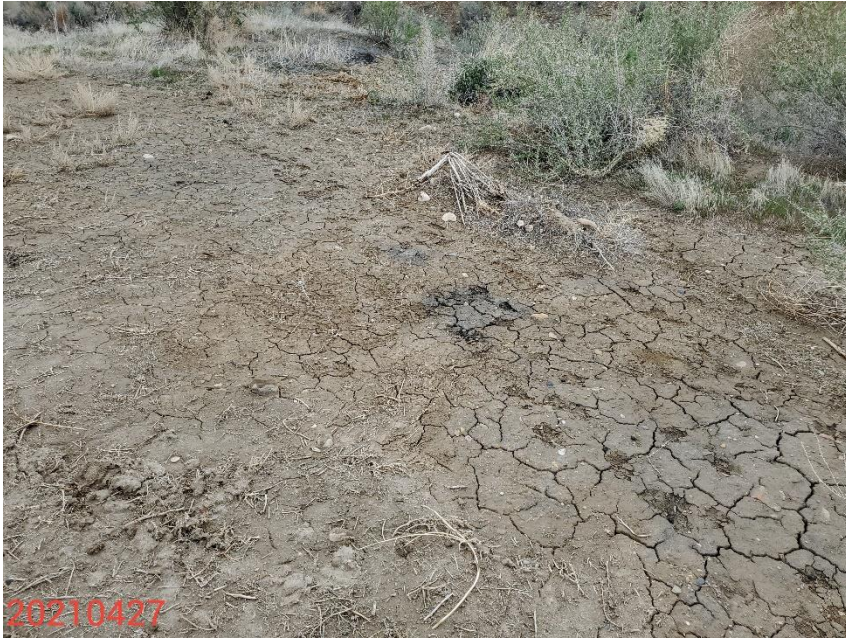
Photo 11: Photo taken from the northeast end of the Location. See comment under photo 9.

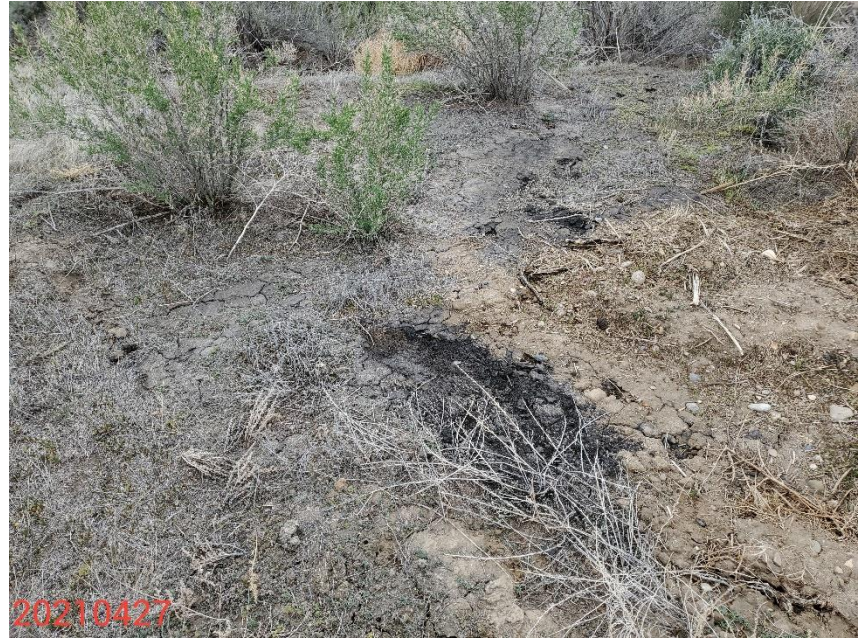
Photo 12: Photo taken from the northeast end of the Location. See comment under photo 9.

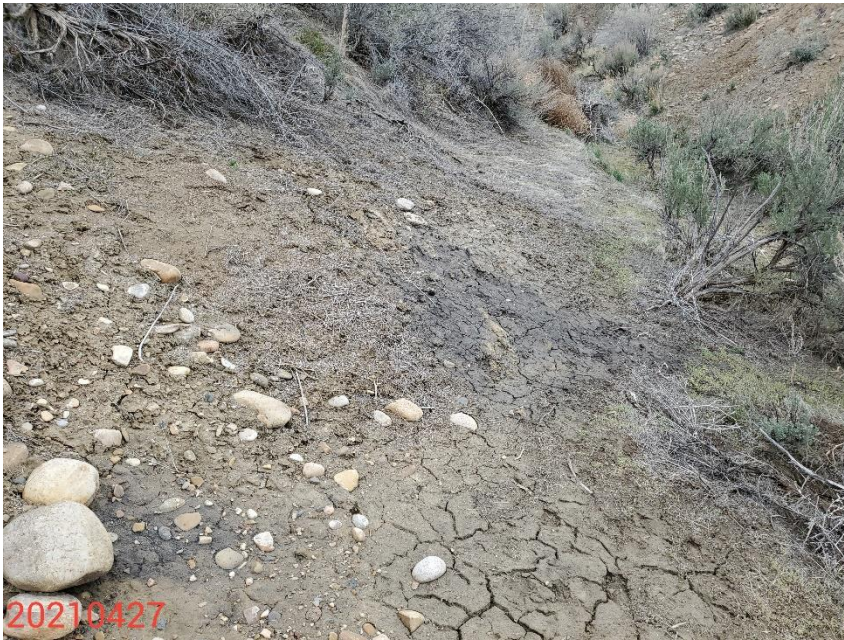
Photo 13: Photo taken from within the drainage east of the Location. Photo shows stained soils were observed on the within the adjacent drainage.

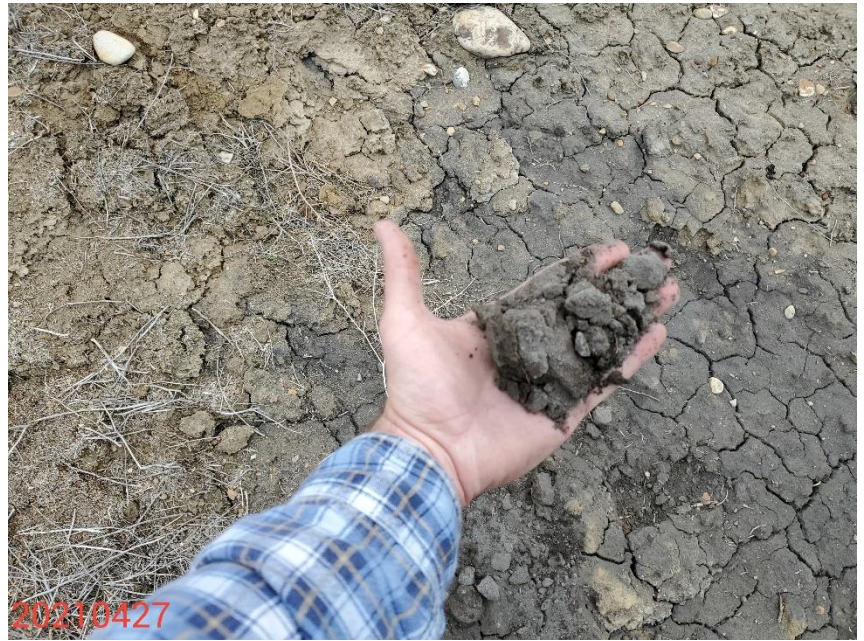
Photo 14: See comments under photo 13.
