## Inspection Photos

Location Name: TEP ROCKY MOUNTAIN LLC PUCKETT/TOSCO-66S95W /34SESW

Location ID: 324218

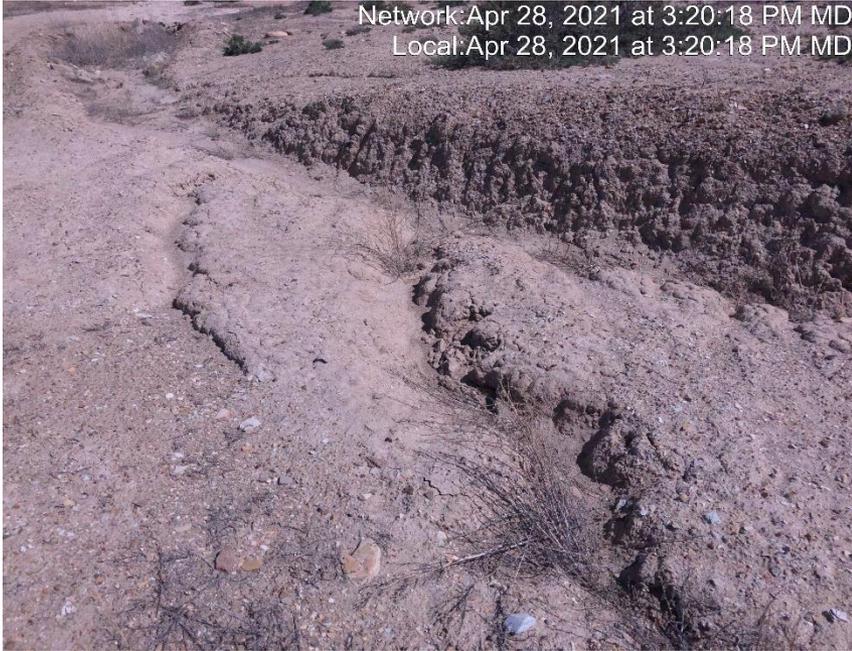
**Photo #3666 Rill erosion.**

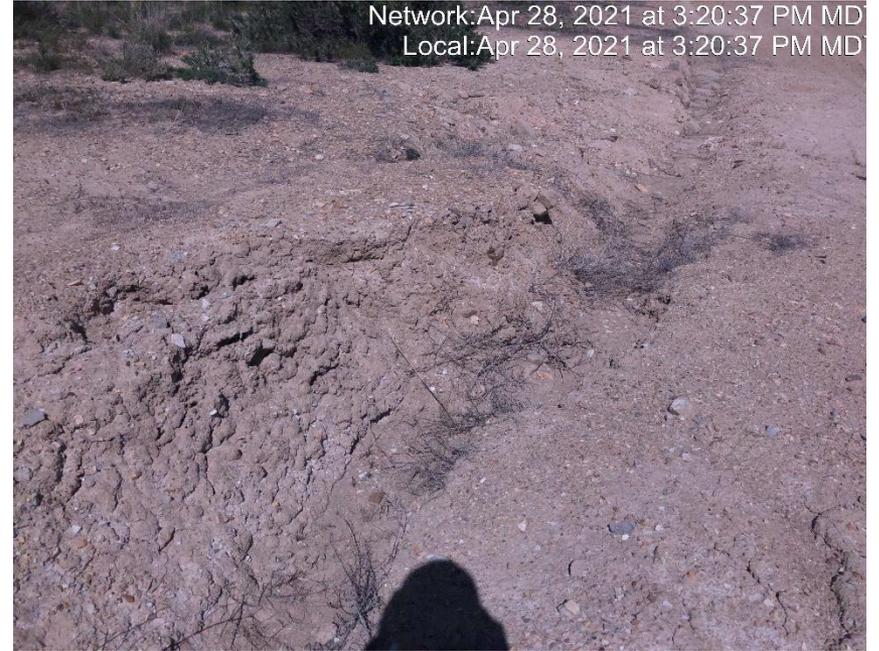
**Photo #3667 Rill erosion.**

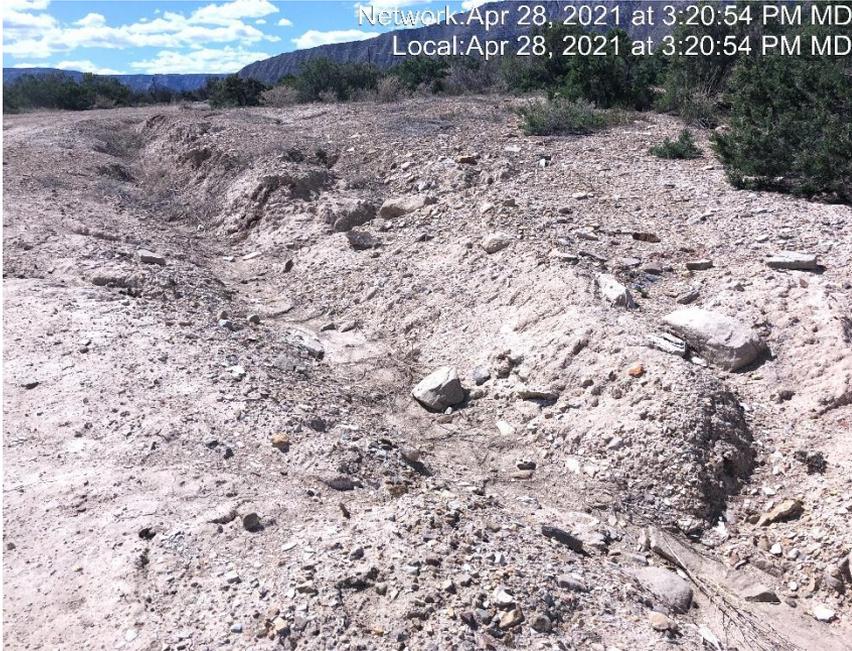
**Photo #3668 No velocity checks.**

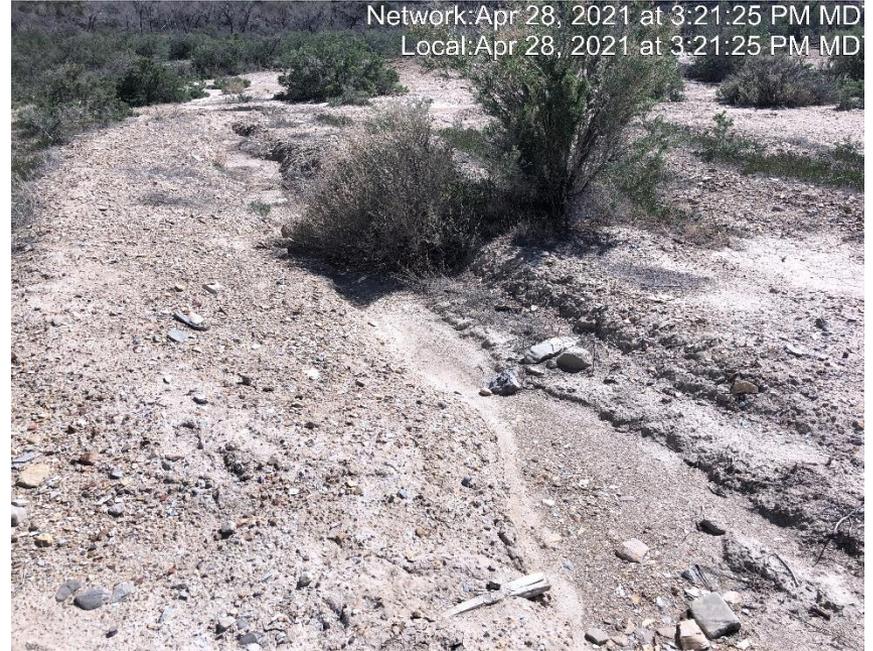
**Photo #3669 Sediment is being transported off of location.**
