Stormwater Inspection Report

Operator:	Laramie Energy, LLC
Project:	Cascade Creek
Location:	CC 603-23-32 Pad
Date:	Thursday, April 29, 2021
Weather:	Clear, Light Wind, 70°, Lo 38°

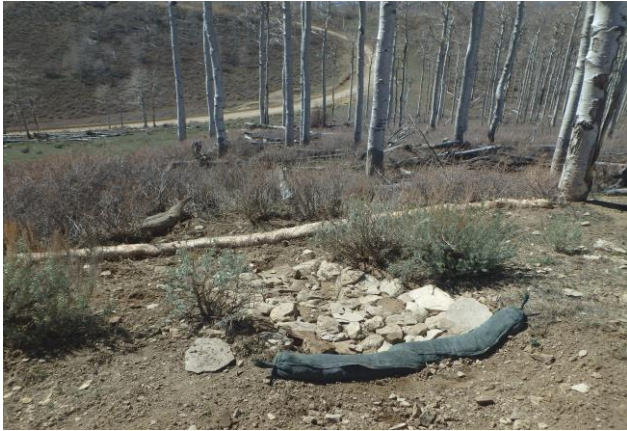
Photo 1

Outlet Identified in Photo #17

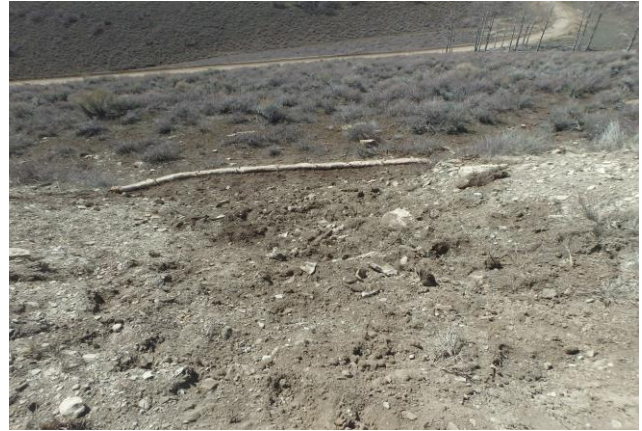
Photo 2

Issue Identified in Photo #19
