# Inspection Photos

4/30/2021

Operator: TEP ROCKY MOUNTAIN LLC - 96850

Location ID: 335275

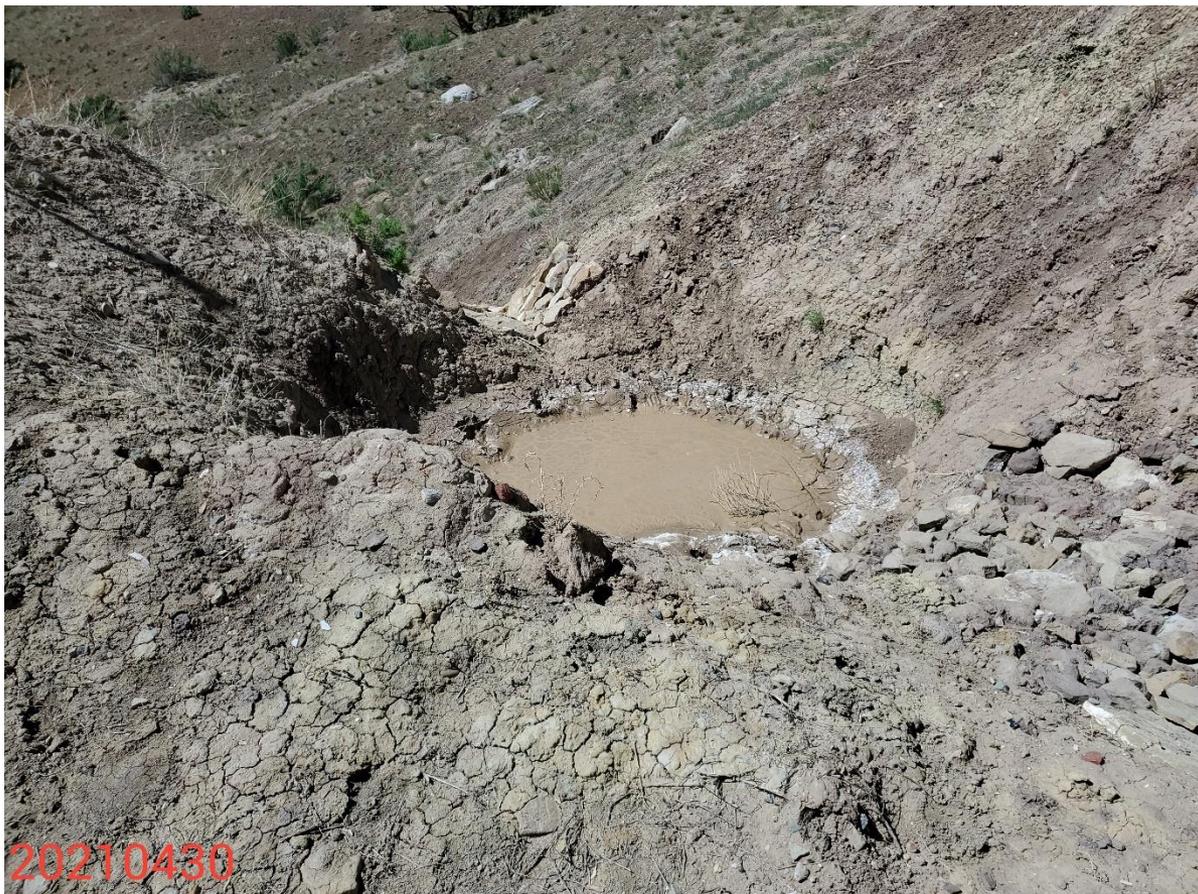
**Photo 1:** Photo shows sediment trap on the southwest corner of the Location. Sediment trap observed to not have been installed with geotextile lining in accordance with good engineering practices; soils observed to be eroding beneath the rock arming at the inlet/outlet

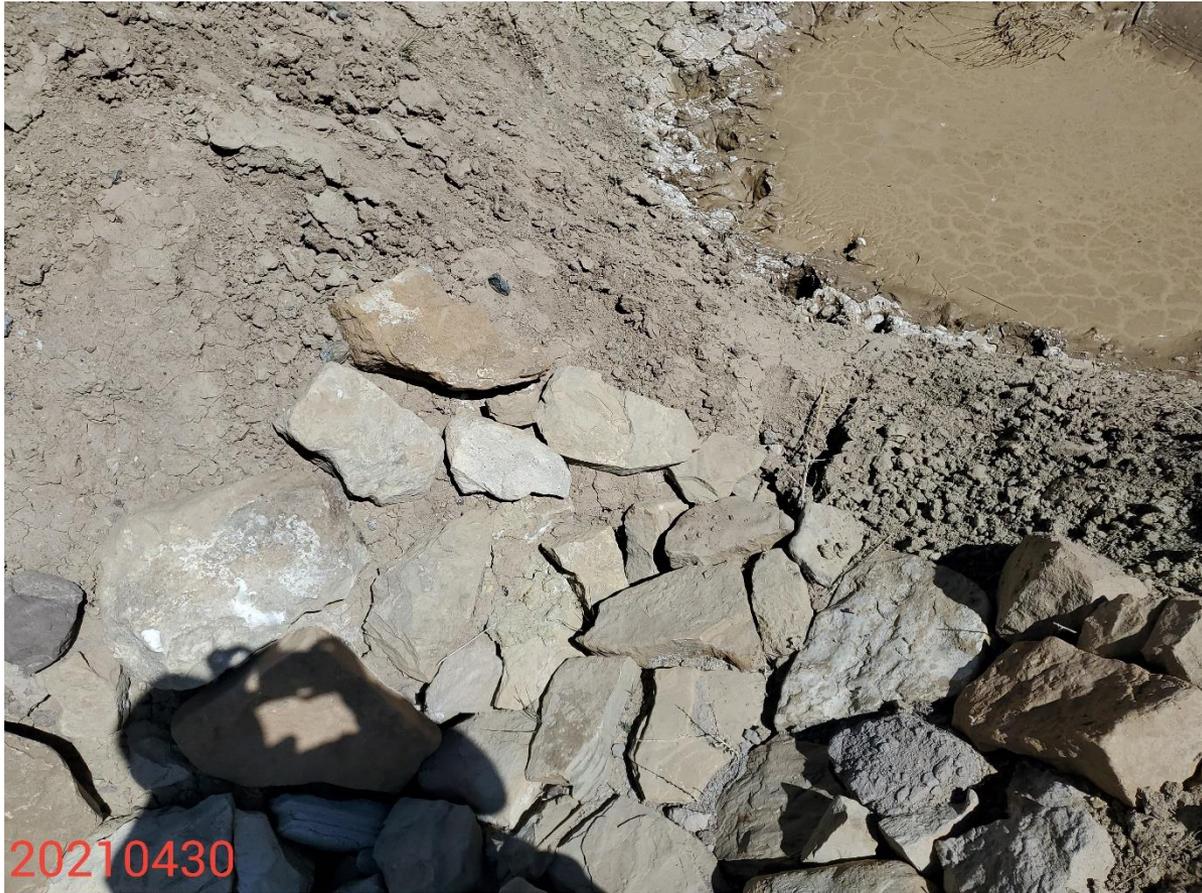
**Photo 2:** See comments under photo 1. Soils observed to be eroding beneath the rock armoring.

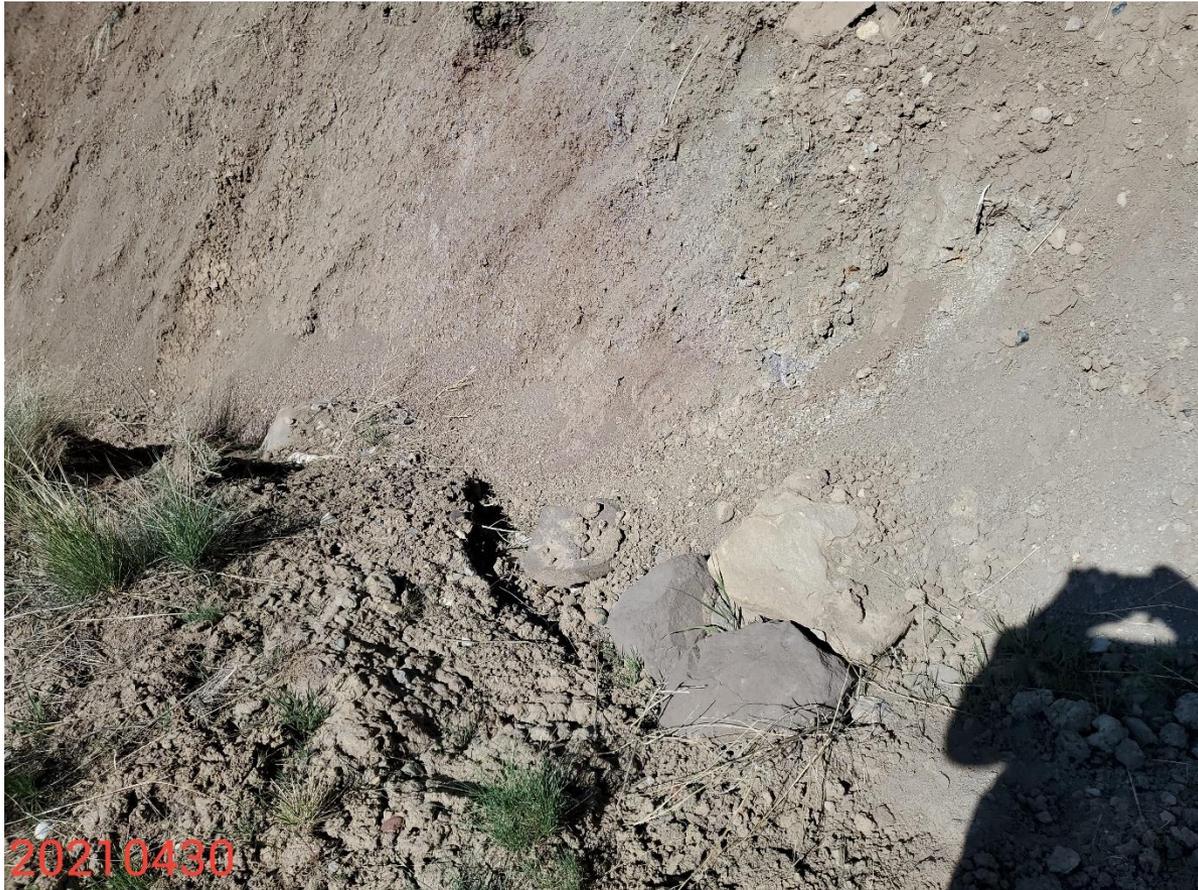
**Photo 3:** See comments under photo 1. Soils observed to be eroding beneath the rock armoring.

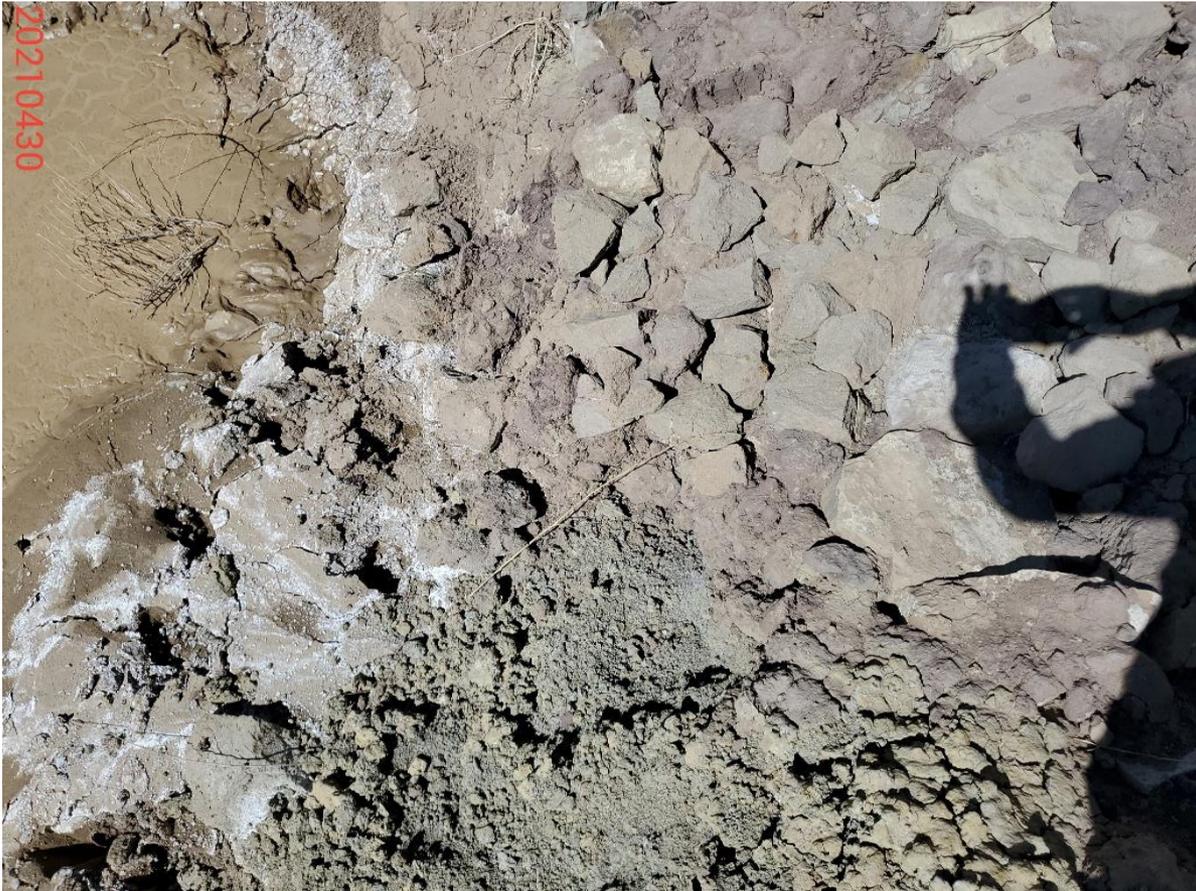
**Photo 4:** See comments under photo 1. Soils observed to be eroding beneath the rock armoring.

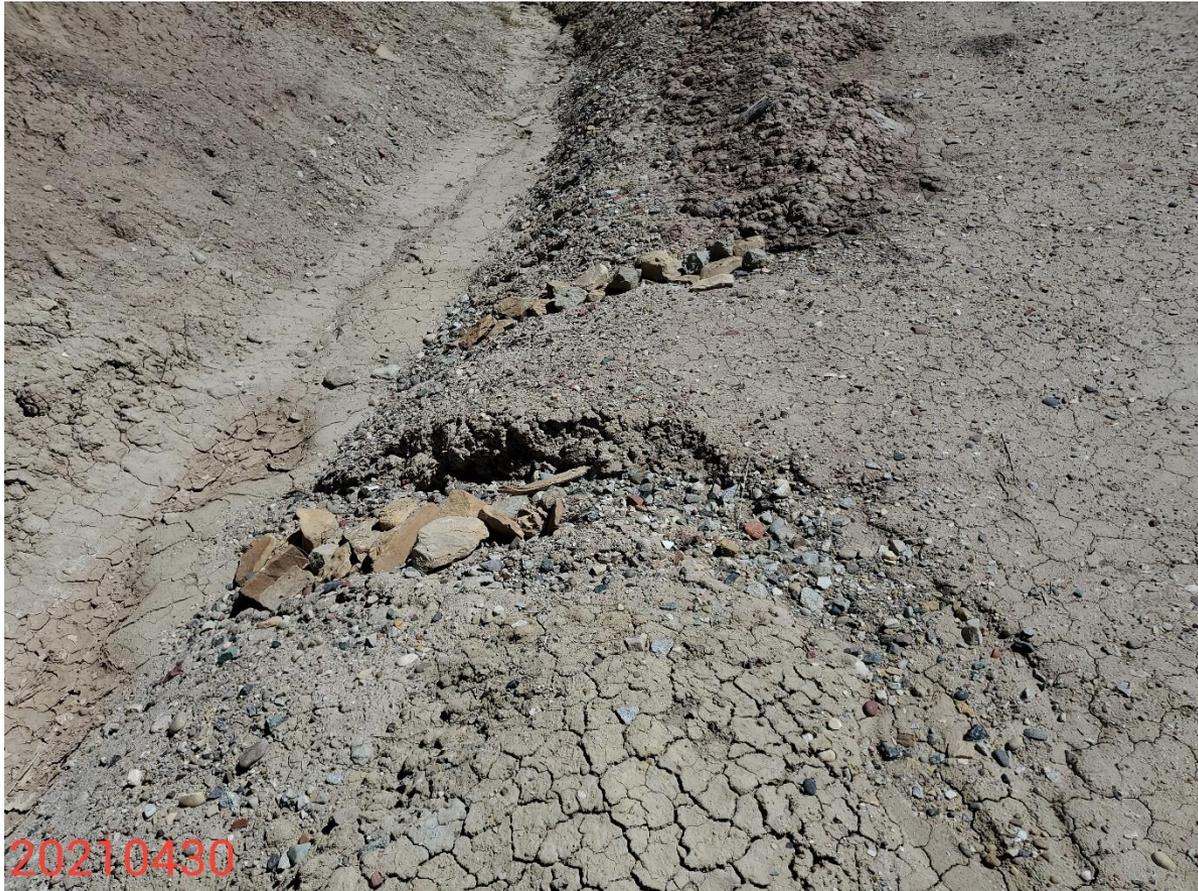
**Photo 5** Photo taken from the ditch. Photo shows example of areas observed along the ditch, where rock armoring was placed to mitigate degradation and protect ditch/location; control measures inadequate to prevent degradation.

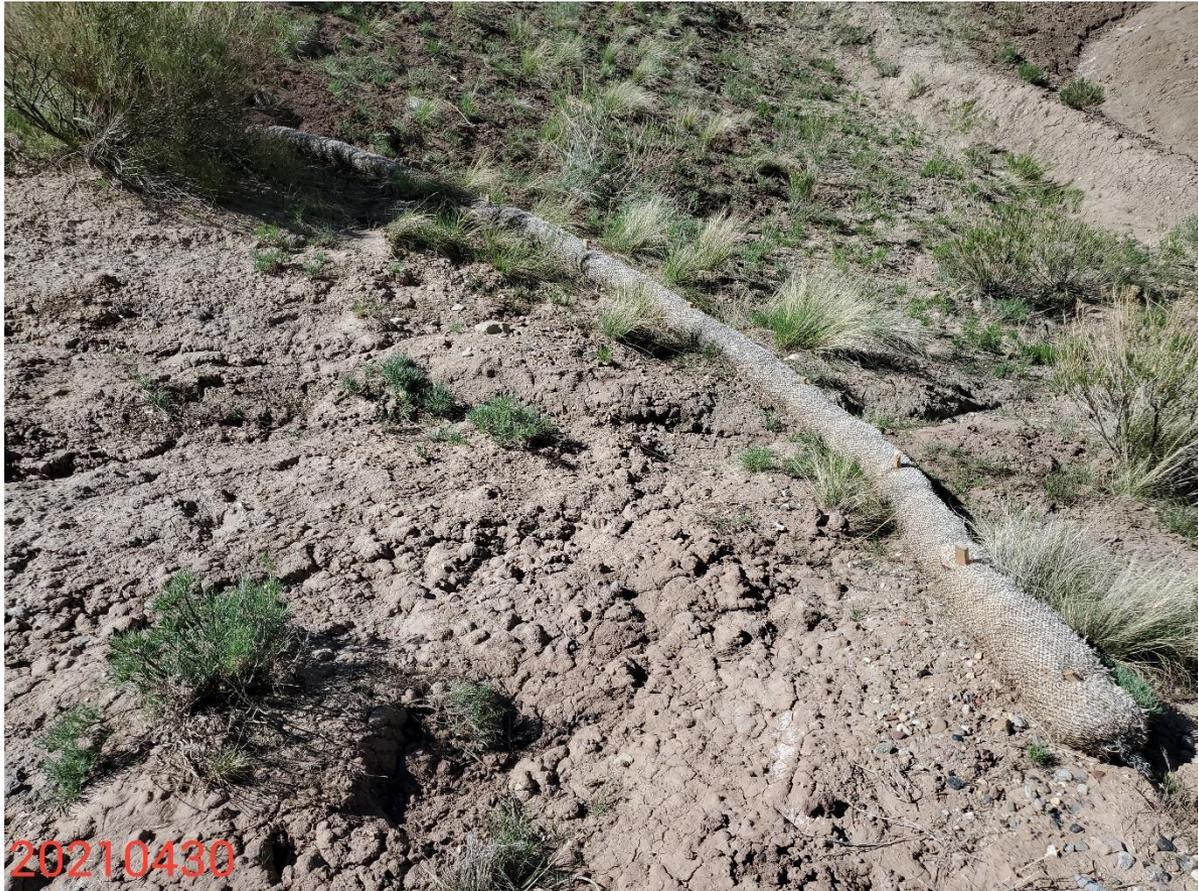
**Photo 6:** Photo taken from the slopes on the northeast end of the Location. Photo shows Operator has placed a single erosion log on the slopes. Erosion logs are required to be trenched/backfilled per good engineering practices. Additionally, erosion logs are temporary control measures used to reduce flow velocities, capture sediment and release runoff as sheet flows over stabilized areas; erosion logs alone are not an appropriate control measure to stabilize soils/slopes per good engineering practices and the site's conditions.

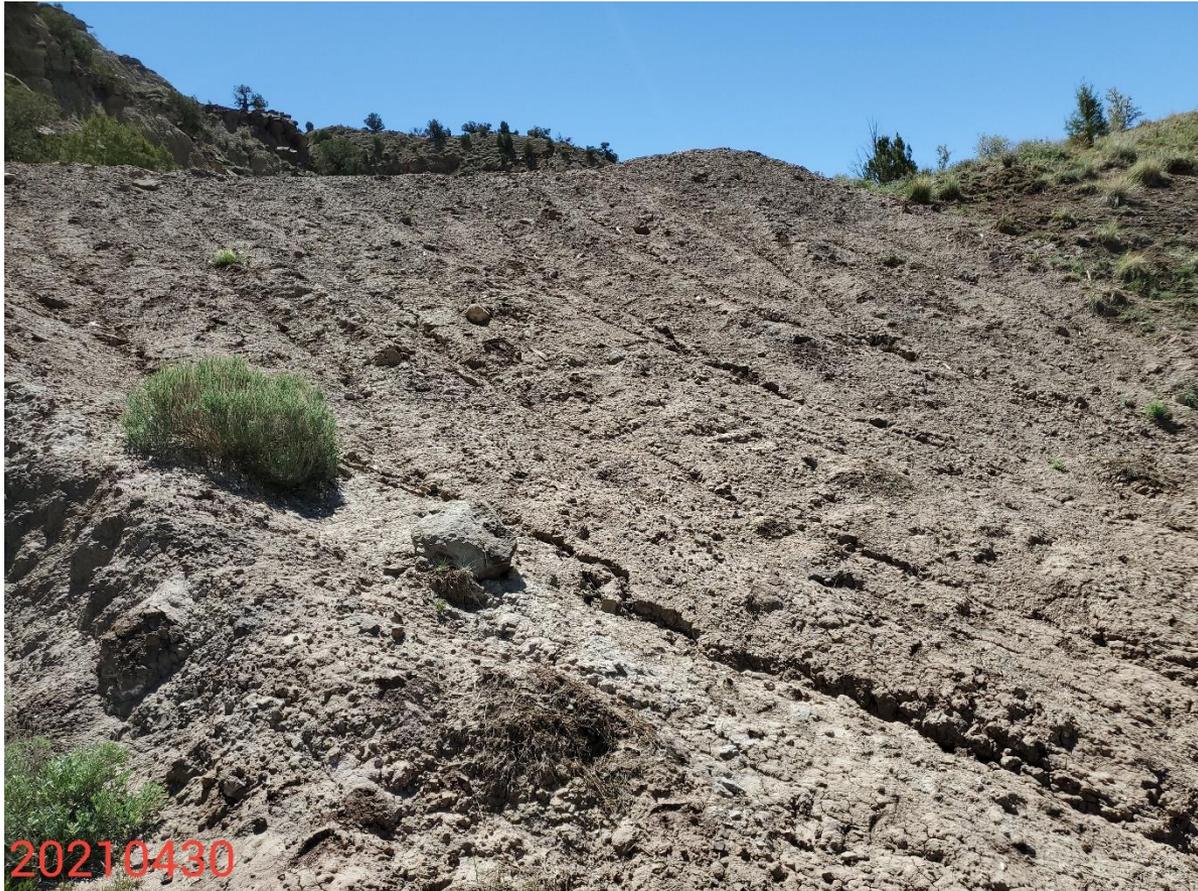
**Photo 7:** Photo taken from the northeastern slopes of the Location, facing east. Previous inspections required Operator to implement control measures to stabilize and protect the slopes of the Location. Photo shows control measures remains missing or insufficient to stabilize and protect slopes.

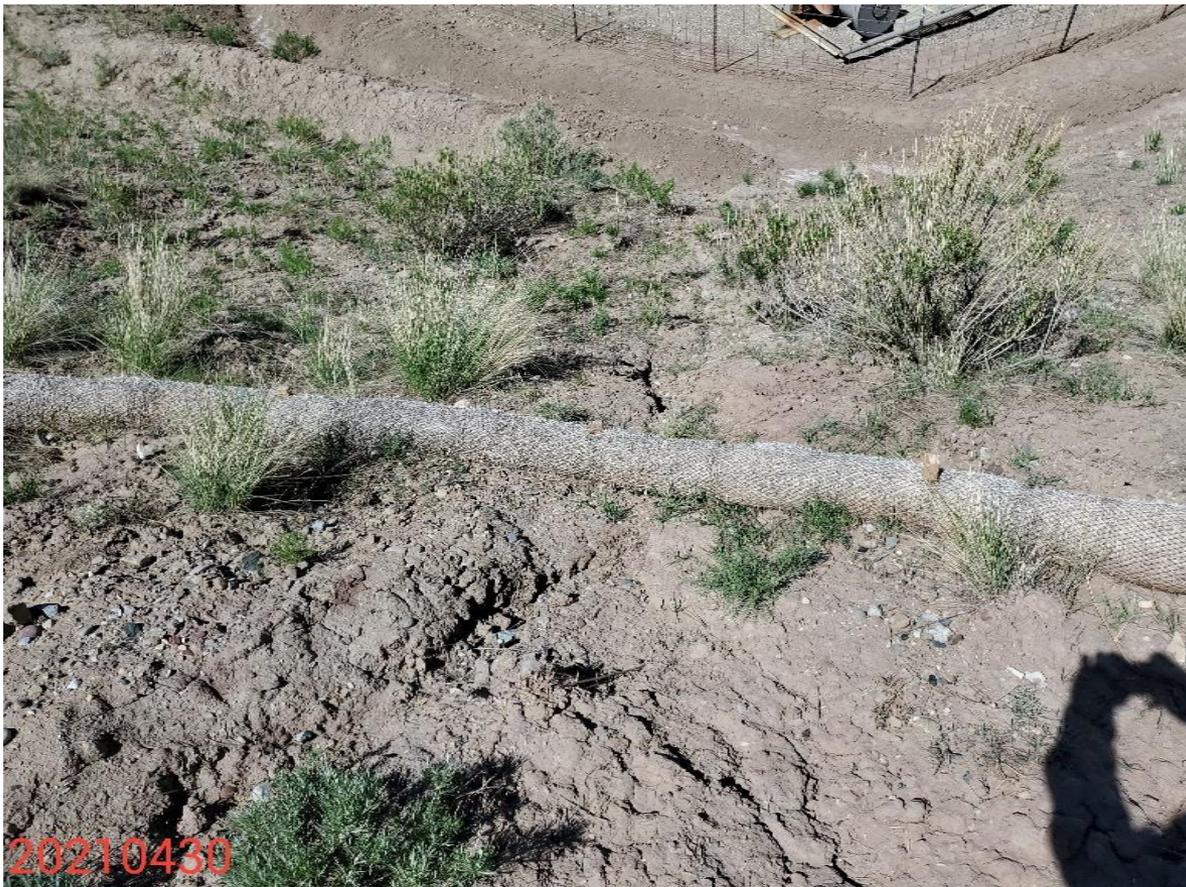
**Photo 8:** See comments under photo 6. Photo also shows stormwater movement will travel beneath the wattle within the gully.

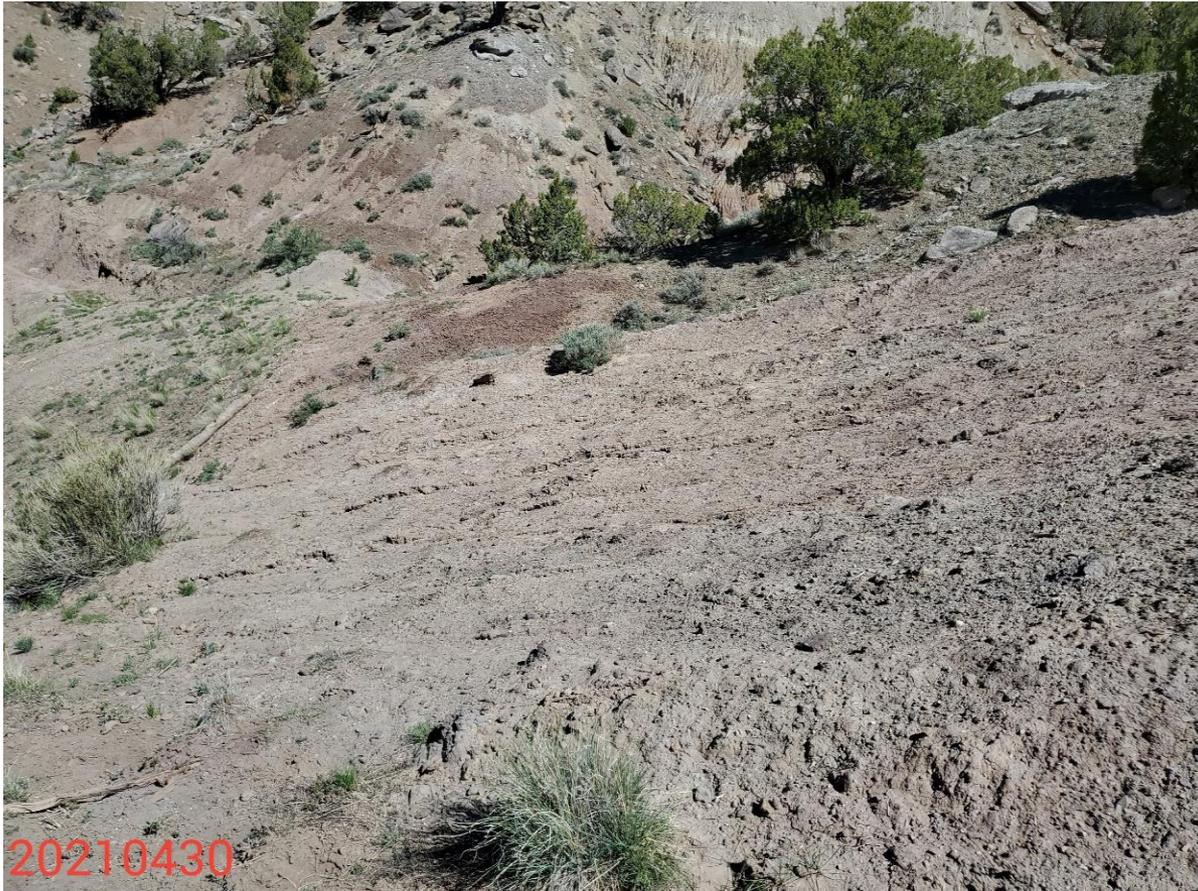
**Photo 9:** Photo taken from the northeastern slopes of the Location, facing north. See comments under photo 7.
