TEP
KP 23-17
Location # 335208

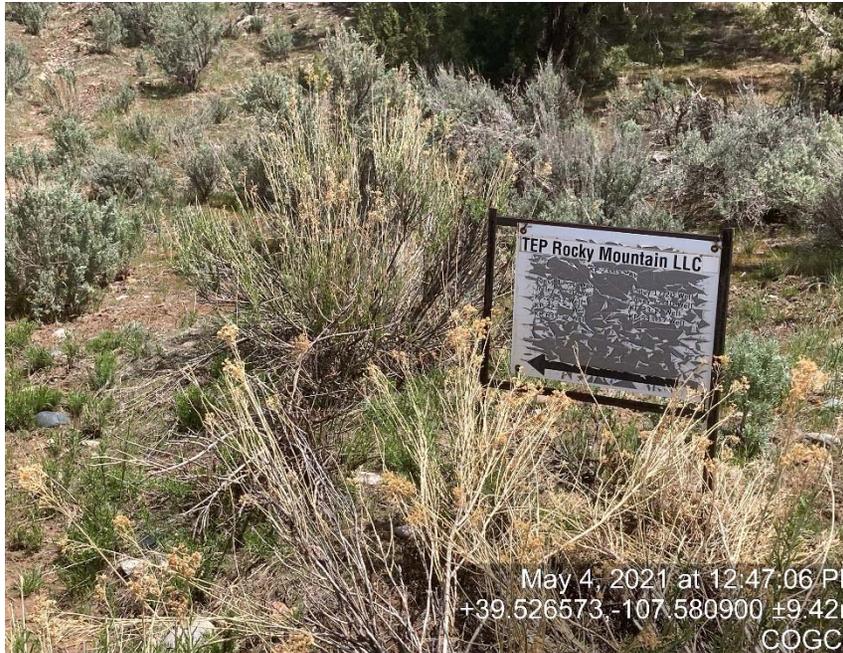
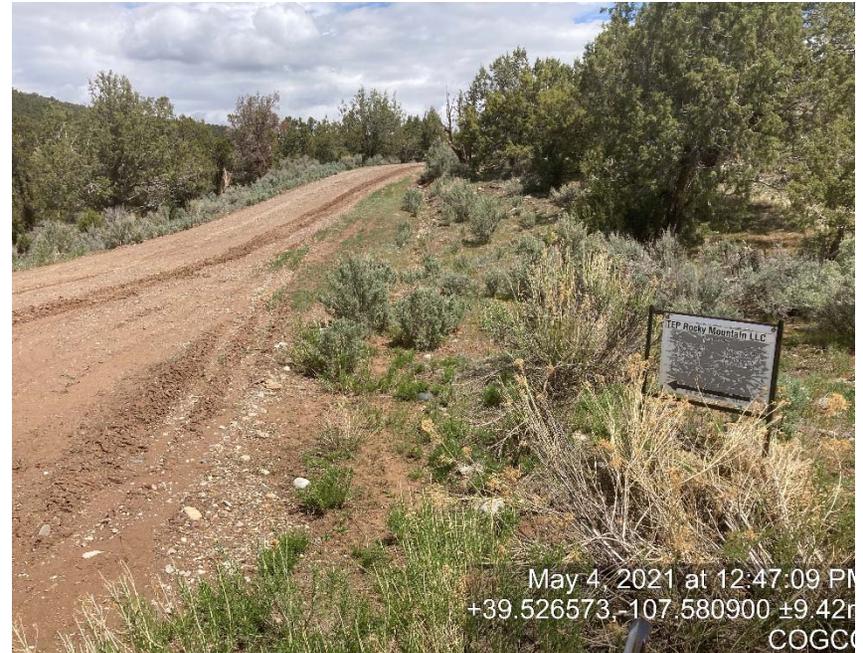
Location entrance signage is illegible

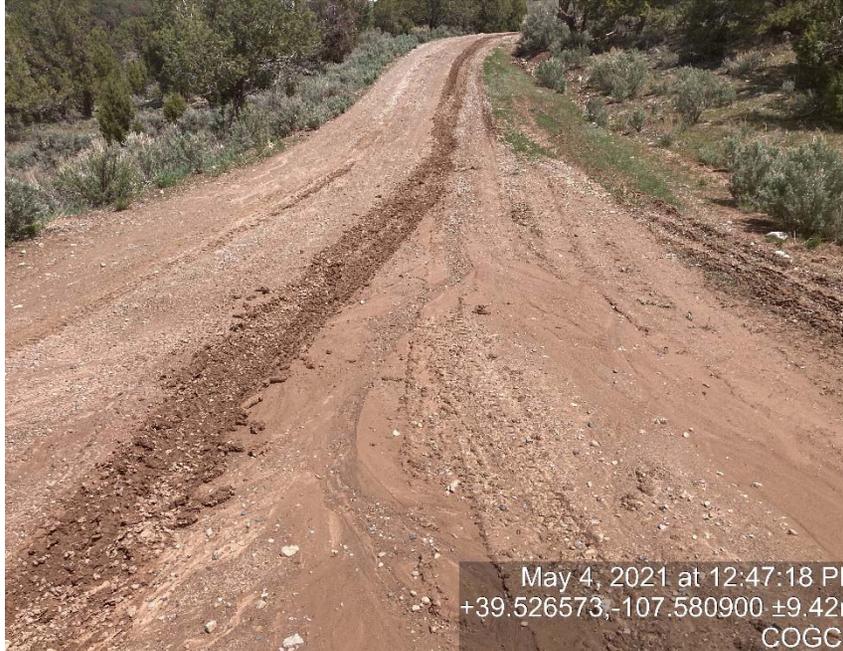
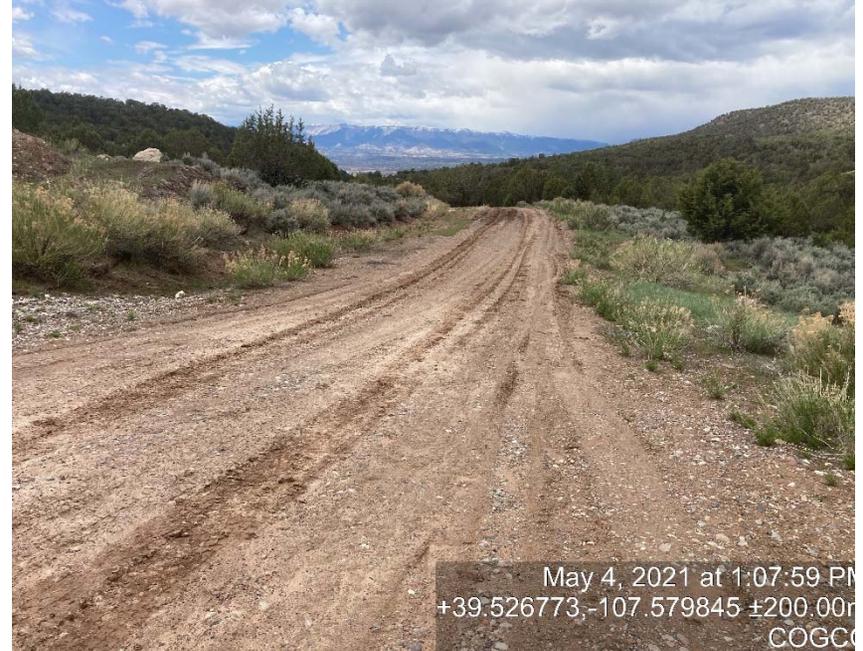
Lack of stabilization/compaction

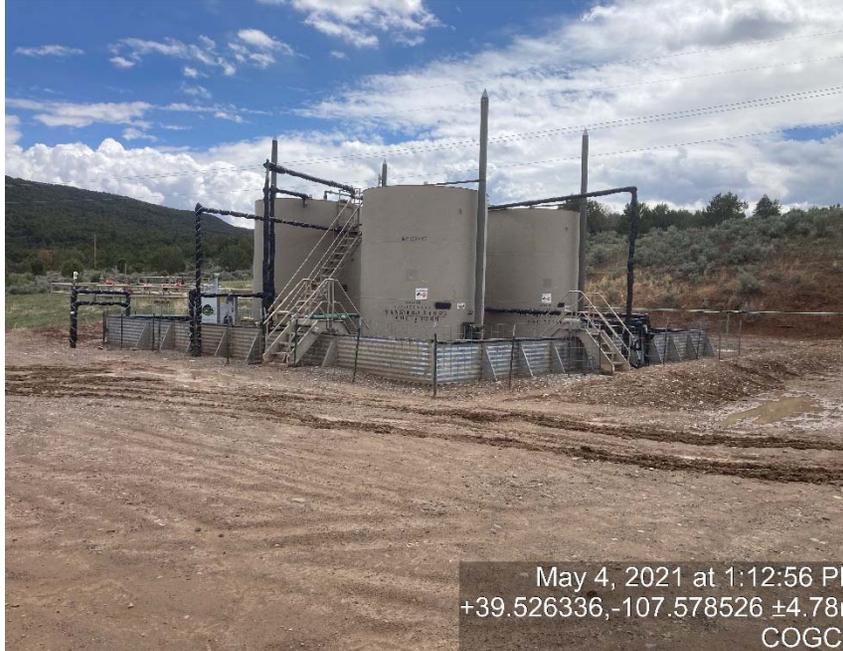
Location/lack of tank battery signage

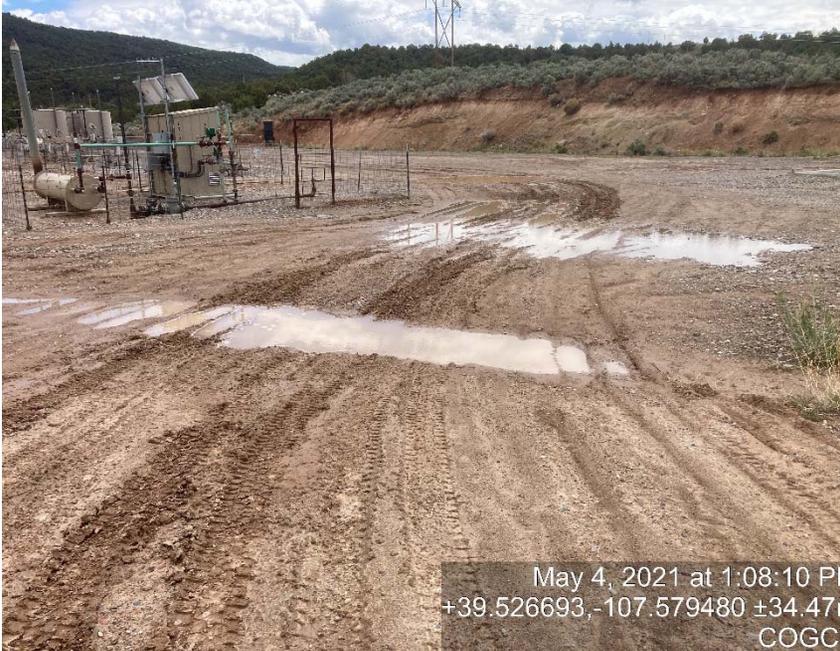
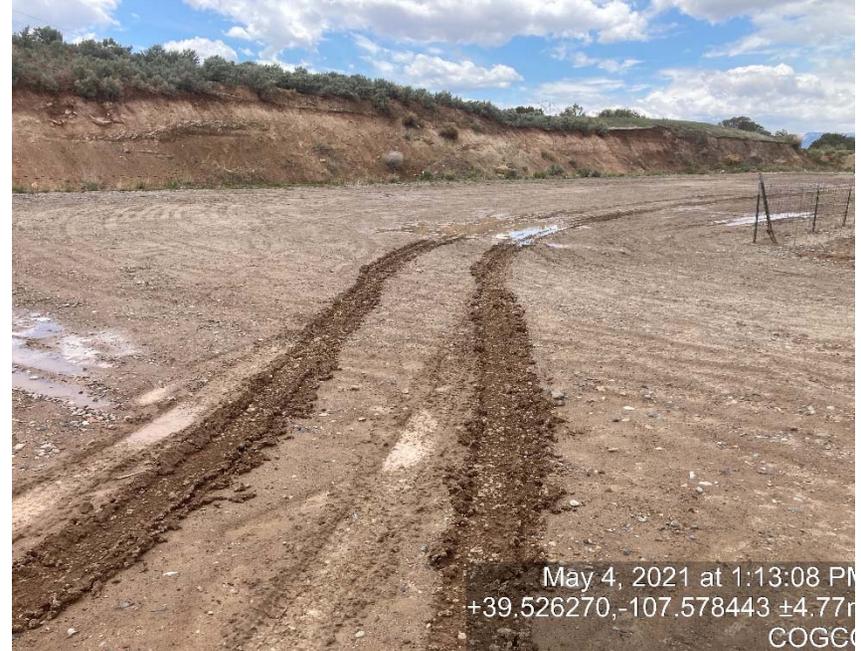
Lack of stabilization/compaction

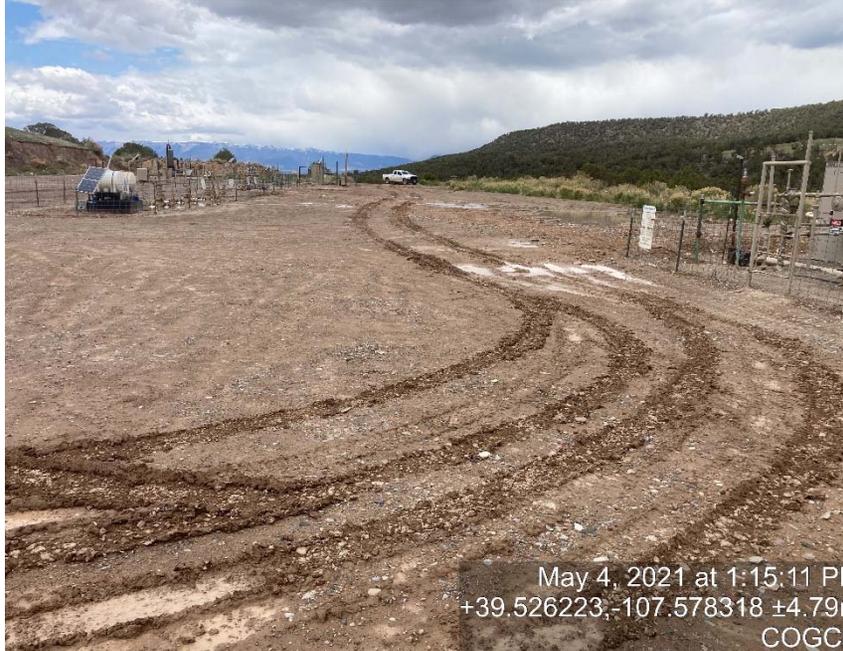
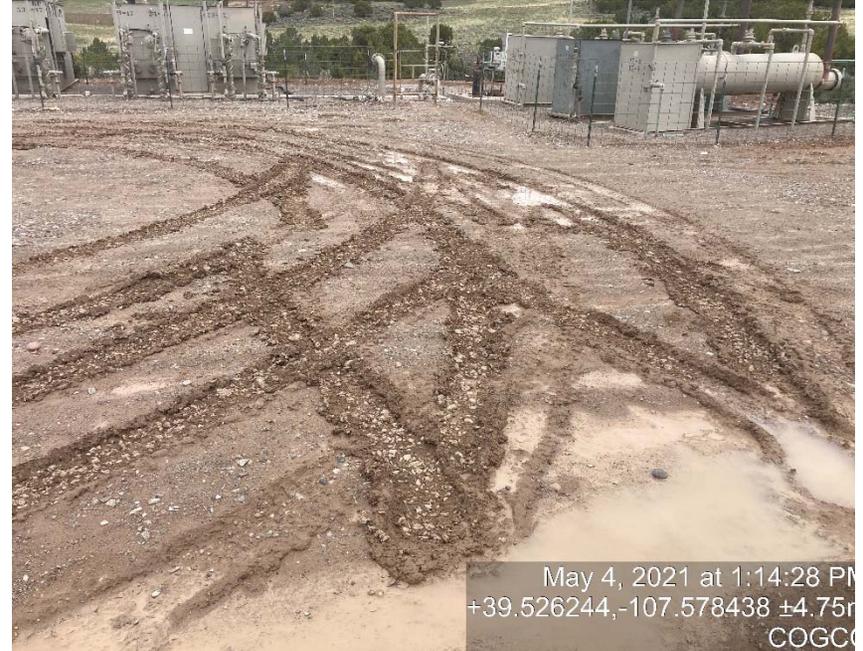
Lack of stabilization/compaction

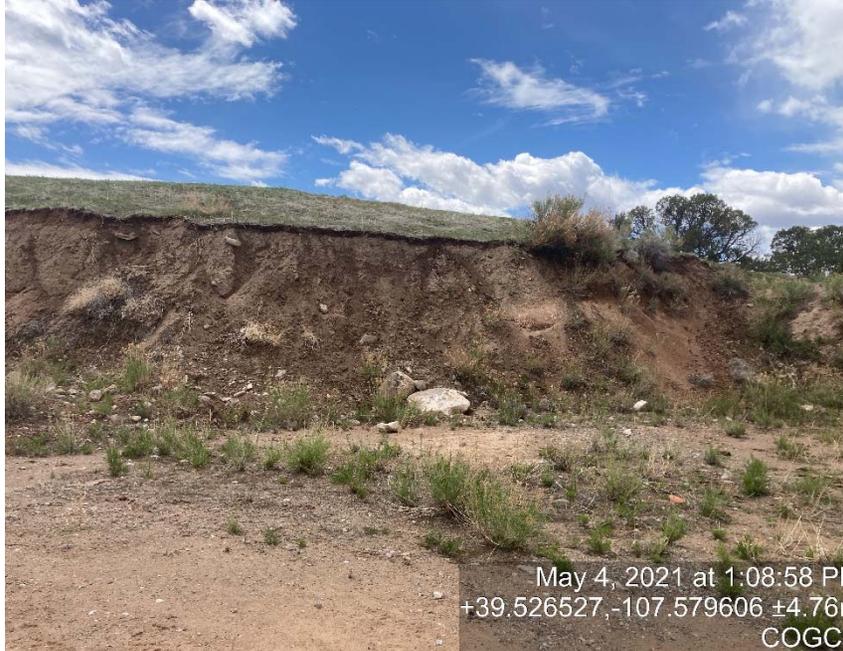
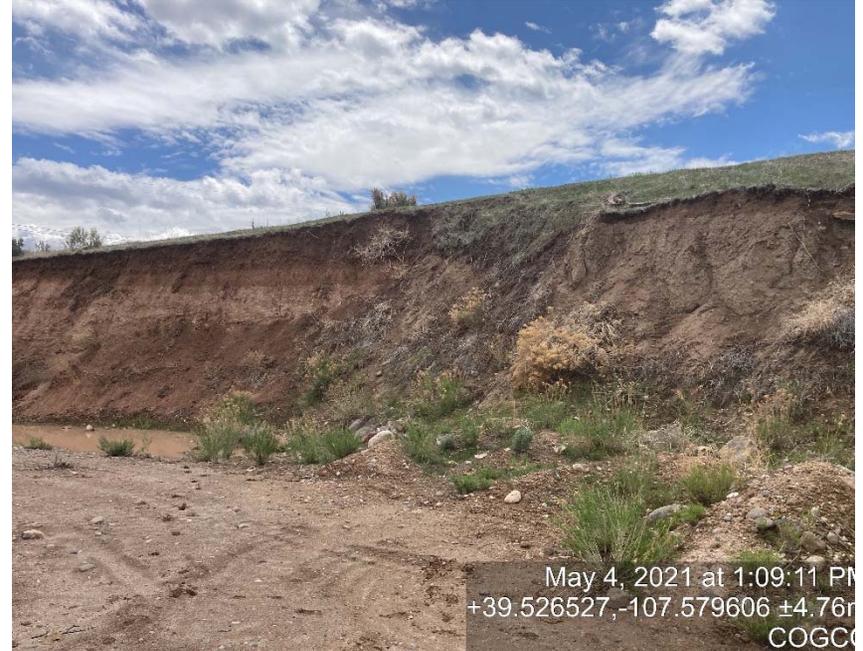
Cut slope on south side of location shows signs of erosion and lack of stabilization.

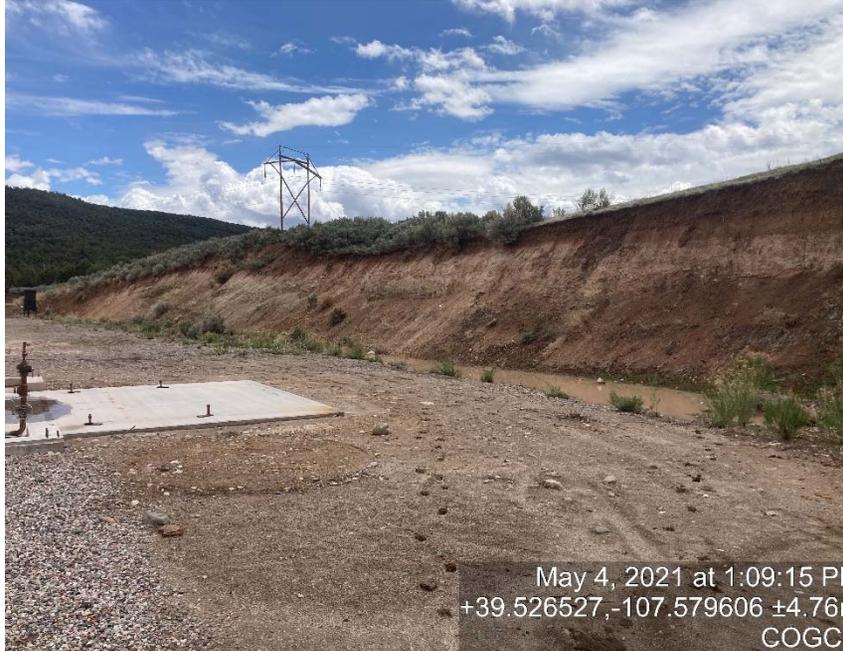
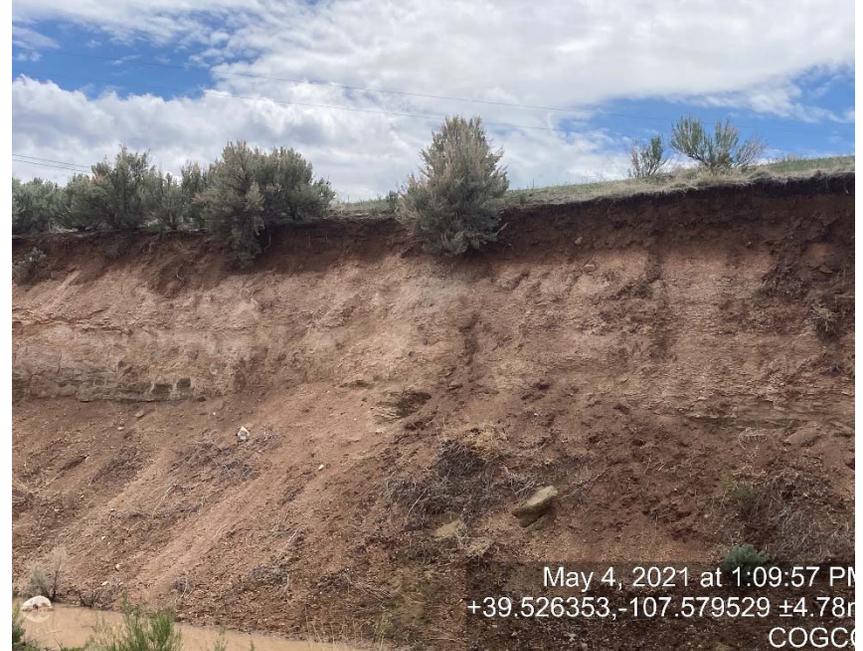
Cut slope on south side of location shows signs of erosion and lack of stabilization.
