**Inspection Photos**  
**Paul Heinze #1 Flowline**  
**Spill ID 479232 (AC)**

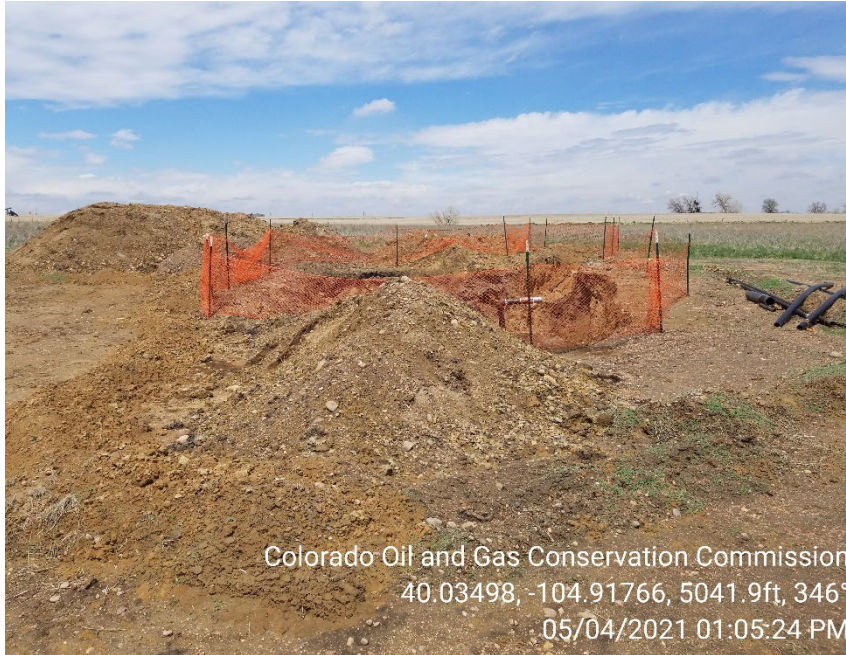
**Photo 1 – Spill area. Fencing has been repaired around open excavation. Trash on location.**

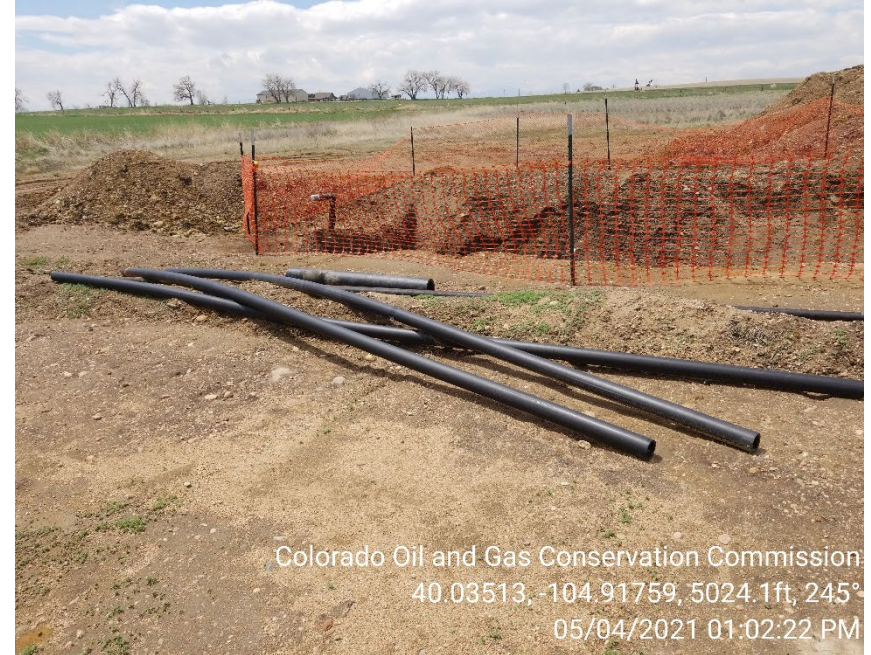
**Photo 2 – Trash on location.**

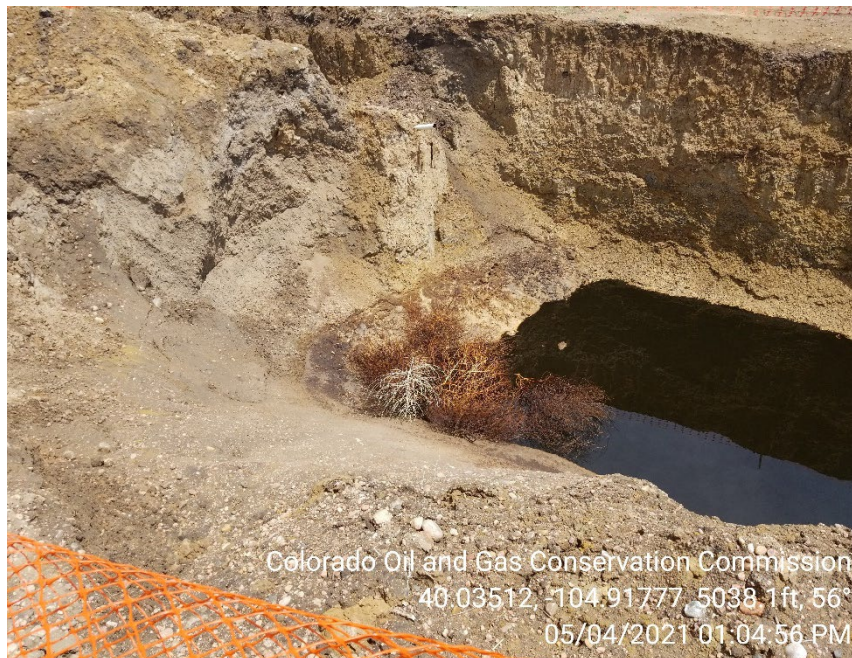
**Photo 3 – Open excavation. Free product observed on groundwater. Impacts remain in situ.**

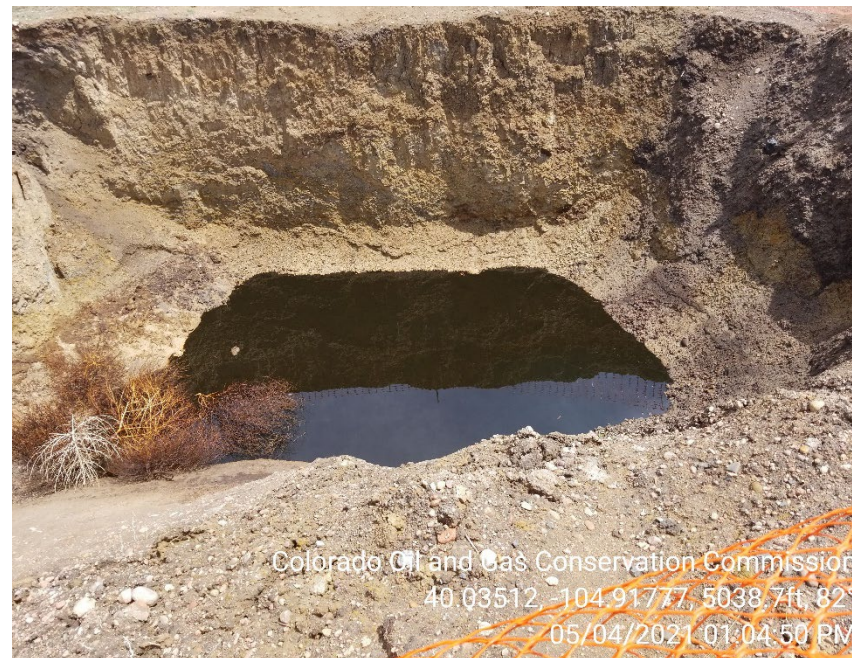
**Photo 4 – Open excavation. Free product observed on groundwater. Impacts remain in situ.**

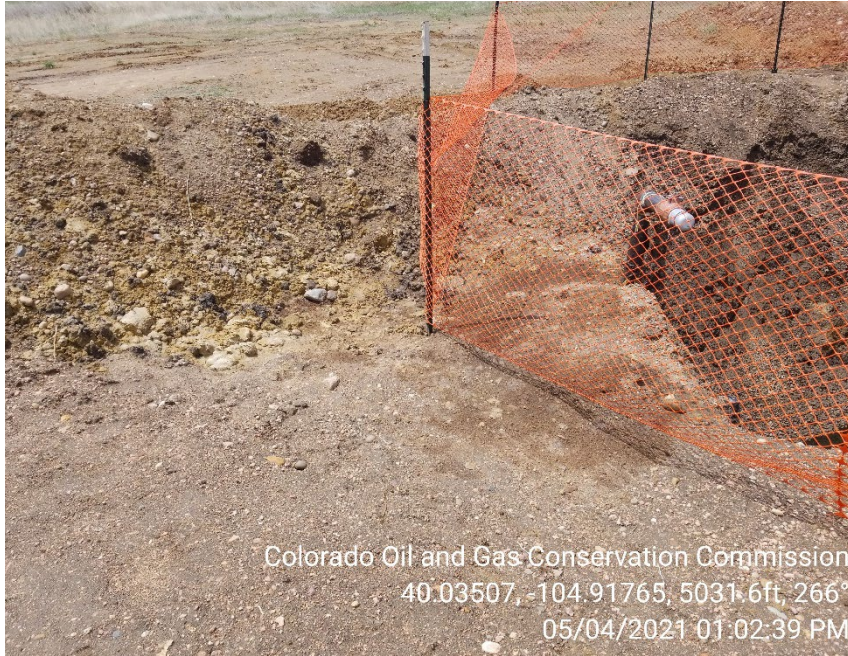
**Photo 5 – Impacted soils remain on surface outside of excavation area.**

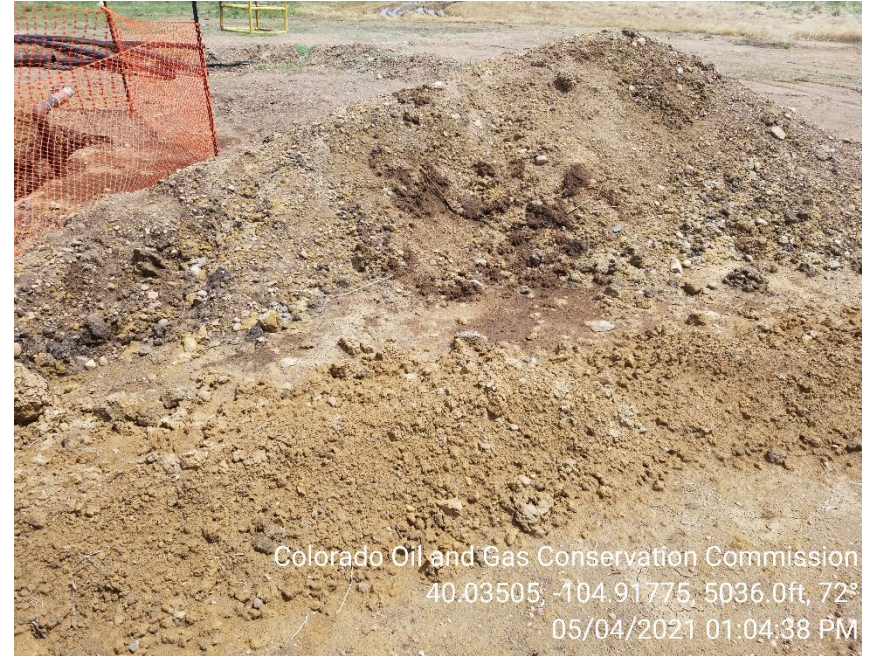
**Photo 6 – Impacted soils remain on surface outside of excavation area. Soils stockpiled on location with inadequate BMPs.**

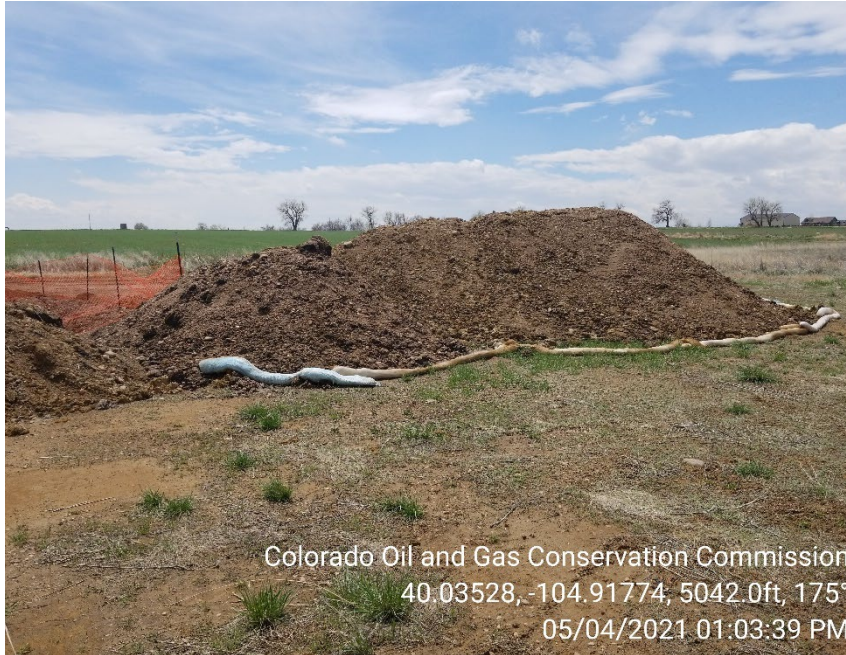
**Photo 7 – Soils stored on location with inadequate BMPs**

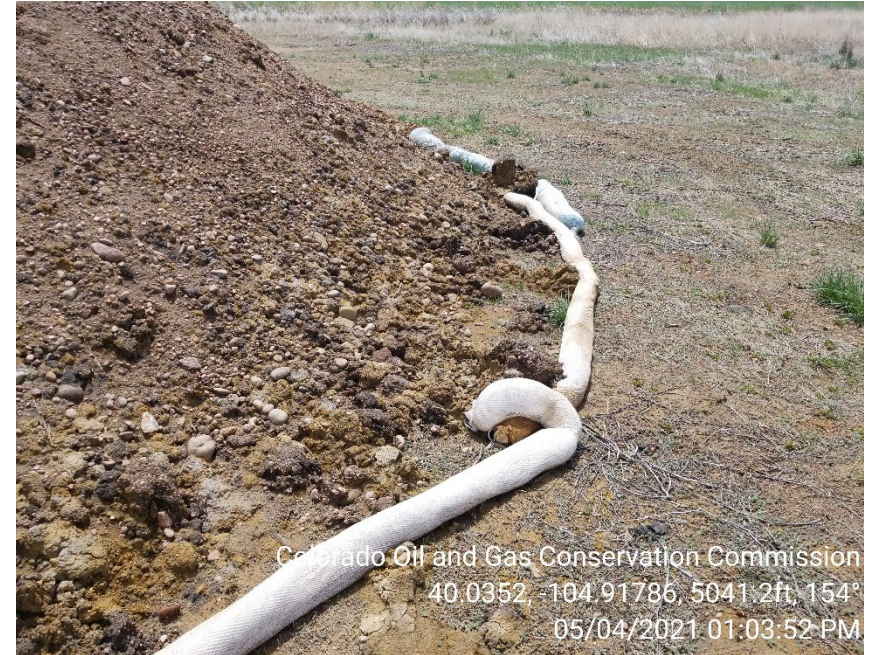
**Photo 8 – Soils stored on location with inadequate BMPs**

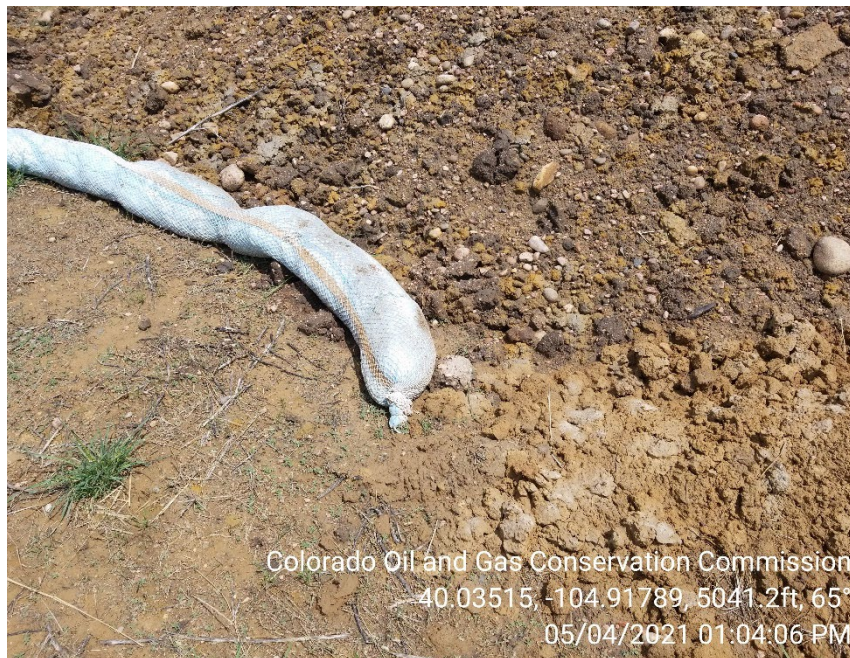
**Photo 9 – Soils stored on location with inadequate BMPs**

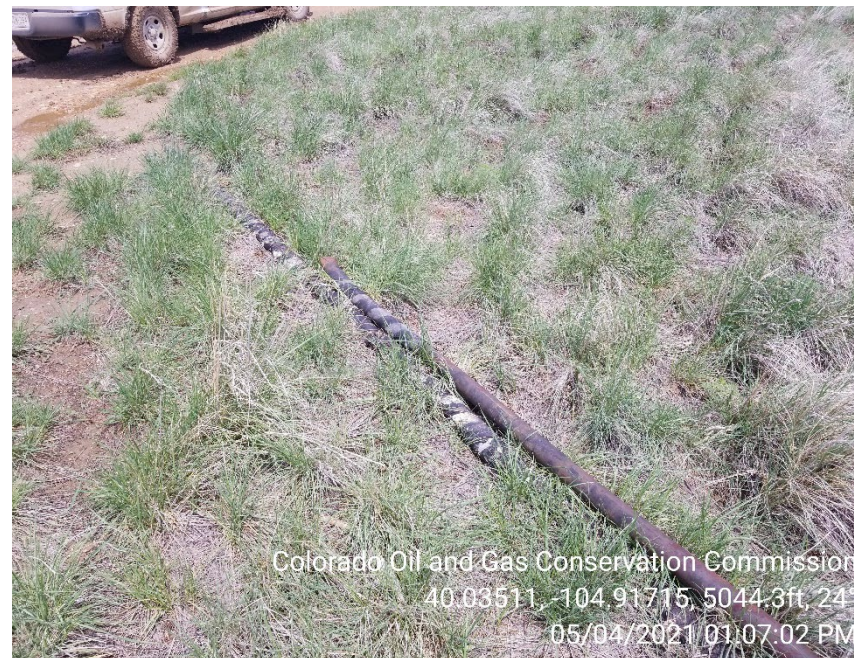
**Photo 10 – Trash on location**
