Inspection Photos

ID:429852

Operator: DOVER ATWOOD CORPORATION

Inspection Date: 5/5/2021

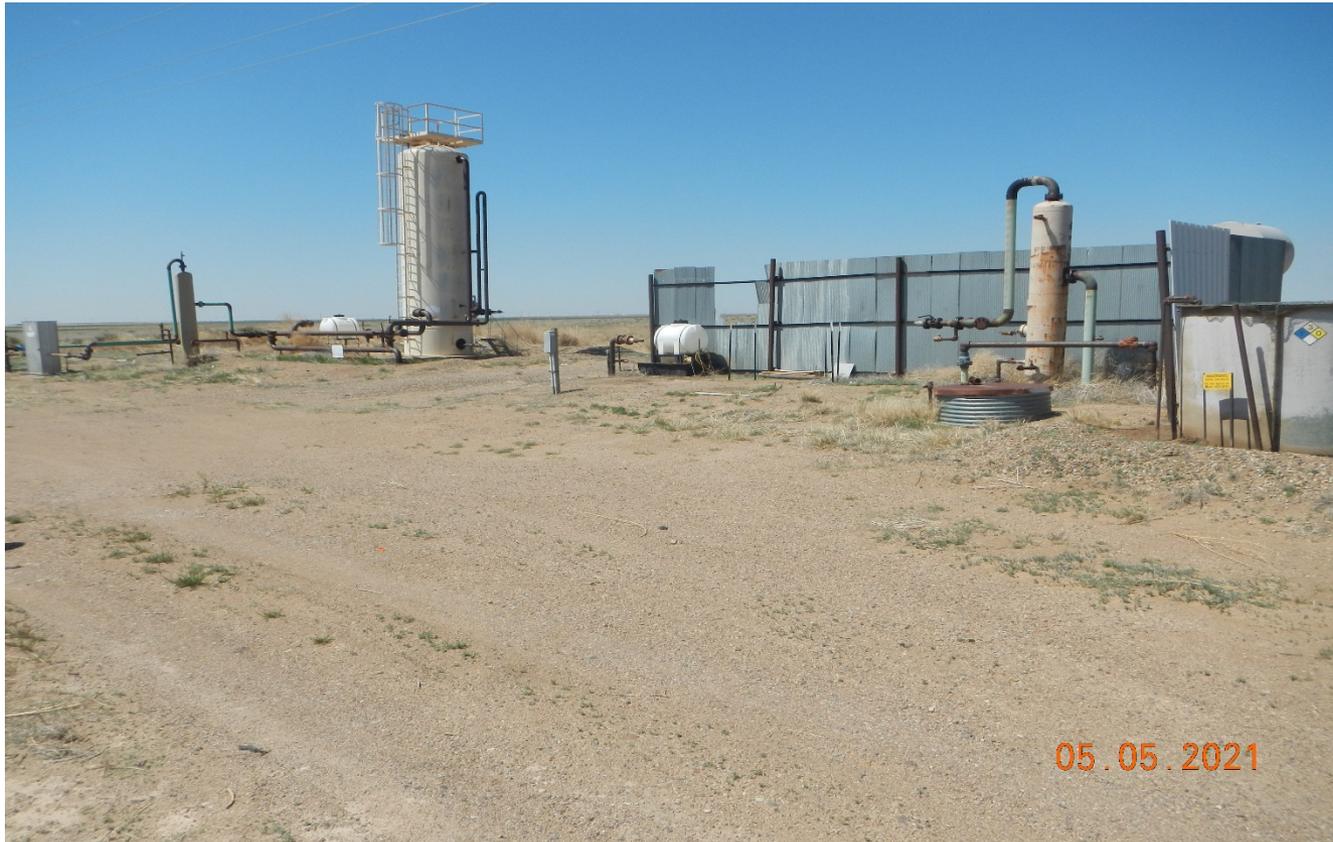
Photo 9. Facing southwest toward the location which is adjacent to County Rd. 44.

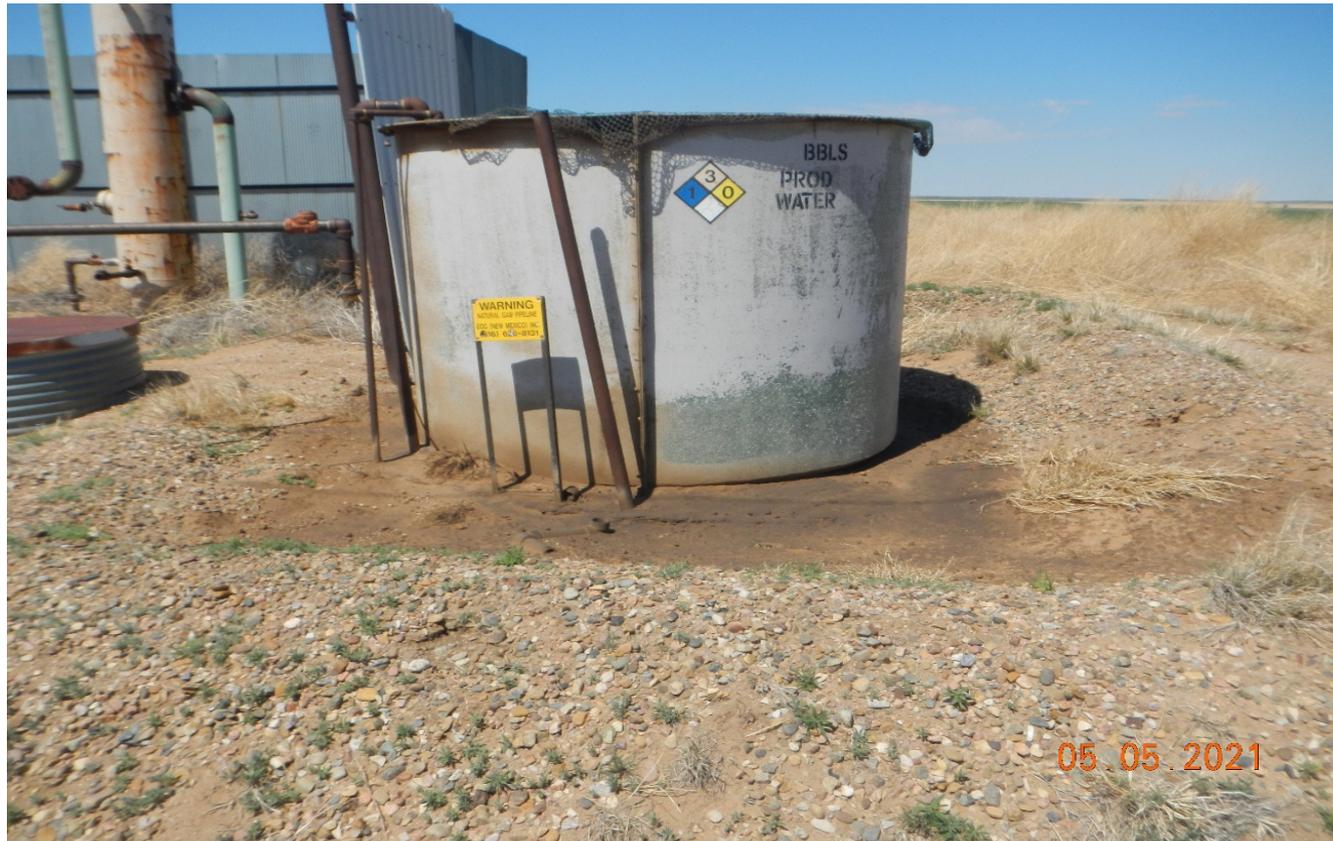
Photo 2. There is oil stained soil near the Produced Water tank. The tank is labeled produced water but appeared to contain oil inside. Netting was over the top of tank. Additionally the berm does not appear to be sufficient to contain a spill.

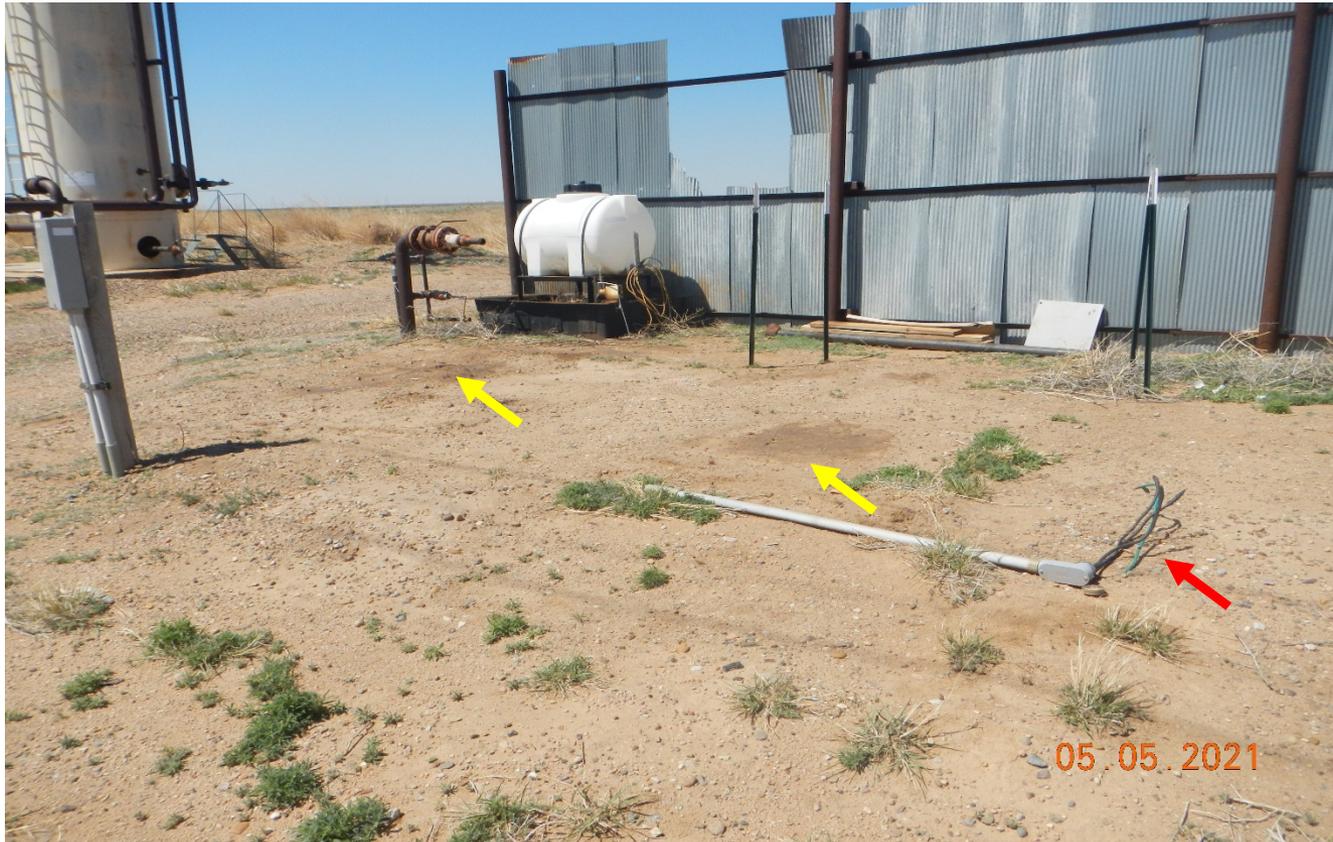
Photo 3. The black containers have been removed. There is an exposed electric utility that remain at red arrow. There is oil stained soil shown at yellow arrow.

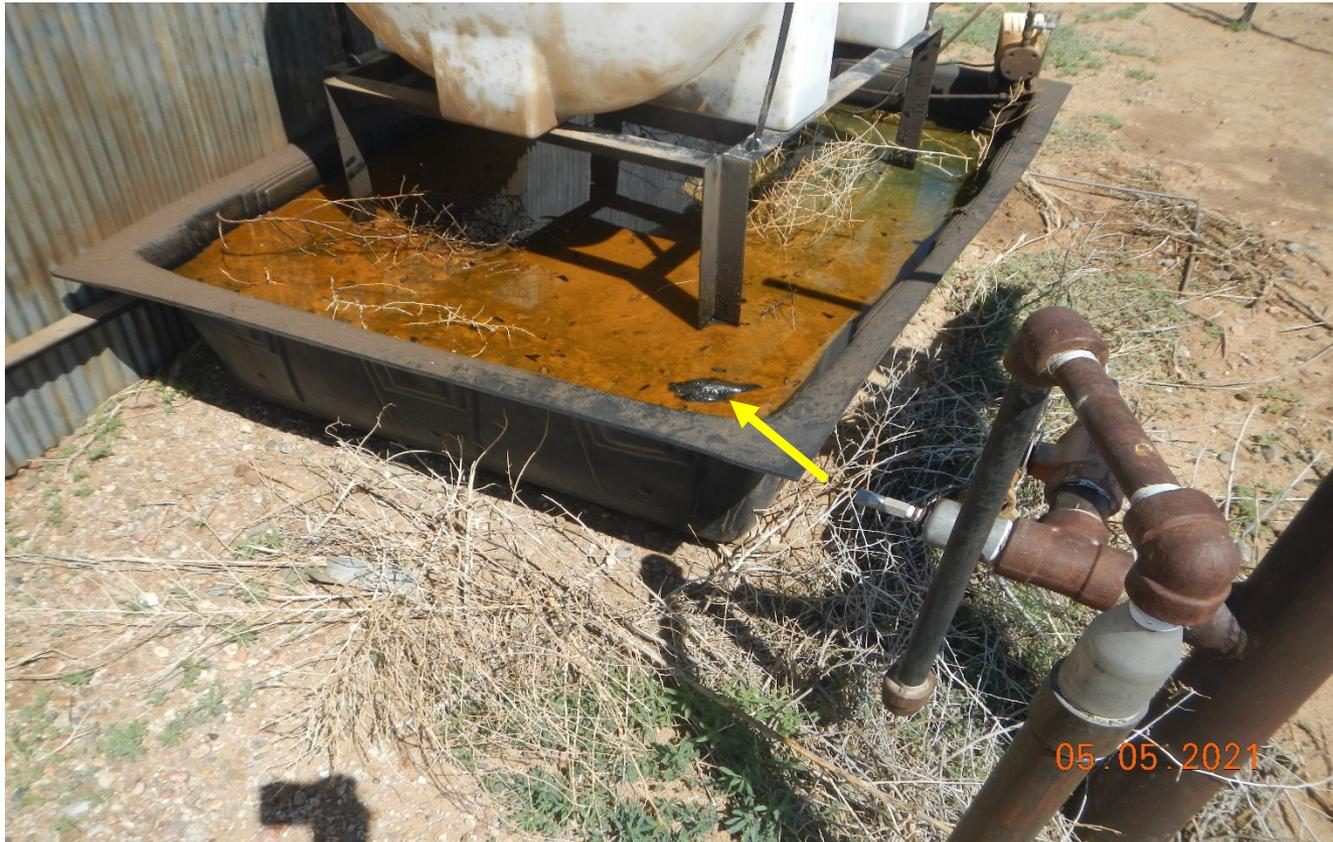
Photo 4. There is oily waste inside this containment which is near the top of the containment and appears to have spilled over. The oily waste has not been removed and properly disposed since last inspection. There is now a dead bird observed shown at red arrow.

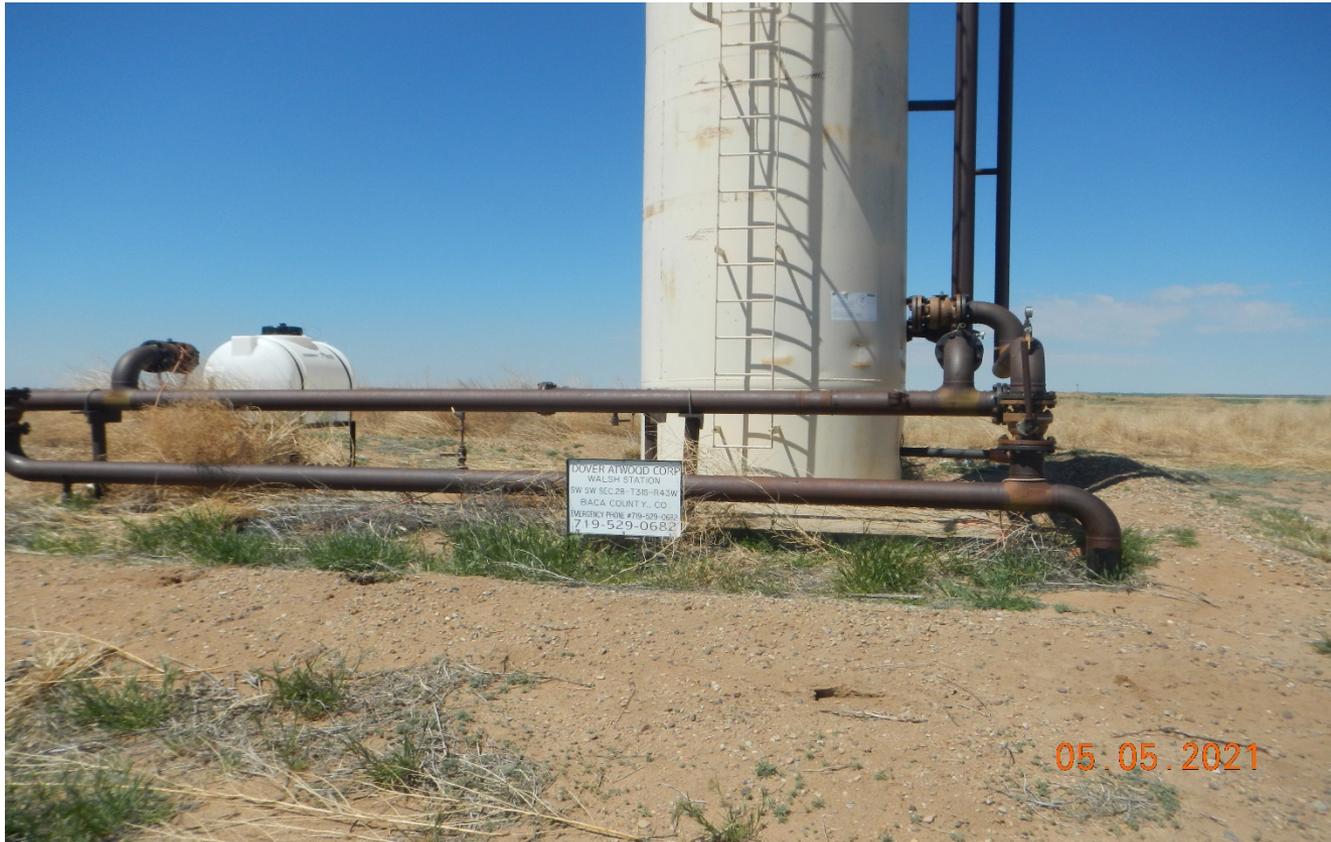
Photo 7. The facility sign is posted but contains incomplete and inaccurate information. Previous corrective action was not performed.

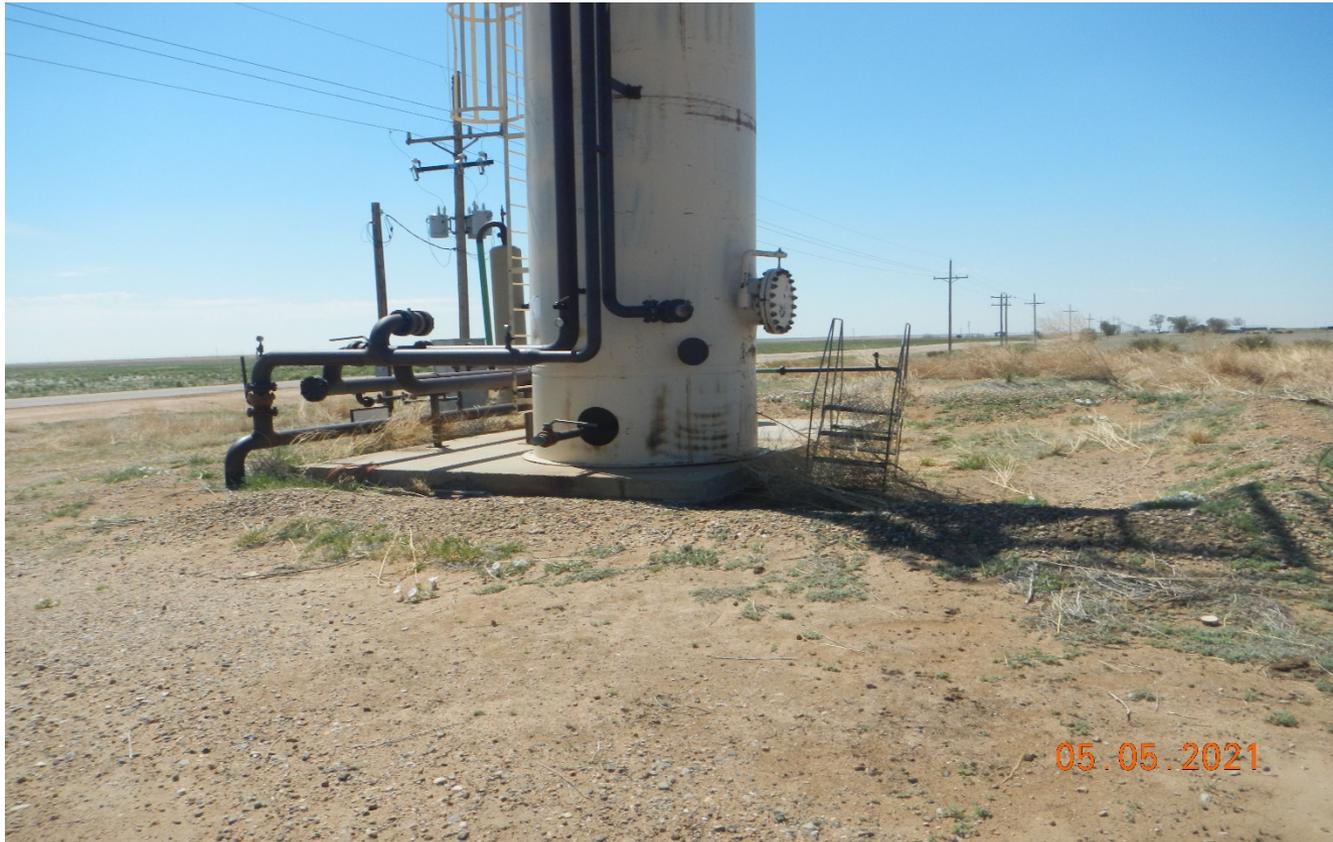
Photo 6. The berm around the tank vessel is inadequate in size and has animal burrows in it. The berm has not been repaired since previous inspection.

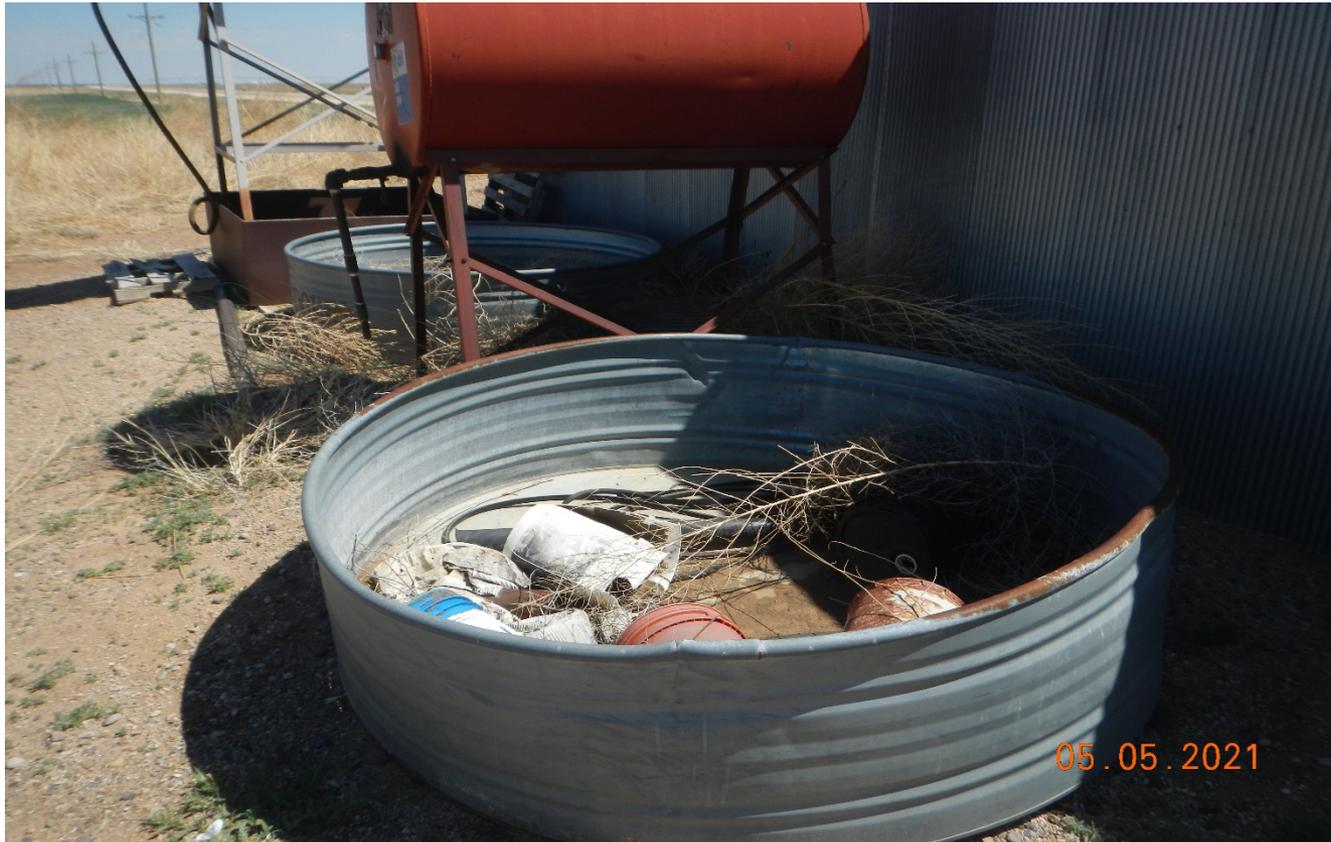
Photo 7. On the backside of the metal panels is unused equipment. There is various supplies and waste stored in the tanks. Unused equipment/supplies has not been removed. Previous corrective action was not performed.

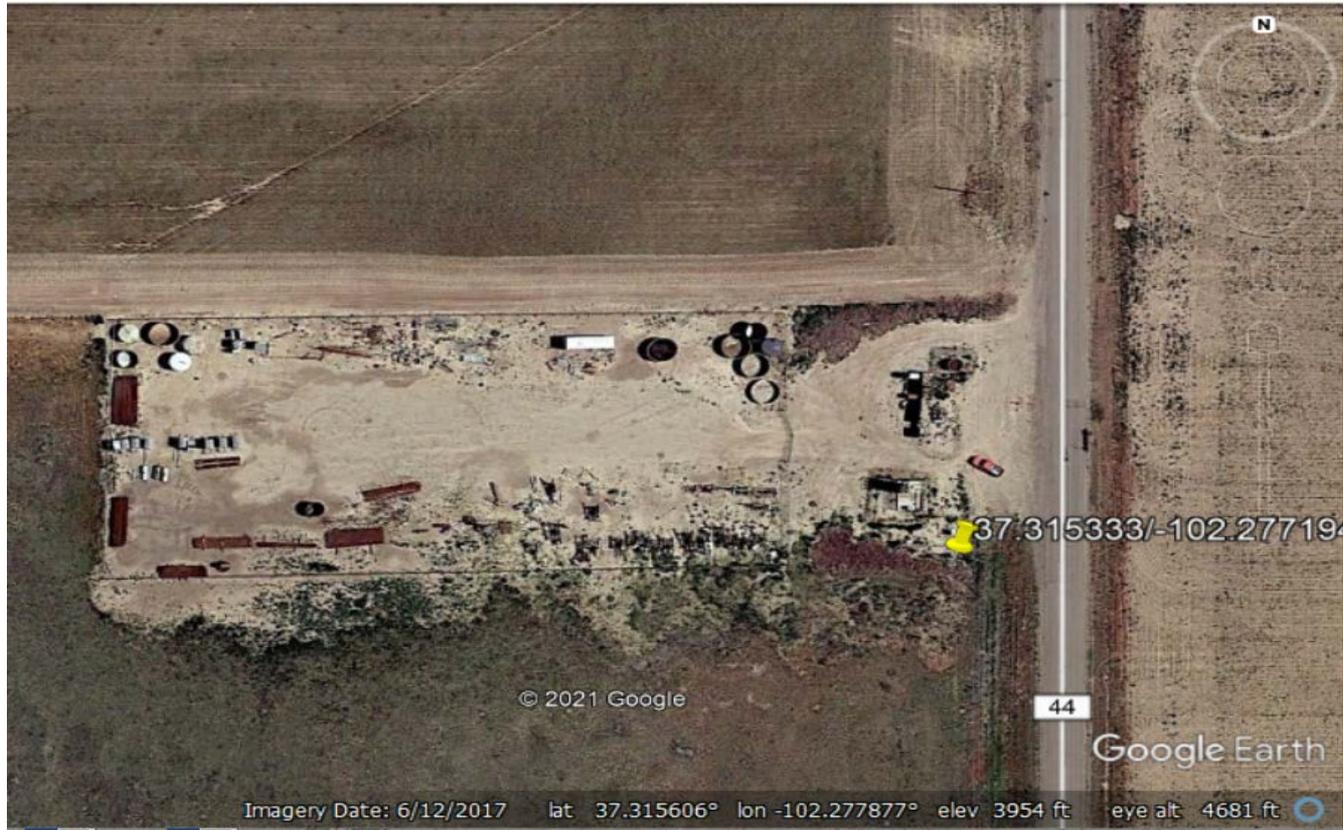
Photo 8. Aerial imagery shows a storage yard behind the compressor facility. The storage yard no longer exists however, the disturbance area needs to be reclaimed.

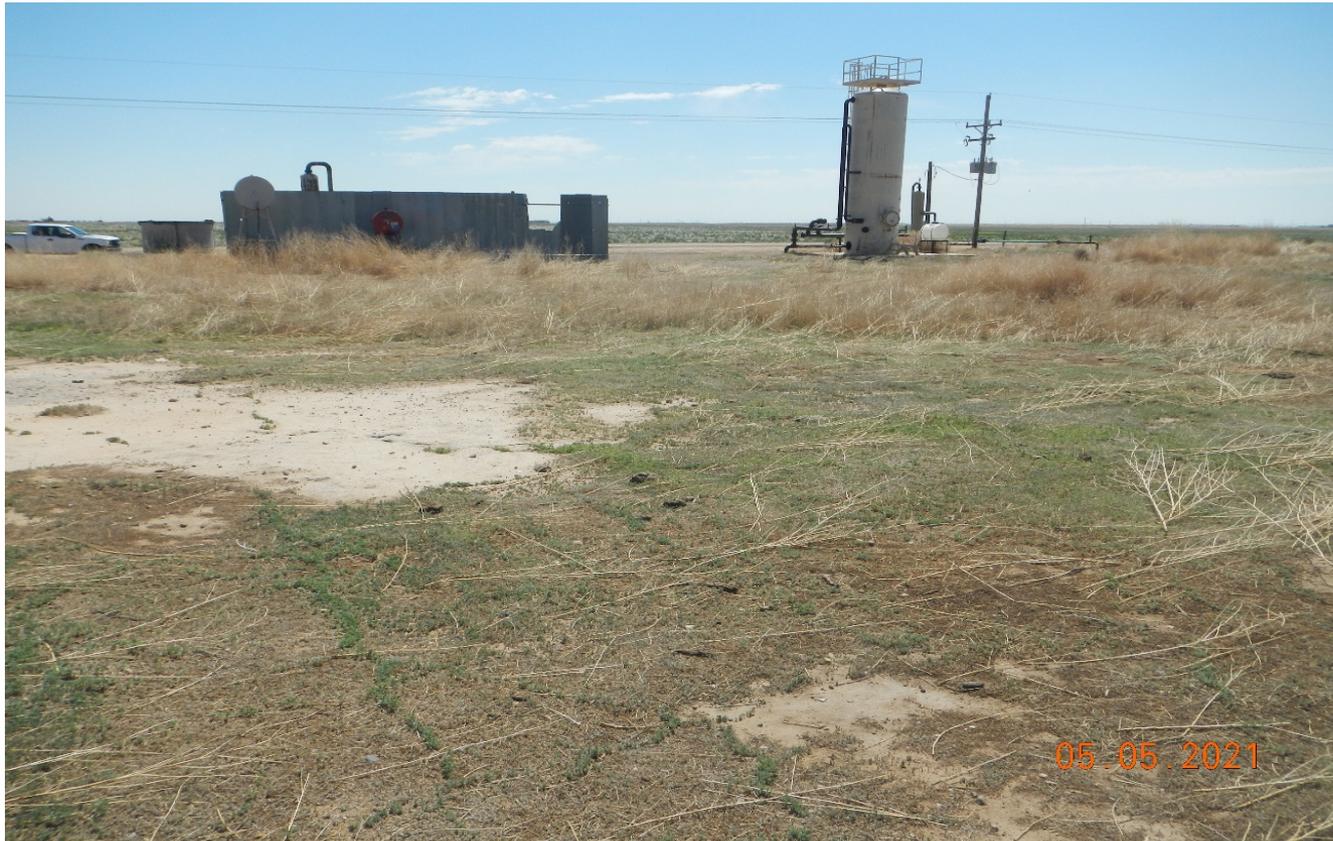
Photo 9. Facing southeast behind the compressor facility. There is undesirable weeds throughout this disturbed area which weeds will need to be controlled and the disturbance area reclaimed.

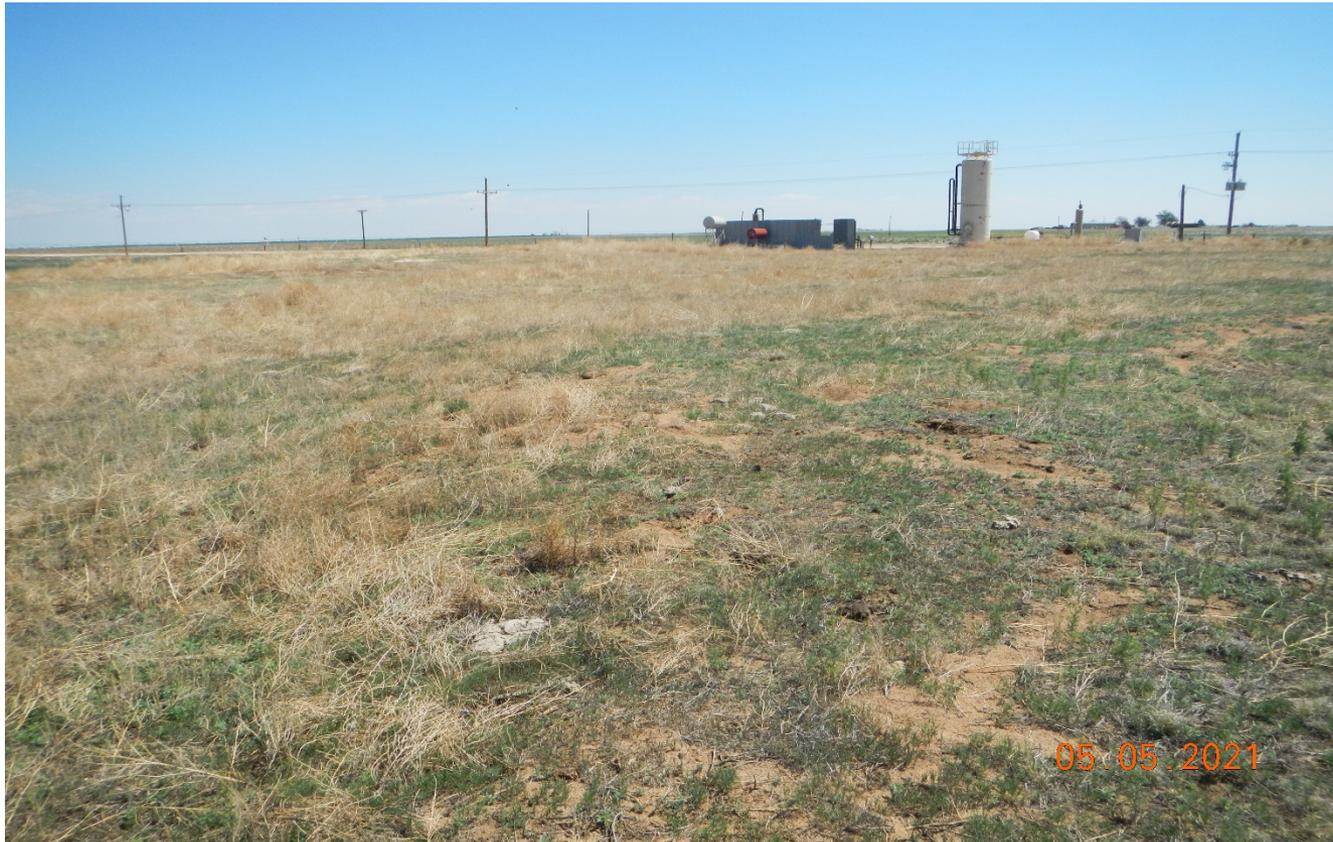
Photo 10. Facing northeast behind the compressor facility. There is undesirable weeds throughout this disturbed area which weeds will need to be controlled and the disturbance area reclaimed.

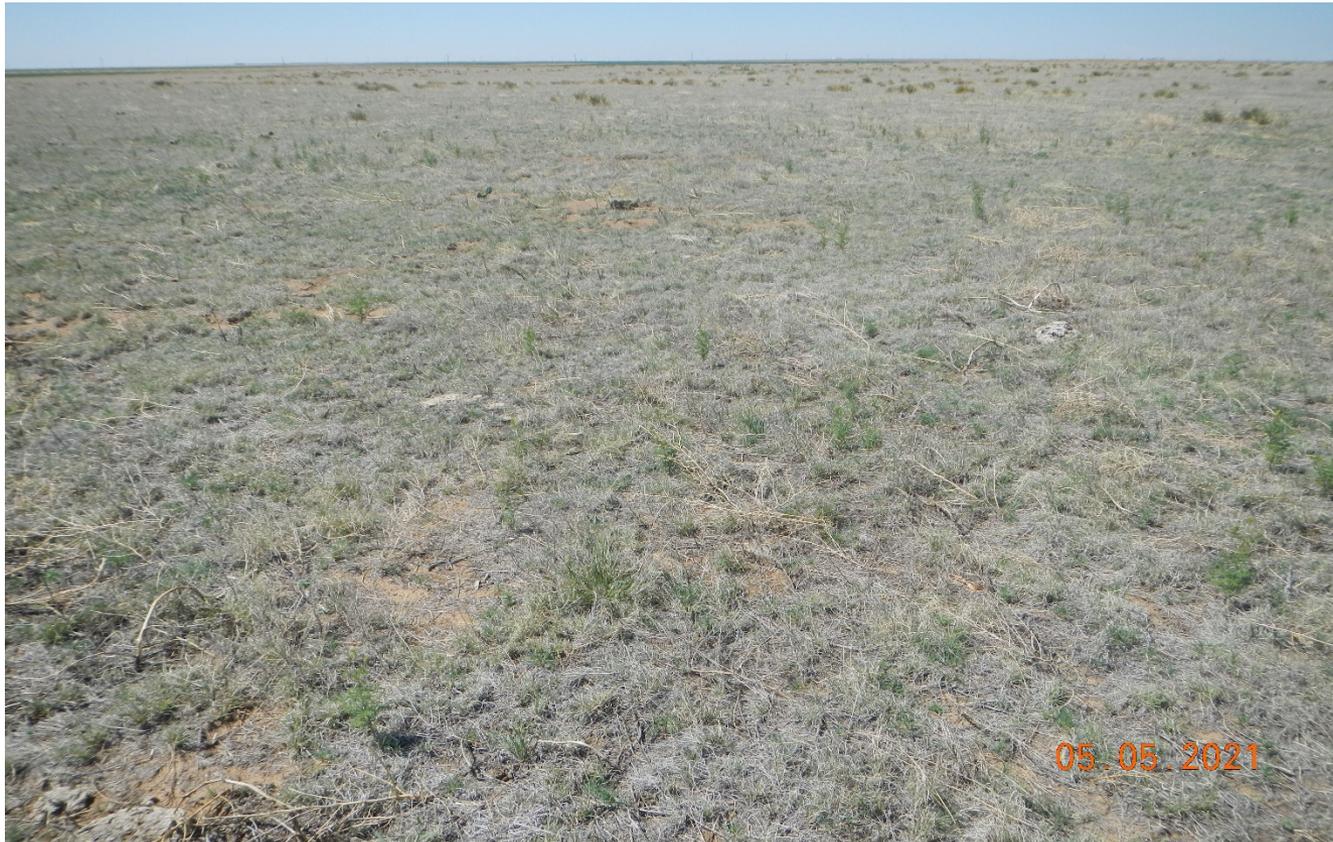
Photo 11. Facing west toward the surrounding undisturbed pasture which consists of desirable native vegetation.
