Inspection Photos

Operator: Beeman Oil and Gas
API: 067-09363
Date: 5/5/2021

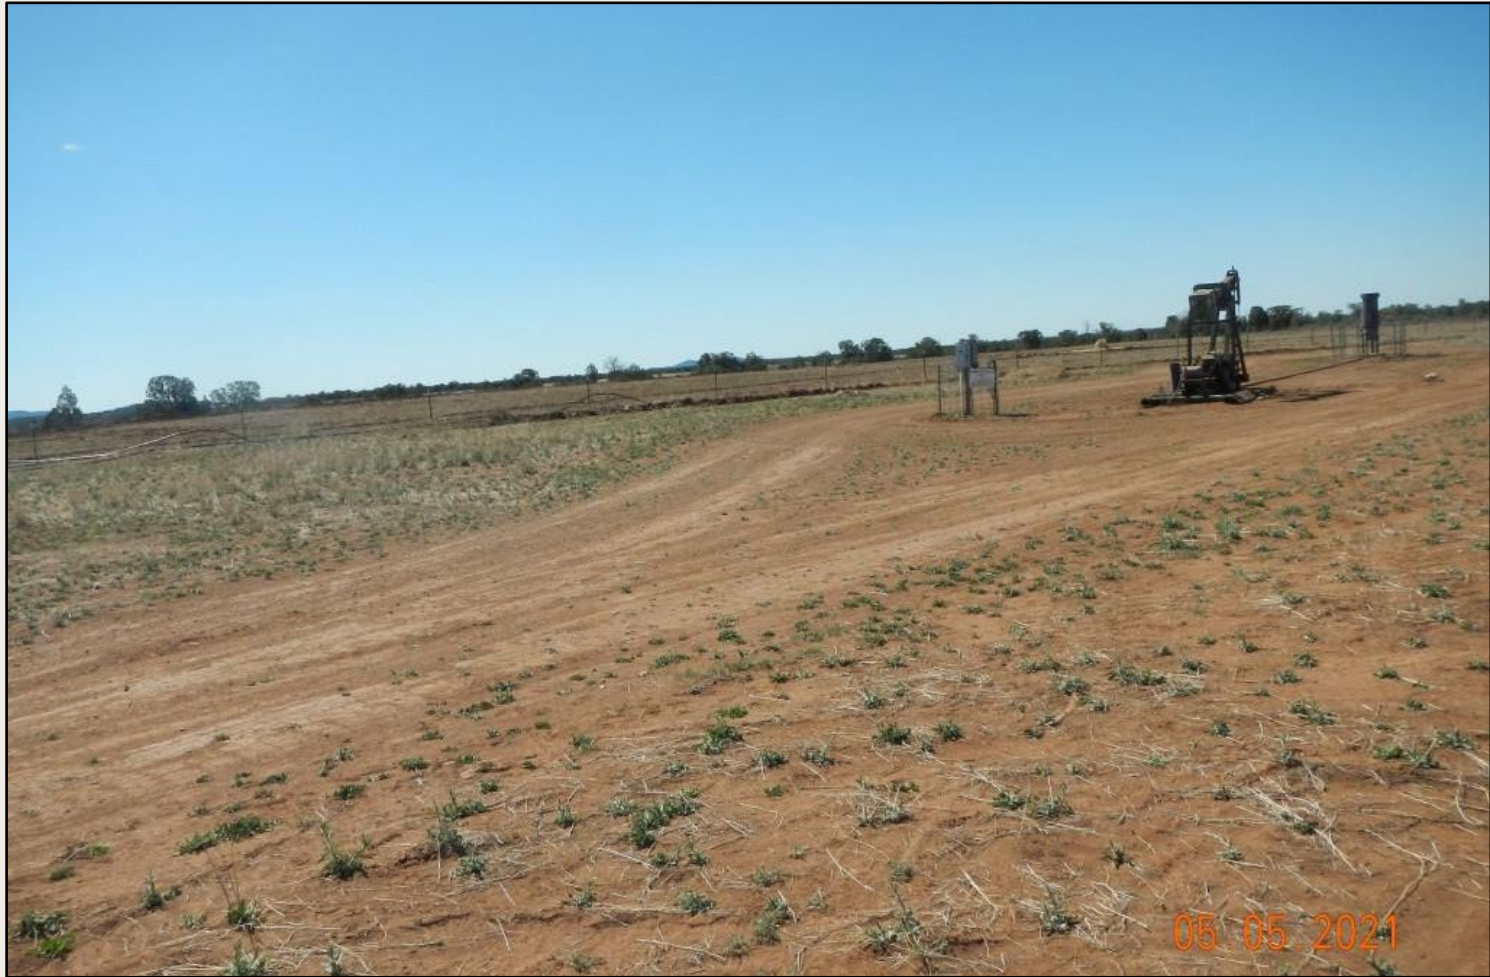
Photo 1. View of the project area from the northwestern corner facing center.

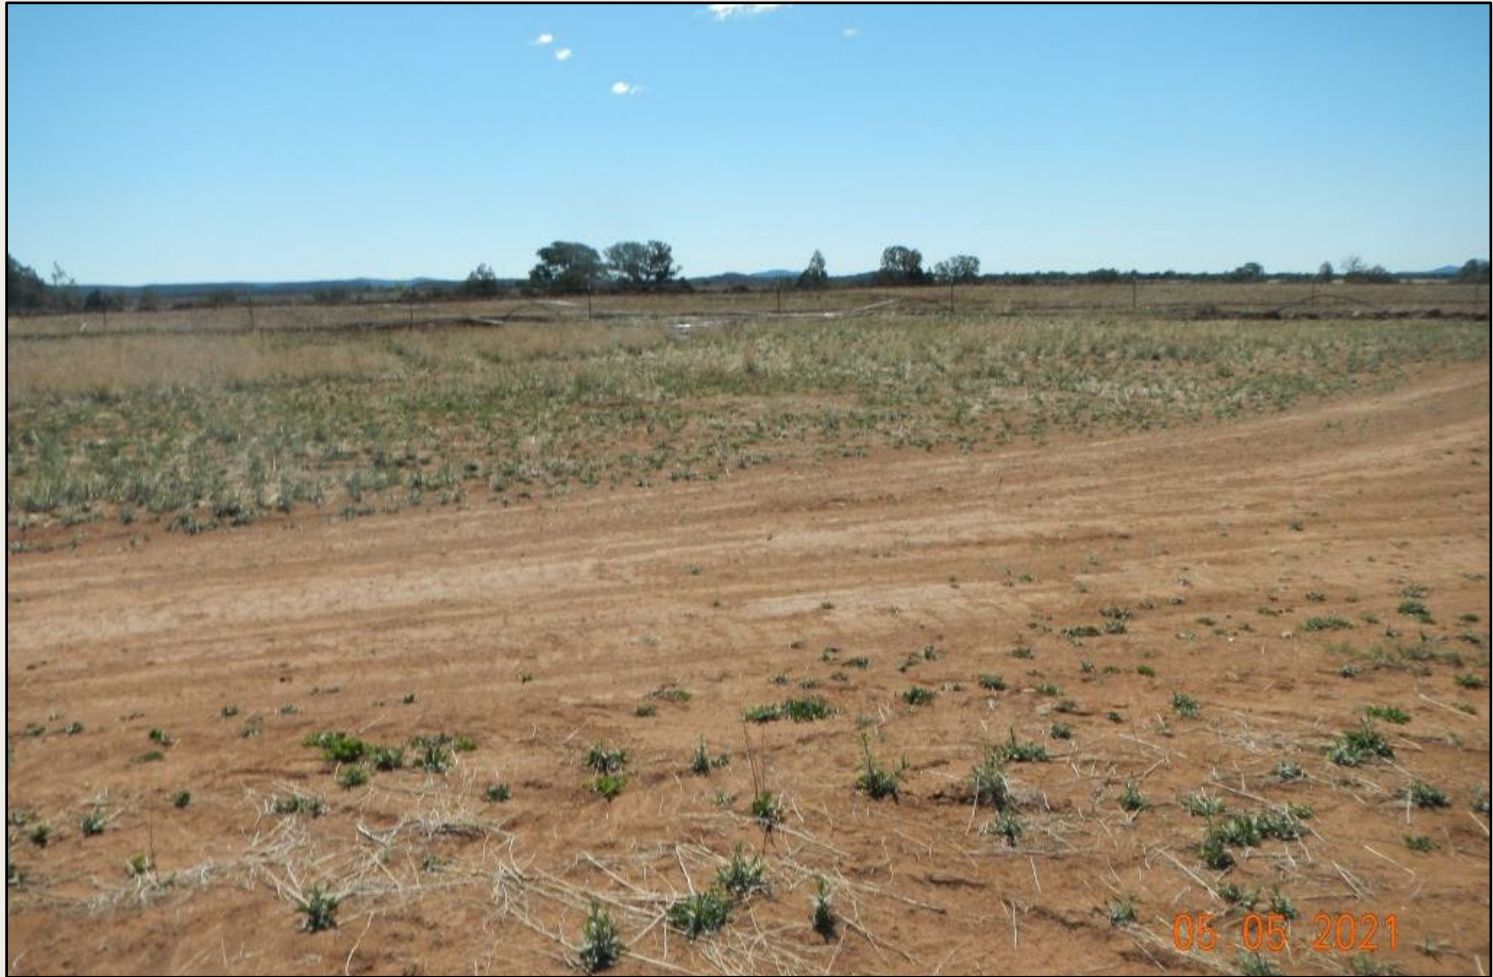
Photo 2. View of the northern project area facing eastward from the northwestern corner.

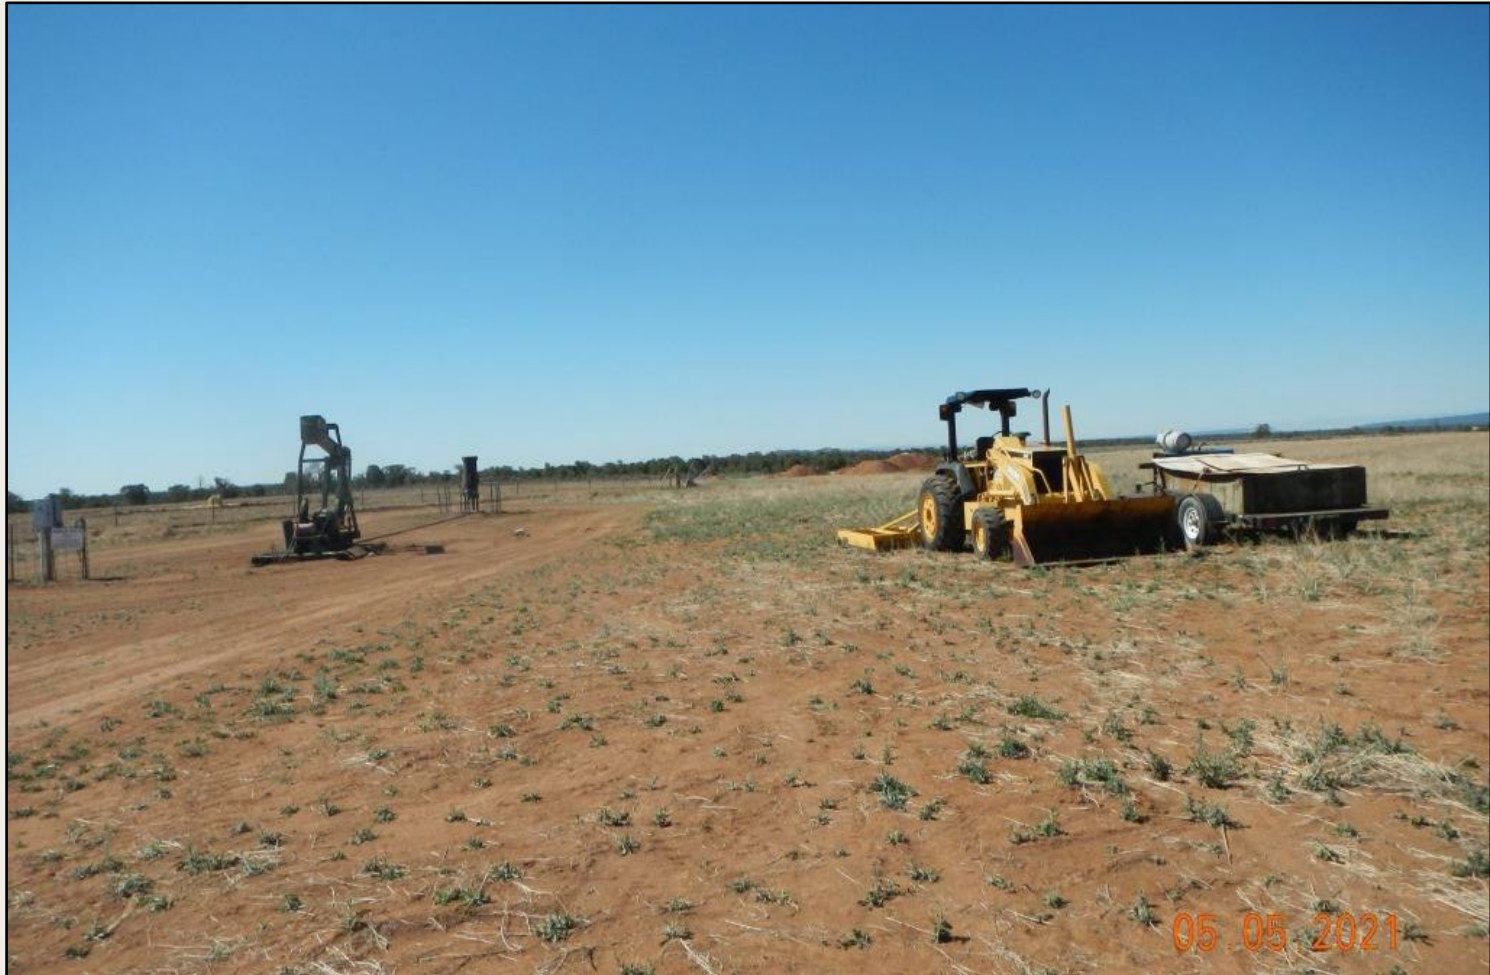
Photo 3. View of the western project area from the northwestern corner facing southward. Vegetation is largely continuous with surrounding field, and comprised of scattered grasses (not identifiable at this time), field bindweed, and Russian knapweed. Unused equipment needs to be removed and properly stored offsite.

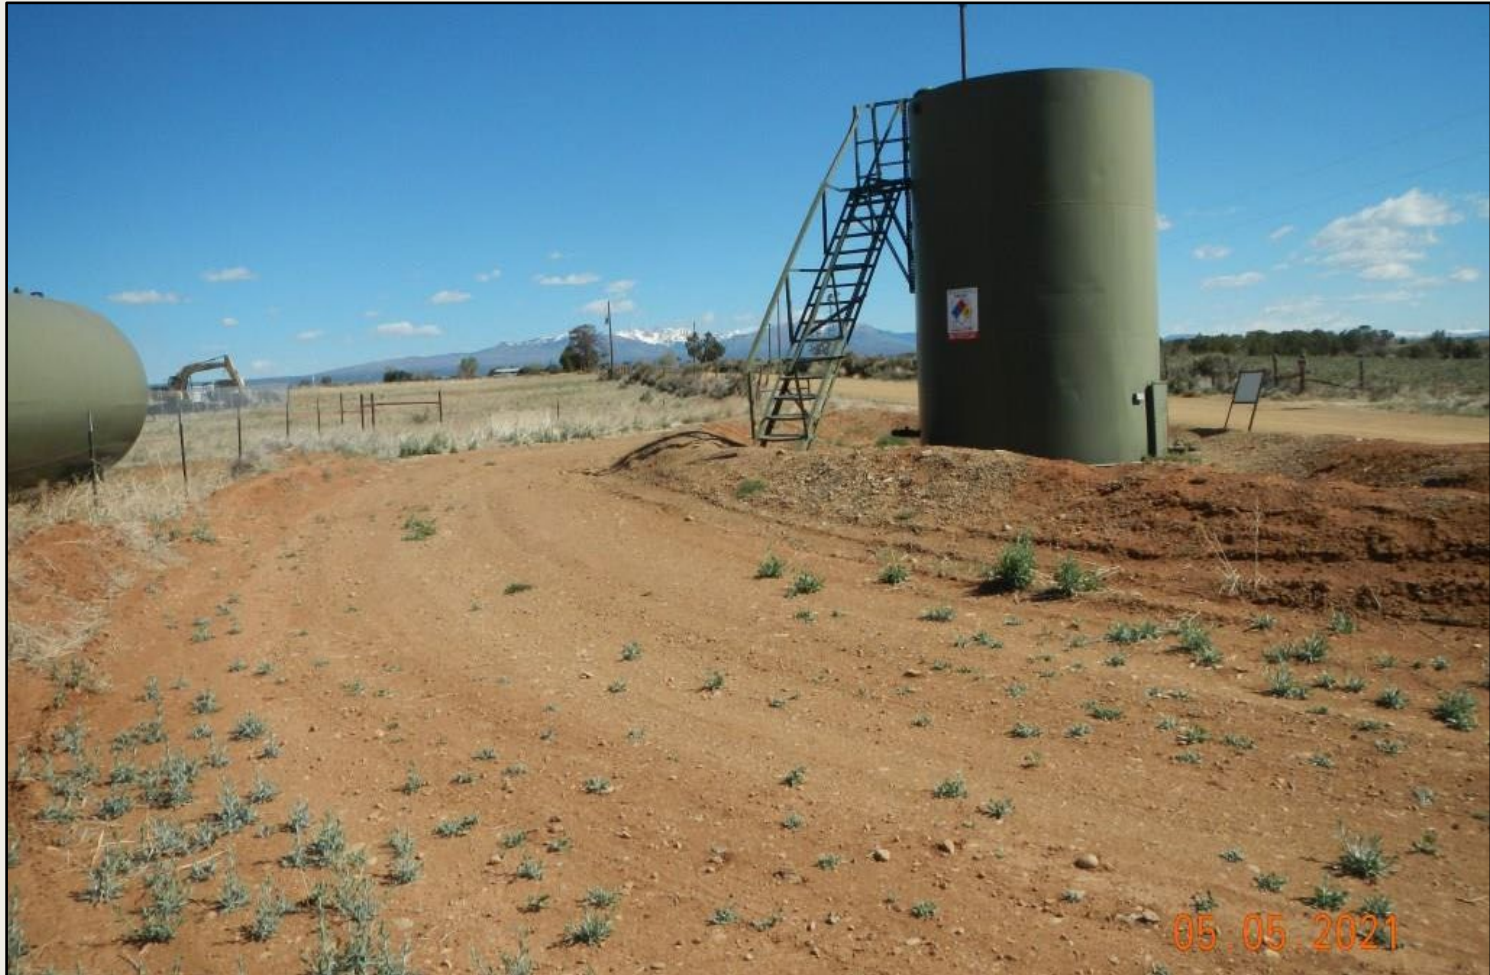
Photo 4. View of tank facilities located east of the well location.

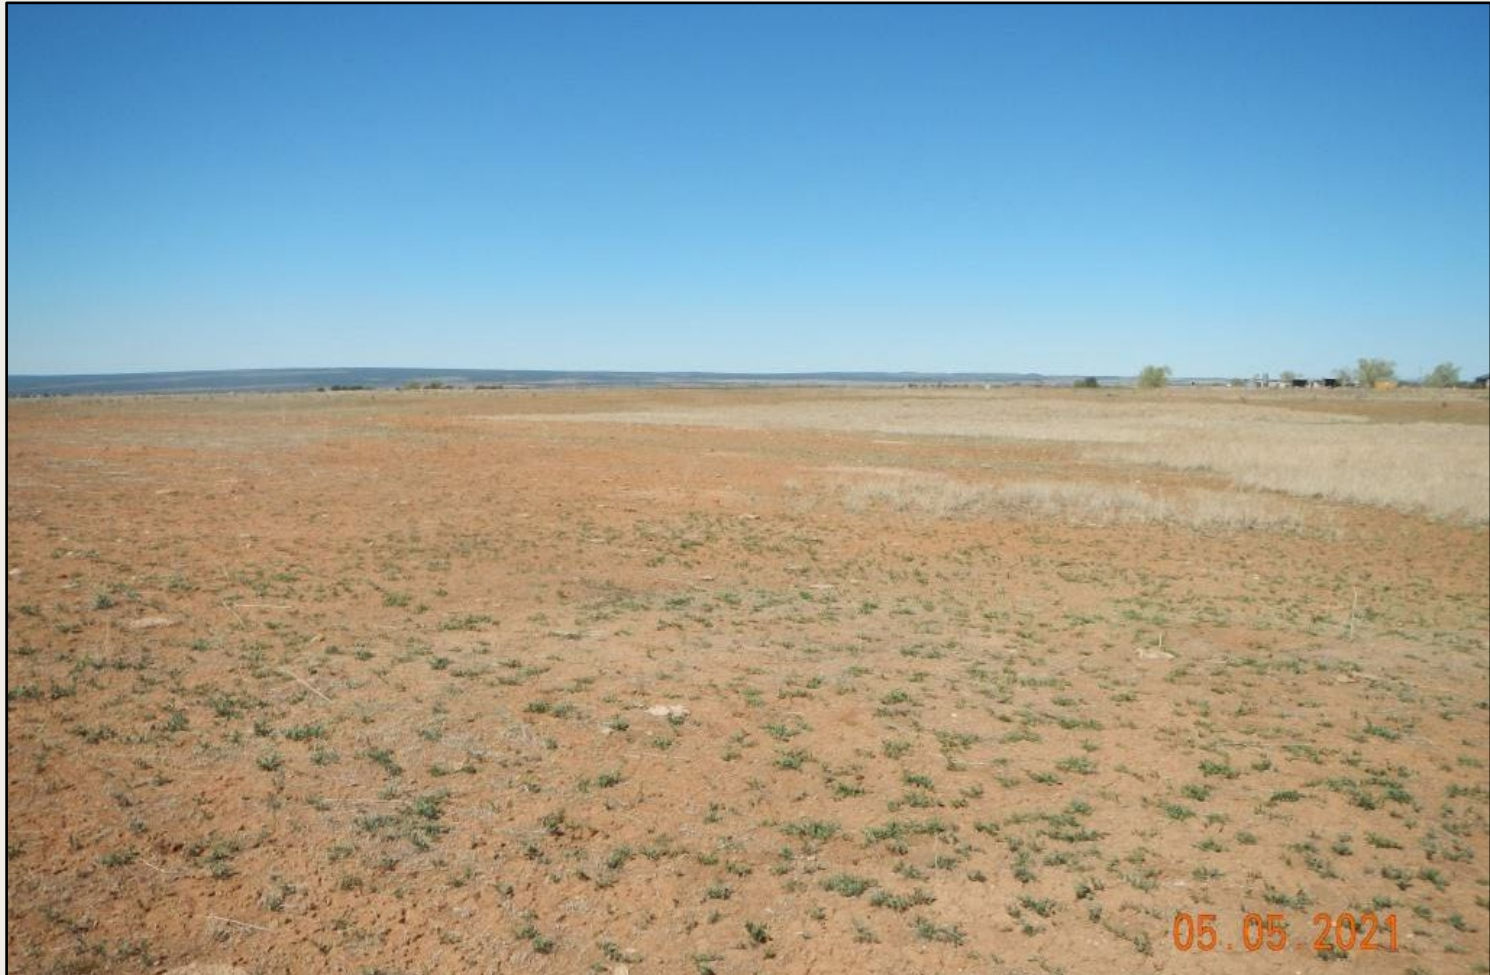
Photo 5. View of reference area comprised of open field, comprised of scattered grasses (not identifiable at this time), field bindweed, and Russian knapweed.
