Inspection Photos
Operator: Williford Res.
API: 067-07253
Date: 5/5/2021

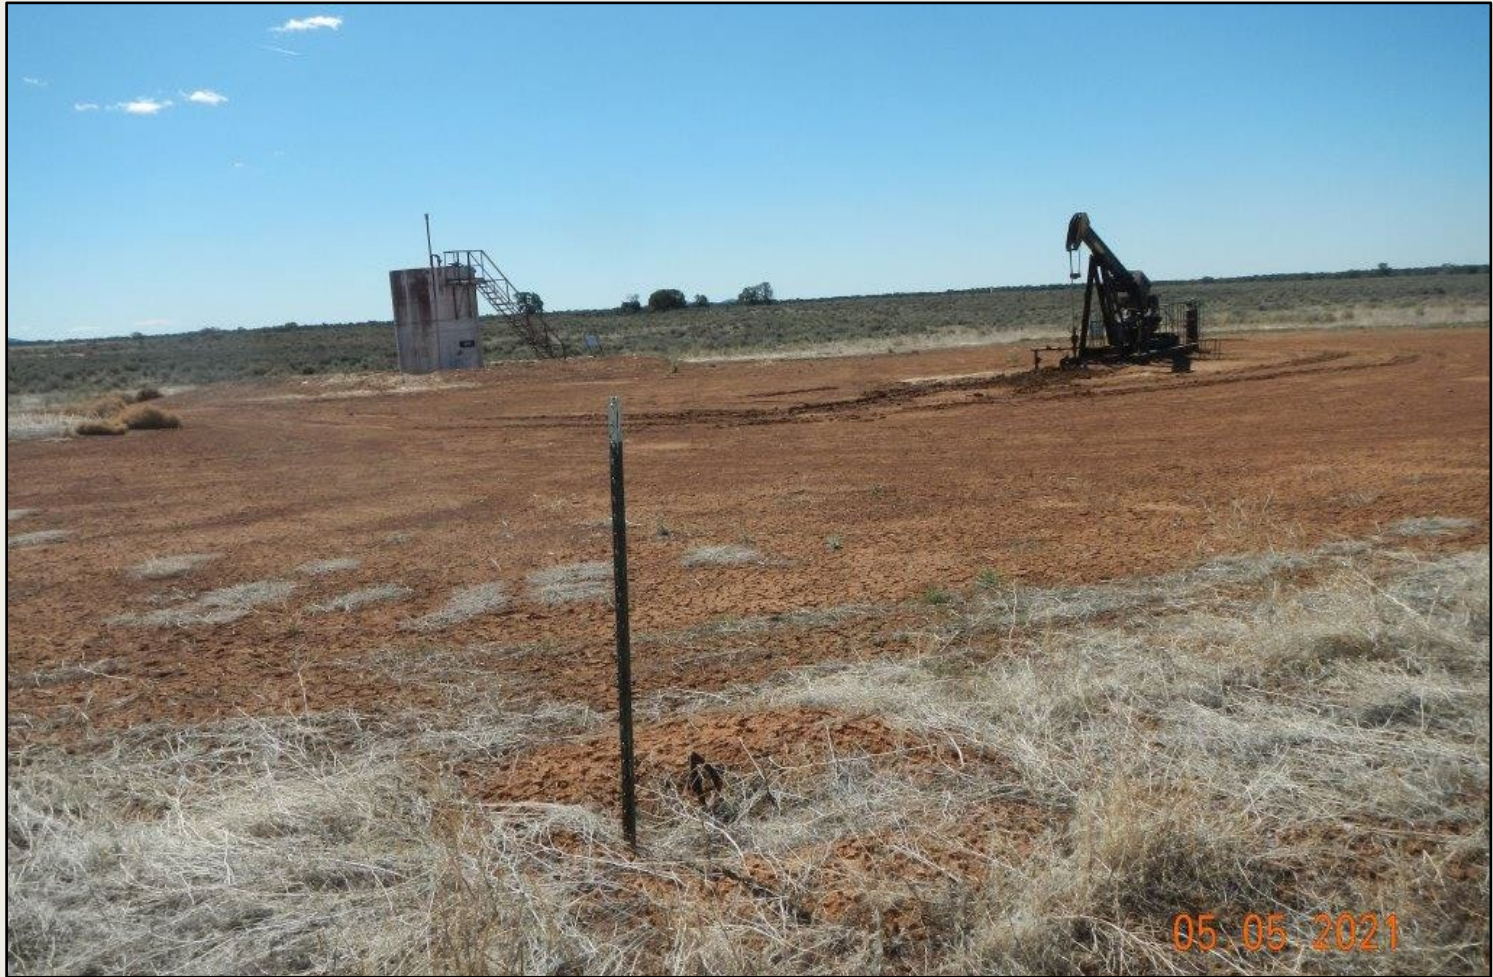
Photo 1. View of the project area from the northwestern corner facing center.

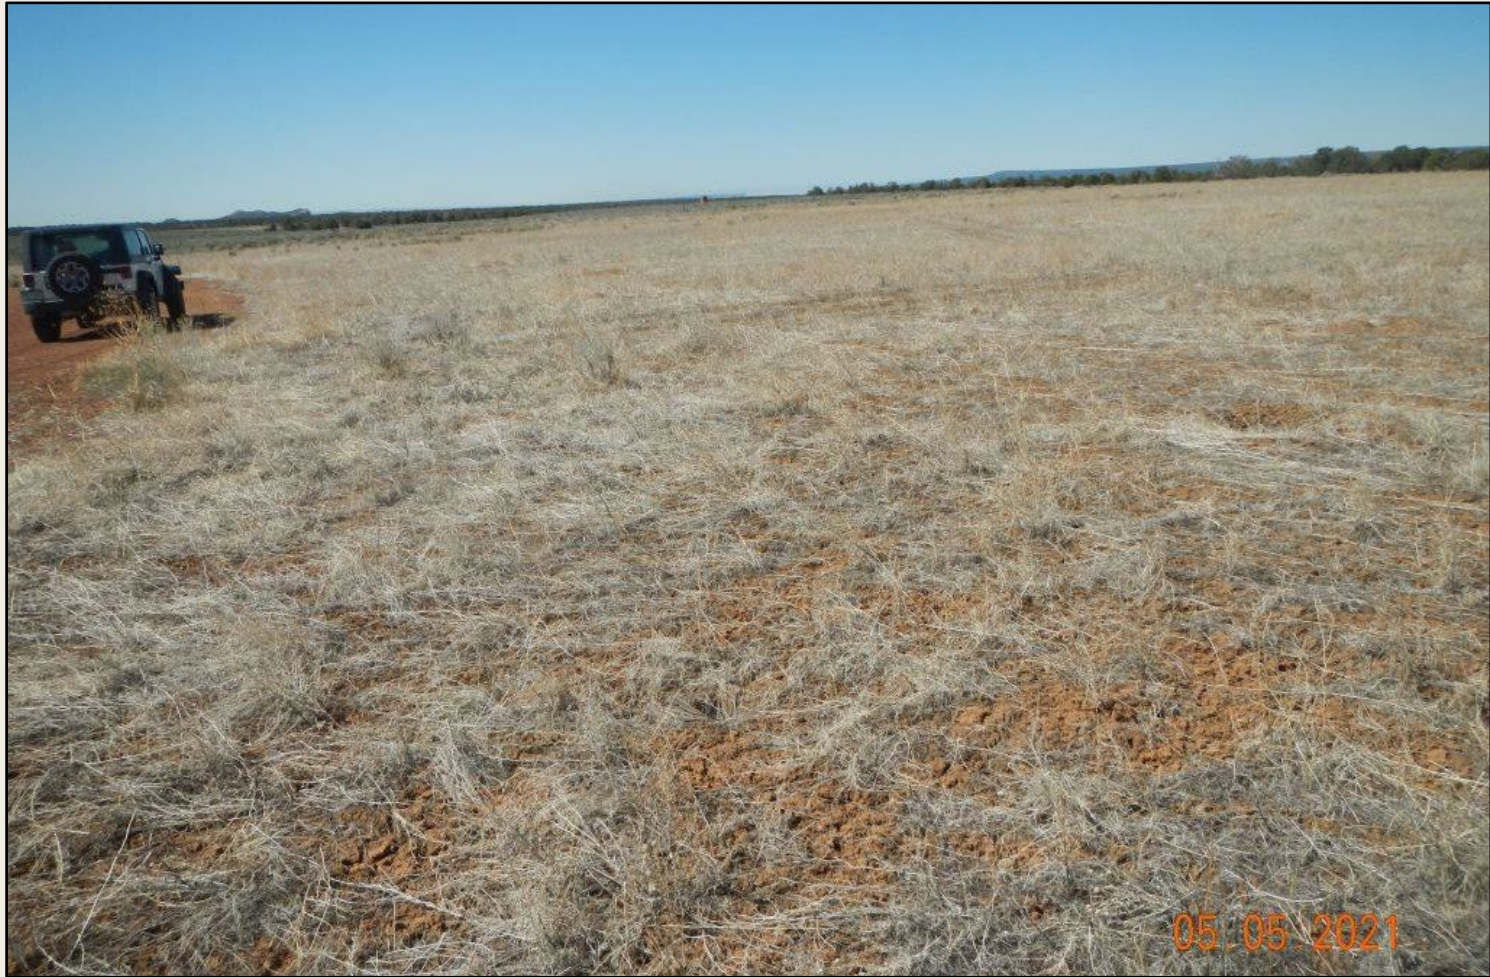
Photo 2. View of the western project area facing southward from the northwestern corner. Vegetation is largely continuous with surrounding field. Grasses such as Indian ricegrass, and dense weeds such as Russian knapweed observed.

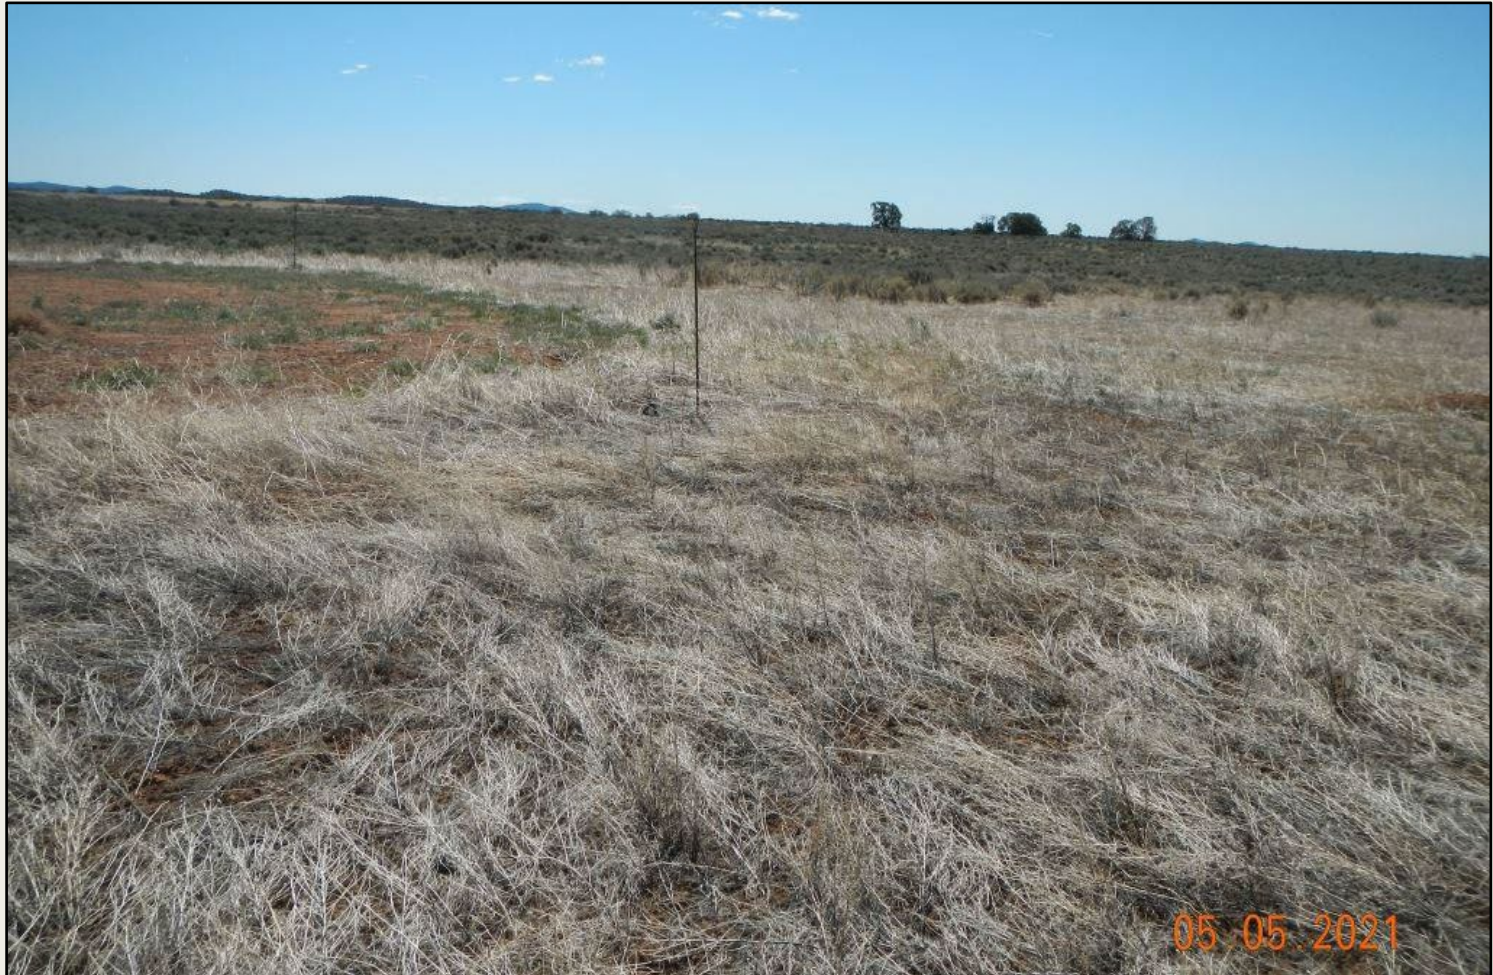
Photo 3. View of the southern project area from the southwestern corner facing eastward.

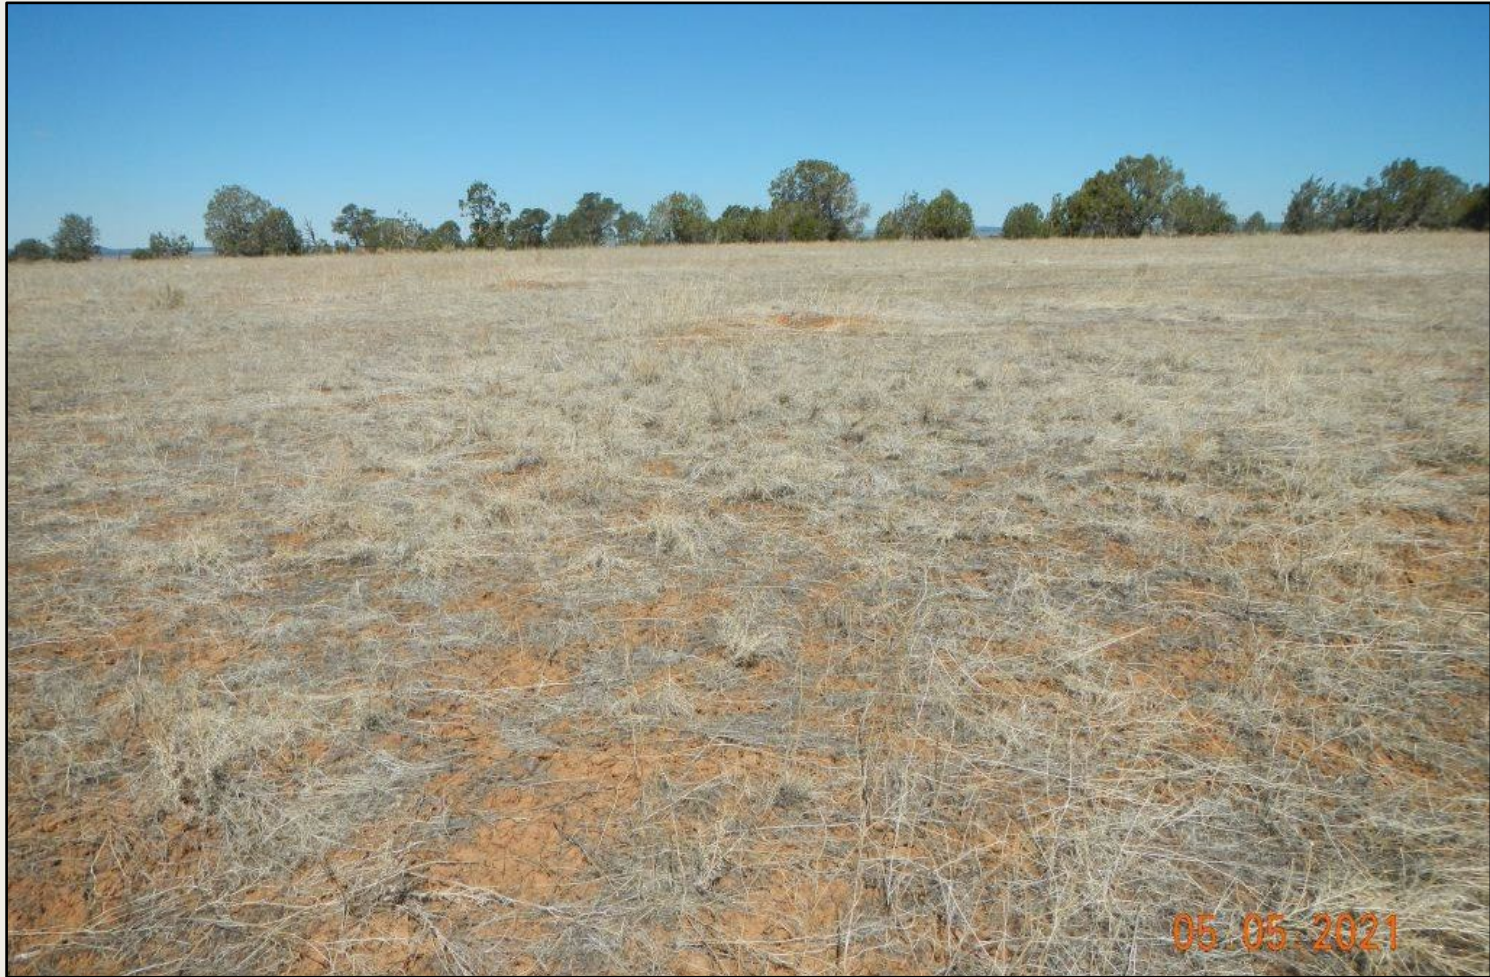
Photo 4. View of reference area comprised of open field, comprised of scattered grasses (not identifiable at this time), field bindweed, and Russian knapweed.
