## Inspection Photos

Location Name: LR J15 595 PAD

Location ID: 335568

Inspection Date: May 6, 2021

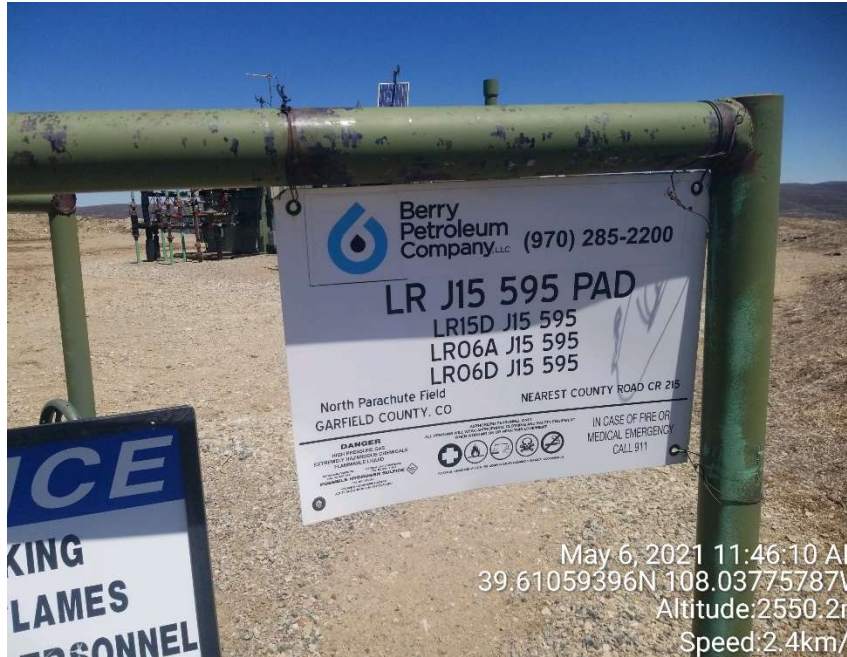
Location sign.

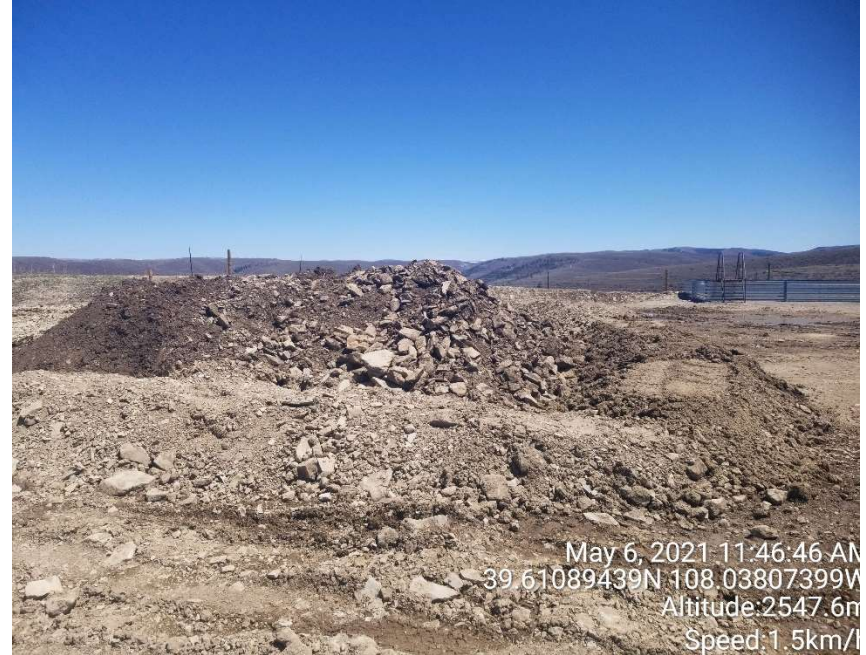
Additional material that was not observed during a September 24, 2020 Inspection (Doc #699700196). Additional material had a detectable hydrocarbon odor and some potential staining was observed.

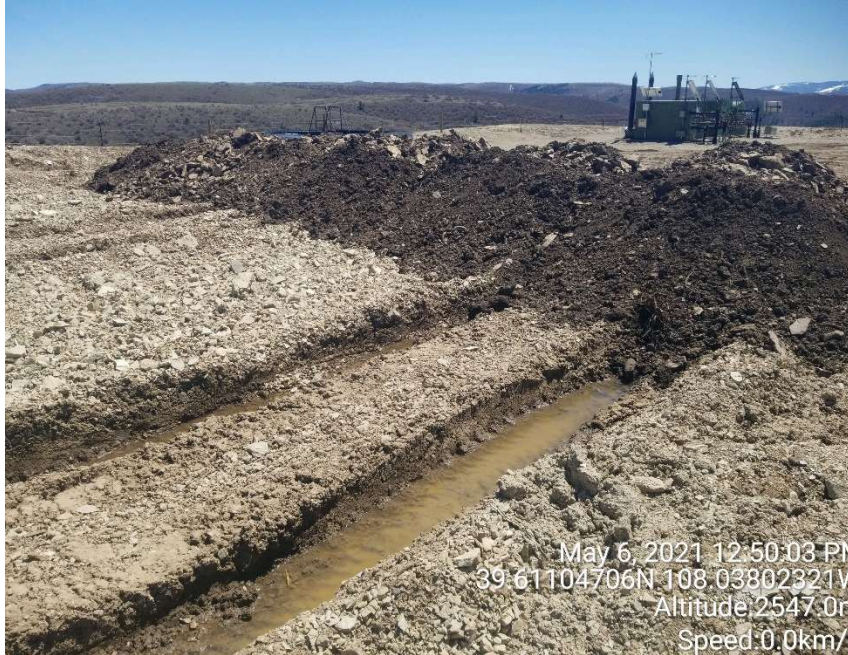
**Additional material that was not observed during a September 24, 2020 Inspection (Doc #699700196). Additional material had a detectable hydrocarbon odor and some potential staining was observed. Note the stormwater accumulations located in vehicle ruts in the landfarm material.**

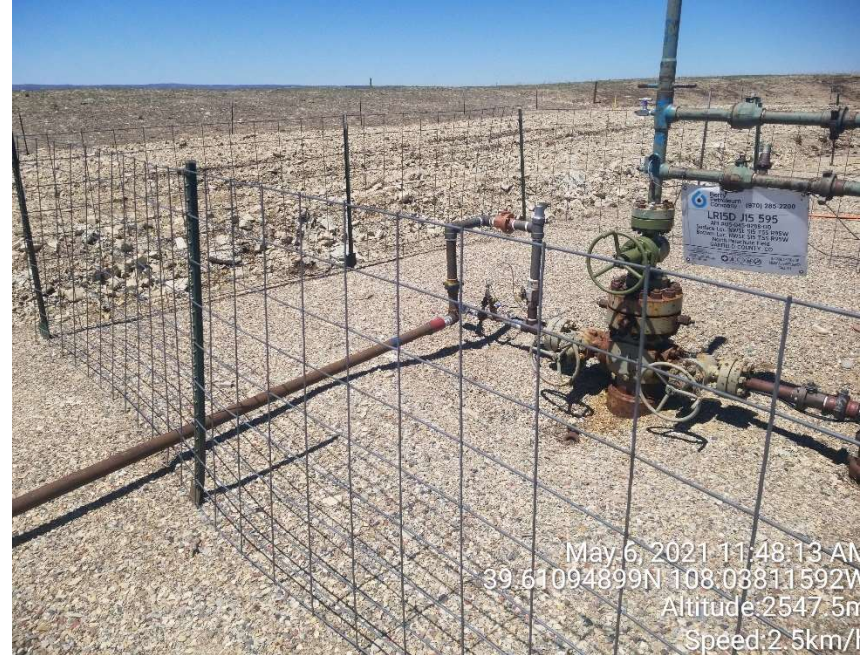
**Steel pipeline leading from well API 05-045-11288 to a structure that is associated with Spill/Release Point ID 474500, Remediation #15535 remediation activities.**

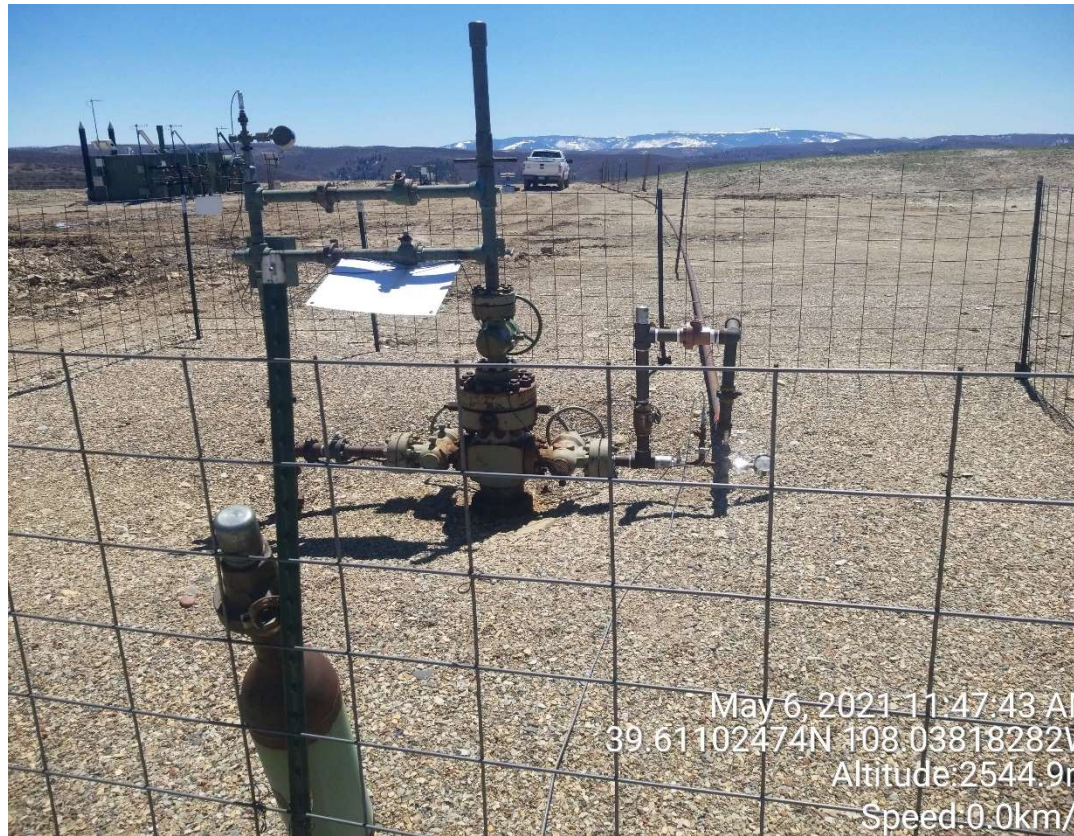
May 6, 2021 11:47:43 AM  
39.61102474N 108.03818282W  
Altitude: 2544.9m  
Speed: 0.0km/h

**Steel pipeline leading from well API 05-045-11288 to a structure that is associated with Spill/Release Point ID 474500, Remediation #15535 remediation activities.**
