# Inspection Photos

Operator: LARAMIE ENERGY LLC - 10433

Location ID: 335090

Garfield County, CO

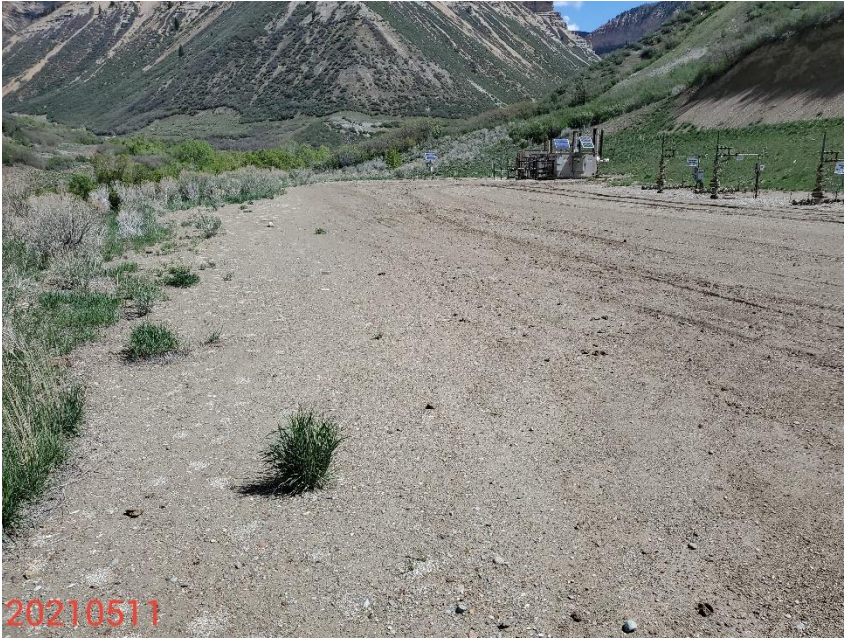
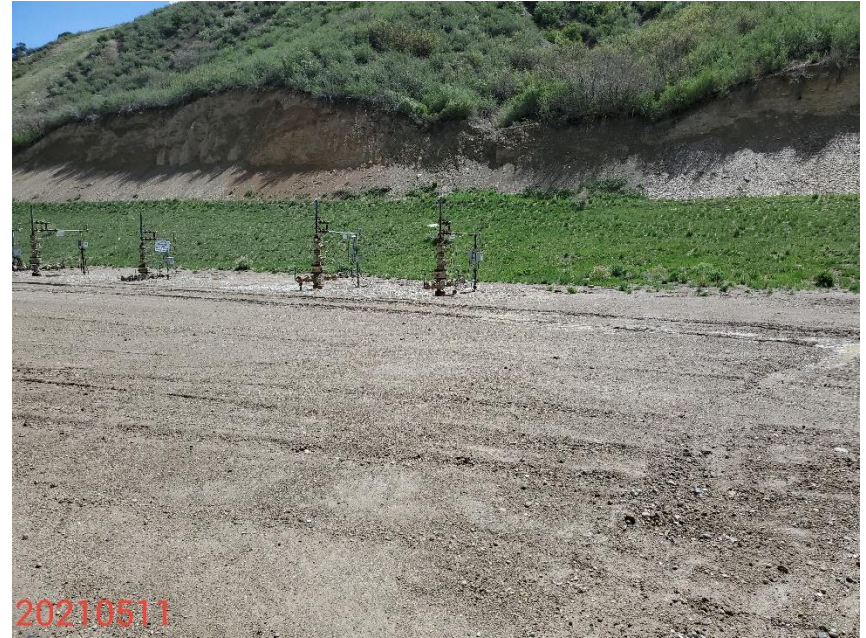
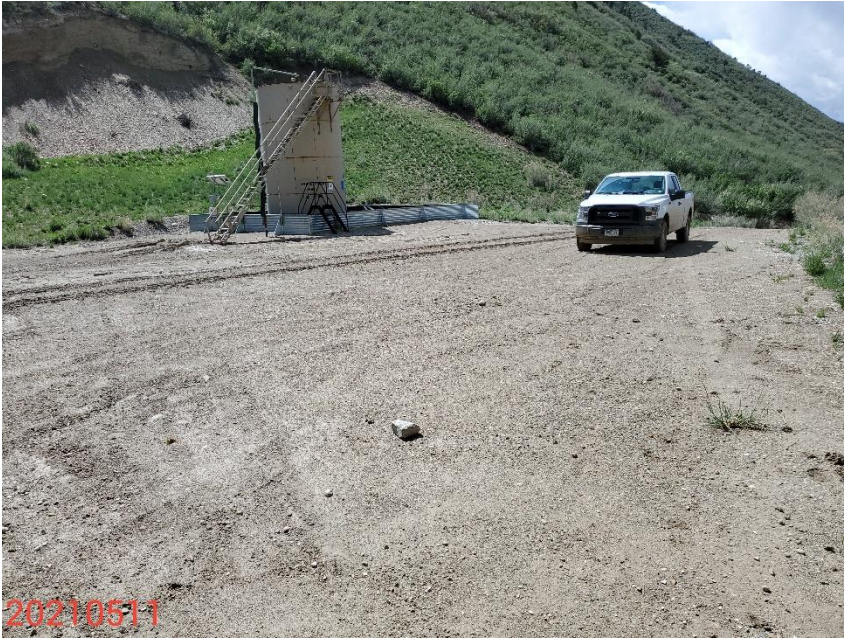
**Photo 1:** Photo taken from the west end of the production area, facing north. Photos 1-3 provide an overview of the Location from north, east to south.

**Photo 2:** See comments under photo 1.

**Photo 3:** See comments under photo 1.

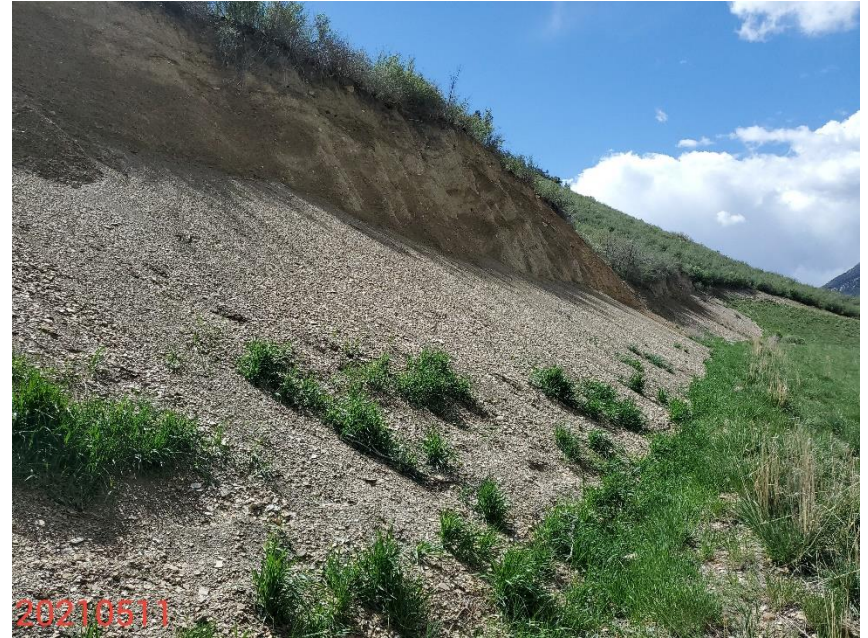
**Photo 4:** Photo taken from the cut slopes on the west end of the Location. Slopes have not revegetated; BMPs to provide long term protection and stabilization are missing or insufficient.

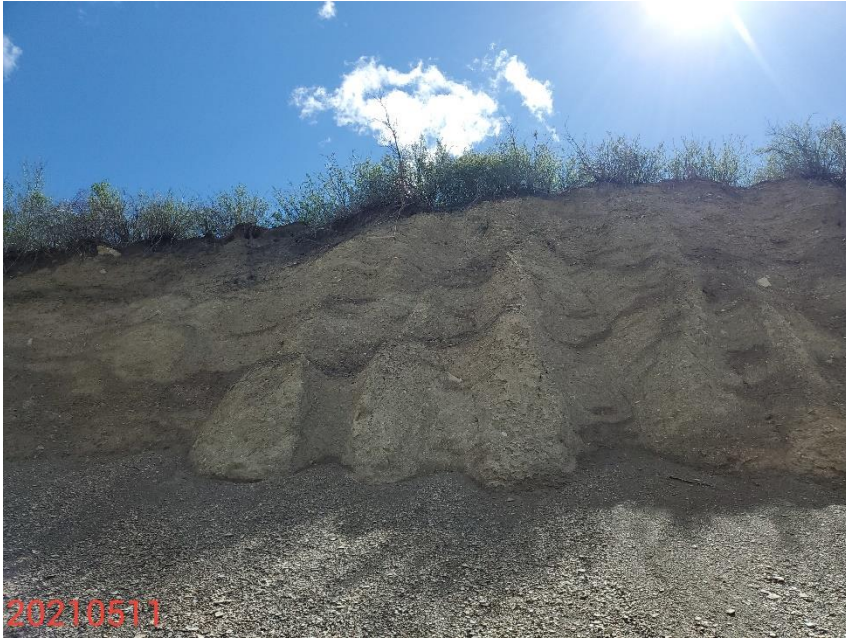
**Photo 5:** Photo taken from the cut slopes on the west end of the Location. BMPs to provide long term protection and stabilization are missing or insufficient.

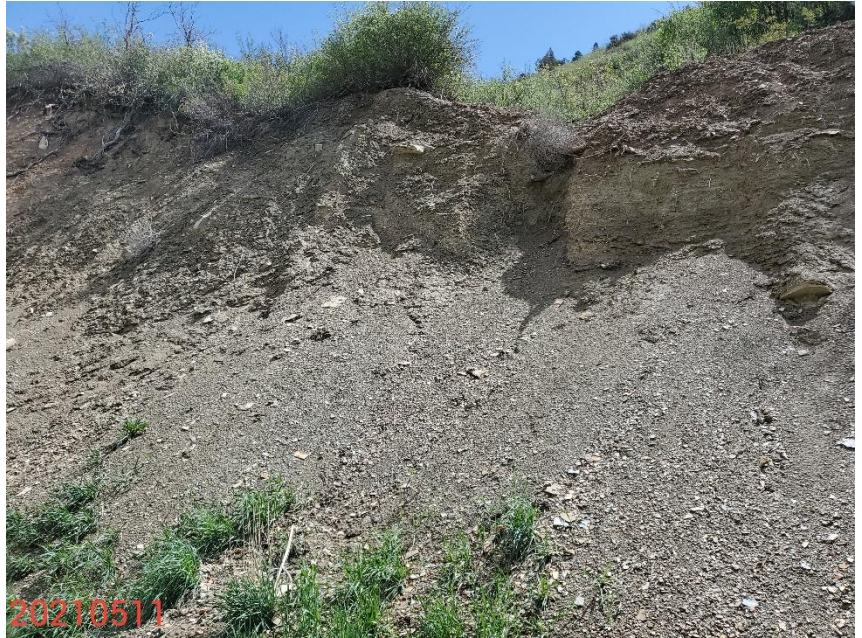
**Photo 6:** Photo taken from the cut slopes on the west end of the Location. BMPs to provide long term protection and stabilization are missing or insufficient.

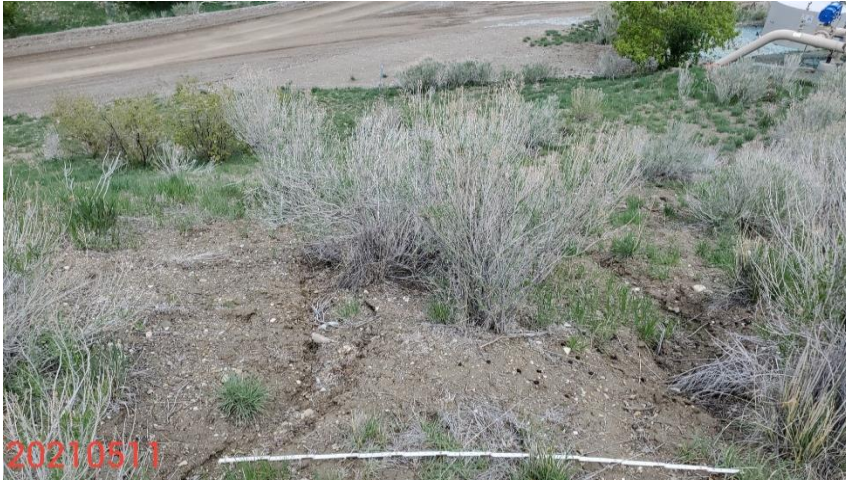
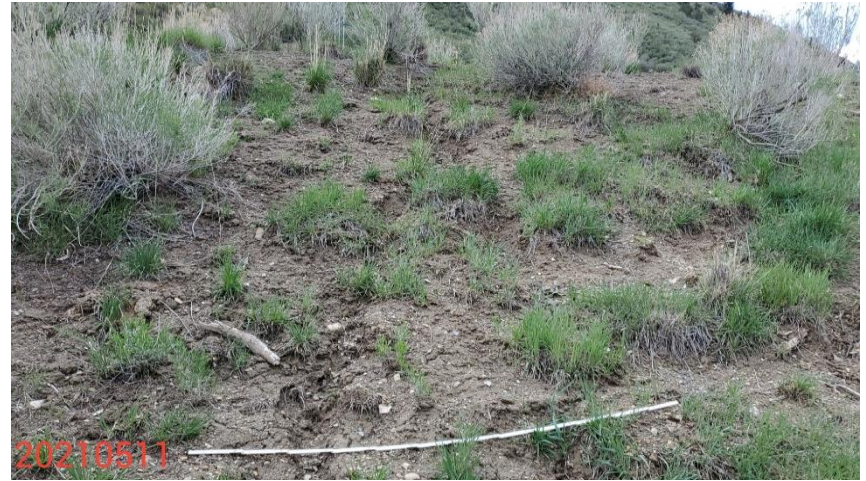
**Photo 7:** Photo taken from the slopes on the northwest end of the Location. Areas of stormwater rilling and degradation observed in these areas. 6 foot measuring stick for reference.

**Photo 8:** See comments under photo 7.

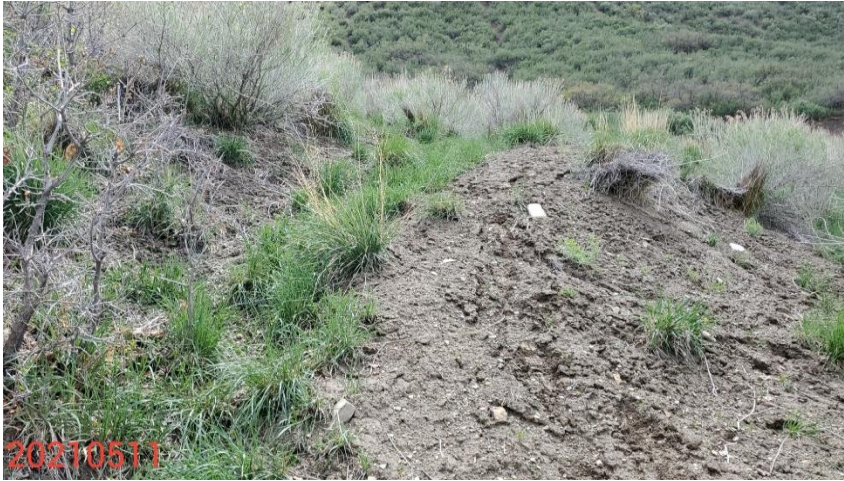
**Photo 9:** Photo taken from the stormwater ditch/berm on the northwest end of the Location. Photo shows areas where erosion was observed on the berm.

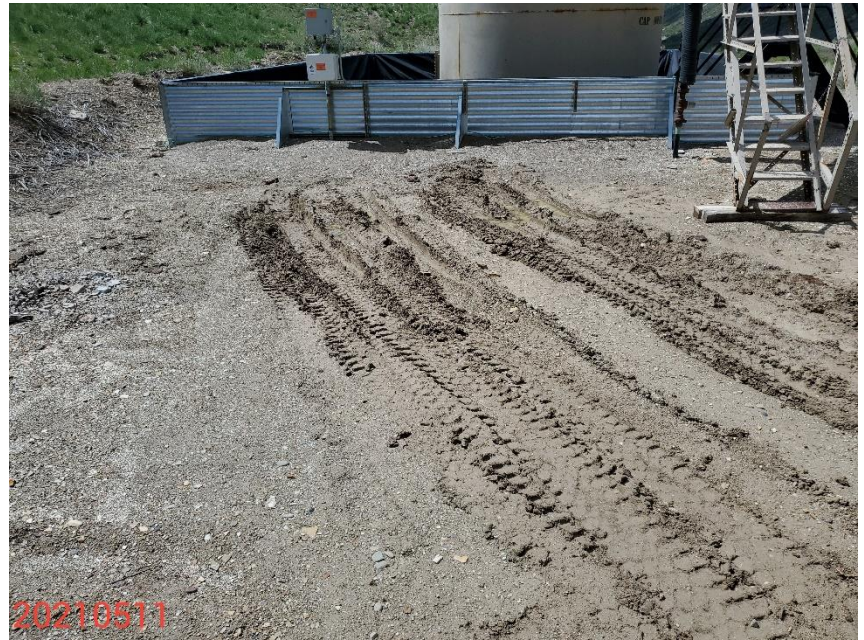
**Photo 10:** Photo taken from the tank battery. Photo shows control measures to stabilize the production area are missing or insufficient.

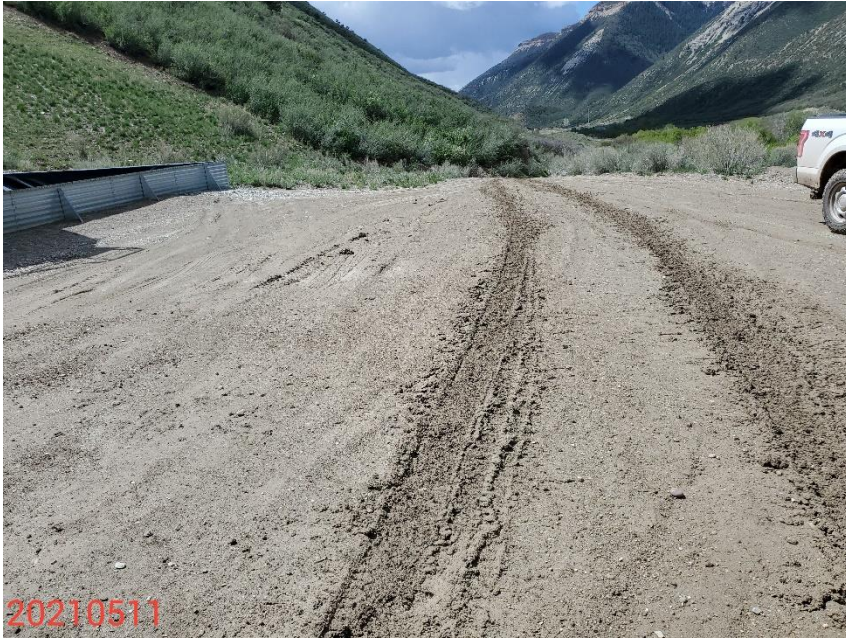
**Photo 11:** Photo taken from the southwest end of the Location, facing south. Photo shows control measures to stabilize the production area are missing or insufficient.

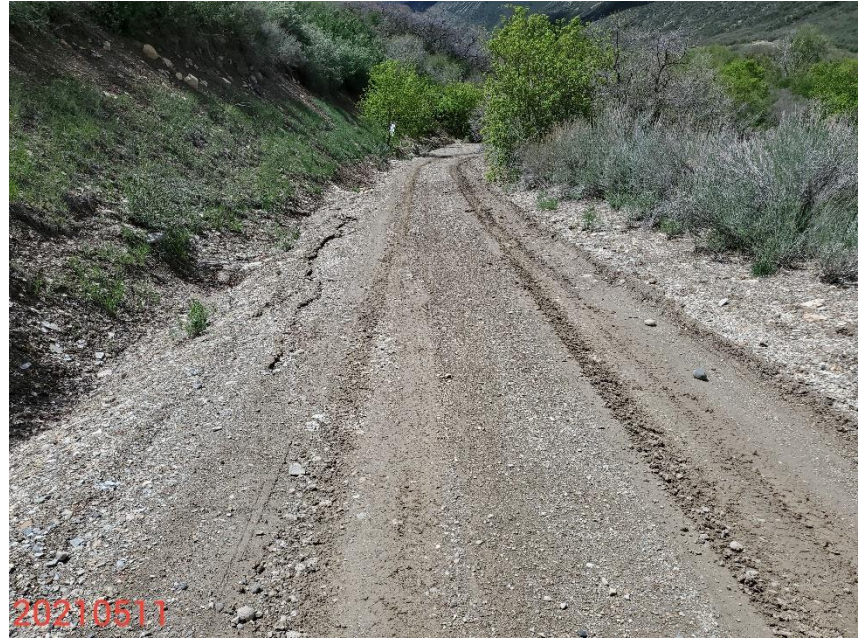
**Photo 12:** Photo taken from the access road, facing south. Photo shows example of erosion degradation observed on access road.

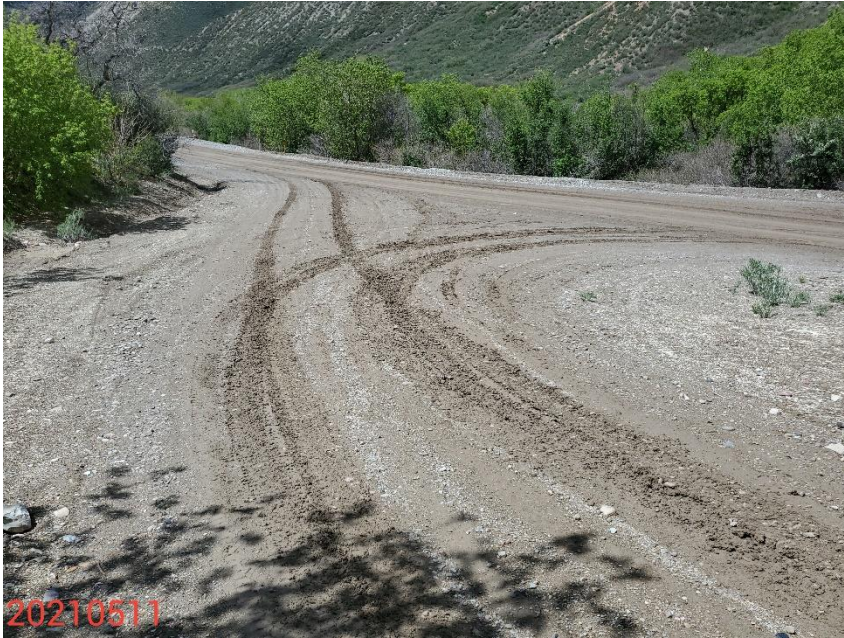
**Photo 13:** Photo taken from the access road entrances, facing southwest. Photo shows BMPs to stabilize production areas/access road and to prevent off-location sediment transport during wet conditions are missing or insufficient
