Inspection Photos

5/11/2021

Operator: TEP ROCKY MOUNTAIN LLC #96850

Location ID: 324441

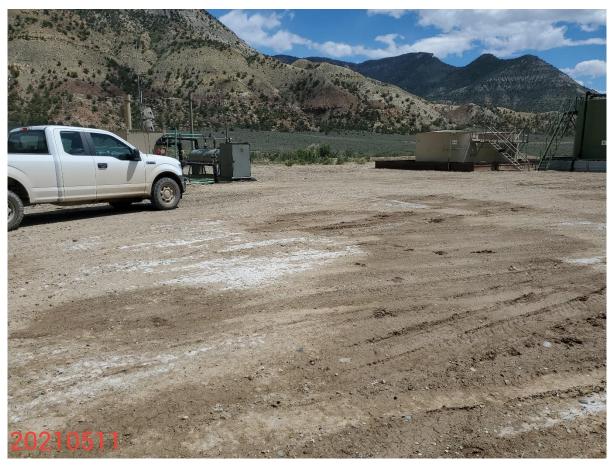
Photo 1: Photo taken from the north end of the Location, facing east. Photos 1-3 provide an overview of the Location from east, south to southwest

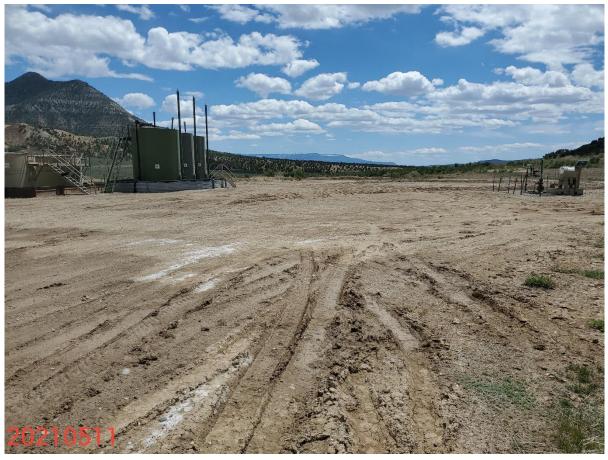
Photo 2: See comments under photo 1.

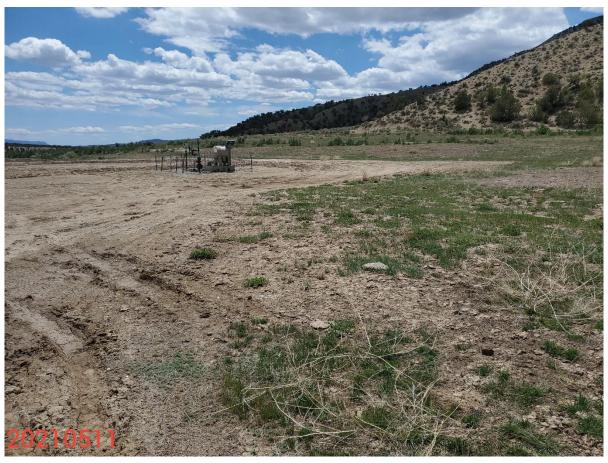
Photo 3: See comments under photo 1.

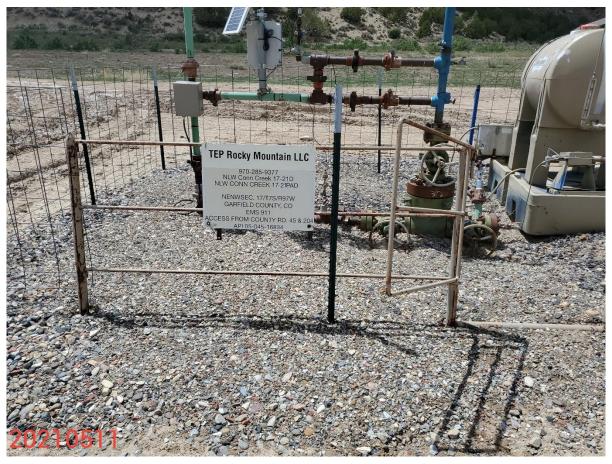
Photo 4: Photo of wellhead

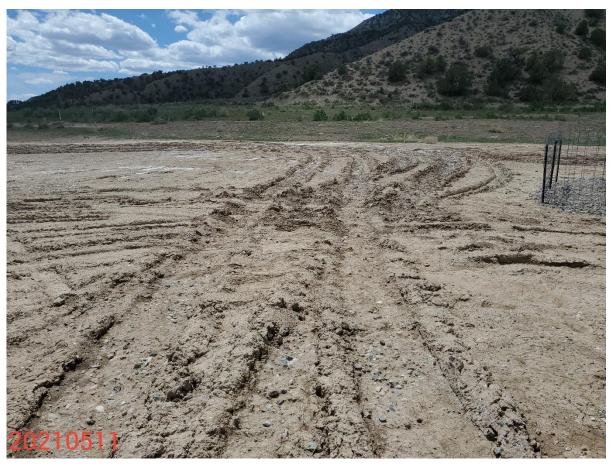
Photo 5 Photos 5-8 taken from the production area. Photos show control measures to stabilize and protect unpaved areas of the Location are missing or insufficient.

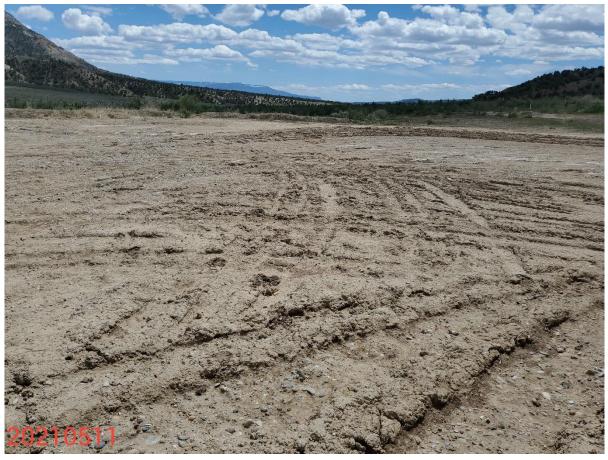
Photo 6: See comments under photo 5.

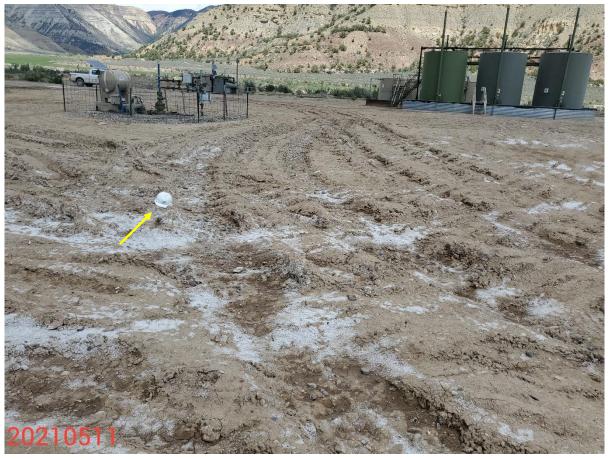
Photo 7: See comments under photo 5. Hard-hat for reference.

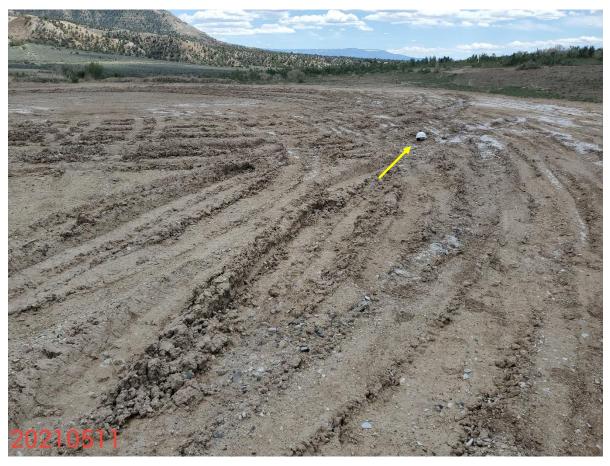
Photo 8: See comments under photo 5. Hard-hat for reference.

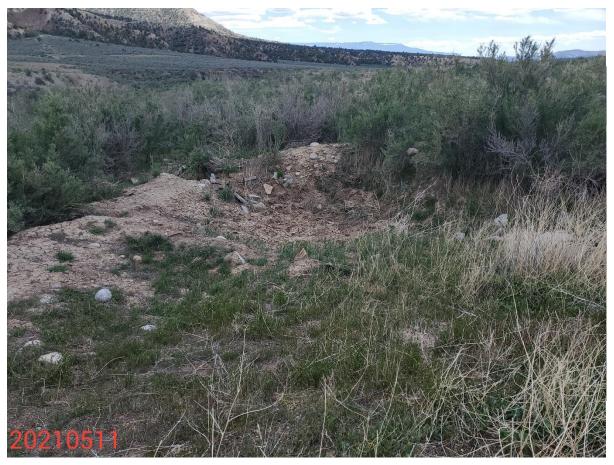
Photo 9: Photo taken from the sediment trap on the south end of the Location. Sediment trap has not been maintained in proper functioning condition.

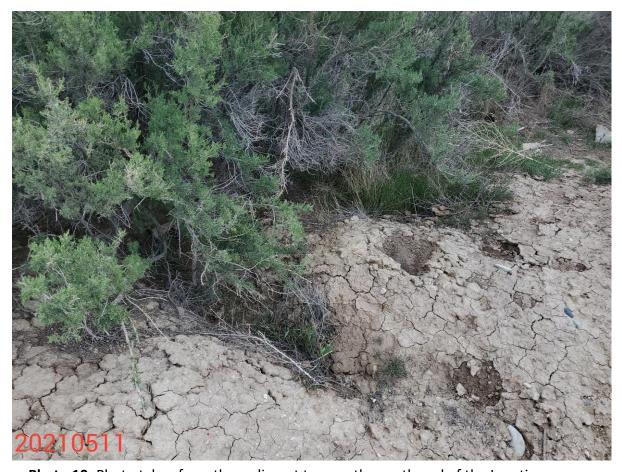
Photo 10: Photo taken from the sediment trap on the south end of the Location. Sediment trap has not been maintained in proper functioning condition. Erosion degradation evident.

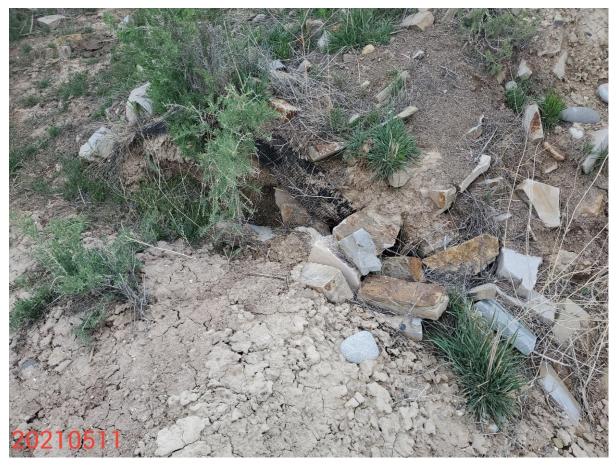
Photo 11: Photo taken from the sediment trap on the south end of the Location. Sediment trap has not been maintained in proper functioning condition. Erosion degradation evident. .

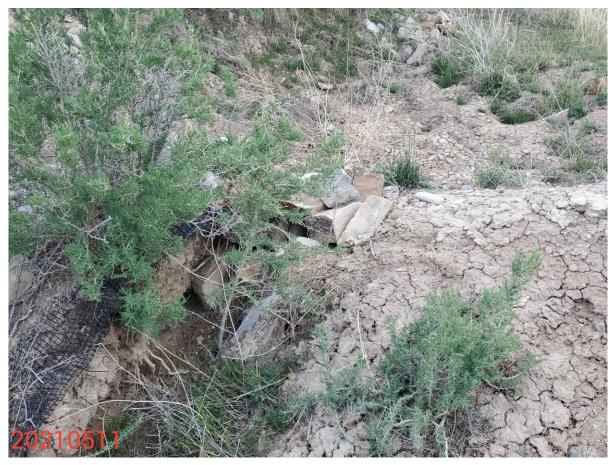
Photo 12: Photo taken from the sediment trap on the south end of the Location. Sediment trap has not been maintained in proper functioning condition. Erosion degradation evident.

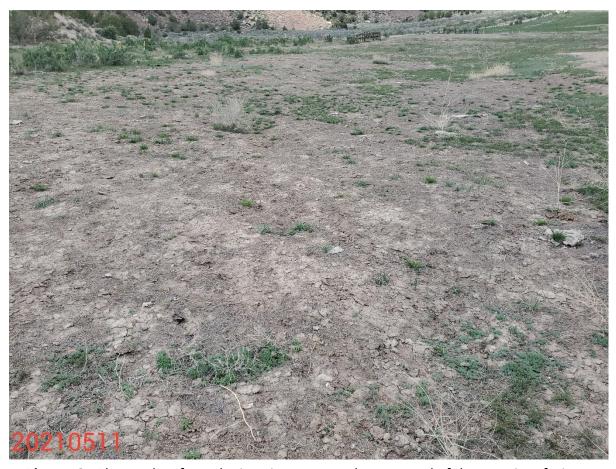
Photo 13: Photo taken from the interim areas on the west end of the Location, facing north. Desirable perennial vegetative establishment is sparse; interim areas largely bare. Vegetation observed on interim areas predominantly undesirable weedy plant species.

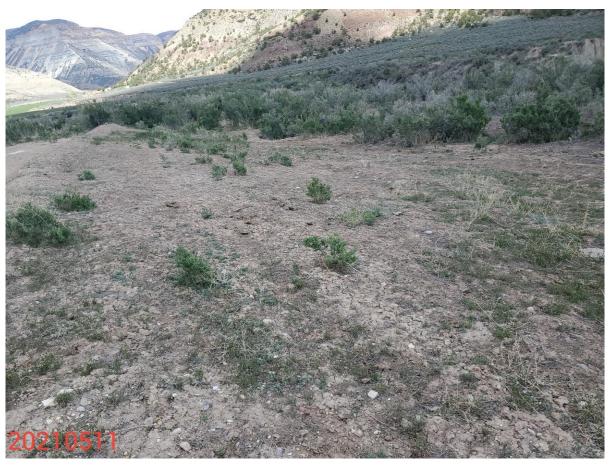
Photo 14: Photo taken from the interim areas on the southeast end of the Location, facing northeast. See comments under photo 13.

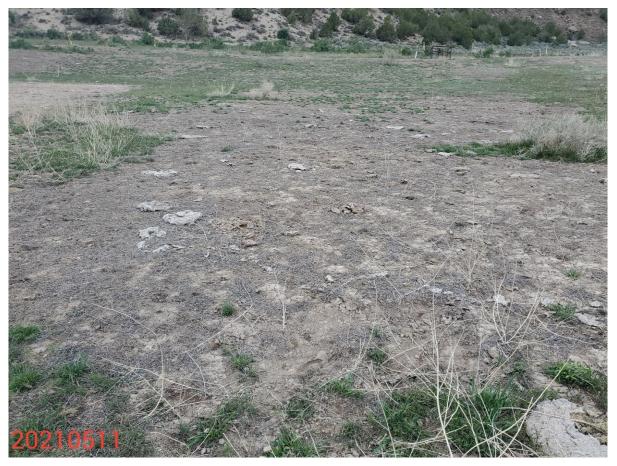
Photo 15: Photo taken from the interim areas on the north end of the Location, facing west. See comments under photo 13.

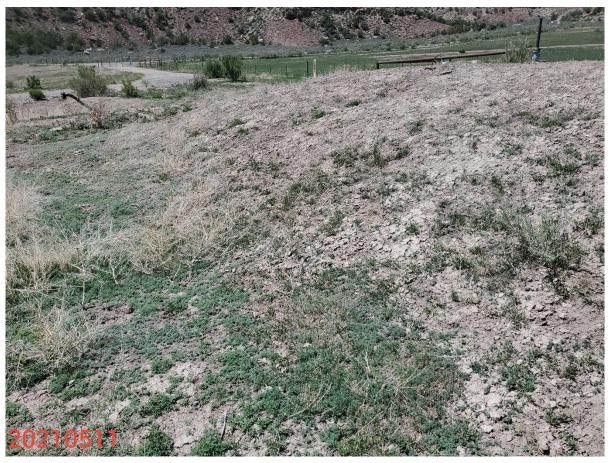
Photo 16: Photo taken from the soil stockpile on the northwest end of the Location. Photo shows vegetation observed on stockpile are undesirable weedy plant species. Stockpile not protected in accordance with Rule 1002.c

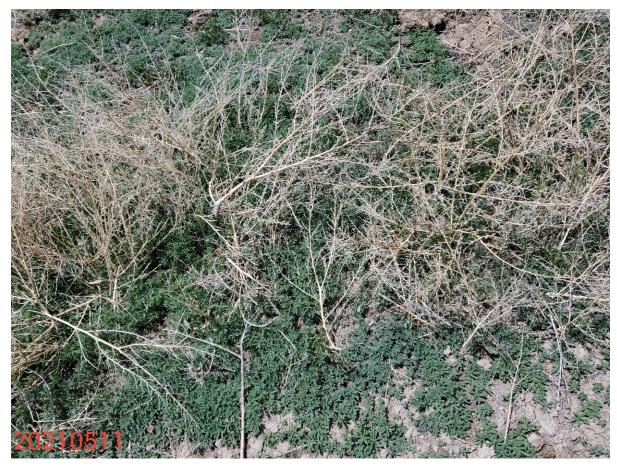
Photo 17: Continued from photo 16. Photo shows vegetation observed on stockpile are undesirable weedy plant species. Stockpile not protected in accordance with Rule 1002.c

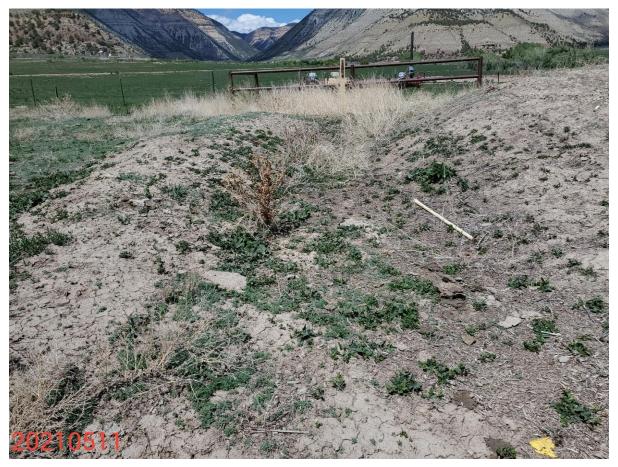
Photo 18: Continued from photo 16. Photo shows vegetation observed on stockpile are undesirable weedy plant species. Stockpile not protected in accordance with Rule 1002.c

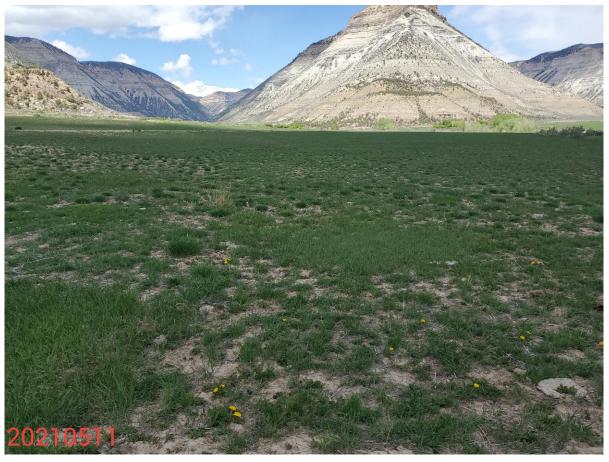
Photo 19: Photo shows vegetation on the adjacent reference areas.
